## Postscript to ‘Restoring an Eddystone S.840A – Second Version of Stratton’s ‘Economy’ Communications Receiver’, by Gerry O’Hara, G8GUH/VE7GUH

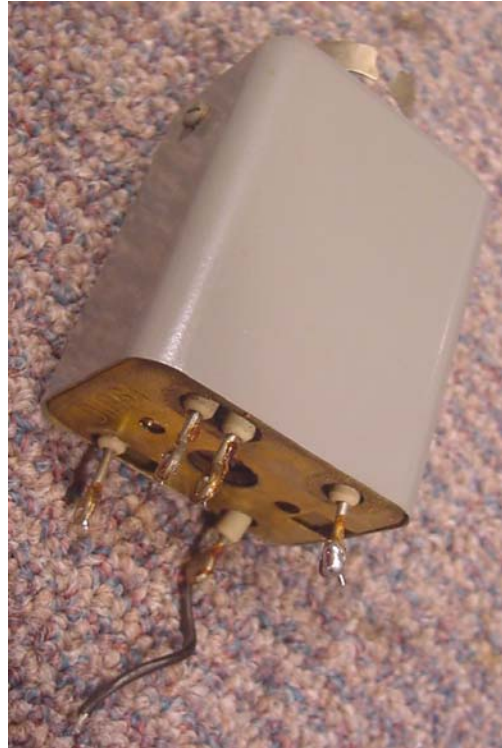
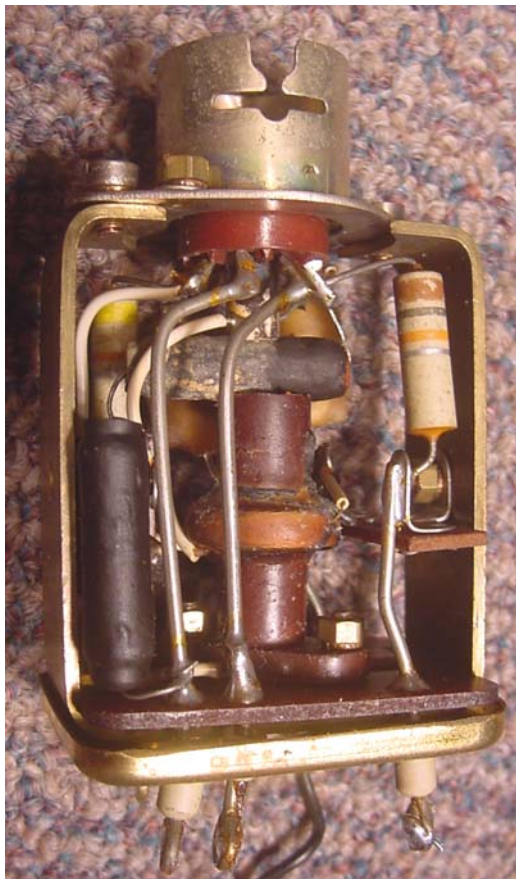
So, I took the BFO unit out of the set and opened it up. This necessitates unsoldering components and wires from the base of the unit (five in total) and undoing the two retaining screws – this is not as difficult as it sounds (photo, above).

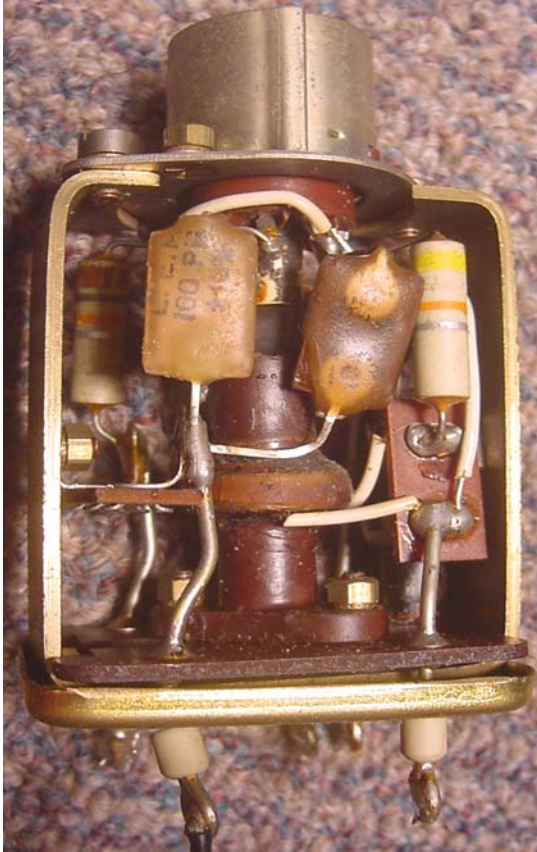
On opening the unit up, it was a bit of a mess inside (photos, left and at top of the next page) – three very tired-looking 0.01uF bypass capacitors that were very leaky and very low capacitance (two on the heater supply and one on the HT/screen supply) and two resistors that were out of tolerance. I replaced all these components and re-fitted the unit into the set –

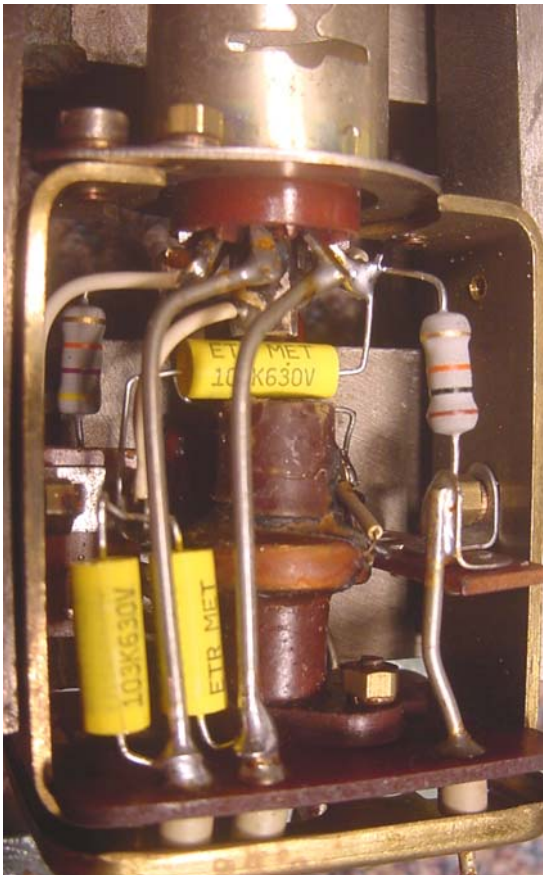
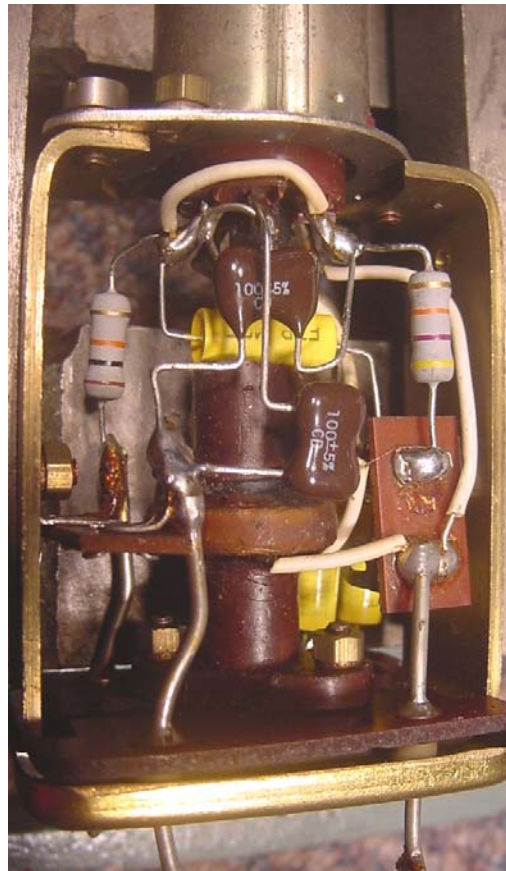
The BFO is now working perfectly (as it should with all-new components! - photos below). It's quite amazing it was working at all given the state of the old ones...
