My Eddystone S.750 Revisited – Gerry O’Hara VE7GUH

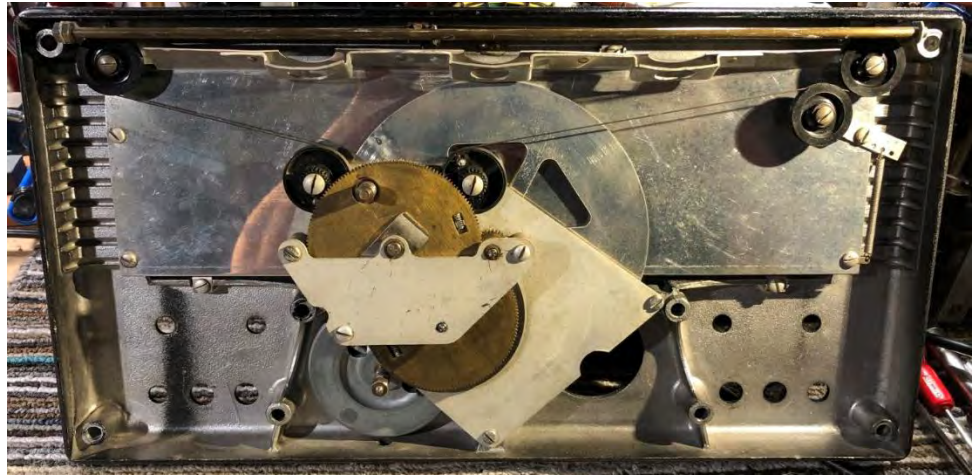
Off came the front panel (photo, right) – this is a fairly straightforward operation – remove the knobs, remove the nuts and threaded rings from the control shafts, pry-off the metal fingerplate (its secured with double-sided sticky-tape),

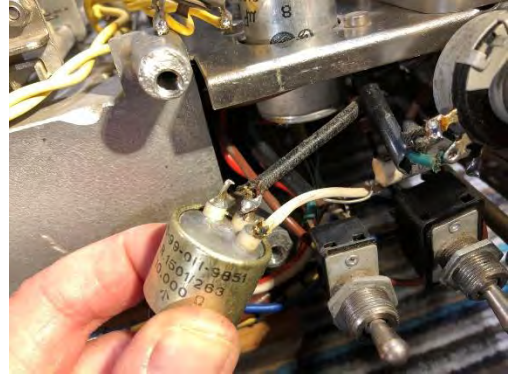
Next, I checked the IF gain control. This is a wire wound 10Kohm pot, used as a rheostat, which changes the bias, and hence gain, of the second (85KHz) IF stage. I am not sure about this pot, but the RF gain control pot on these sets is not a linear taper, rather it is anti-log taper – unusual for a wire wound pot. Eddystone used specially-wound pots to provide the required taper. Of course, these are 'unobtainium', so I had replaced this IF pot with a linear taper pot 14 years ago – a British-made military grade one

manufactured by 'Colvern' (photo, right). On testing this now, I found that it had become erratic in action over the first part of its travel – this, combined with it likely being of incorrect taper, was causing the control problem I had noticed. I found a new wire-wound linear taper pot in the 'junk box'. Connecting a fixed-value resistor between the slider and one end of a linear pot alters its taper depending on the ratio of the fixed resistor to the resistance value of the pot – it's a neat trick – see article [here](#). Of course, this also affects the overall value of the pot/resistor combination, so care needs to be taken when doing this to select the appropriate component values to best-suit the circuit. I decided to install the linear pot without a taper-compensating resistor as a first step, then, if the control proved too 'one-ended' (all the control action near one end of the track), I would experiment with different values of fixed resistor.

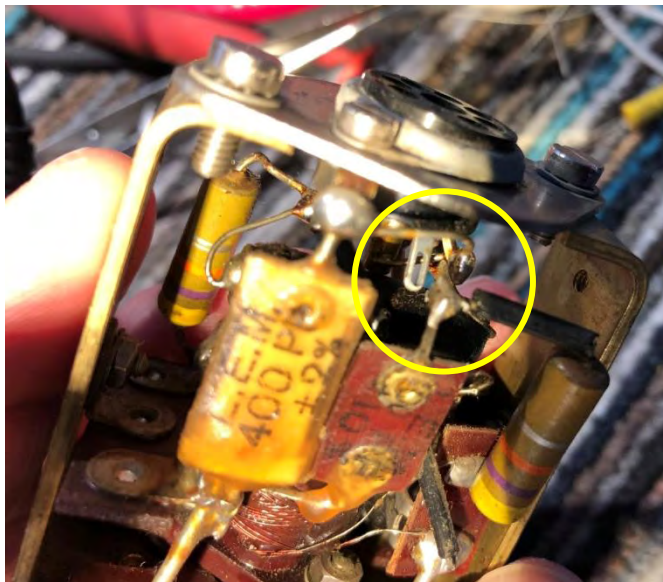
socket (circled yellow in photo, above). It had been like that for the last 70 years... and working ok, up to now. The grid pin was cleaned, some liquid flux applied and the joint made good. I guess it must have been Friday afternoon in the Bathtubs' BFO assembly department back in July 1950...

With the new pot fitted, I moved on to the BFO unit. The can includes all the BFO components, not just the BFO coil, ie. a couple of resistors, three tubular paper caps and two silver mica caps. The various connections to the can were unsoldered, the can removed from the chassis and the frame removed from the can. I found the cause of the intermittent during a close visual inspection – an un-made joint. The grid pin (1) of the tube socket had never been soldered to the grid leak resistor and the silver mica grid cap: the resistor and the cap were soldered together, but this joint was just resting against pin 1 of the tube

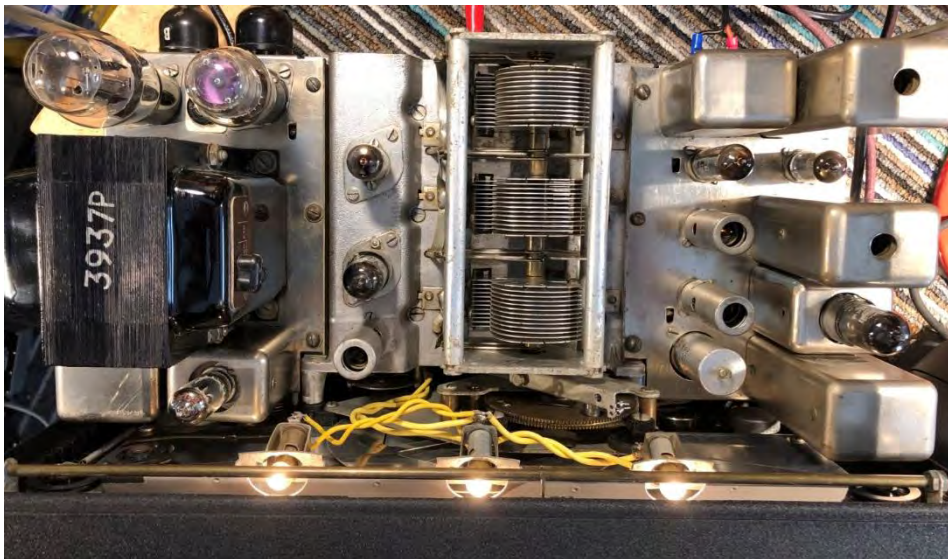
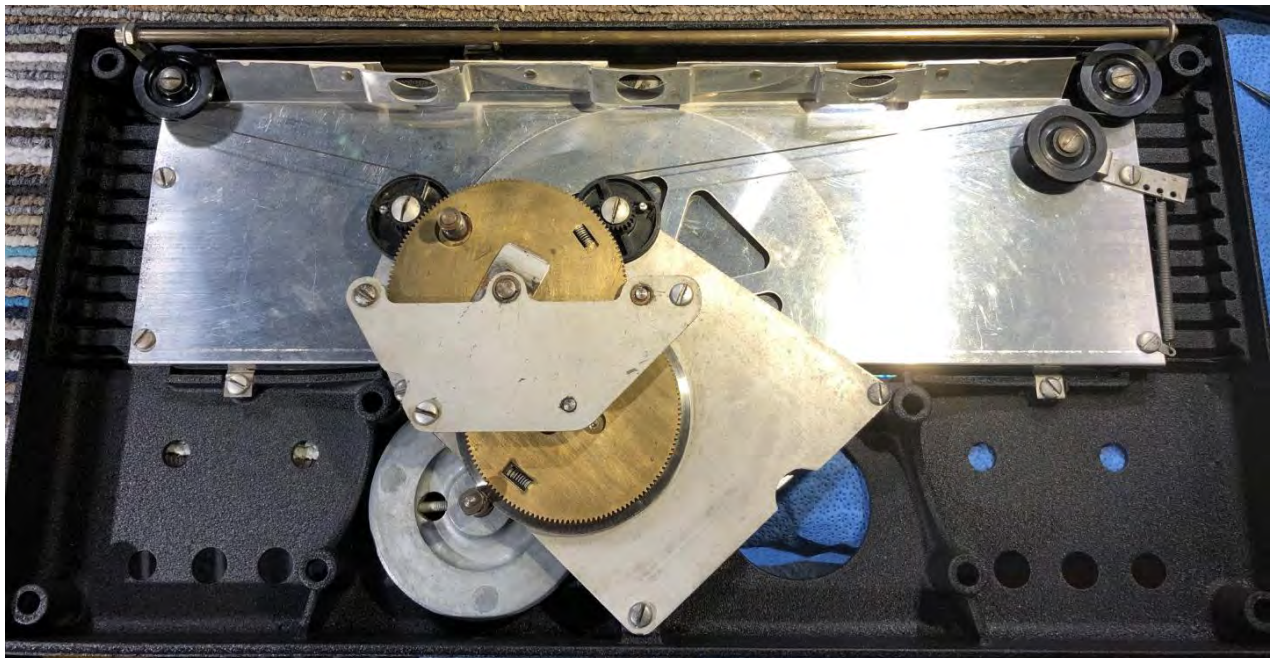
Left: Top view of chassis with the replacement front panel installed. Below: Replacement (powder-coated) front panel with scale plate and tuning mechanism/gearbox installed
