A Story about an Eddystone 888A

Introduction

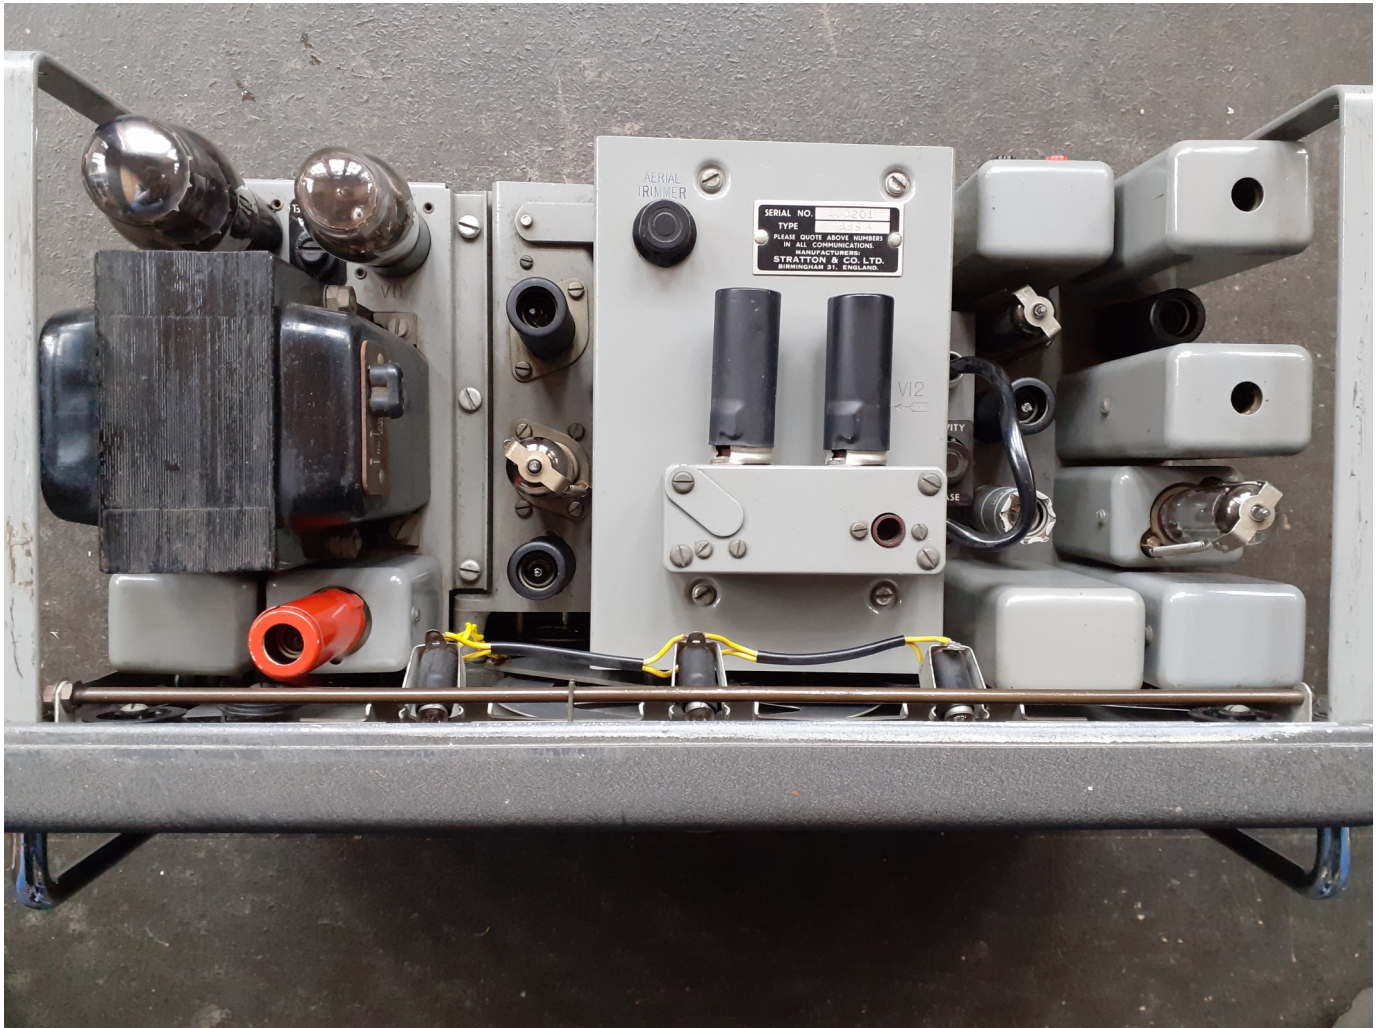
The case was removed – it came off very easily – and I looked inside. Wow, I thought, this is going to be a 'doddle'; it is all as clean and tidy as the outside, so there is nothing for me to do. I can start looking at the electronics.

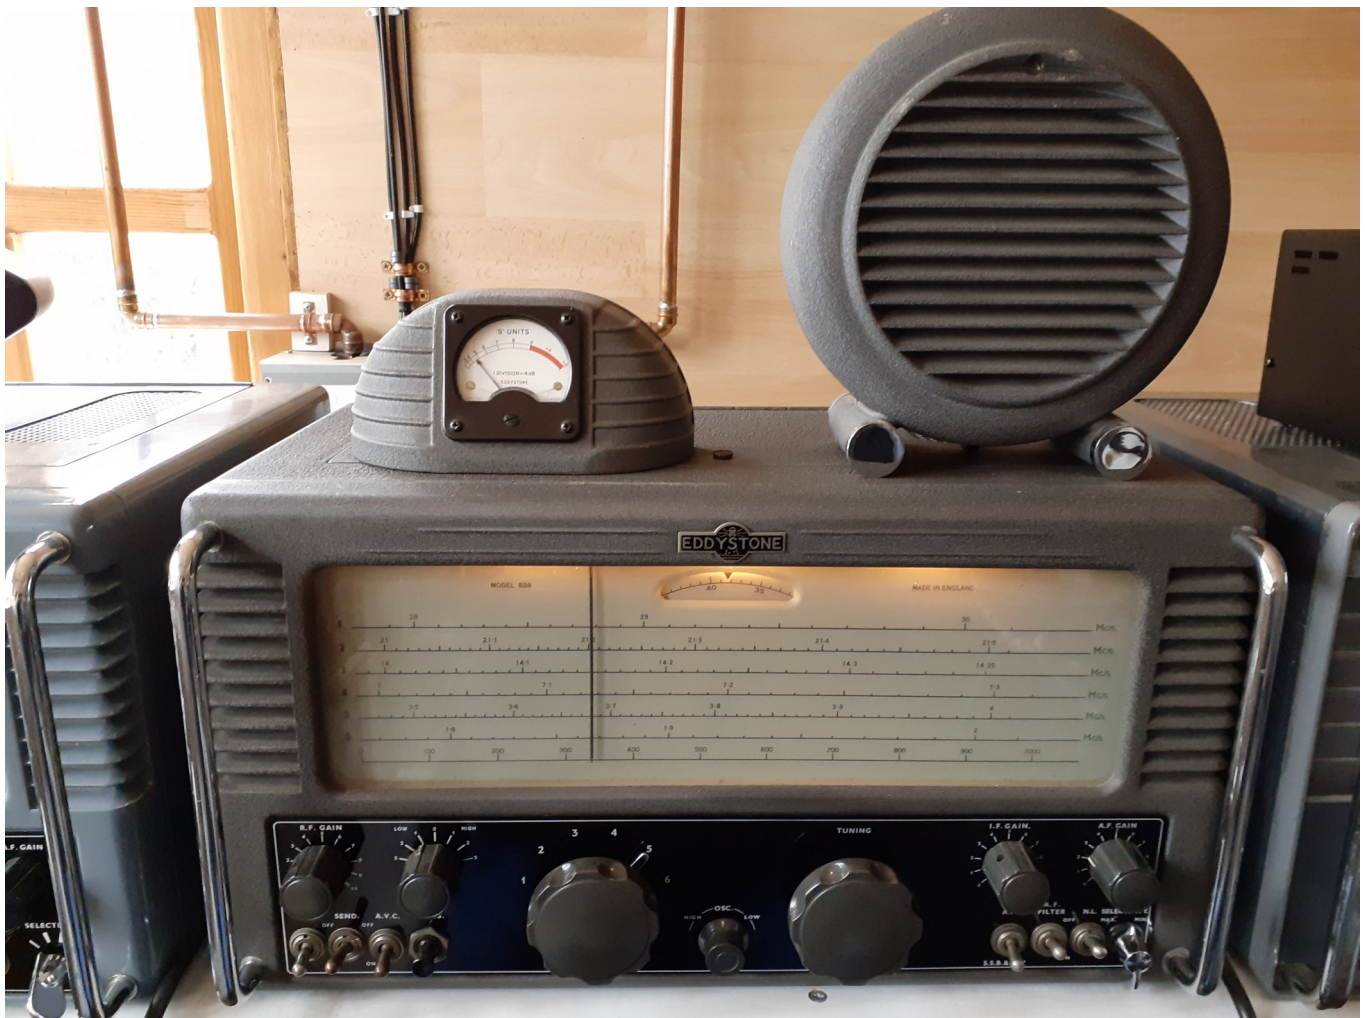
The photograph above shows the receiver with its signal strength meter and loudspeaker connected; working on the 80 metre band that afternoon. However, it was clear that all was not well. When receiving narrow-bandwidth AM signals, it worked reasonably well provided that they were strong signals

and maximum RF Gain and IF Gain were not deployed. On SSB though, the product detector appeared to be over-sensitive and prone to producing a lot of distortion. But that was something for another day. That afternoon I enjoyed myself, using my first receiver designed specifically for the amateur bands.

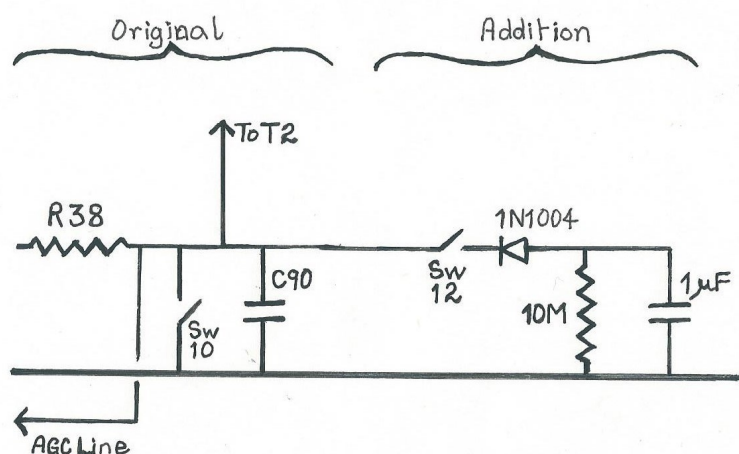
Figure 1: Addition to AGC System

I felt that the standard AGC response times were too fast for typical amateur SSB signals. Therefore, I set about developing a simple little modification to provide slower response times when receiving SSB signals. Firstly, I re-purposed the Send/Receive switch – Sw12 – to act as an On/Off switch for the mod-

ification. I did this by disconnecting and joining together the two original wires which connect Sw12 across R 41. Once this was done and these wires were insulated and tucked away safely, I had the On/Off switch which I needed. The circuit diagram of the modification is shown in **Figure 1**. On the left – annotated as Original – is part of the standard AGC circuit. On the right – annotated as Addition – are the three new/additional components and the re-purposed Sw12. After some experimentation using off-air signals, I settled on the component values shown. Other operators may well
