Refurbishment of an Eddystone EA12

by Victor Jenkins

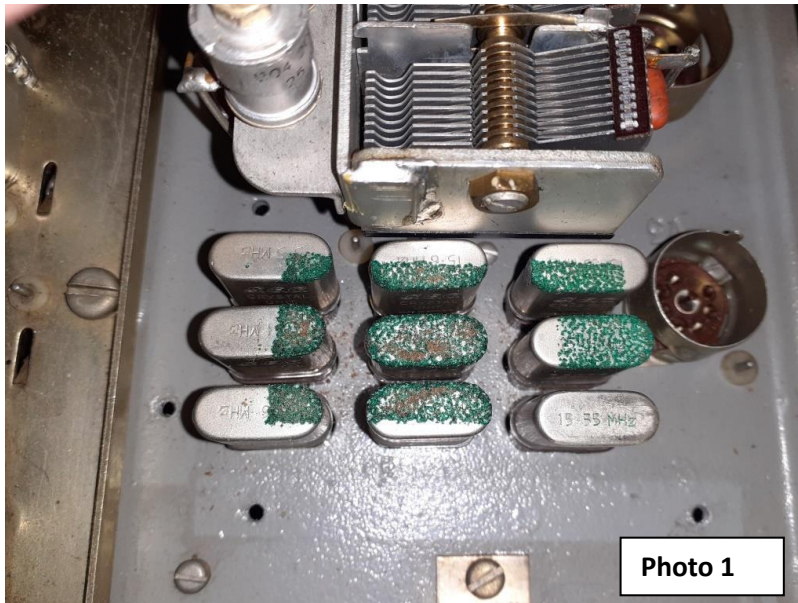
As soon as I removed all the internal covers and started looking inside the receiver, some significant issues became clear. The first thing I observed was that the foam rubber pad which keeps the crystals properly located in their respective sockets was badly decomposed

and the crystal cans were covered in corrosion. This is shown in **Photo 1**. Next, I examined all the mechanical aspects of the receiver, to check the operation of the controls and the state of the lubrication. All the controls appeared to be working correctly, although several felt a bit stiff, and there were still some signs of a little lubrication. I examined the main tuning mechanism very carefully; looking for possible causes of the

In order to refit the internal covers, I had to deal with the issue of the corrosion on the crystal cans. I was lucky because it looked much worse than it was. The corrosion was caused by hydrochloric acid which is a known by-product of the long-term degradation of a lot of the foam rubber produced during the 1960s. Which makes sense given that my crystal cans were covered in a mixture of green and black crystals, copper chloride and copper oxide, perhaps. Fortunately, the damage to the cans was not serious and I was able to clean it off with warm water and a brush. The contact pins were cleaned and polished and the crystals were put back in their respective holders. Then I made a new foam rubber pad to hold them in place. I used new, medical-grade foam which has adhesive on one side and a pure cotton sheet bonded onto the other side. This is manufactured by Hapla and I obtained some small sheets of it from www.medicalsupplies.co.uk. I fitted it inside the cover so that the cotton sheet would press onto the crystal cans.

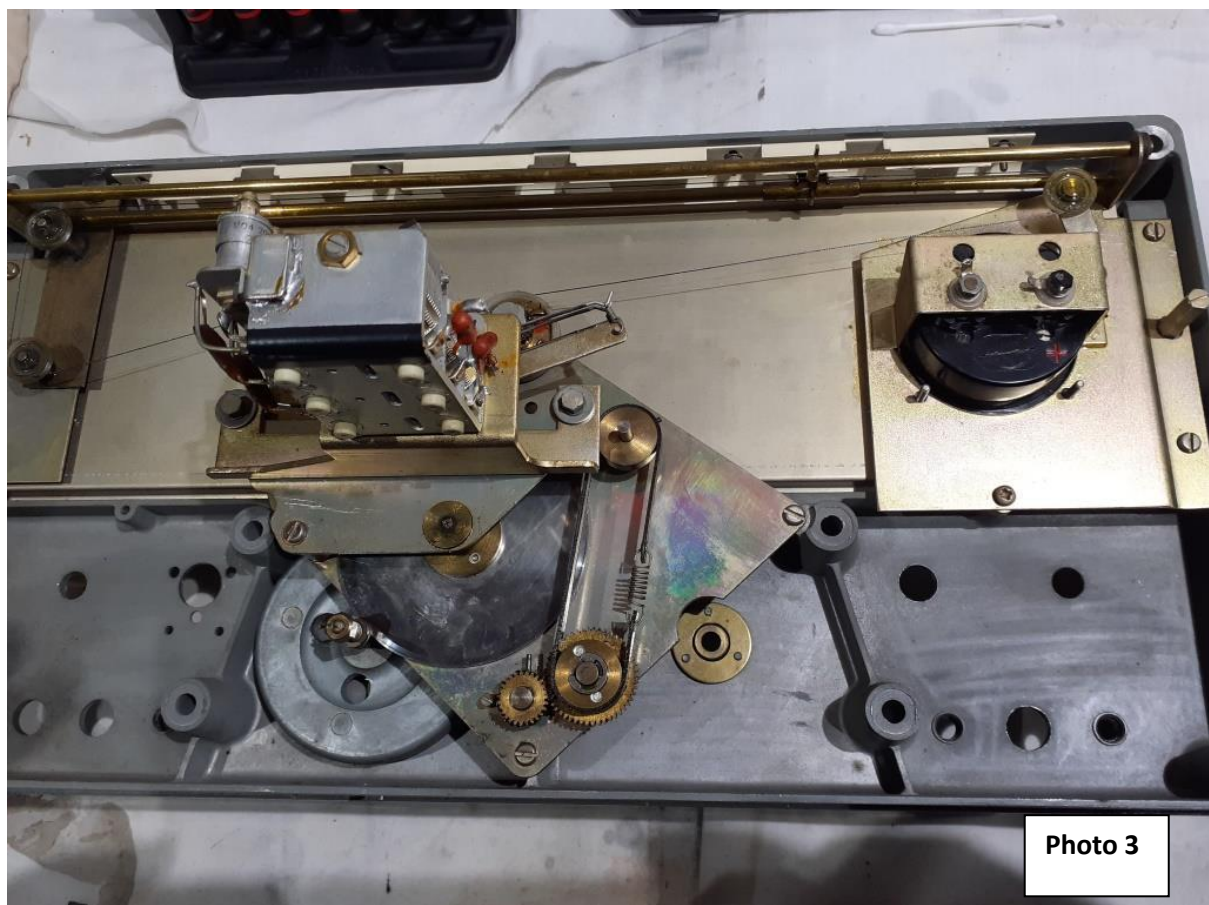
When carefully examining the receiver, as reported above, I was thinking ahead to the work that I was starting to plan, including how best to disassemble and re-assemble the receiver. I noted that the main tuning capacitor is bolted to the back of the front-panel assembly and not to the top of the coil-box assembly; as is the case for receivers like the 730, 940 etc. This can be seen in **Photo 3**.

There is a warning note in the Eddystone User Manual for the EA12 against touching these bolts because any adjustment to their positions can have serious consequences for the accuracy of the main tuning linearity. Therefore, I planned to disconnect the six wires which connect the tuning capacitor to the coil box; leaving the tuning capacitor firmly attached to the front panel, when removing it from the rest of the chassis. This approach has the advantage of giving easy access to the three fixed capacitors - C43, C45 and C66 – which are mounted between the bottom of the tuning capacitor and the top of the coil box.

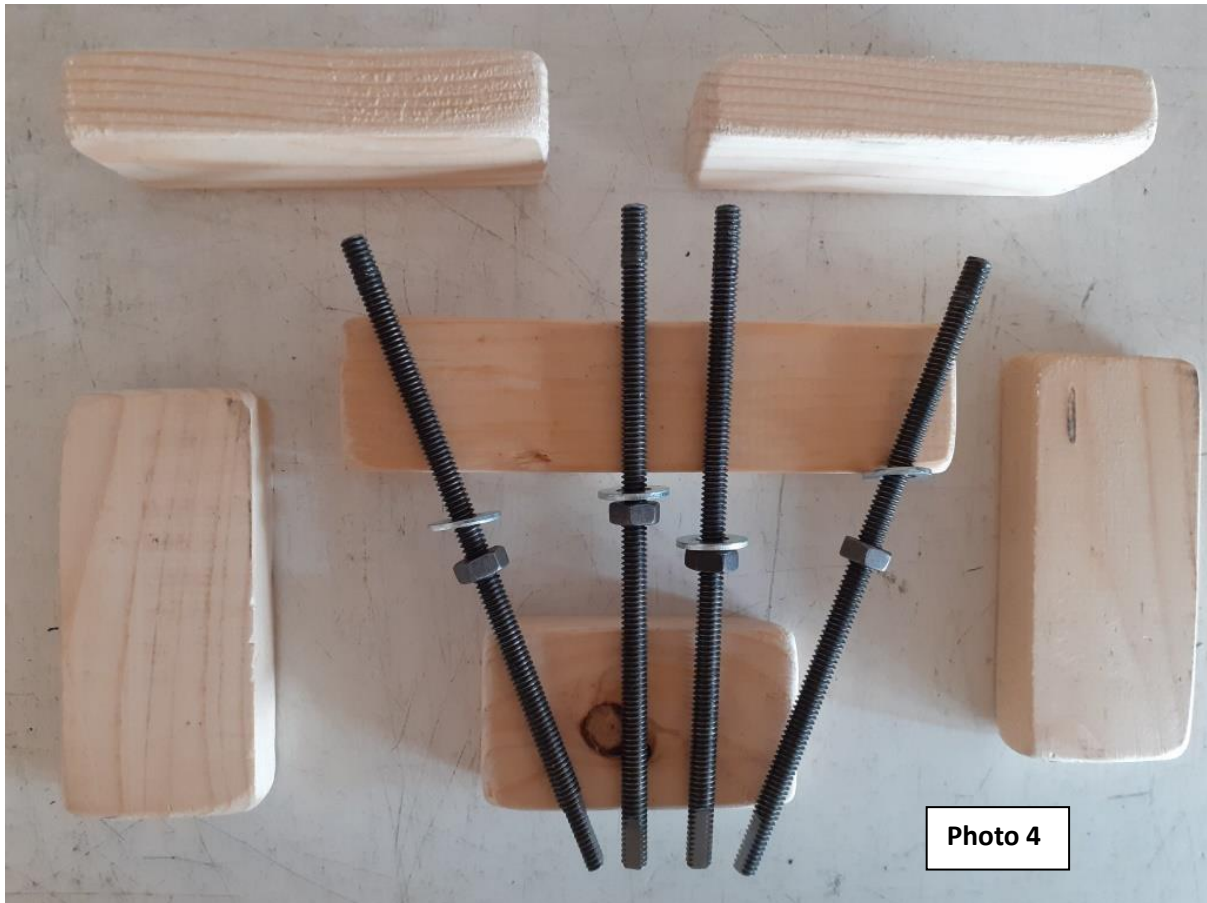
The initial ideas for some sort of jig or other apparatus to assist with the removal and subsequent re-attachment of the front-panel assembly were overly complex and, probably, difficult to make. The final solution comprises some pieces of wood, four pieces of threaded steel rod – 4 inches long and threaded in 2BA – along with four matching nuts and plate washers. As shown in **Photo 4**.

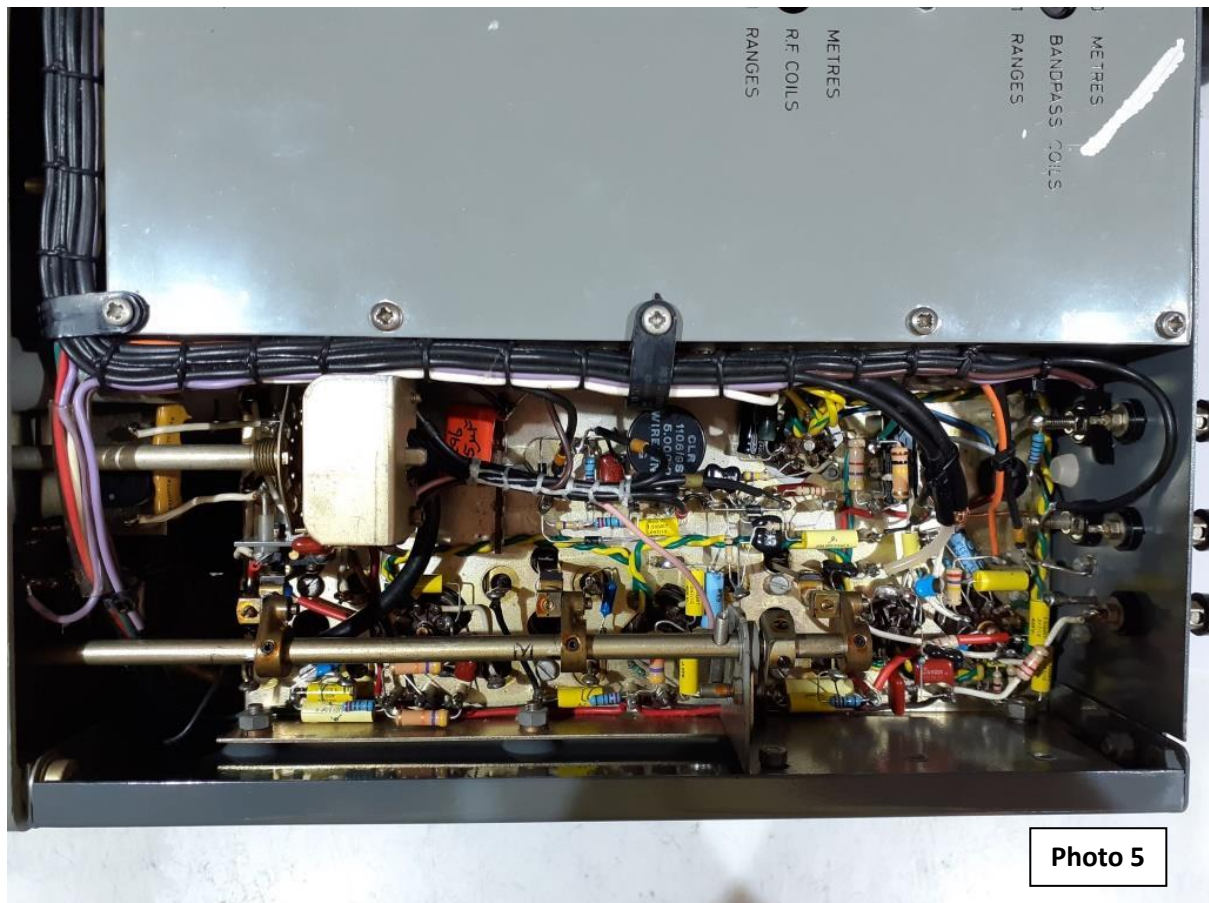
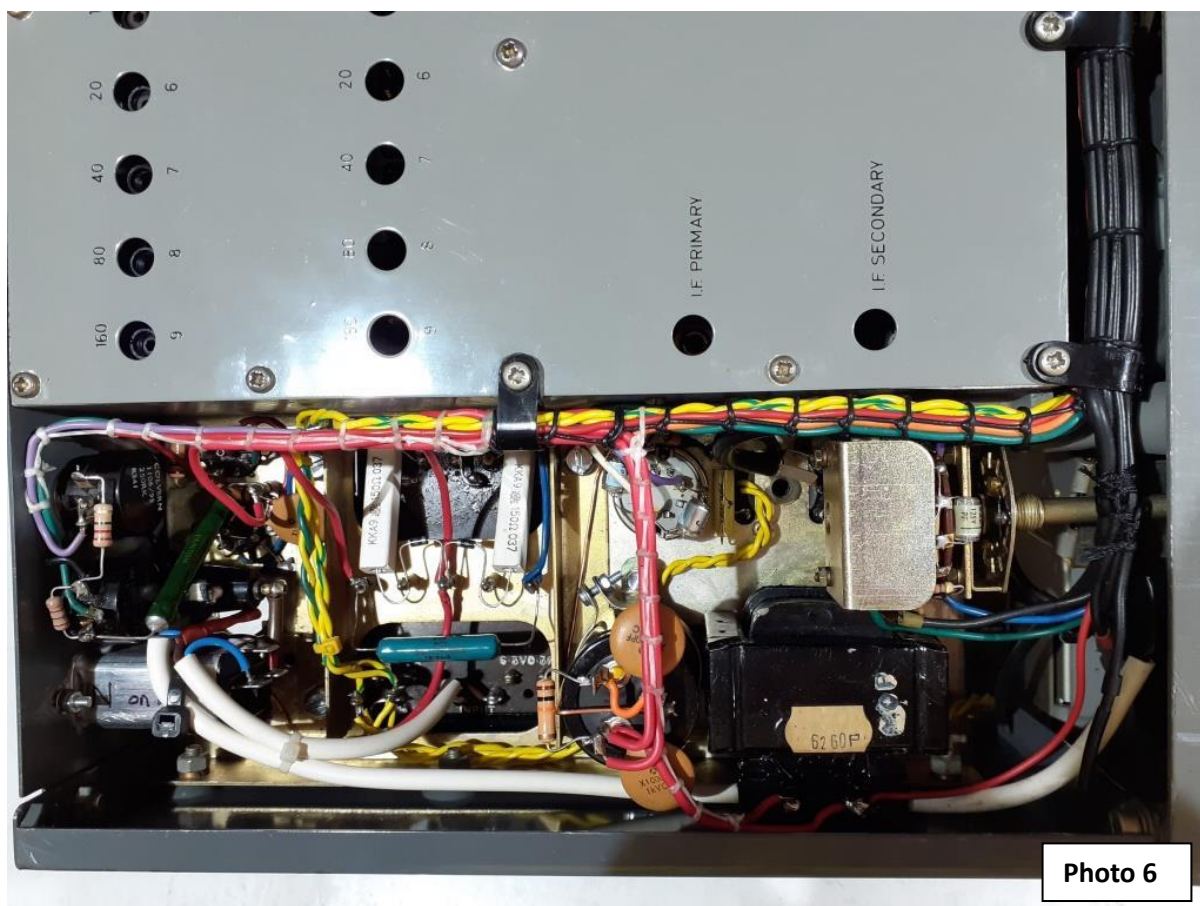
Photo 6

The underside of the chassis after the passive components had been changed is shown in **Photo 5** and **Photo 6** which were taken after the rebuild of the receiver was complete.

A big advantage of using modern components is that they are significantly smaller than the original ones; even when selecting new ones with a higher performance specification. This makes it possible to re-arrange the components into a single layer around each valve base. This step improves access, should a repair be required in the future. Also, it reduces coupling and heat transfer between components.

High-stability resistors and silver-mica capacitors were used wherever they might yield improved performance. The old paper decoupling capacitors were replaced with pairs of capacitors; one plastic and one ceramic. The HT supply to each valve was given additional decoupling and all the earthing points were scrutinised. Firstly, to make sure that they were sound electrically. Secondly, to make sure that there was not a better way of arranging the earth connections, given the new arrangement of components.

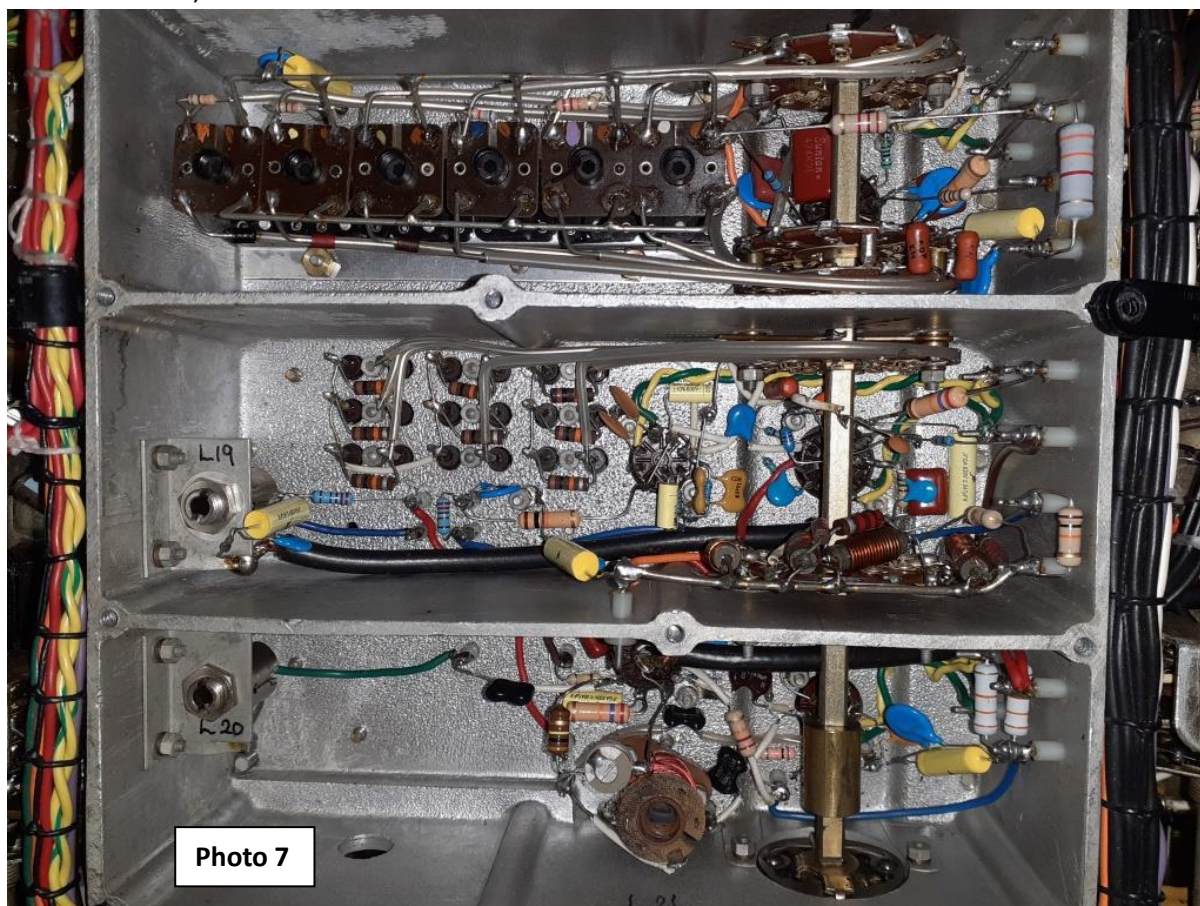
An important first step was to clean and lubricate all the switch contacts and then to lubricate the mechanical parts of the switches. As with other Eddystone receivers, there are a lot of bolted earth connections inside the coil box. Therefore, I followed my own advice in my article on [RF Earthing of Eddystone Receivers](#) and made sure that all of these bolted connections were sound and working properly. The underside of the coil box, after refurbishment, is shown in **Photo 7**.

It should be noted that this photograph includes the two additional filters described below.

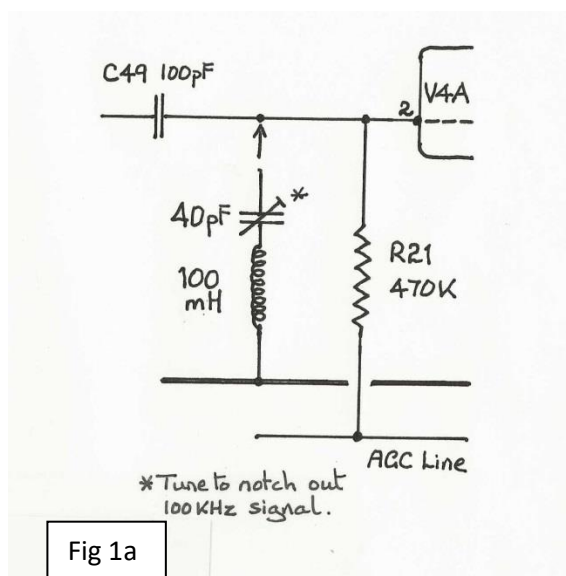
During my search, I discovered that there was a significant 100KHz component to the unwanted signals being presented to the first grid of the second mixer (valve V4A) and there is no IF trap at this point. Therefore, I made one out of a 40pF preset capacitor and a 100mH inductor and fitted it at the junction of C49 and R21, down to an earth point. As expected, this modification reduced the level of unwanted signal, but had negligible impact on receiver sensitivity. The circuit diagram of this filter is shown in **Figure 1a**.

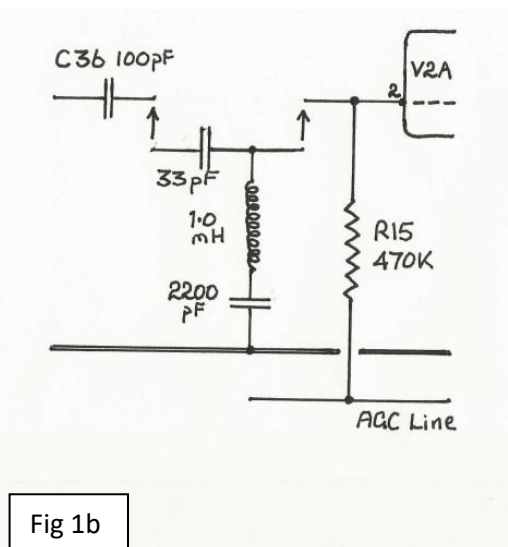
When I examined the operation of the first mixer, I discovered significant levels of unwanted and noise-like signals being presented to the first grid at frequencies below 1.5MHz. Therefore, I added another simple filter after C36. Again, this modification reduced the level of unwanted signal, but had negligible impact on receiver sensitivity. The circuit diagram of this filter is shown in **Figure 1b**.

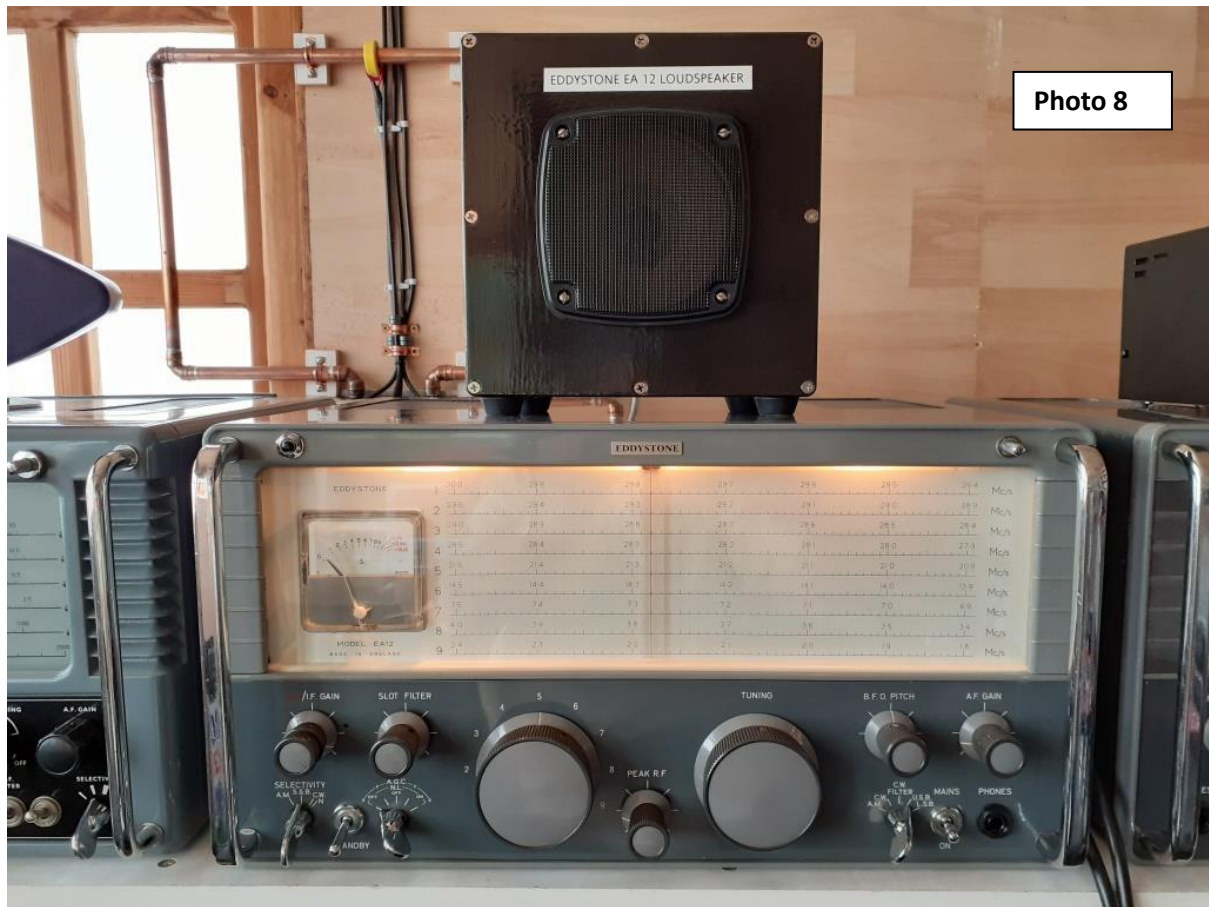
Photo 8 shows my EA12 on my operating bench, flanked by my 730 and 940 receivers, with its loudspeaker fitted inside an Eddystone diecast box and sitting on top. It is tuned to 21.281MHz and is receiving LZ3TY at S4 and producing good audio. On frequency bands above a 20MHz it works well and is a pleasure to use. On the bands below 20MHz it cannot

cope with the high levels of RF interference where I live.
