Refurbishing an Eddystone Model S830/2 Communications Receiver – Gerry O'Hara

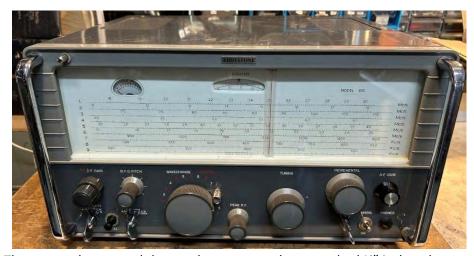
the tuning knob was spun, intermittent instability on some bands, and poor sensitivity/dial calibration. Also, the crystal calibrator push-switch did not work, the AF gain control was noisy, the RF gain control was only partly functional (working over part of its track then cut out), and the AF gain control sported an 'imposter'

knob (photo, above right). The owner also wanted the speaker output to be a standard ¼" jack socket rather than have to use a 12-pin Jones plug on the rear apron, and to have a 'modern' (IEC) power connector installed instead of the 'kettle plug' that Eddystone fitted to sets of that vintage.

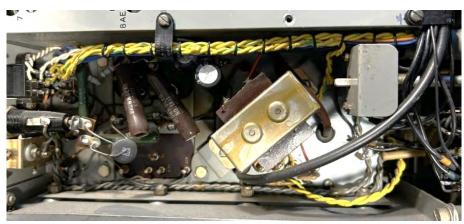
I then removed the two large 'Brown Devil' power resistors (photo, right) - these connect the B+ winding on the power transformer to the rectifier diodes. The value of these (previously replaced) parts was incorrect (250ohms, should be

140ohms), so would be replaced. Removing these resistors allowed a closer inspection of the power supply compartment revealing significant heat damage. This reminded me of the first S830/4 set I owned and refurbished, ie. toasted, cracked, or discoloured insulation, with bare wire exposed where the brittle insulation had fallen away (photo, left). This damage is a result of inadequate ventilation to allow the heat generated by the four power resistors in the compartment to escape – bearing in mind these sets were often used 24/7 for many

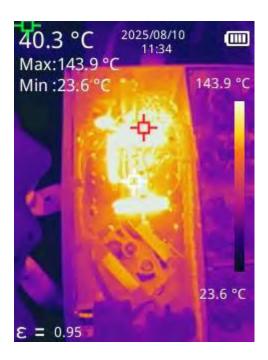
After the set had been operating for an hour or so, I took some thermal images of the underside of the chassis, especially the rebuilt power supply section (image, right). All looked ok, with the hot spots being the four power resistors (two as surge limiters in the B+ secondary of the power transformer feeding the rectifiers, and two as dropping resistors to the two 150vDC OA2 voltage stabilizer tubes). These resistors were running between around 122C and 152C, which is ok. The B+ choke windings were running at around 35C, which is good, and the power transformer was hardly warm to the touch (Eddystone generally over-spec'd their power transformers after a problem they had with the

first version of the S680 receivers just after WWII...!). I was surprised to see that the fuse element was running at 85C (image, left), even though the current

draw through the fuse was measured at 133mA: the 830/2 spec. notes that if an external power supply is used, this should be able to provide 160mA B+ current at 250vDC, so 133mA seems reasonable current draw, though a little lower than I was expecting, hence my selection of a 200mA slow blow fuse rating. I then left the set on soak test for a few hours more to make sure everything was running reliably.

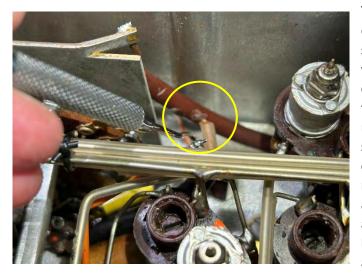
The inner of this short length of coax had detached from the wiper lug on the 'S1f' switch wafer – circled in photo, left (probably while I was manipulating the nearby coupling capacitor between the 1st local oscillator and the 1st mixer stage out of its 'hidey hole' to replace it). Unfortunately, this lug is in the same orientation as the one I had to access on switch wafer 'S1g' to install the replacement 2.2Mohm resistor – and just as awkward to access (or even see!). To gain access to the end of the coax and the wiper lug on the 'S1f' switch wafer, I had to remove another coil assembly (L17), which allowed

sufficient (but still very tight) access to strip a short piece of insulation from the inner coax wire and solder it to the lug on the switch wafer. I then re-installed L17 and wired it into the circuit. All resistance/continuity checks were now ok.

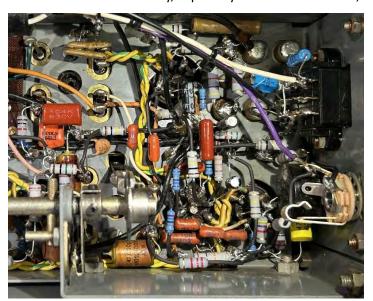
there was severe instability, especially with the AGC active, but only on AM and CW. This was soon

traced to another (tiredness-induced) error - I had forgotten to install the 0.1uF AGC bypass capacitor (this is located in the audio stages and had been removed for access). When the set is in LSB or USB modes, a 10uF (tantalum) AGC bypass capacitor is switched into circuit to increase the time constant - slower is more suitable for SSB, and this prevented the instability. Installing a 0.1uF AGC capacitor (faster time constant for AM and CW) fixed the instability issue. I left the chassis on soak test for a couple of hours and all seemed ok. The photo, left shows the reworked audio stages.

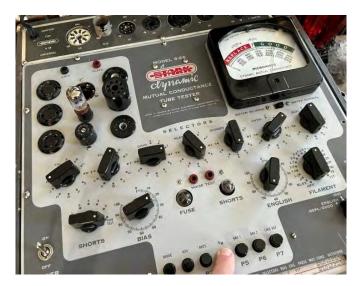
I next tested all the tubes on a STARK 9-66 tester (photo, right). All tested very good, except the 6AT6 AM detector/AGC/1st audio tube, in which the triode section was weak. All the 6AT6 tubes I could find were 'pulls' and the best of them tested around the same as the one in the set, so I left it in place. It seemed to work ok, but I noted to the owner that if he had a better one, he may want to install it. I also cleaned all the tube pins and replaced two of the smaller tube shields with the correct size ones from my junk box.

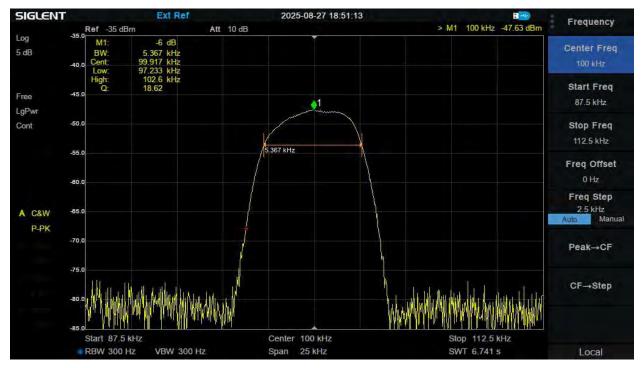
Above: 100KHz IF response on 'AM' setting of the Selectivity control (5.37KHz @ -6dB). This was subsequently tweaked to provide a 6KHz bandwidth and a flatter top to the response curve. Below: 100KHz IF response on 'SSB' setting of the Selectivity control (2.7KHz @ -6dB)

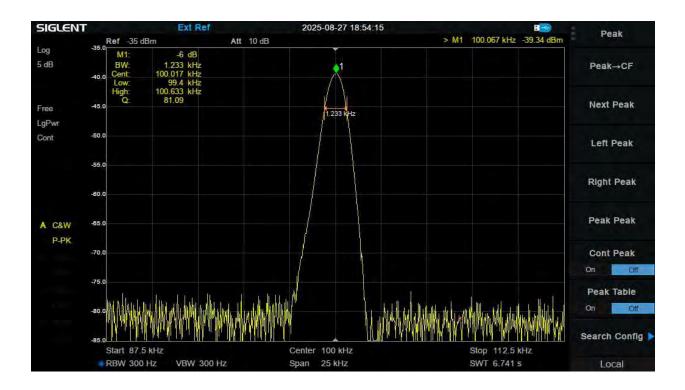
Above: 100KHz IF response on 'CW' setting of the Selectivity control (1.23KHz @ -6dB). This was subsequently tweaked to provide a 1.3KHz bandwidth. Below: 100KHz IF response on 'N' (crystal) setting of the Selectivity control (47Hz @ -6dB). This was subsequently tweaked to provide a slightly wider (73Hz) bandwidth.

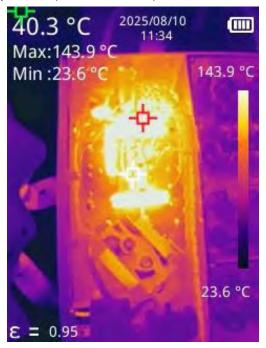
Above left: Power supply compartment. The hot spots are the four power resistors. Above right: Close-up of the power resistors in the power supply compartment. The hot spot (149C) is one of the dropper resistors to one of the OA2 150v stabilizer tubes

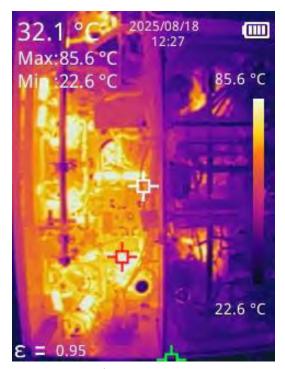
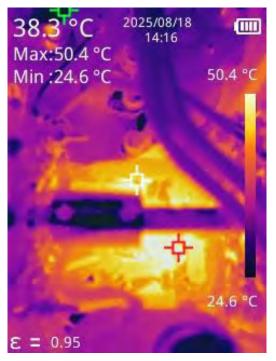
Above left: The 2^{nd} IF/AF compartment – the hot spot (85C) is a 2W resistor in the audio output stage. Above right: Close-up of the 1^{st} local oscillator compartment – the hot spot (50C) is a 1W resistor
