## Unusual Instability Issue on a Refurbished Eddystone S830/2 – Gerry O'Hara

### Instability Noted

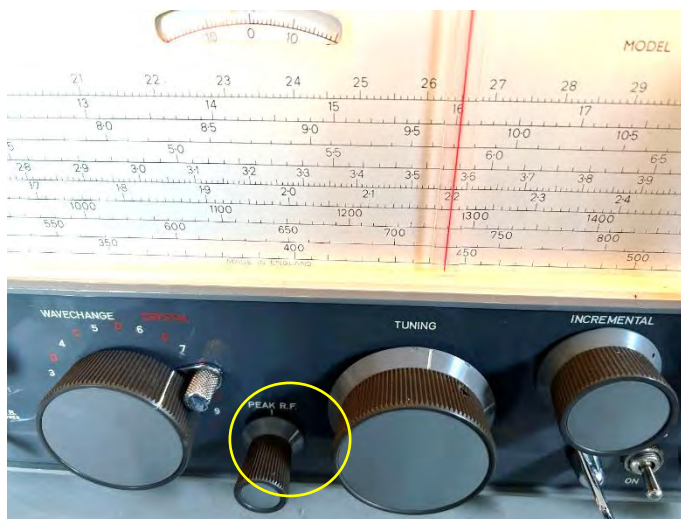
While tuning around the bands one evening, I noted that on Band 7 (upper part of the Broadcast Band), when the 'Peak RF' control was rotated to around half-way into the right-hand quadrant of its 180 degree rotation (circled in photo, right), the set started to 'motorboat' (see video [here](#)) – this is a position of the Peak RF control not normally needed, as the bands all peak around mid-travel. After some further tuning around, I noted that this instability only occurred above around 1280KHz on this one band, ie. between 1280 and 1550KHz, and only with the RF gain fully advanced. It did not matter whether an antenna was connected or not.

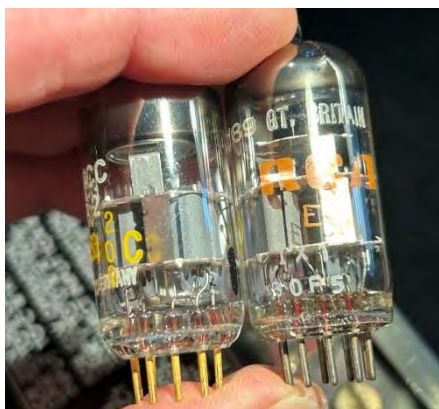
While I was swapping tubes, I noticed that the RF amplifier tube that had been fitted (and that I had tested on a STARK 9-66 tester during the refurbishment work), was actually an E88CC(!). I had not

noticed this at that time - I must have been distracted, or just assumed that the correct tube had been fitted knowing how fastidious the owner of this set is. The E88CC and ECC189 (photo, left: E88CC on the left, ECC189 on the right) are similar tubes, ie. both are 'frame grid' construction and with similar characteristics, however, the ECC189 (6ES8) is specifically designed for use as a cascode amplifier – as in the S830/2, at up to VHF, and this is the tube type that Eddystone specify for the RF amplifier stage in the S830/2. The (Westinghouse) E88CC installed in the set was a 'strong' tube, with a Gm of 7000 in each triode, so I tried replacing it with a similarly 'strong' (RCA)

ECC189, with a Gm of around 9250 in each triode. This actually resulted in slightly degraded performance on all bands, especially the dual-conversion ones (Bands 1 through 6), ie. above 1.5MHz – I chalked this down to the receiver having been aligned with the E88CC tube installed. The motorboating was still present with the 'strong' ECC189 tube installed, however, I also tried a much weaker ECC189 (Gm around 2500 each section), and the motorboating stopped – not a very satisfactory cure though(!). I decided to re-install the high-Gm ECC189 in the set and later align the antenna, RF amplifier, and 1st mixer stages to optimize performance again once the motorboating issue was resolved.

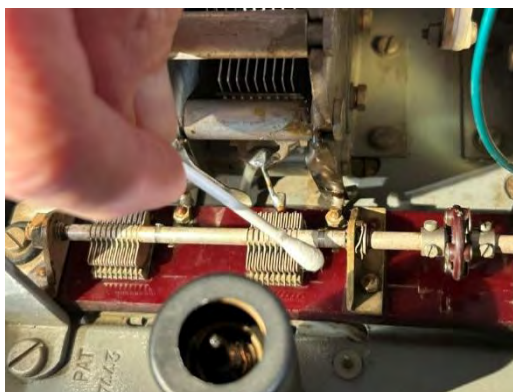
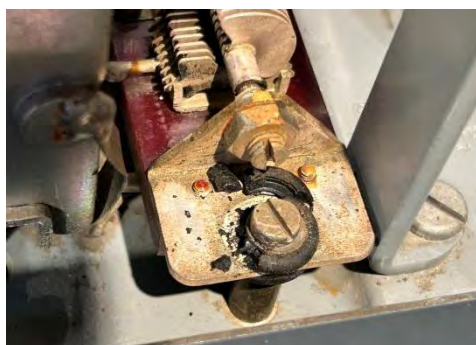
So, with the issue not being tube-related (other than a weaker tube 'fixing' it), I started the next stage of troubleshooting by checking the grounds on the 'Peak RF' tuning gang. I gave the grounding contacts a thorough clean, re-lubed the bearings, wiped Deoxit D5 onto the ground contact fingers and contact points on the tuning gang shaft (photo, right), and made sure the nuts securing this assembly were tight. I found two slack nuts – one on a grounding contact and one on the screw holding the rear bracket of the 'Peak RF' assembly in place (the nut was almost falling off, but was very hard to see, buried deep in the rear of the coilbox – barely-visible in fact), and the nut did fall off as I tried to access it(!).

attached to the screw on the top of the chassis. The rubber grommet that the screw passes through on the end bracket of the assembly was perished (hardened) – photo, above left, so I replaced that as well (photo, right). None of this effort made the slightest difference to the motorboating (of course!), but at least the 'Peak RF' assembly is working well and secured properly on a resilient mount.

It would be very difficult to replace this nut and lock-washer due to the very poor access without removal of at least the Band 1 antenna coil assembly, and likely disconnecting several wires running to other antenna coil assemblies. So instead, I inserted the screw from within the coilbox, with the lock-washer and nut then being easily

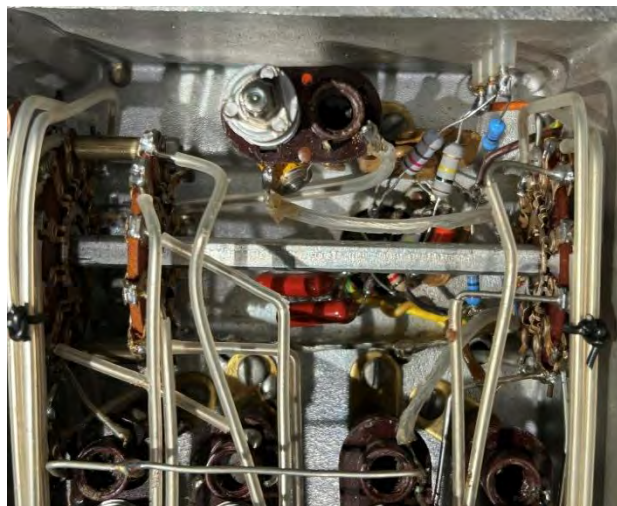
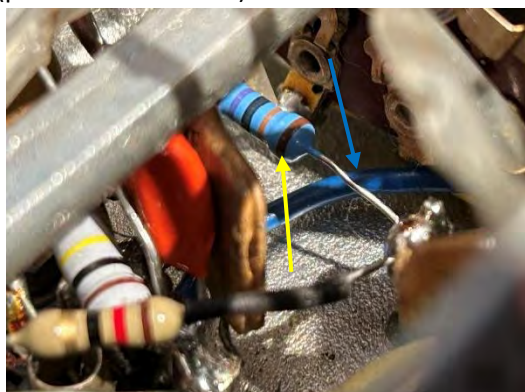
With the above work eliminating the tubes and the Peak RF tuning gang from the list of potential causes of the instability, I then turned to the possibility of poor lead dress, dry joint(s), or an ineffective (corroded) ground connection in the coilbox – especially in the RF amplifier compartment (photo, right).

With the set tuned to around 1450KHz on Band 7 and the 'Peak RF' control adjusted to induce the motorboating, I went around the components and wires in the RF and 1st mixer compartments of the coilbox, poking components and moving wires slightly using a plastic chopstick. Just about every wire associated with Band 7 (and some that were not!) altered the tone of the motorboating. I eventually tracked the issue down to the dress of the wire connecting the plate of the RF amplifier tube (pin 5 of the ECC189) to wafer S1d of the band change switch (this is the wire with blue insulation at the tip of the blue arrow in photo, left), relative to the AGC line connection to this tube. The AGC line is connected to the grid of the RF amplifier tube via a 270Kohm filter resistor (tip of the yellow arrow in photo, left), and a 12ohm 'grid stopper' resistor – the latter to mitigate VHF instability. The other end of the 270Kohm resistor is grounded to RF by a 0.1uF disc ceramic capacitor, and connects to the AGC line that also connects to the grid of the 1st mixer tube (via a 470Kohm resistor) and to the grids of the 2<sup>nd</sup> IF amplifier stages (via 270Kohm resistors).

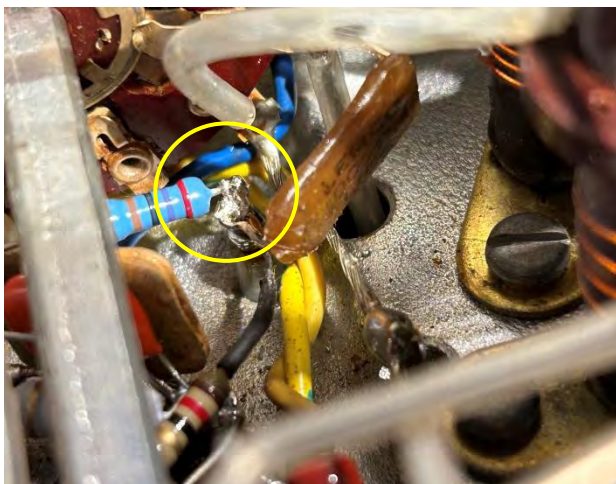
I found that moving the plate connection wire away from the end of the 270Kohm resistor connecting to the 12ohm grid stopper resistor cured the motorboating, but the wire tended to flex back close to its original position. To effect a more secure fix, I removed the 270Kohm resistor and replaced it with another dressed with a very short lead to the grid stopper resistor, circled in photo, right – compare this with the lead dress in the photo above (and yes, these two 270Kohm resistors appear to have different markings in the photo, but they do not – I also checked their values using a DMM). In this slightly revised configuration, the very short lead connecting to the grid stopper resistor is much less liable to RF pickup from the plate connection wire, and any RF picked up by the other (longer) lead of the resistor that is closer to the plate connecting wire, is grounded to RF by the 0.1uF disc ceramic capacitor, and

isolated from the grid by the 270Kohm resistor. I also dressed the resistor body further away from the plate connecting wire. The result was a much more satisfactory fix, even if the plate wire 'creeps' towards its original position over time.

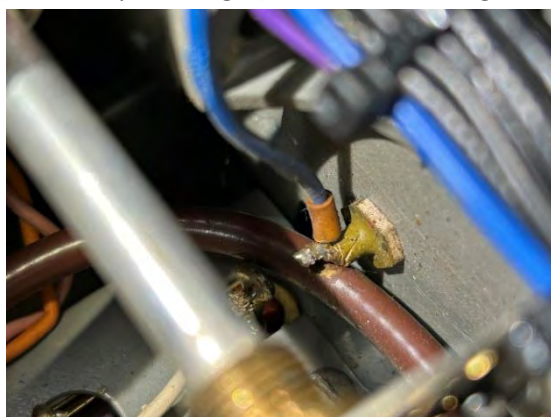
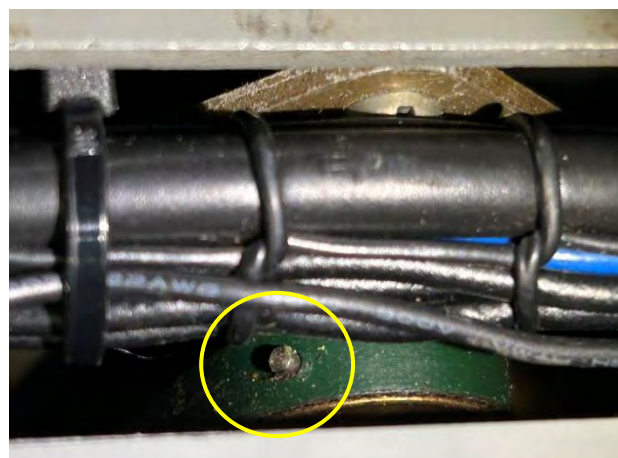
I also fixed a few other things I had noted while working on the set. The first was that there was something catching the 'Peak RF' control as it was rotated. This turned out to be caused by the small locating spigot on the pulley mounted on the Peak RF control shaft that engages with the neoprene/fabric drive belt to the Peak RF tuning gang (circled in photo, right) - this was catching on the

top surface of the wiring loom that runs in front of the coilbox. I added a couple of additional small cable ties to pull the loom out of the way to fix this.

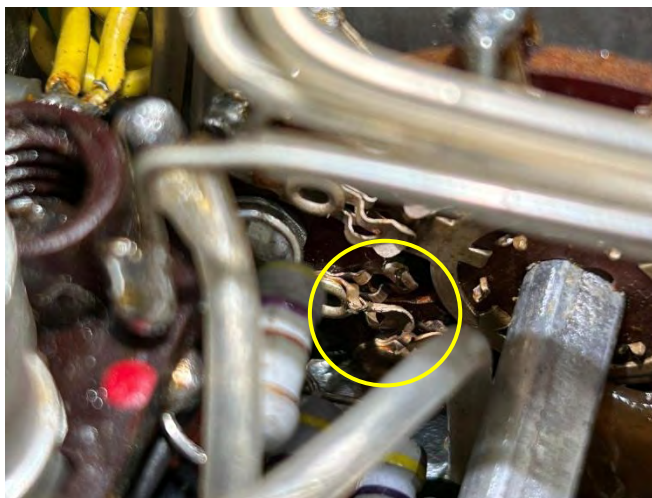
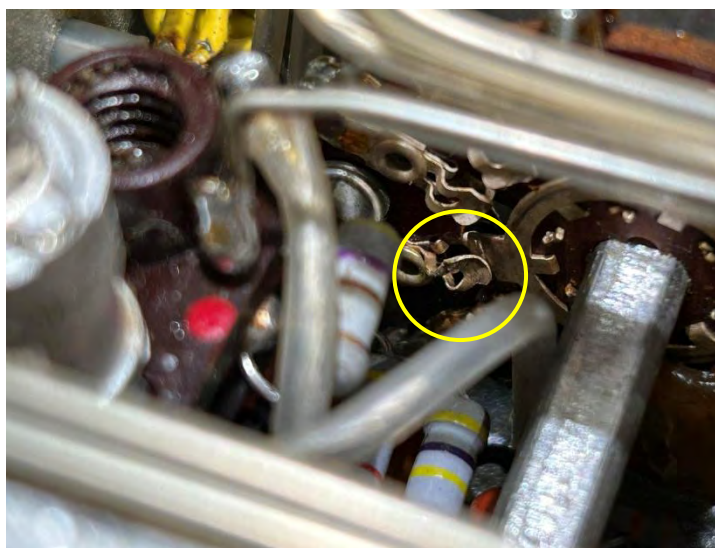
The second was a repair to a feed-through capacitor in the coilbox wall, noted during my close inspections of the wiring during the troubleshooting (photo, left).

There was a small crack and chip on the ceramic body of this capacitor— so, I cleaned-up the ceramic body using IPA, and then added some 2-part epoxy around the body to make it secure.

Finally, when I was closely inspecting the RF amplifier compartment to locate the source of the instability problem, I had noticed that the upper stator contact for Band 7 on the band change switch wafer S1c (antenna transformer secondary selection to the RF amplifier tube grid) had been bent/mangled (circled in photo, right). This most likely happened due to wear/slight misalignment of the upper stator contact, resulting in the edge of the rotor catching the edge of the upper contact while the switch was being operated (rotated clockwise from Band 6 given the way the contact was bent). This stator contact was mangled so much that it was no longer contacting the rotor, however, the lower contact was still pressing against the rotor ok, so the switch was operating normally electrically, even with the mangled upper stator contact.

I did my best to straighten and reorientate the upper stator contact until the switch was working with both the upper and lower contacts pressing against the rotor on Band 7, and such that the rotor slid between the two contacts easily from either direction as the switch was rotated (the repaired upper stator contact, with the rotor sitting between the upper and lower stator contacts, is circled in photo, left). The switch has been operated many times since and is working ok, however, the owner of the set has been advised to be aware that a similar 'crash' of rotor and stator contacts could happen again in

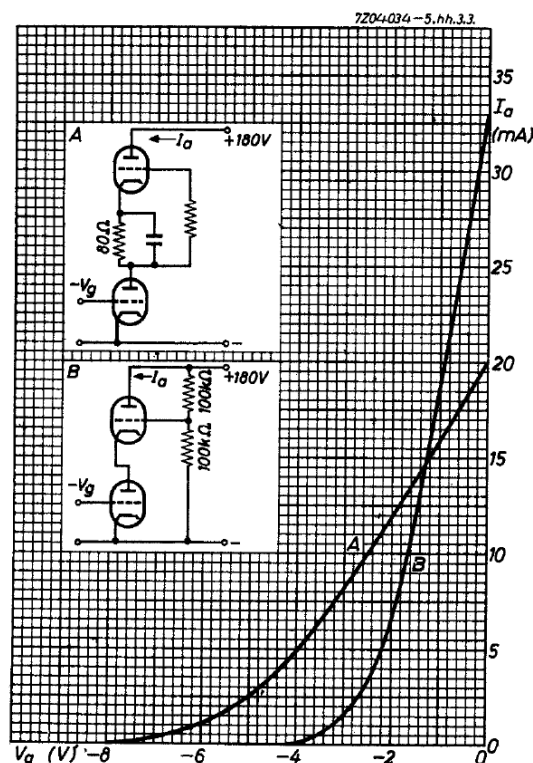
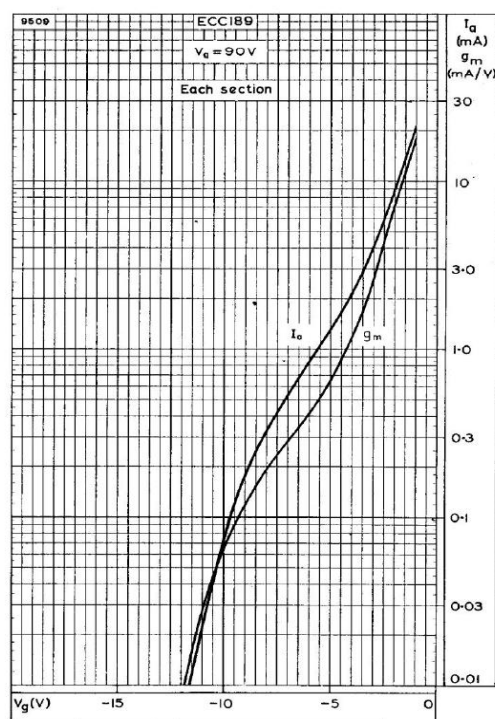
To confirm this, I pulled out the characteristic curves for each of these two tubes: the plate current  $v$  grid voltage curves for the ECC189 and E88CC are shown right (E88CC above, ECC189 below). Comparing these two curves for the grid voltage required to give a cut-off corresponding to 1mA plate current, the ECC189 requires around -5v, and has a fairly linear curve, extending down to -13v for 0.1mA plate current. The E88CC requires -3.5v in the 'B' cascode circuit configuration shown on its plot (as found in the S830/2) for a 1mA plate current, however, the curve for this tube is much less linear below this grid voltage, and indicates complete cut off at around -4v.
