Unusual Instability Issue on a Refurbished Eddystone S830/2 – Gerry O’Hara

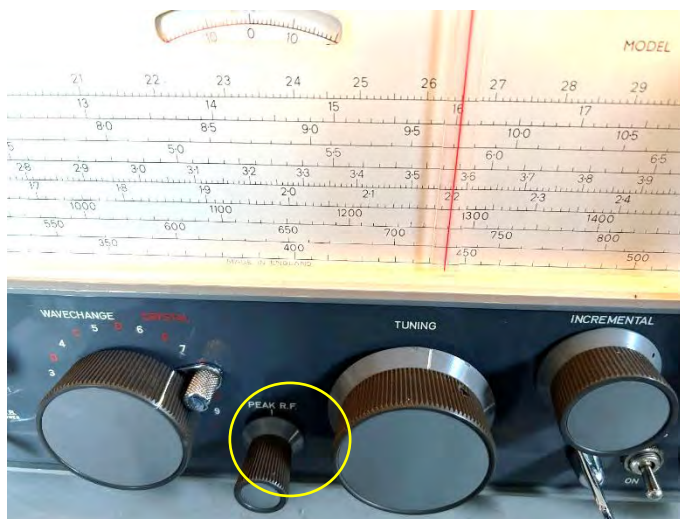
While tuning around the bands one evening, I noted that on Band 7 (upper part of the Broadcast Band), when the ‘Peak RF’ control was rotated to around half-way into the right-hand quadrant of its 180 degree rotation (circled in photo, right), the set started to ‘motorboat’ (see video [here](#)) – this is a position of the Peak RF control not normally needed, as the bands all peak around mid-travel. After some further tuning around, I noted that this instability only occurred above around 1280KHz on this one band, ie. between 1280 and 1550KHz, and only with the RF gain fully advanced. It did not matter whether an antenna was connected or not.

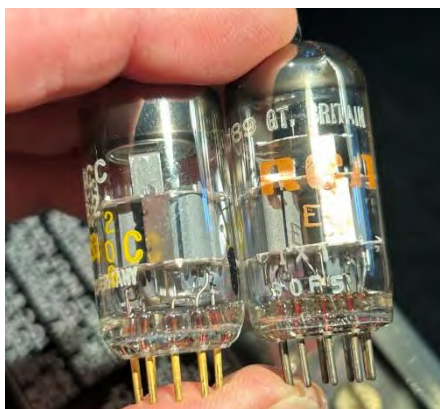
While I was swapping tubes, I noticed that the RF amplifier tube that had been fitted (and that I had tested on a STARK 9-66 tester during the refurbishment work), was actually an E88CC(!). I had not

noticed this at that time - I must have been distracted, or just assumed that the correct tube had been fitted knowing how fastidious the owner of this set is. The E88CC and ECC189 (photo, left: E88CC on the left, ECC189 on the right) are similar tubes, ie. both are ‘frame grid’ construction and with similar characteristics, however, the ECC189 (6ES8) is specifically designed for use as a cascode amplifier – as in the S830/2, at up to VHF, and this is the tube type that Eddystone specify for the RF amplifier stage in the S830/2. The (Westinghouse) E88CC installed in the set was a ‘strong’ tube, with a Gm of 7000 in each triode, so I tried replacing it with a similarly ‘strong’ (RCA)

ECC189, with a Gm of around 9250 in each triode. This actually resulted in slightly degraded performance on all bands, especially the dual-conversion ones (Bands 1 through 6), ie. above 1.5MHz – I chalked this down to the receiver having been aligned with the E88CC tube installed. The motorboating was still present with the 'strong' ECC189 tube installed, however, I also tried a much weaker ECC189 (Gm around 2500 each section), and the motorboating stopped – not a very satisfactory cure though(!). I decided to re-install the high-Gm ECC189 in the set and later align the antenna, RF amplifier, and 1st mixer stages to optimize performance again once the motorboating issue was resolved.

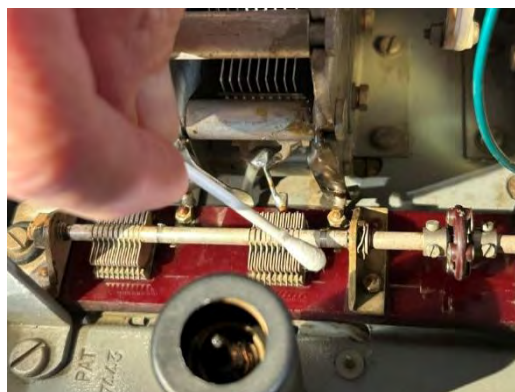
So, with the issue not being tube-related (other than a weaker tube 'fixing' it), I started the next stage of troubleshooting by checking the grounds on the 'Peak RF' tuning gang. I gave the grounding contacts a thorough clean, re-lubed the bearings, wiped Deoxit D5 onto the ground contact fingers and contact points on the tuning gang shaft (photo, right), and made sure the nuts securing this assembly were tight. I found two slack nuts – one on a grounding contact and one on the screw holding the rear bracket of the 'Peak RF' assembly in place (the nut was almost falling off, but was very hard to see, buried deep in the rear of the coilbox – barely-visible in fact), and the nut did fall off as I tried to access it(!).

attached to the screw on the top of the chassis. The rubber grommet that the screw passes through on the end bracket of the assembly was perished (hardened) – photo, above left, so I replaced that as well (photo, right). None of this effort made the slightest difference to the motorboating (of course!), but at least the 'Peak RF' assembly is working well and secured properly on a resilient mount.

It would be very difficult to replace this nut and lock-washer due to the very poor access without removal of at least the Band 1 antenna coil assembly, and likely disconnecting several wires running to other antenna coil assemblies. So instead, I inserted the screw from within the coilbox, with the lock-washer and nut then being easily

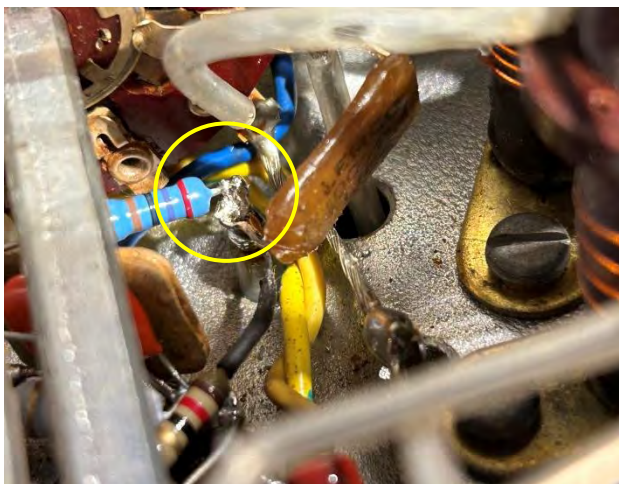
I found that moving the plate connection wire away from the end of the 270Kohm resistor connecting to the 12ohm grid stopper resistor cured the motorboating, but the wire tended to flex back close to its original position. To effect a more secure fix, I removed the 270Kohm resistor and replaced it with another dressed with a very short lead to the grid stopper resistor, circled in photo, right – compare this with the lead dress in the photo above (and yes, these two 270Kohm resistors appear to have different markings in the photo, but they do not – I also checked their values using a DMM). In this slightly revised configuration, the very short lead connecting to the grid stopper resistor is much less liable to RF pickup from the plate connection wire, and any RF picked up by the other (longer) lead of the resistor that is closer to the plate connecting wire, is grounded to RF by the 0.1uF disc ceramic capacitor, and

isolated from the grid by the 270Kohm resistor. I also dressed the resistor body further away from the plate connecting wire. The result was a much more satisfactory fix, even if the plate wire 'creeps' towards its original position over time.

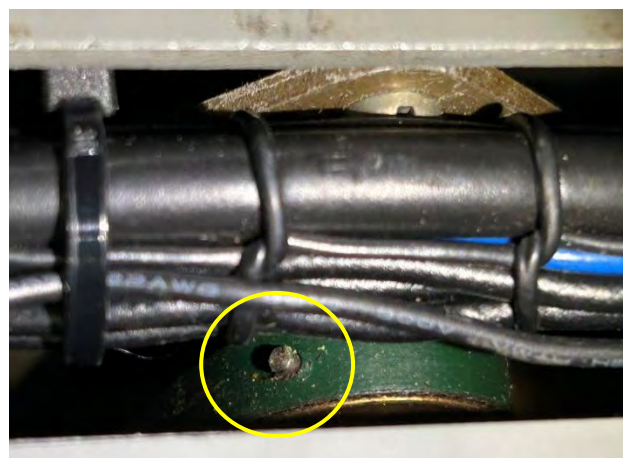
The second was a repair to a feed-through capacitor in the coilbox wall, noted during my close inspections of the wiring during the troubleshooting (photo, left).

There was a small crack and chip on the ceramic body of this capacitor— so, I cleaned-up the ceramic body using IPA, and then added some 2-part epoxy around the body to make it secure.
