# **Refurbishment of an Eddystone EA12**

# by Victor Jenkins

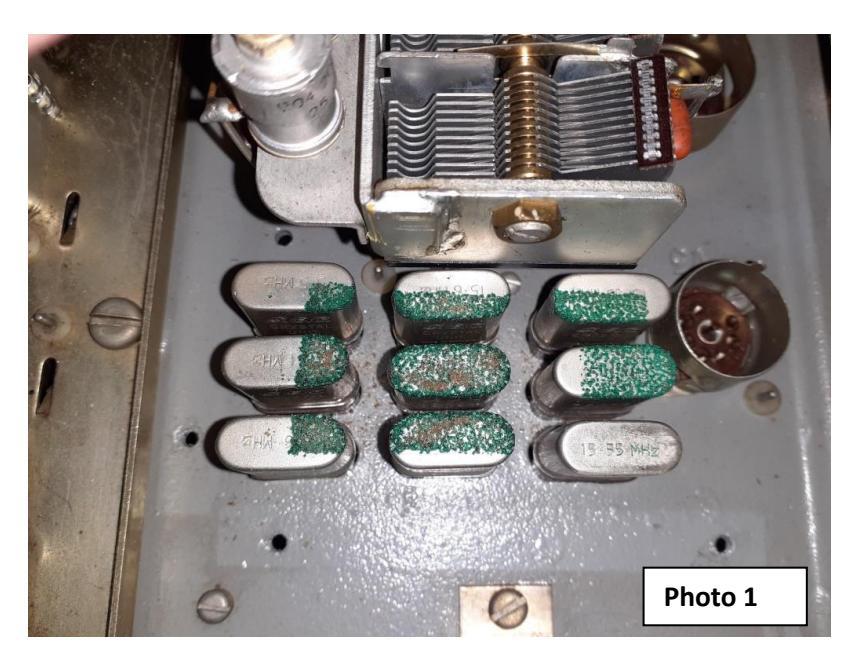
As soon as I removed all the internal covers and started looking inside the receiver, some significant issues became clear. The first thing I observed was that the foam rubber pad which keeps the crystals properly located in their respective sockets was badly decomposed

and the crystal cans were covered in corrosion. This is shown in Photo 1. Next, I examined all the mechanical aspects of the receiver, to check the operation of the controls and the state of the lubrication. All the controls appeared to be working correctly, although several felt a bit stiff, and there were still some signs of a little lubrication. I examined the main tuning mechanism very carefully; looking for possible causes of the

In order to refit the internal covers, I had to deal with the issue of the corrosion on the crystal cans. I was lucky because it looked much worse than it was. The corrosion was caused by hydrochloric acid which is a known by-product of the long-term degradation of a lot of the foam rubber produced during the 1960s. Which makes sense given that my crystal cans were covered in a mixture of green and black crystals, copper chloride and copper oxide, perhaps. Fortunately, the damage to the cans was not serious and I was able to clean it off with warm water and a brush. The contact pins were cleaned and polished and the crystals were put back in their respective holders. Then I made a new foam rubber pad to hold them in place. I used new, medical-grade foam which has adhesive on one side and a pure cotton sheet bonded onto the other side. This is manufactured by Hapla and I obtained some small sheets of it from <u>www.medicalsupplies.co.uk</u>. I fitted it inside the cover so that the cotton sheet would press onto the crystal cans.

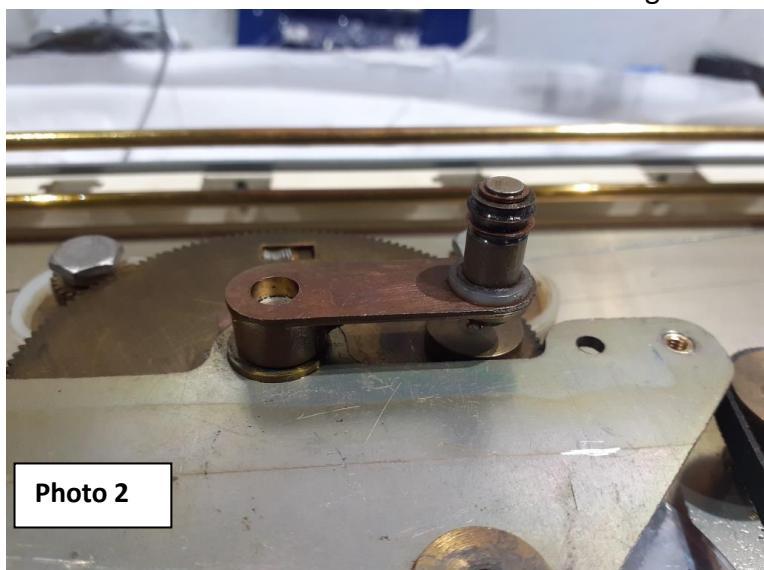
backlash detected while tuning the receiver. I determined that the main tuning capacitor did not have sufficient lubrication and was quite stiff to turn. Also, there was some wear in the rolling pinion which connects the drive arm to the linearising arm of the main tuning mechanism. This is shown in **Photo 2.** This movement was visible as the main tuning knob

was rocked from side to side.

I observed that the flywheel was incorrectly adjusted and was applying side-ways pressure to the friction-drive disc. Therefore, I adjusted the position of the flywheel, sideways on its shaft, to remove this pressure and then gave the disc a thorough clean with methylated spirits to leave it shiny and dry. My next task was to remove the rolling pinion from the linearising mechanism, in order to fix the back-lash problem. But I could not do this without separating the main tuning capacitor from the front-panel assembly; despite the warning against doing this that I had found in the Eddystone manual. Therefore, I carefully drew around the mounting bracket with a marker pen, before undoing its mounting bolts and separating it from the front-panel assembly; watching closely that the two little tension springs did not go flying. At this point the cause of the backlash became clear; the tuning capacitor was very stiff to turn and in need of some serious lubrication. As a result, there was an indentation worn in the nylon washer that is located between the pinion and the linearising arm. I solved the wear issue by turning the washer over and lubricated the tuning capacitor. Once the tuning capacitor was re-mounted on the front-panel assembly, it became clear that the backlash problem had been fixed and the main tuning control was much freer in use.

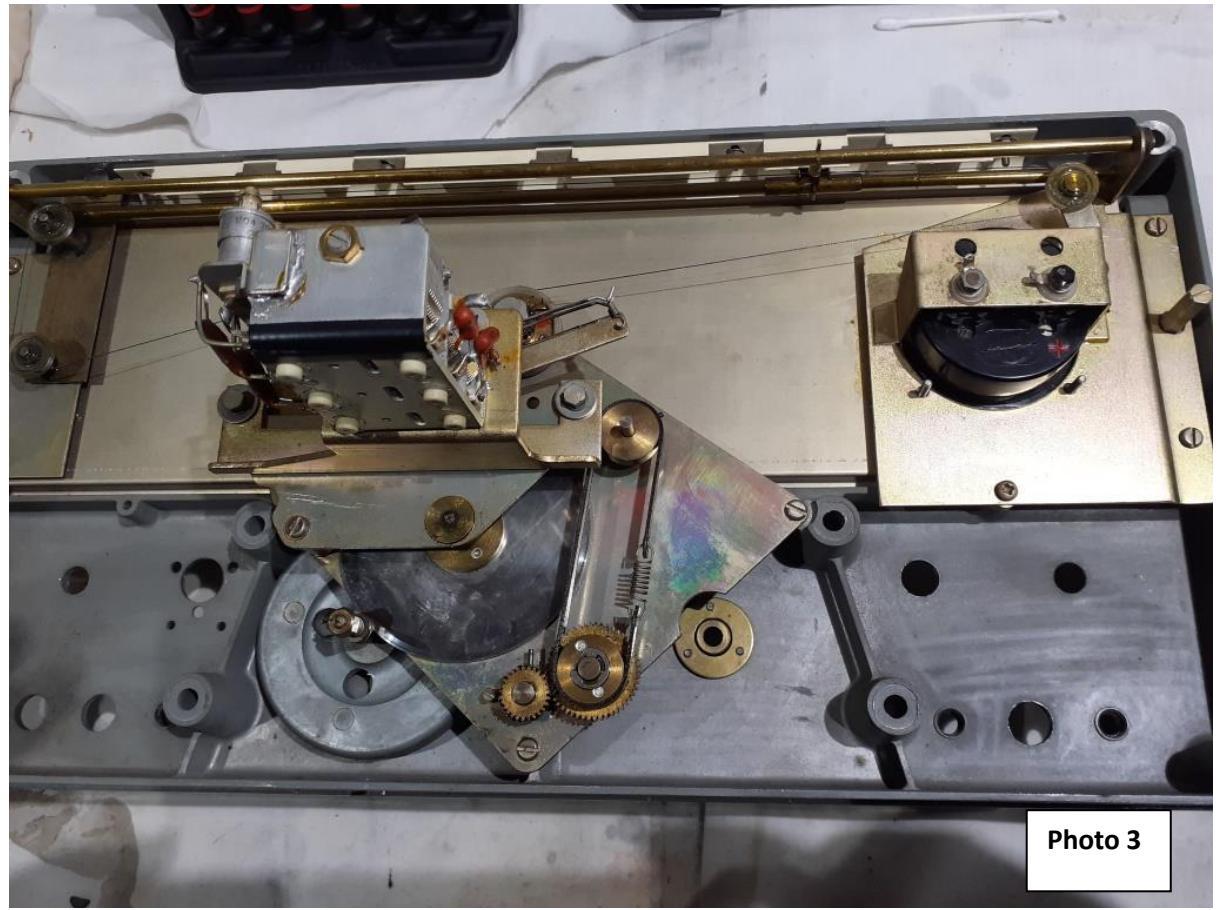
When carefully examining the receiver, as reported above, I was thinking ahead to the work that I was starting to plan, including how best to disassemble and re-assemble the receiver. I noted that the main tuning capacitor is bolted to the back of the front-panel assembly and not to the top of the coil-box assembly; as is the case for receivers like the 730, 940 etc. This can be seen in **Photo 3**.

There is a warning note in the Eddystone User Manual for the EA12 against touching these bolts because any adjustment to their positions can have serious consequences for the accuracy of the main tuning linearity. Therefore, I planned to disconnect the six wires which connect the tuning capacitor to the coil box; leaving the tuning capacitor firmly attached to the front panel, when removing it from the rest of the chassis. This approach has the advantage of giving easy access to the three fixed capacitors - C43, C45 and C66 – which are mounted between the bottom of the tuning capacitor and the top of the coil box.

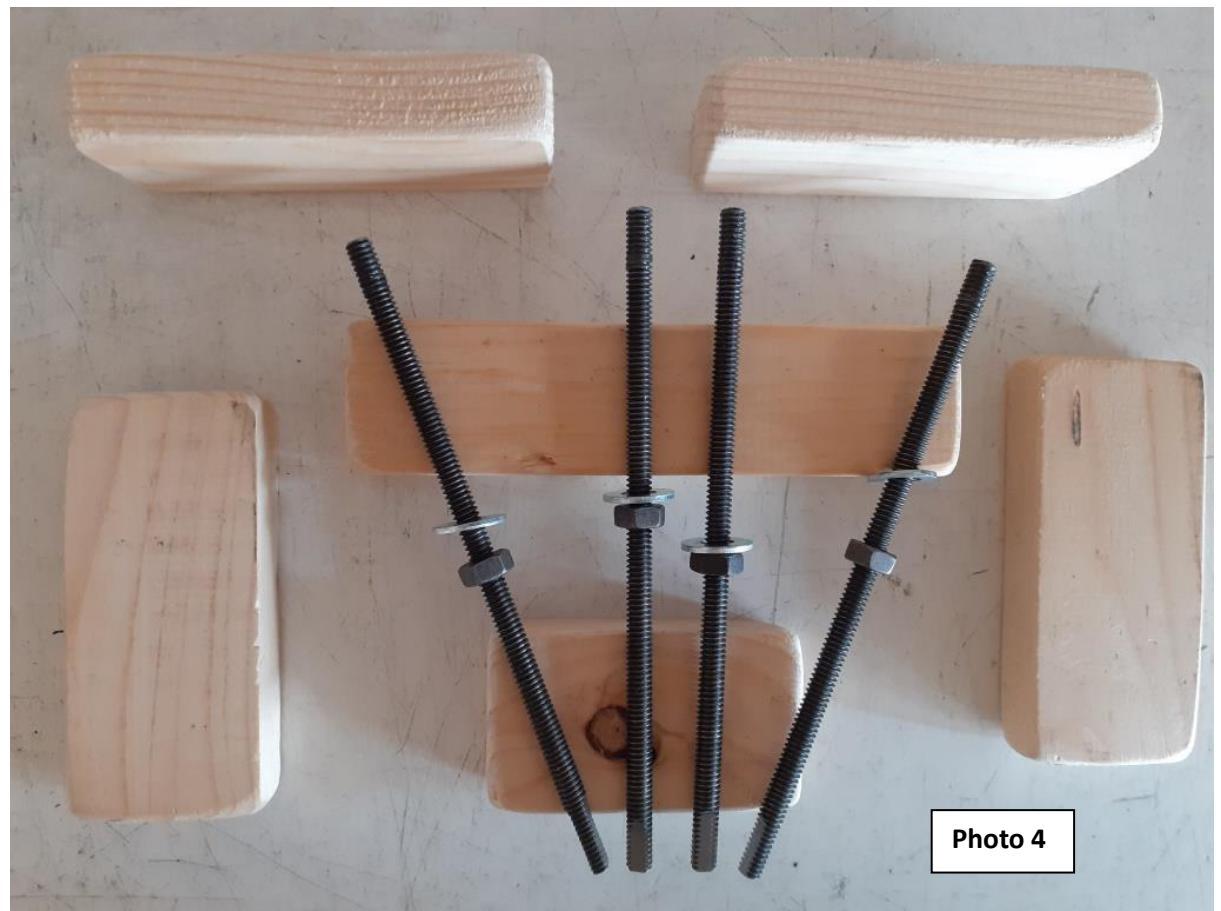
The initial ideas for some sort of jig or other apparatus to assist with the removal and subsequent re-attachment of the front-panel assembly were overly complex and, probably, difficult to make. The final solution comprises some pieces of wood, four pieces of threaded steel rod – 4 inches long and threaded in 2BA – along with four matching nuts and plate washers. As shown in **Photo 4**.

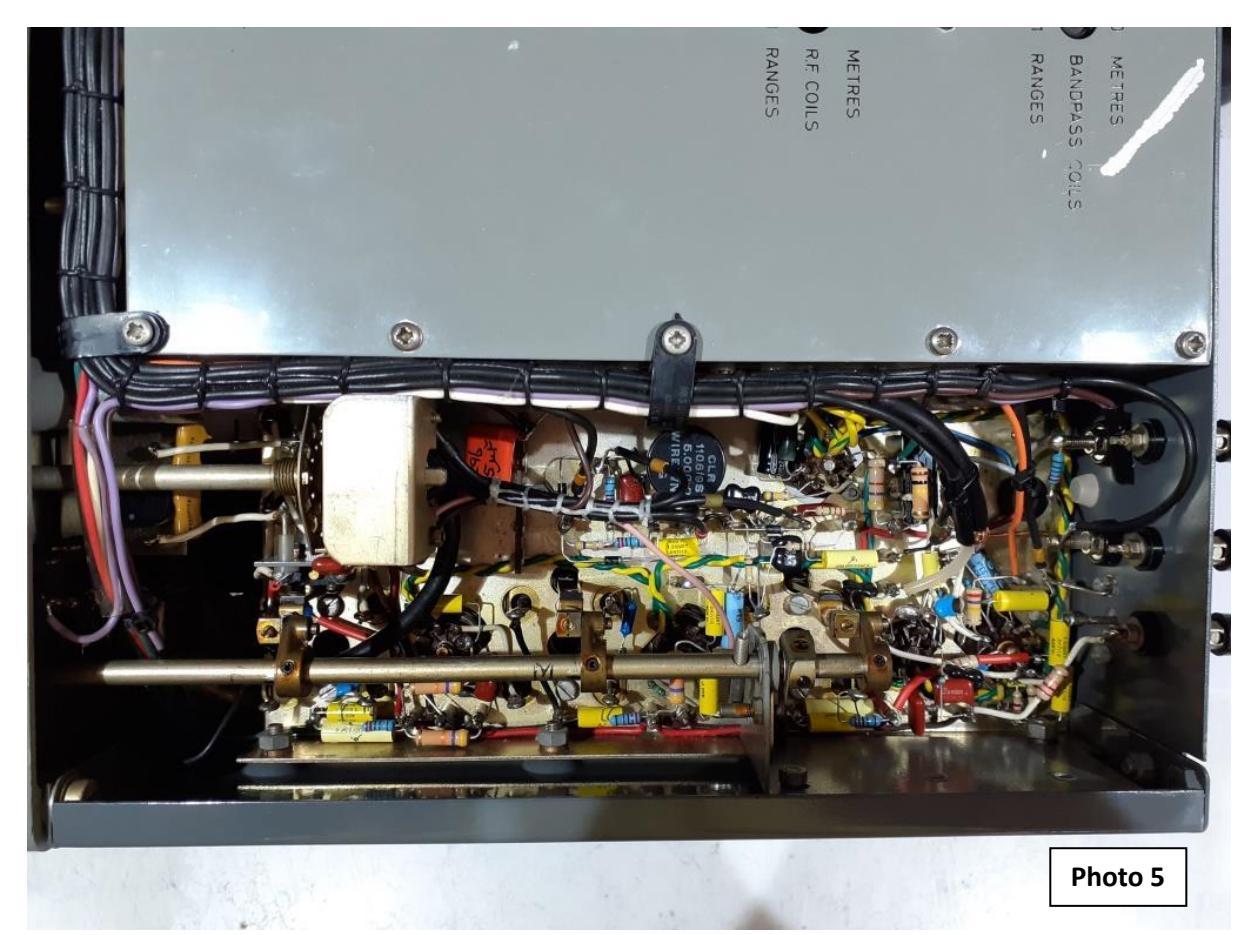
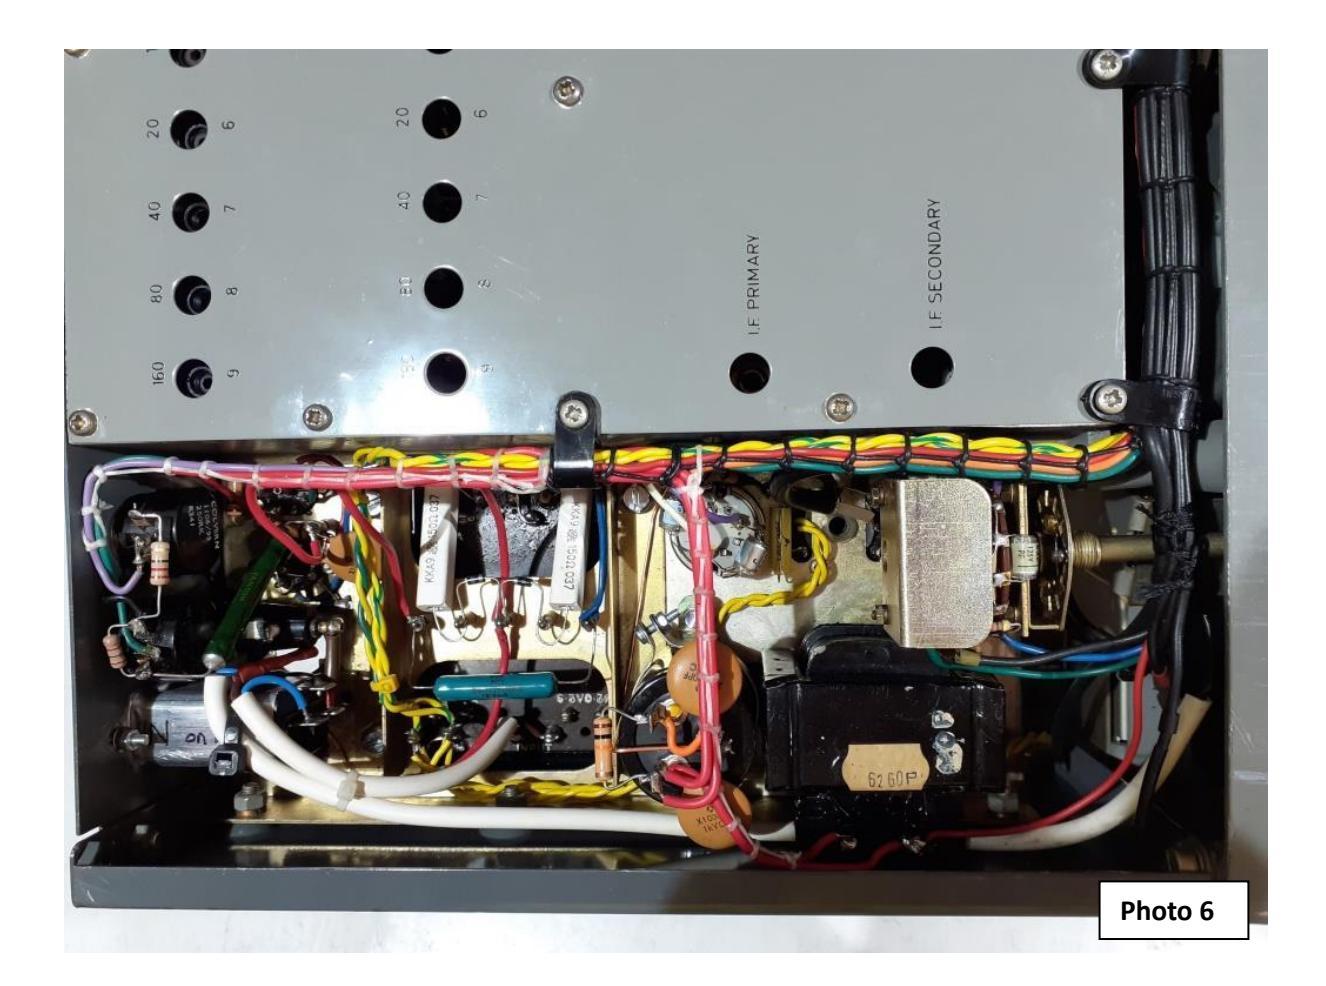
The underside of the chassis after the passive components had been changed is shown in **Photo 5** and **Photo 6** which were taken after the rebuild of the receiver was complete.

A big advantage of using modern components is that they are significantly smaller than the original ones; even when selecting new ones with a higher performance specification. This makes it possible to re-arrange the components into a single layer around each valve base. This step improves access, should a repair be required in the future. Also, it reduces coupling and heat transfer between components.

High-stability resistors and silver-mica capacitors were used wherever they might yield improved performance. The old paper decoupling capacitors were replaced with pairs of capacitors; one plastic and one ceramic. The HT supply to each valve was given additional decoupling and all the earthing points were scrutinised. Firstly, to make sure that they were sound electrically. Secondly, to make sure that there was not a better way of arranging the earth connections, given the new arrangement of components.

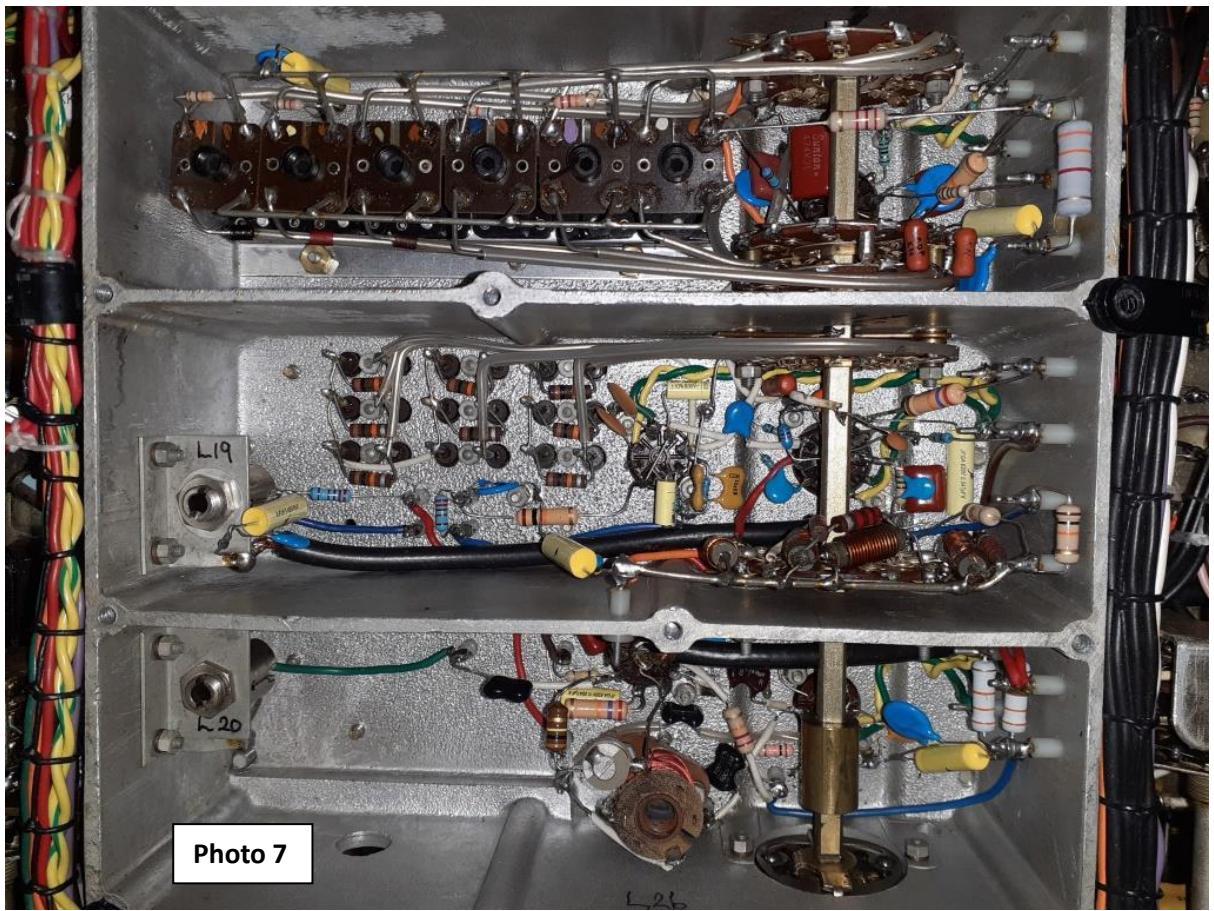
An important first step was to clean and lubricate all the switch contacts and then to lubricate the mechanical parts of the switches. As with other Eddystone receivers, there are a lot of bolted earth connections inside the coil box. Therefore, I followed my own advice in my article on <u>RF Earthing of Eddystone Receivers</u> and made sure that all of these bolted connections were sound and working properly. The underside of the coil box, after refurbishment, is shown in **Photo 7**.

It should be noted that this photograph includes the two additional filters described below.

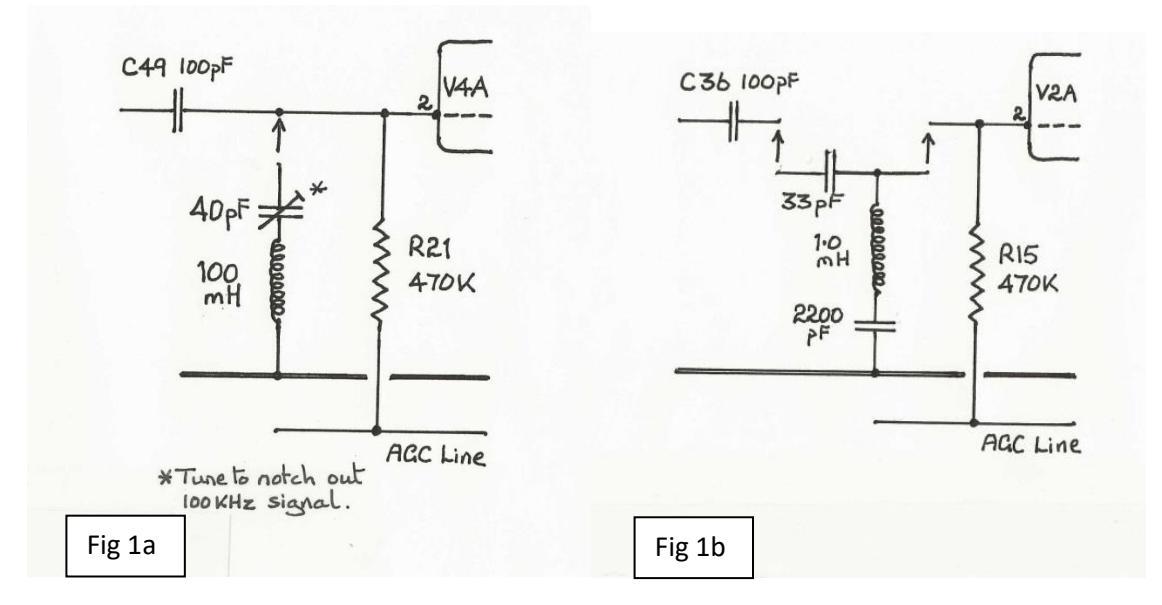
During my search, I discovered that there was a significant 100KHz component to the unwanted signals being presented to the first grid of the second mixer (valve V4A) and there is no IF trap at this point. Therefore, I made one out of a 40pF preset capacitor and a 100mH inductor and fitted it at the junction of C49 and R21, down to an earth point. As expected, this modification reduced the level of unwanted signal, but had negligible impact on receiver sensitivity. The circuit diagram of this filter is shown in **Figure 1a**.

When I examined the operation of the first mixer, I discovered significant levels of unwanted and noise-like signals being presented to the first grid at frequencies below 1.5MHz. Therefore, I added another simple filter after C36. Again, this modification reduced the level of unwanted signal, but had negligible impact on receiver sensitivity. The circuit diagram of this filter is shown in **Figure 1b**.

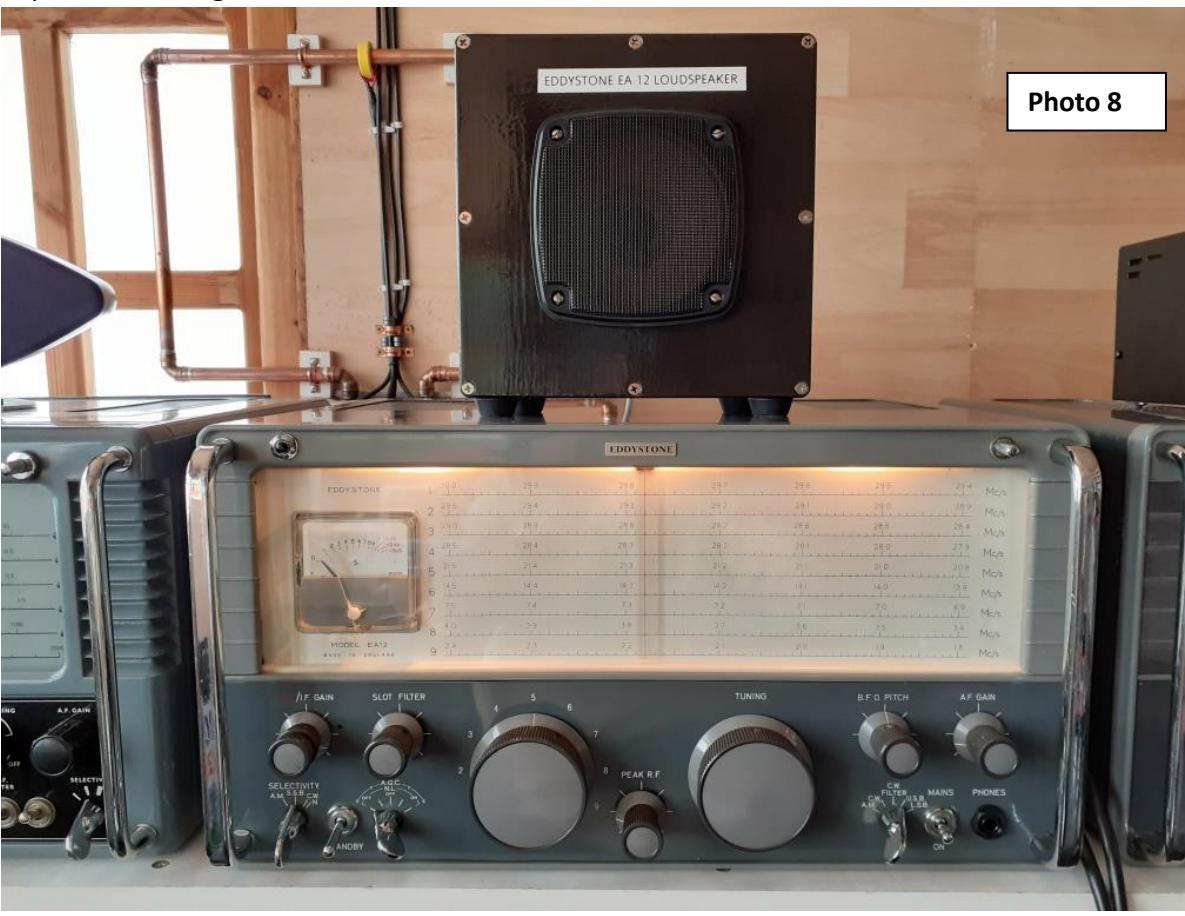
**Photo 8** shows my EA12 on my operating bench, flanked by my 730 and 940 receivers, with its loudspeaker fitted inside an Eddystone diecast box and sitting on top. It is tuned to 21.281MHz and is receiving LZ3TY at S4 and producing good audio. On frequency bands above a 20MHz it works well and is a pleasure to use. On the bands below 20MHz it cannot

cope with the high levels of RF interference where I live.
