Restoration of an Eddystone EB35 MkI - by Gerry O'Hara, G8GUH/VE7GUH

Restoration of an Eddystone EC10 MkI Solid-State Receiver (Part 1) - by Gerry O'Hara, G8GUH/VE7GUH

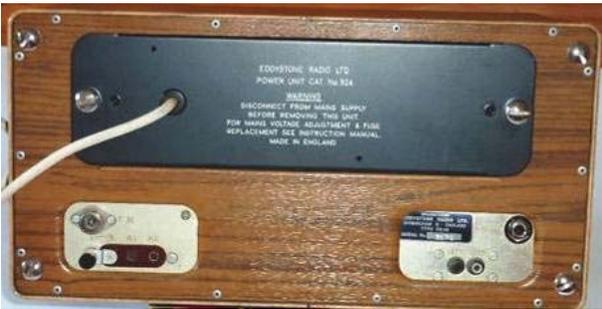
"...The case is covered with a horrible "wood finish" plastic. Obviously the work of a mis-guided previous owner - but no! the case rivets show that it seems to be original!..."

more like a piece of lounge furniture (at least for the late-1960's/early-1970's) than a communications radio – modified (plastic) side panel vents, a faux teak-finish (see photo and the excerpt from an email from an EUG forum member, left), a brushed aluminium fingerplate and removal of the handles (photo, below).

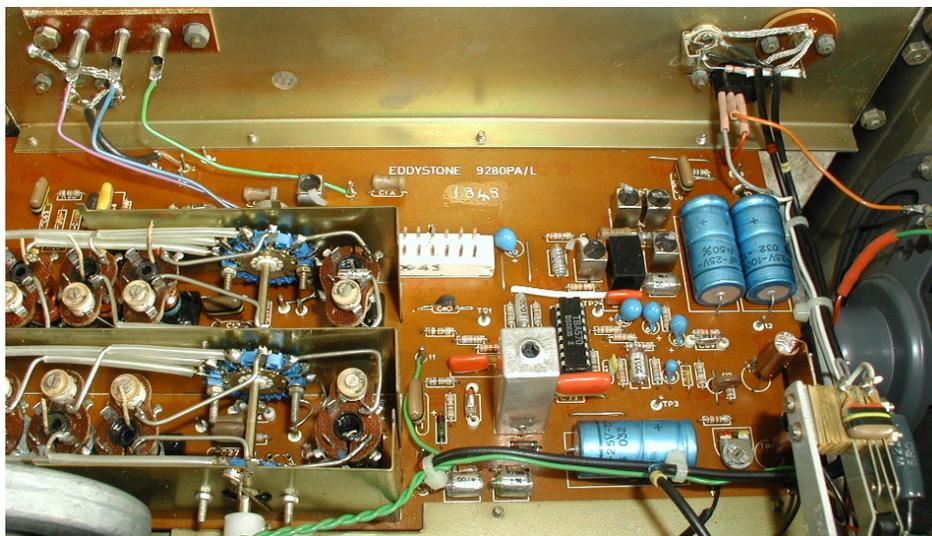
scales plus a new-style Eddystone logo adorned the fingerplate beneath the 'Statesman' name. More importantly, the electronics were completely overhauled, but amazingly not with an all-silicon line-up (complementary AC127/AC128 were used in the AF output stage). The circuit included FET AM and FM front-ends and a TBA570 IC IF strip and 1st audio stage (photo, below), the extra switch on the front panel

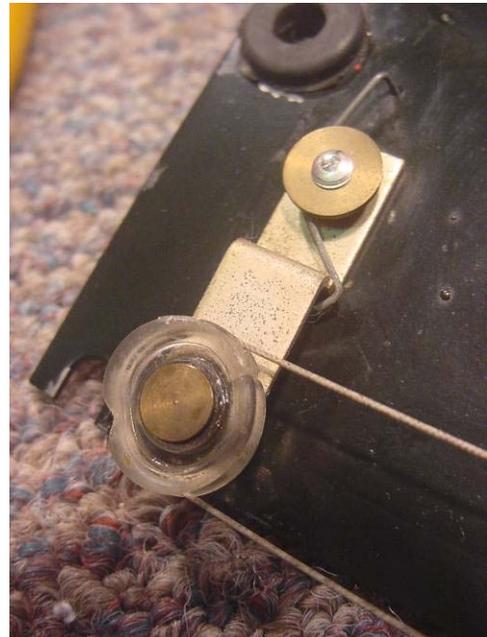
and tuning shaft bearing with suitable grease (I used a very sparing amount of white Lithium-grease, but Molybdenum grease is also good for this). Clean the friction clutch mechanism and try to keep the outer edge of the drive plate and mating surface on the tuning shaft grease-free. The friction drive on this set was making a strange creaking noise when rotated – traced to some cloth fibres entangled in the compression spring (photo, above) – these were teased out with a soldering pick and this cured the noise. A touch of high-quality machine oil was applied to the gearbox bearings and the mechanism then ran very smoothly – but there was still an annoying squeak! - this was traced to the idler pulley not rotating as it was distorted (photo, right). In a larger Eddystone this would have been a fairly straightforward fix, but in the sets using a Type 898 derivative, this is hard as rivets are used to fix the idler mechanism to the mounting plate and to attach the pulley to the spring-loaded idler arm. In this case I opted for the quick and easy fix – a touch of moly grease on the part of the dial cord that passes over the pulley. No more squeaking and a very smooth (and silent) feel to the tuning at last.

Re-assembly of the front panel and drive mechanism is simply a reversal of the above, but care is needed to ensure that when the dial pointer

is at the '0' mark on the logging scale the circular vernier scale is also reading '0' and the tuning capacitor gang is almost fully meshed (maximum capacitance). Also, check that the spring-tensioned cord operating the slugs in the VHF tuner is working correctly. You may need to adjust the position of the flywheel on the tuning shaft to get the correct amount of float such that the knob spins smoothly – the center hole on the flywheel is threaded and mates with the rear of the tuning shaft. When this is set correctly (apply a little lithium grease to the side that faces the brass bushing on the rear gearbox plate), a locknut holds the flywheel in place.

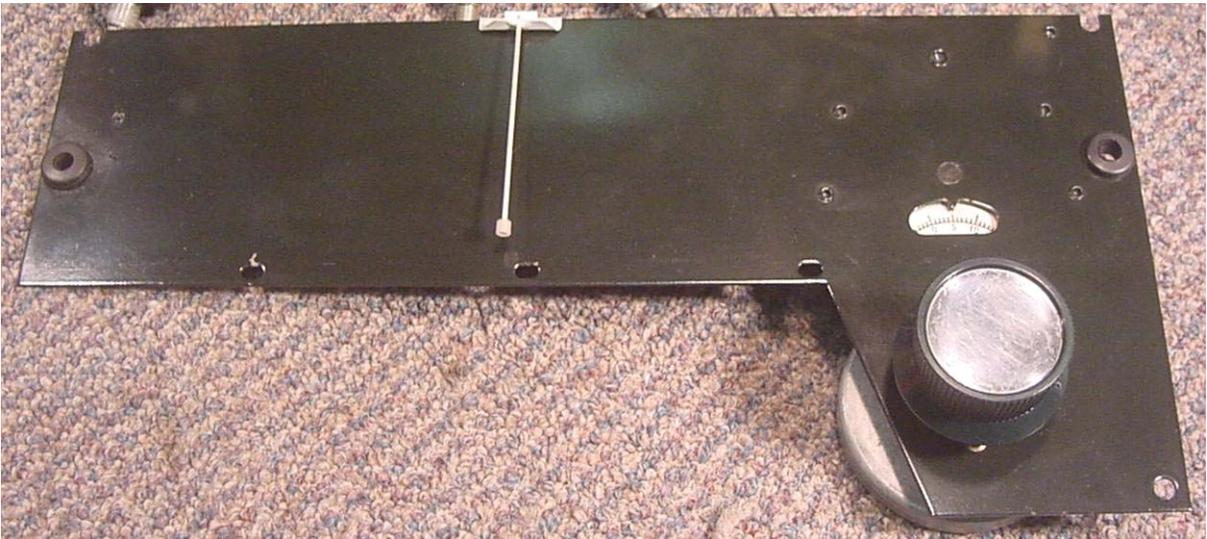
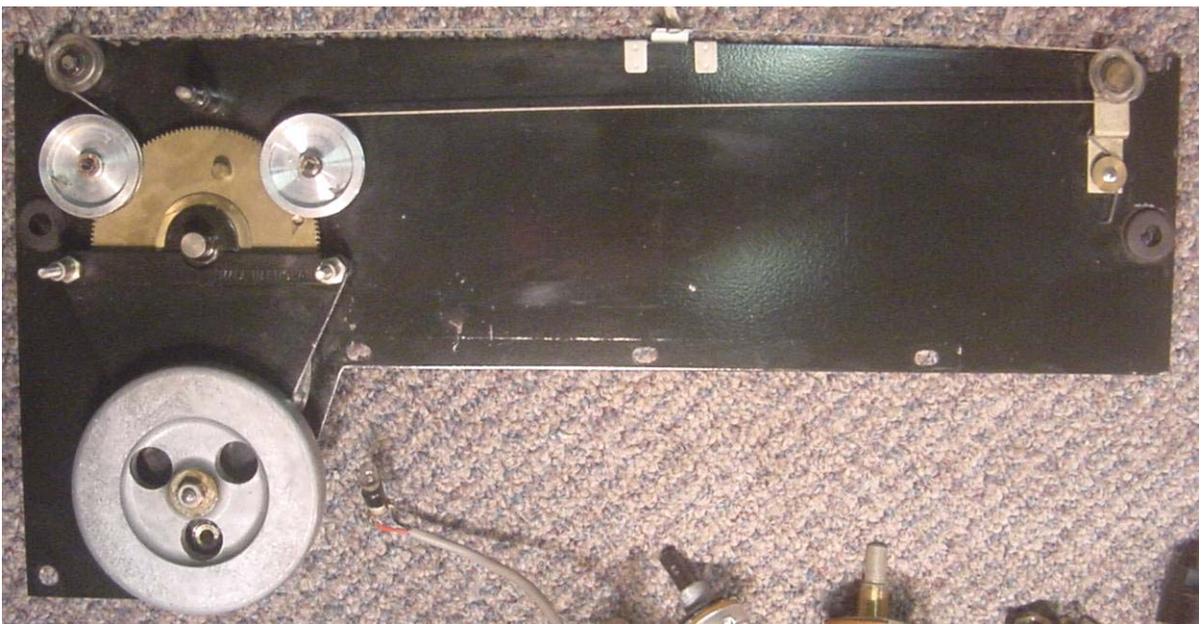
Above/below: the tuning mechanism removed from the set. The main issues here were a dirty friction clutch and a distorted idler pulley (on right, below)

This is also a good time to clean any hardened oil/grease from the gearbox bearings and gears, the friction drive spring (photo, top of following page) and to re-lubricate the gears

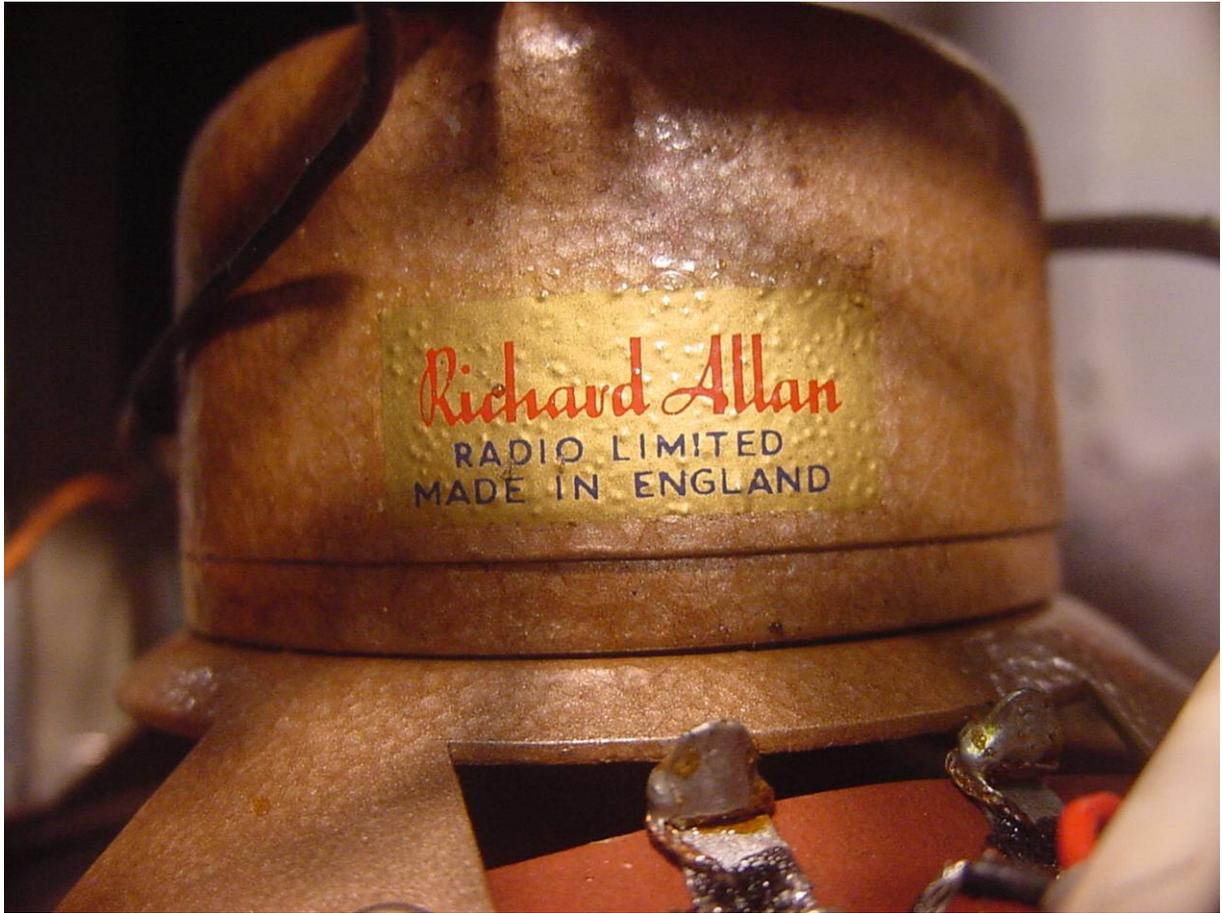
Above: Richard Allen speaker – proudly Made in England! Below: left – cracked control knob with the crack filled with 'JB-Weld', right – when cured, the JB-Weld was touched-up with a permanent marker pen – almost invisible repair

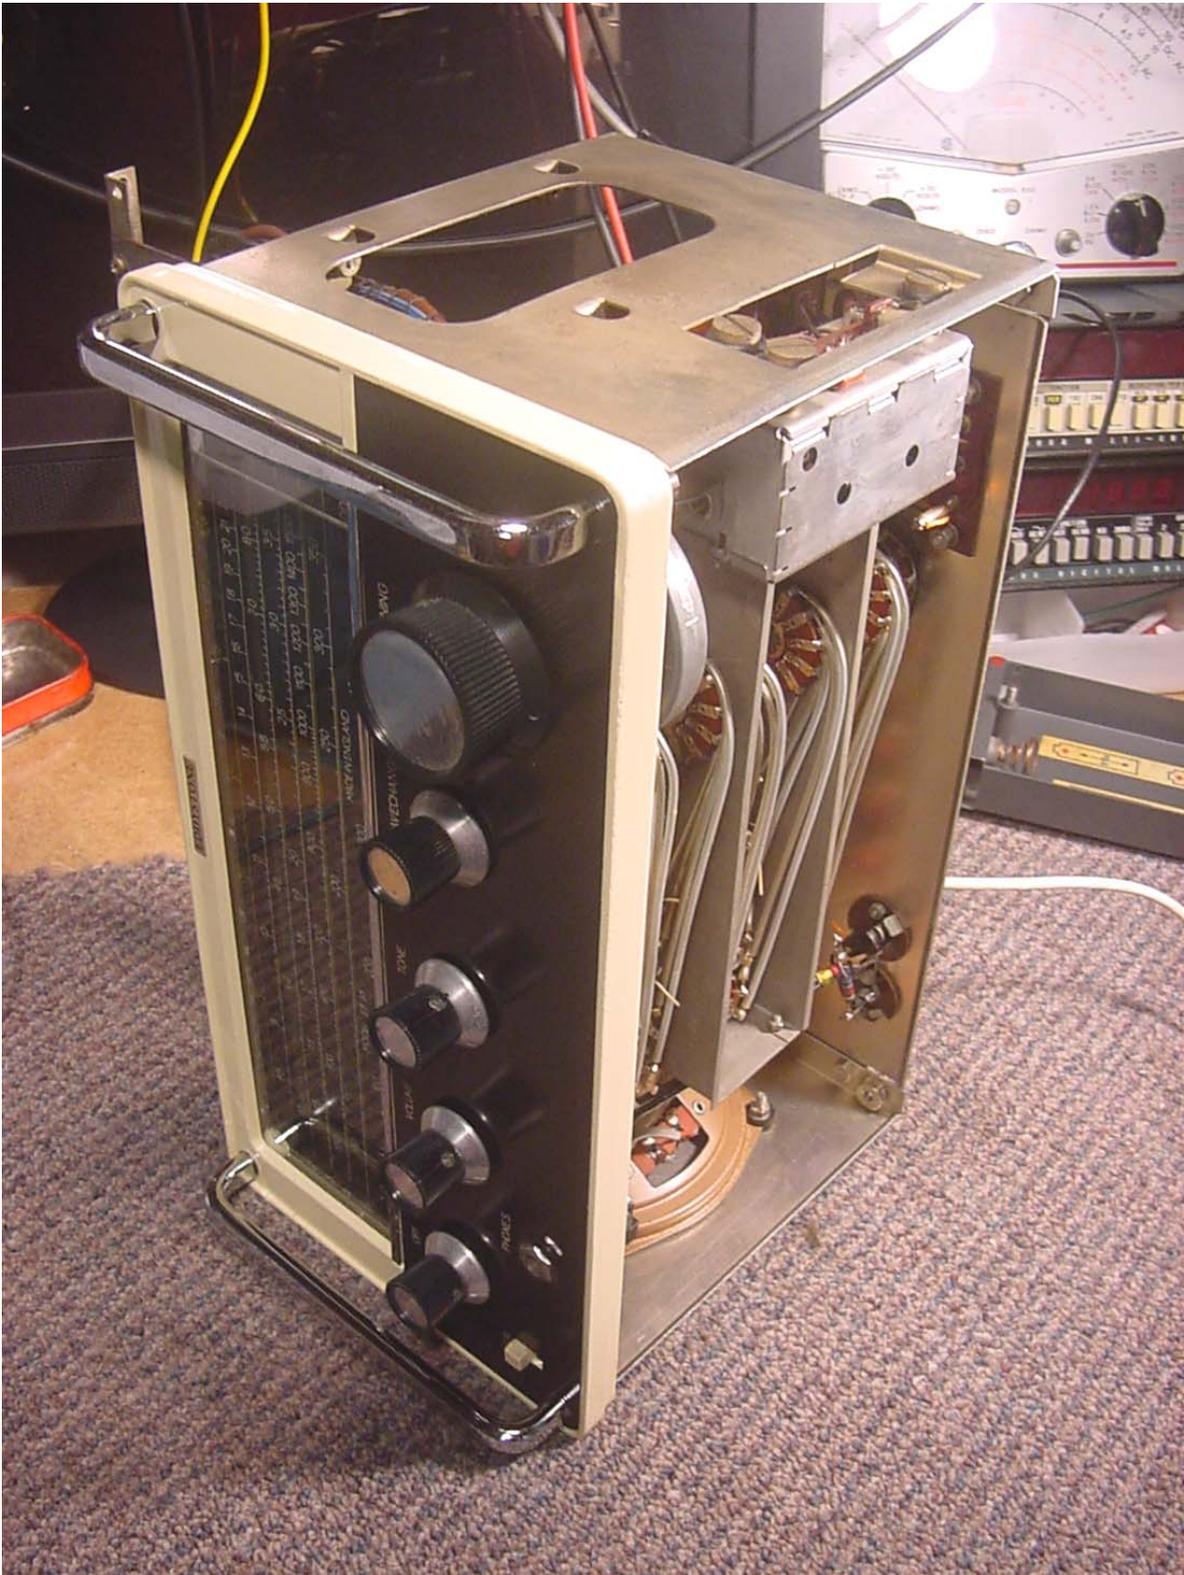
Above: ‘Aaatennn-shun! – must be all those military parades the set had to attend in the ‘good old days’ in Charles’ jalopy... maybe not, but the set has scrubbed-up rather well
