## Restoration of an Eddystone S.680/2 – the late-1940's Eddystone 'Hottie' (but, thankfully, not quite as hottie as the original S.680...), Part 1, by Gerry O'Hara, G8GUH/VE7GUH

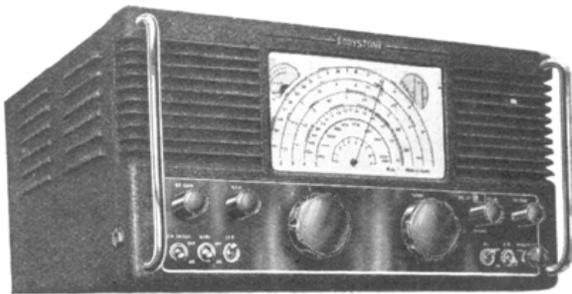
Above: excerpt from the 'Cooke Report' by Bill Cooke, recalling the development problems with Eddystone's 'hottest' post war receiver... Above left: the S.680, aka S.680/2. Top of next page, the S.680X. Spot the difference?

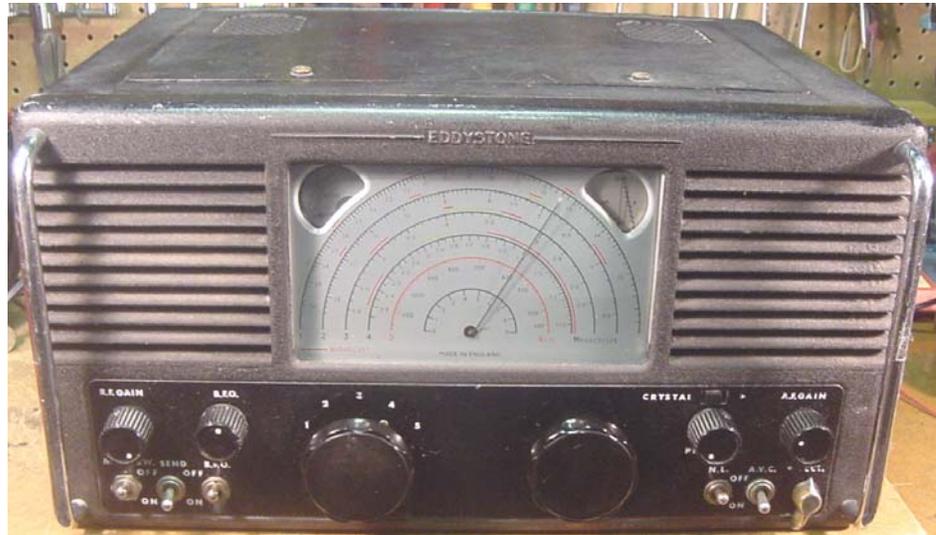
speaker and S-Meter for years also! – I cannot remember the number of times I bid on these items on Ebay). I could tell from the photos sent to me that the S.680/2 was not in all-original condition – the most obvious cosmetic detractions being that the fingerplate had been stripped, re-painted and white 'Letraset' applied during an earlier 'spruce-up' by someone, and the four smaller knobs were non-Eddystone types (photo, above).

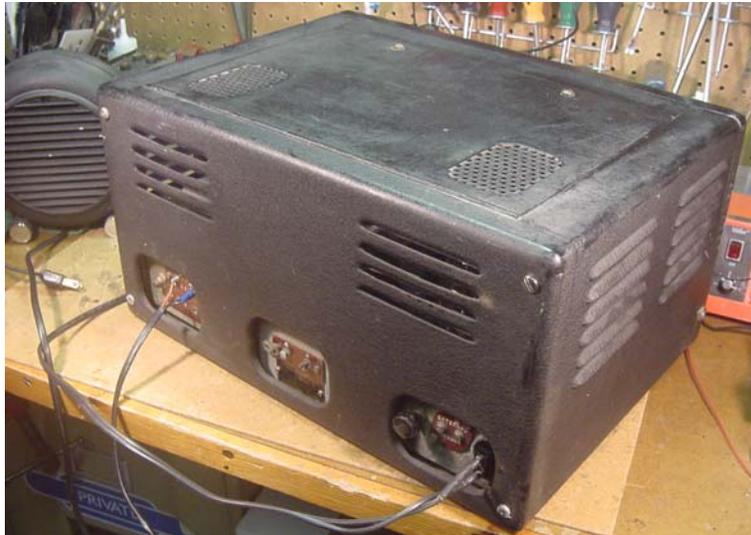
The S.680/2 was in fairly clean condition and was working on arrival (photos above), confirming my thoughts that someone had given the set some ‘TLC’ (and use) at some

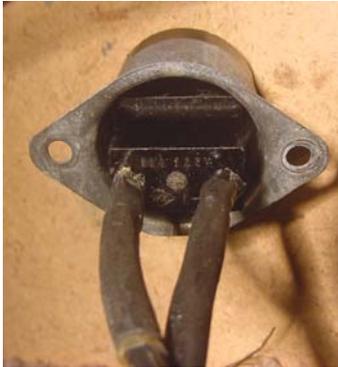
looking two-pin round affair manufactured in the USA and that mated with North American flat 2 pin sockets (photo, left). The power cord that came with the set was fitted with a socket (which was designed for chassis-mounting), its connections with the cord being insulated with shrink-wrap – fairly safe but not acceptable to me – I decided to retro-fit an IEC chassis plug (I have a supply of them retrieved from old computer power supplies). This was a simple enough job as the round connector was fitted into a large round hole cut into the chassis – the IEC connector almost filled the hole and slots

that had been cut into the chassis already for the old connector fit the mounting holes for the IEC connector – no further butchering of the chassis was needed. A small gap was left either side of the IEC socket, but I can live with that. In common with several Eddystone models of this period, both sides of the mains supply are fused. While I was at it, I decided to make a wiring change in the power supply (in the interests of transformer preservation) and use one of the chassis-mounted fuses in the HT supply (between the transformer HT secondary tap to ground) – a mod that is easily reversed should anyone be so inclined. I also noted that the two main HT filter capacitors had been changed-out at sometime – however, the replacements were can-types (though non-matching) and looked ok from above the chassis.

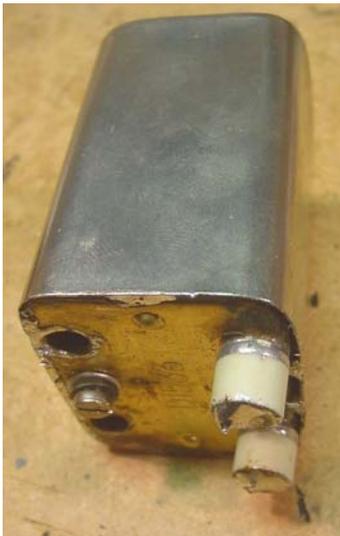
the choke onto the base, and some of the sticky pads (with the sticky side exposed on one side only) to act as padding above and to one side of the choke. I then soldered the chokes leads to the two terminal posts (photo, above) and then slid the choke into the shroud, spot-soldering the base of the can back in place (photo, left) after testing for continuity between the terminal posts.

- I had some experience of taking one of these shrouds apart before – I had repaired an open circuit in the choke in the SPARC Museum's S.750 (did you know that Dr. Barnard stitched an extra head on a dog as his practice party piece). The base of the assembly is soldered onto the main shroud body. Rather than overheat the assembly, I found it better to cut the soldered joint using a knife (with great care!) and then gently pry apart using a small chisel/wide screwdriver blade, taking pains not to damage/distort the shroud. I repeated this 'procedure' on the S.750 AF output transformer (hey, I even have the right medical terminology...). After 5 minutes work I had the base of the unit off and was able to remove the transformer – cutting the leads at the point of connection with the terminal posts and undoing the two 6BA screws that held it in place on a bracket fixed to the base. I left the Paxolin insulating plates in the shroud and tried the 2H choke in the shroud – it fitted easily. I removed two of the terminal posts from the transformer base (the choke only has two connections and the chassis was punched for these, not four as on the transformer). I used double-sided sticky pads and a piece of dense insulating foam to mount

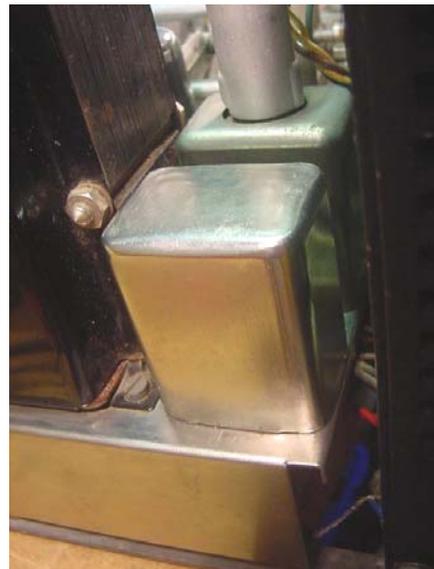
- The choke assembly was then fitted to the chassis in place of the Marconi unit – looks just like the

original must have (photo, right). I left the receiver on soak test for several hours over a few evenings and the choke shroud was getting only mildly warm, the set working well. Job done – thanks for

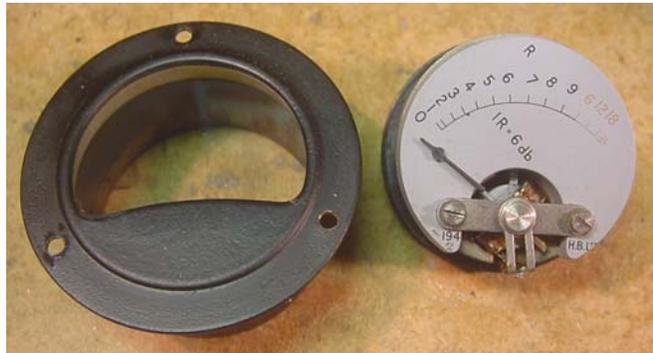
- The S-Meter in my set had some black specks of dirt/paint flecks on the inside of the glass, so the meter was disassembled and the specs removed, the meter glass was cleaned inside and out with anti-static glass cleaner and the meter re-assembled (photo, right).
- The scale itself was dusted with a soft paintbrush and very carefully wiped clean with cotton wool soaked in lukewarm soapy water. The logging scale was inspected but appeared to be finished in a water-soluble fixative, so it was just brushed clean.
- The gearbox, comprising a mix of brass and Paxolin gears, had the usually well-intentioned liberal coating of oily grease build-up. This was carefully removed using Q-Tips, a needle and lighter fluid for the more stubborn deposits. The

gears were then given a very light coat of moly grease and each of the bearings a small drop of high-grade light machine oil. The tuning shaft bush was removed from the front panel and cleaned and given a light coating of moly grease ready for reinstallation.

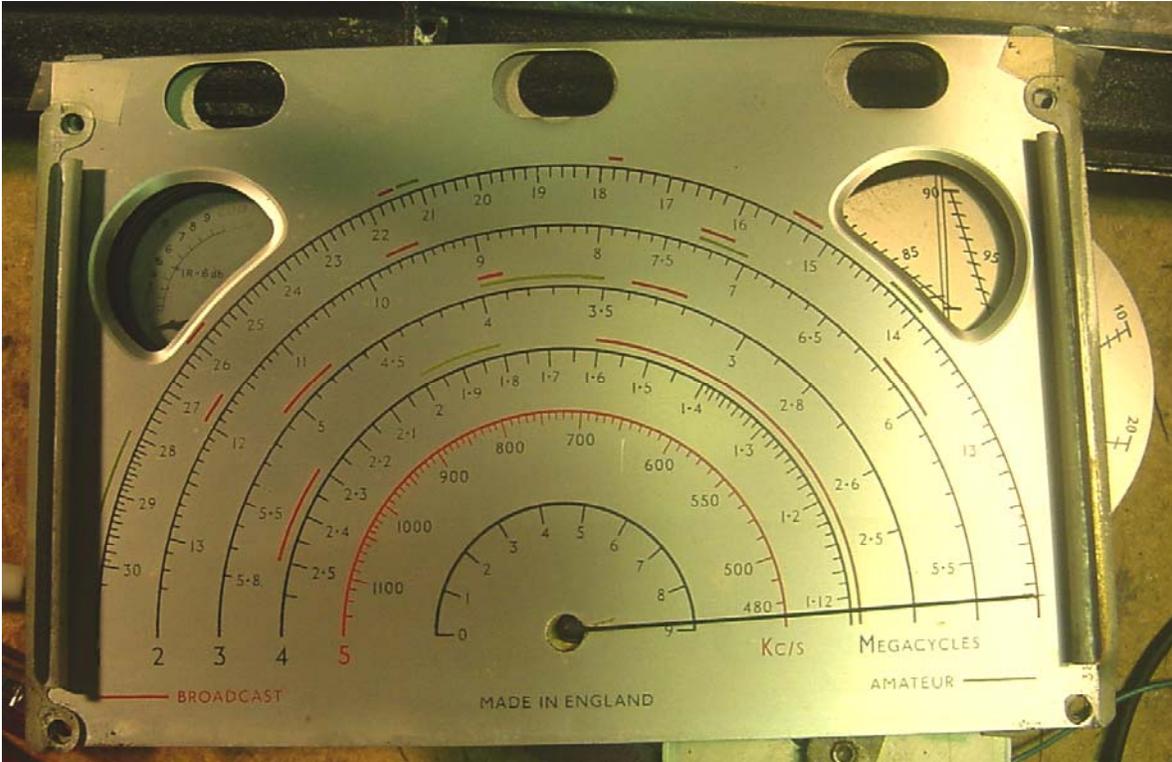
Another view 'close-up and personal' in the S.680/2 gearbox – now looking very clean and ship-shape. Remarkably little wear on those 60+ year old Paxolin gears

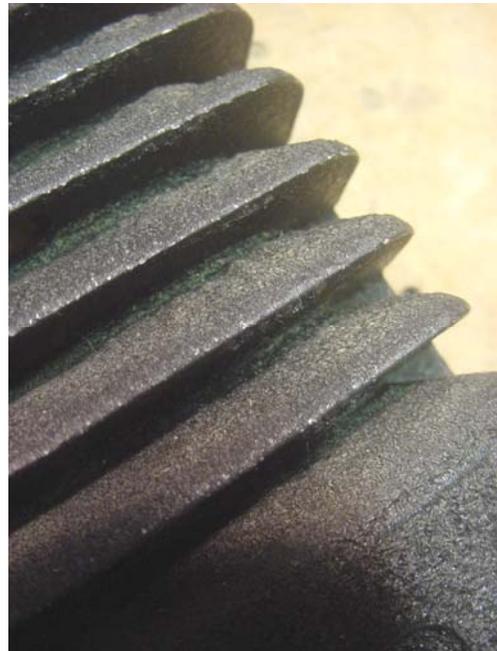
- While cleaning the now bare front panel I noted that the finish was blistering in the louvered areas (photo, right) and was coming away from the aluminium in other areas – it had been repainted with a black wrinkle finish at some point in its life. That decided it – I would have the case and front panel both sandblasted and re-finished with a black wrinkle powder coat – this would mean a bit of a hiatus in the restoration process... but well-worth the effort.
- The BFO tuning capacitor had fallen apart when I was removing it from the front panel – I had previously noticed a crack in the ceramic plate

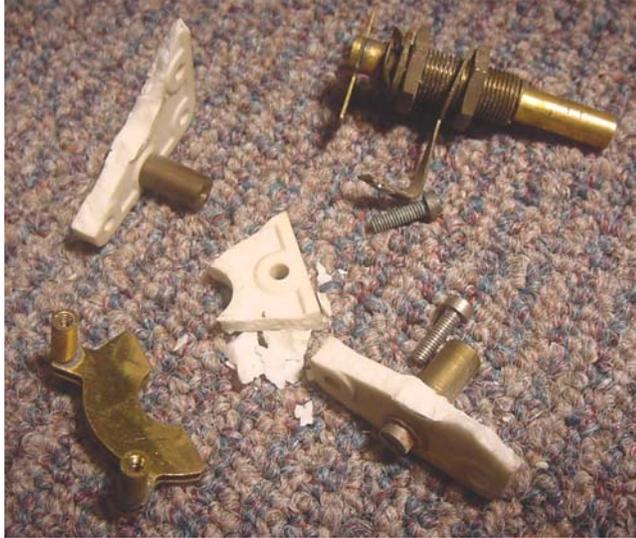
but had not realized just how badly it was damaged (photo, right). I think someone had tried to over-tighten the nut on the shaft collar in a misguided attempt to make the control action 'feel better' – it had a very loose feel. This over-tightening had cracked the ceramic. After removal from the set I repaired the ceramic plate with superglue on the clean breaks and with 'JB-Weld' in the areas where the ceramic had crumbled away – a bit of a fiddly job, but it worked.

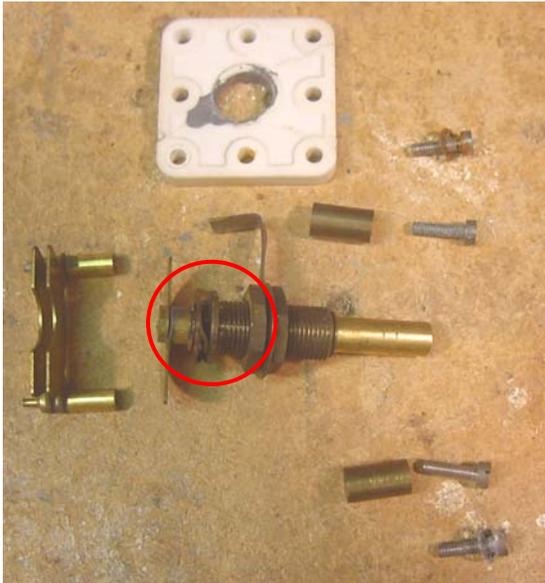
The torque of the shaft was adjusted by careful adjustment of the spring/wiper located on the inside edge of the shaft collar (circled in photo, below) and the capacitor re-assembled and tested – works fine (note – be careful applying/using JB-Weld as it does conduct electricity albeit with a very high resistance).

- As it happened, after all this fiddling, it turned out that Pat's parts set (an S.750) had a suitable capacitor that could be used as a donor for the ceramic plate. So, I ended-up using the intact ceramic plate from the S.750 and the rest of the hardware from the capacitor in my set. The repaired ceramic plate was swapped-into the capacitor from the parts set – I am sure it will come in useful one day!

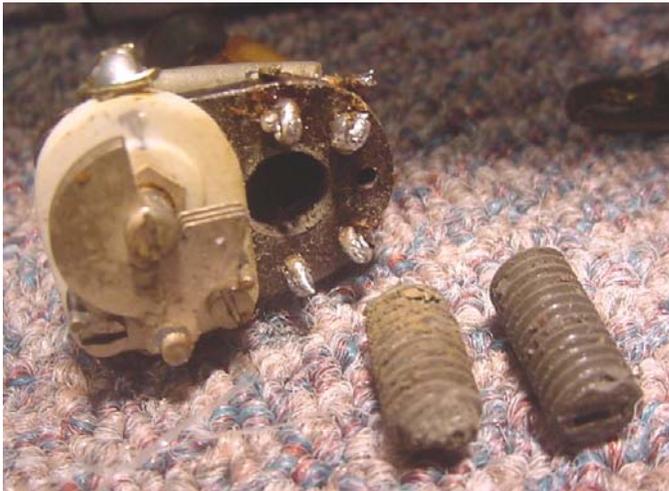
While the restoration work was on-hold pending powder-coating of the front panel and case, I undertook a close inspection inside the coilbox. I noticed that the slug in the Range 1 aerial transformer was completely rounded-off and there was no sign of the slot for adjusting this. After some preliminary attempts to remove the slug (someone else had obviously tried this at some time and failed), I decided to remove the transformer assembly from the coilbox to work on it. This was not too difficult to do (six wires to unsolder and one screw holding the former in place). I took my time and

used a scalpel to shape the end of the slug so that a pair of wide (and substantial) tweezers would find purchase and allow the slug to be turned - all that transplant practice coming in handy again! Luckily I had purchased a small supply of the correct slugs from Ian Nutt some time ago, so after cleaning the former out I inserted a new slug and hey-presto, good as new (photos left and below). The slugs in the remaining RF transformers looked ok – all ready for tweaking if necessary during re-alignment.

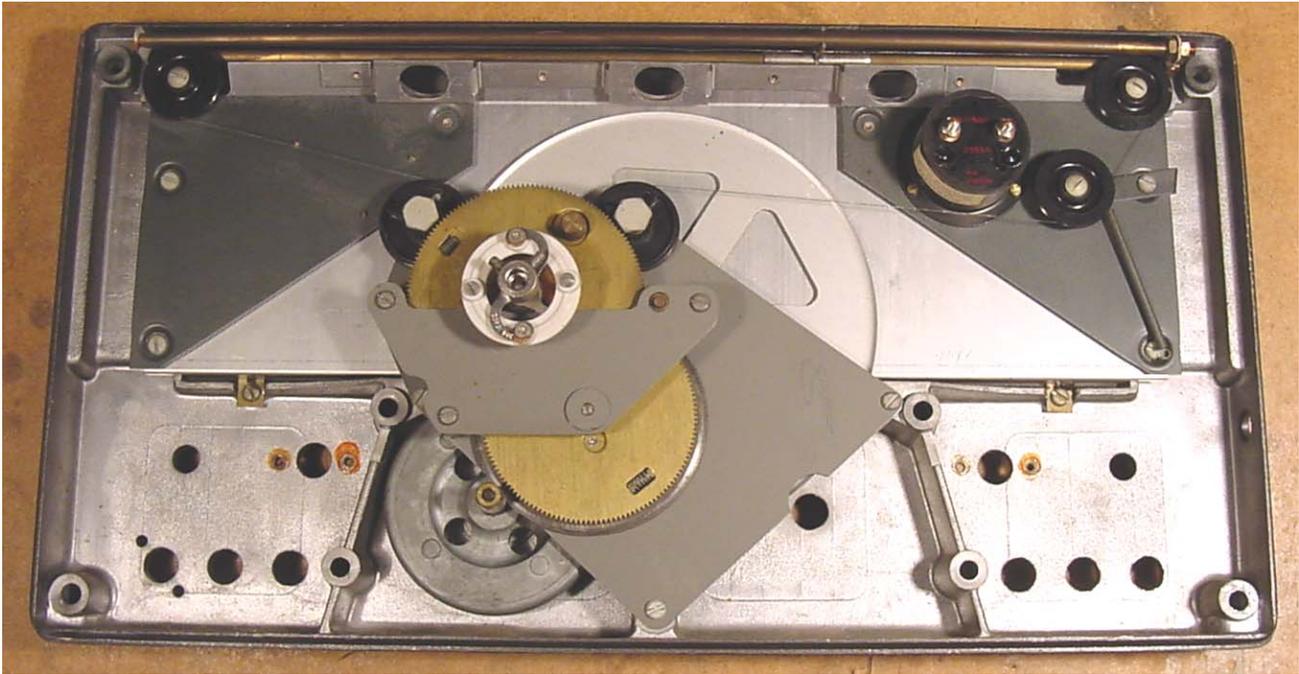
Above: Late-model S.680X front panel and gearbox. Below: S.680/2 front panel and gearbox. This is the most radically-changed part of the set. Note the difference in location of the tuning shaft coupling
