Eddystone Radio Model 840A 1954-61 Restoration

In October 2013 I received a valuable gift: a receiver Eddystone Model 840A, manufactured during the years 1954-1961 at Eddystone in Birmingham, Great Britain.

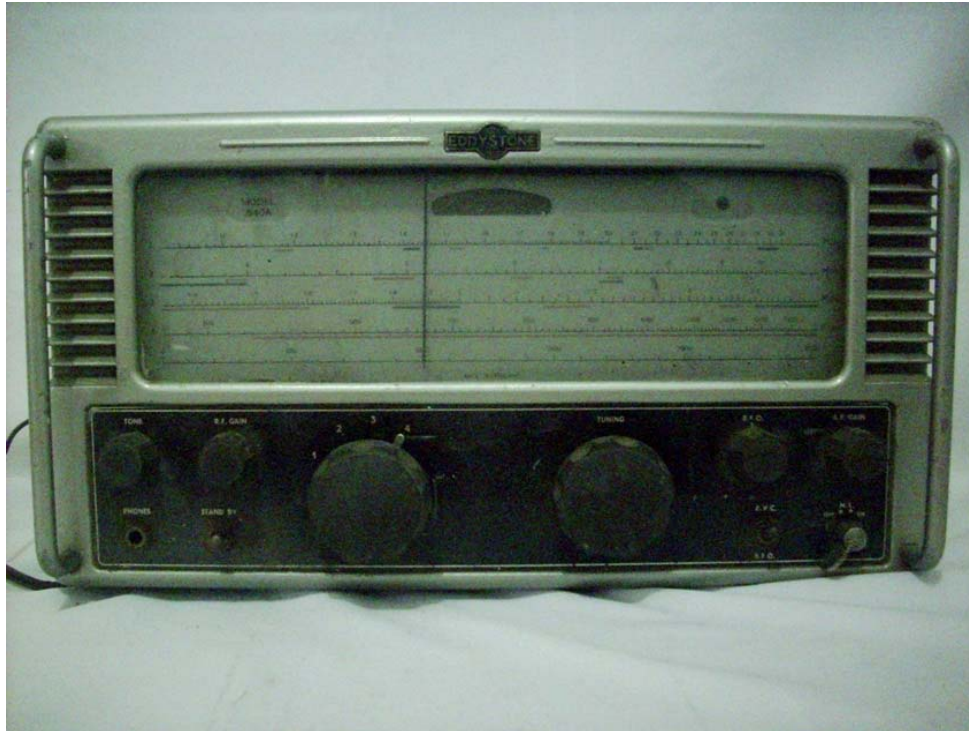
2. The arrival

Excessive dust, insects and cobwebs. The dial was partly obscured and the panel with leftover paint.

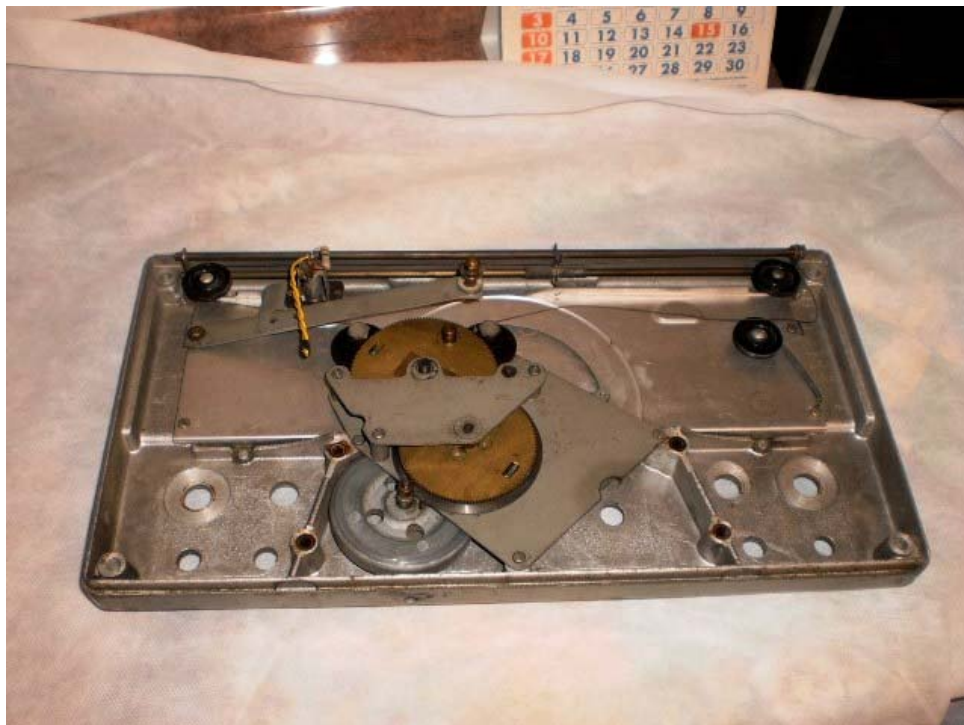
4. The dial and the pulley system.

Unfortunately I had my first give up over 190 restored antique radios. A gear system joining the axis of the *vernier* and variable knobs had Bakelite gears with many broken teeth that were impossible to repair.

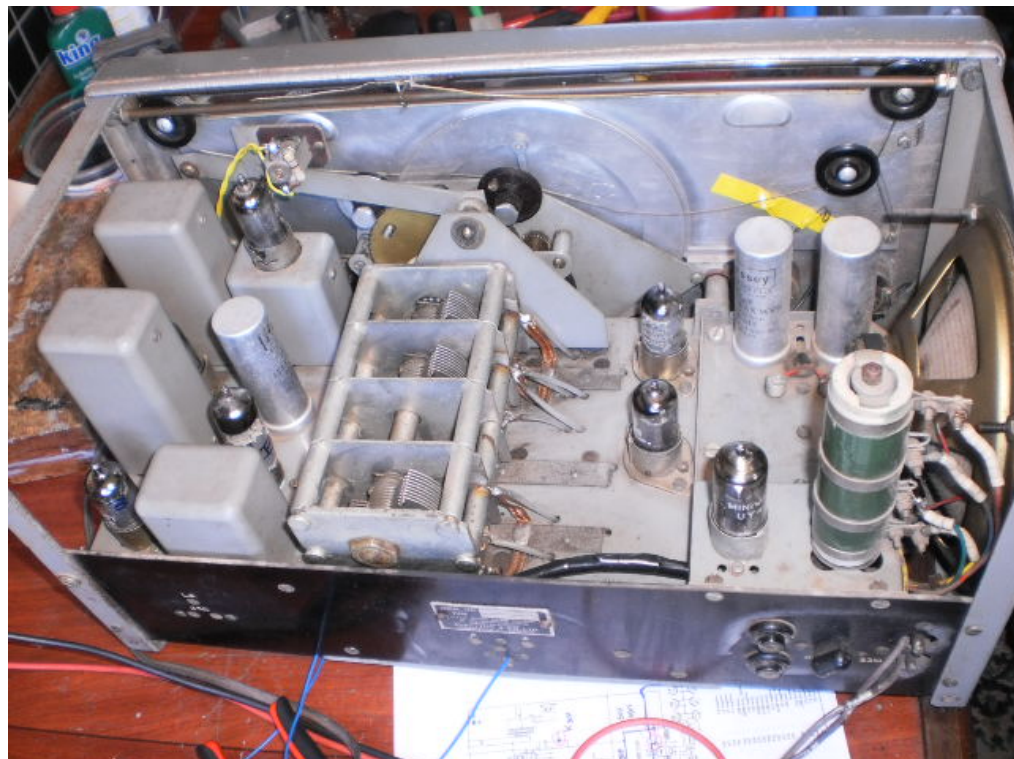
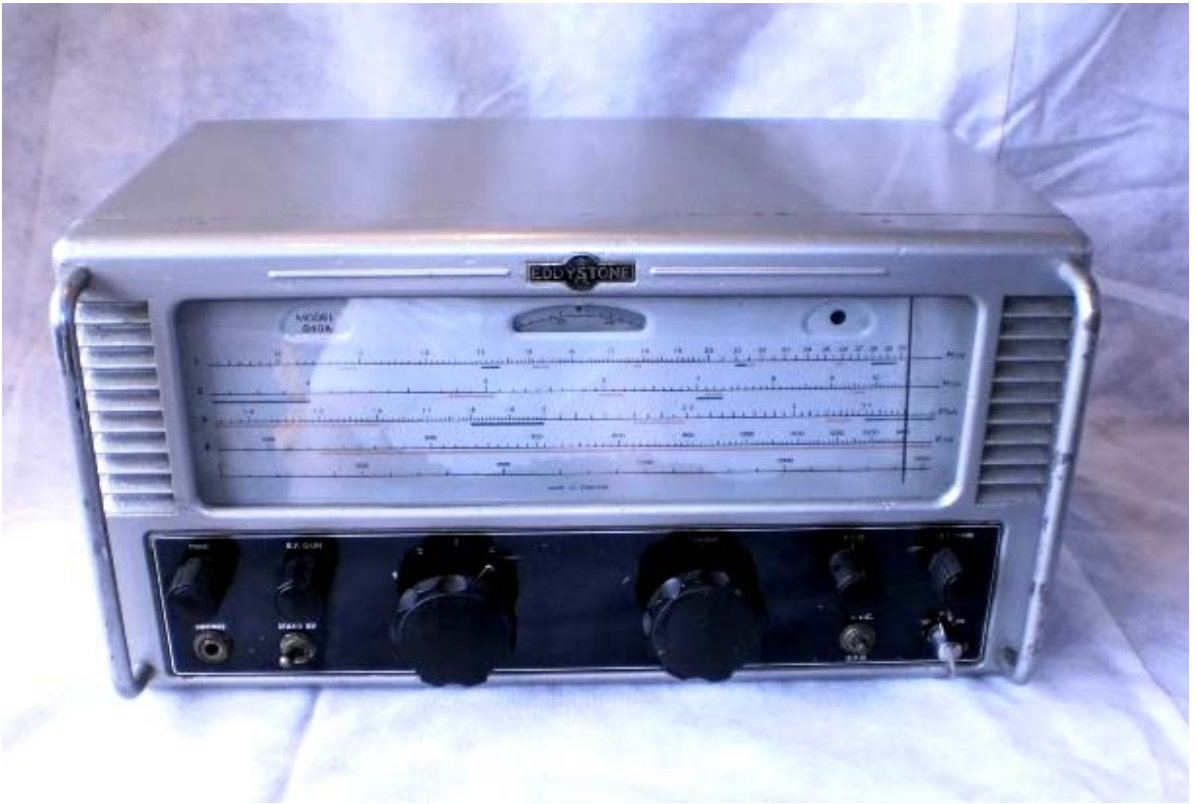
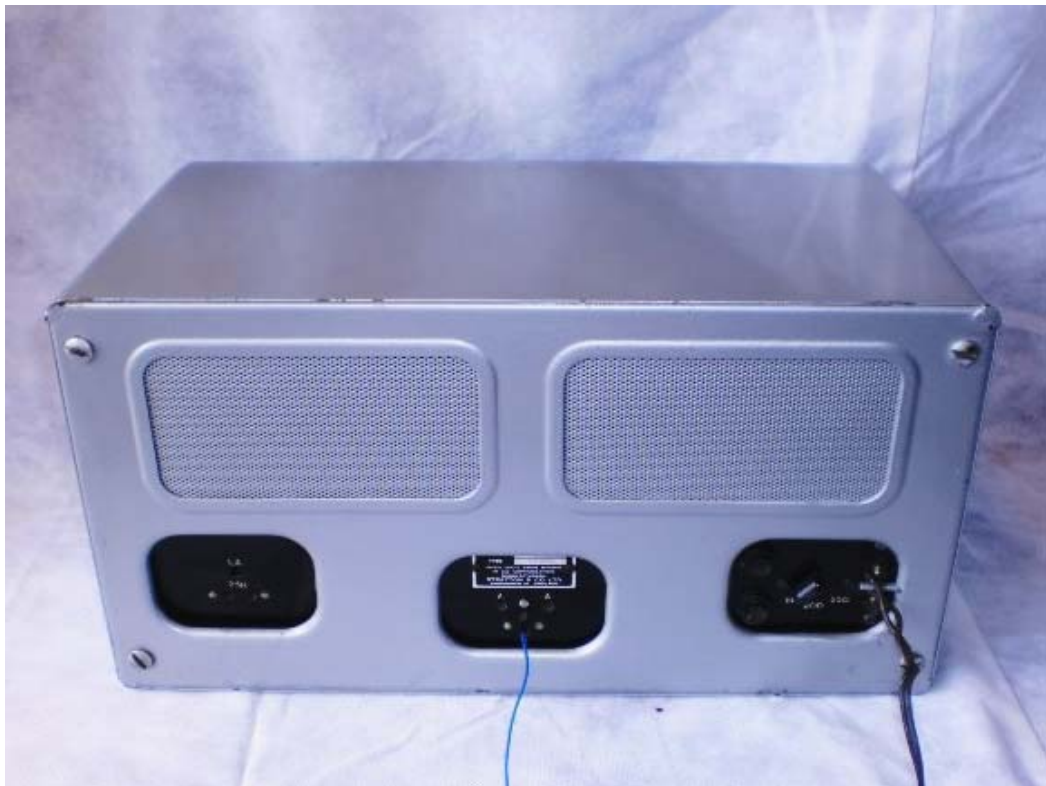
5. The end

Anyway the Eddystone worked perfectly with a good degree of selectivity, volume and range.
