## Eddystone Power Connection Using a 'Marquis' Plug - Philip Leahy<sup>1</sup>

## Introduction

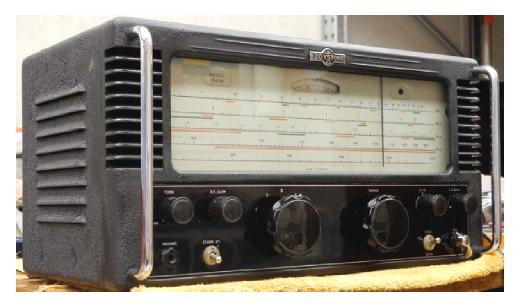
Above: the author's S.840A – raring to go but in need of a power supply connection. Below: the 'business end' – the S.840A power supply chassis socket and an original plug (or rather, what's left of it!)

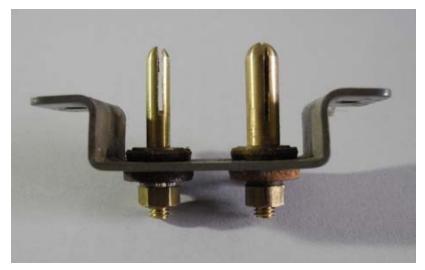
Left: original Eddystone mains input saddle with new pins to suit the Marquis plug - side view

The original pins on the chassis socket were too large at 5 mm (.20") diameter, to fit the Marquis plug. I decided to turn up two new pins of the correct size to suit the plug and to fit the pins to the existing Eddystone cradle. The size of the pins needed were one at 5.6 mm diameter, and the other at 4.1 mm diameter. They were each 28 mm long overall, with 16 mm bifurcated pin, and 12 mm threaded 4BA. I turned them out of brass stock

and bifurcated them with a diamond-encrusted wheel of about 3/4" diameter powered by a

jeweller's flexible rotary tool.

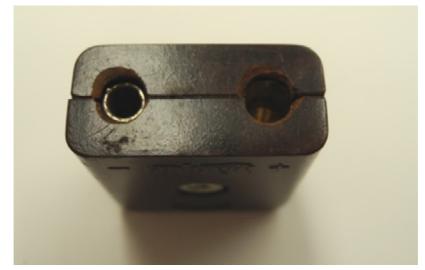
Left: the two pin Marquis plug – end view

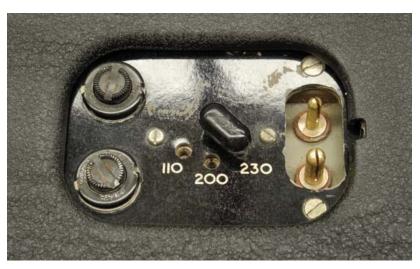
Left: Bakelite panel on the S.840A showing saddle with new pins and access hole straightened out

The original Bakelite panel had a 'figure-of-eight' hole for the original plug and a metal piece protruding from the case which originally would have entered the division in the original two-legged plug. Therefore I needed to straighten up the sides of the existing hole in the Bakelite and remove the metal spike. The spike came off readily after gripping it with pliers and moving it about – rather like a dentist removing a tooth! I then straightened up the Bakelite by carefully sawing the edges with the same diamond -encrusted rotary wheel

and filed it up. Very little different to the original hole and the Marquis plug fitted perfectly. No alteration to the cabinet was necessary, as would have been required with the IEC socket solution, and the Marquis plug is perfectly insulated.

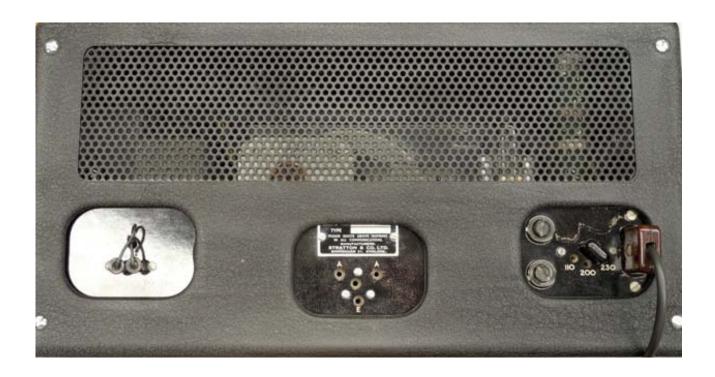
Above: back panel with new plug in position

By using the Marquis plug, I was able to retain the manufacturers intention to have the polarised connection and to keep the set in its original form.
