Eddystone S.504 - Dial Drive Cleaning and Servicing – Roy Kavanagh, GM4VKI¹

S.504 Dial Drive Overview

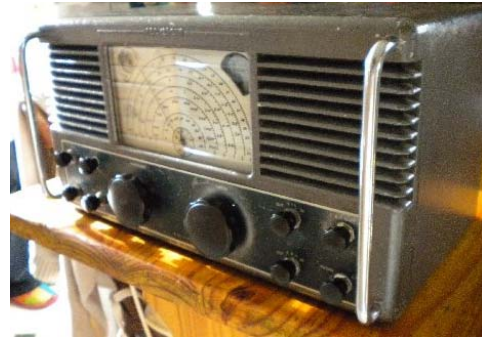
The S.504 (photo, right) was the first communications receiver that Eddystone produced after WWII. It was based on the S.556, a ‘Tea Planters’ Broadcast receiver introduced earlier in 1946. These receivers sported the (then) new-look distinctive fluted-front cabinet style that was to last throughout the next decade, with the 1940’s ‘half-

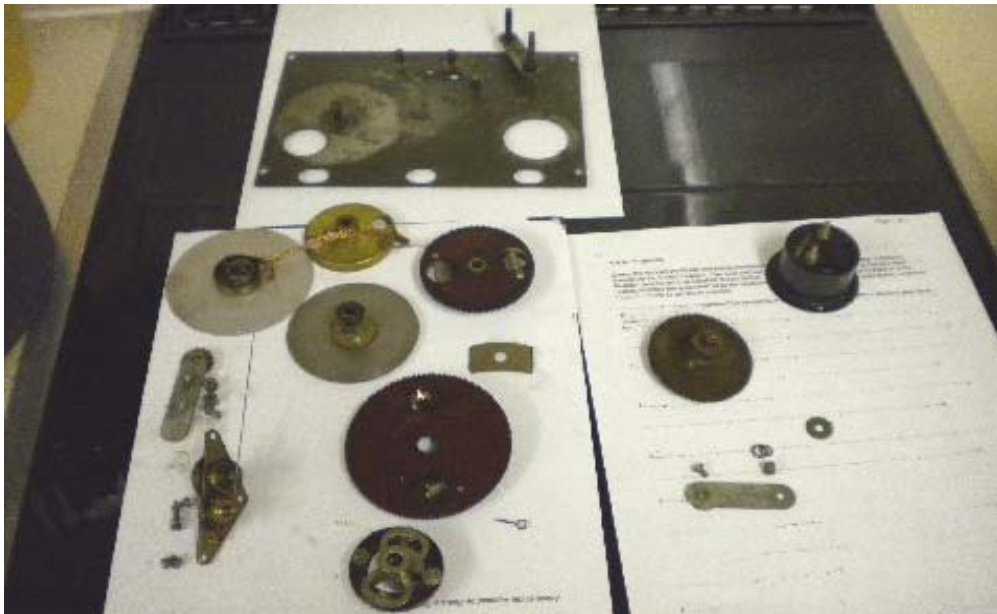
Photo 2. No going back now - all stripped down...

Hey presto – all now clean and in bits! (photo #2) – fun part over. Now the more difficult (but satisfying) part...

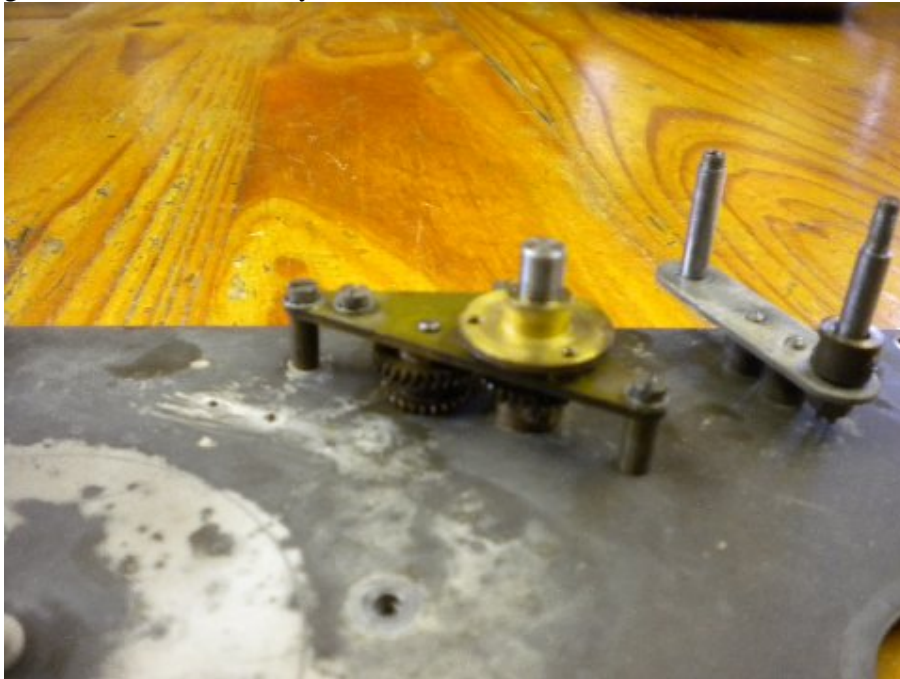
- 4 Refit the band change indicator (I forgot, and had to take the whole thing to pieces and start again – photo #3, above).
- 5 Refit the brass double gear which lies over the band change indicator and slots into the idler gear.
- 6 Now spin the large brass wheel with one finger and adjust the idler until a smooth action takes place in the gears fitted so far.
- 7 Refit the spring steel wheel and its collar.

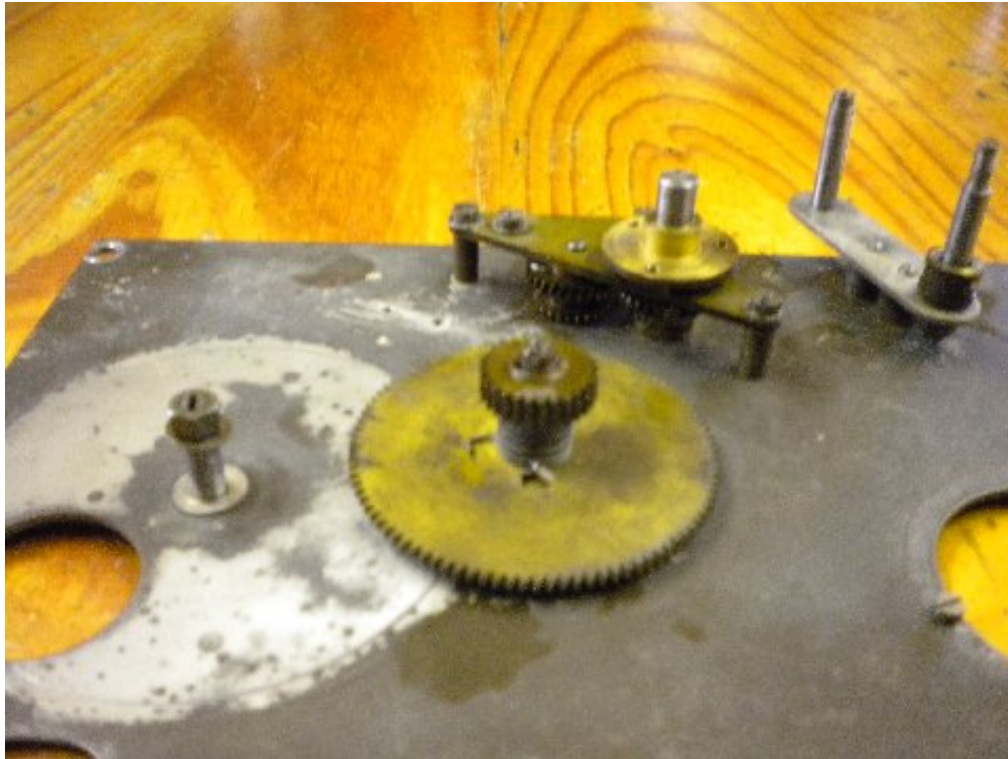
Photo 4. Large brass gear replaced

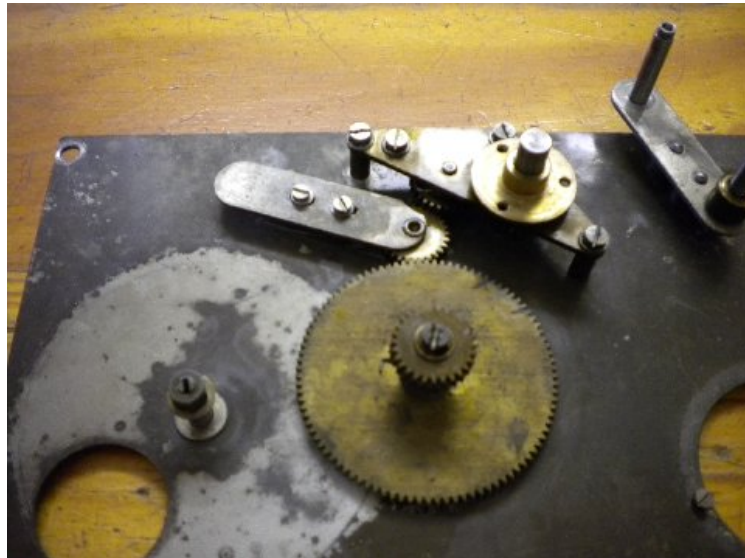
Photo 5. Idler gear fitted

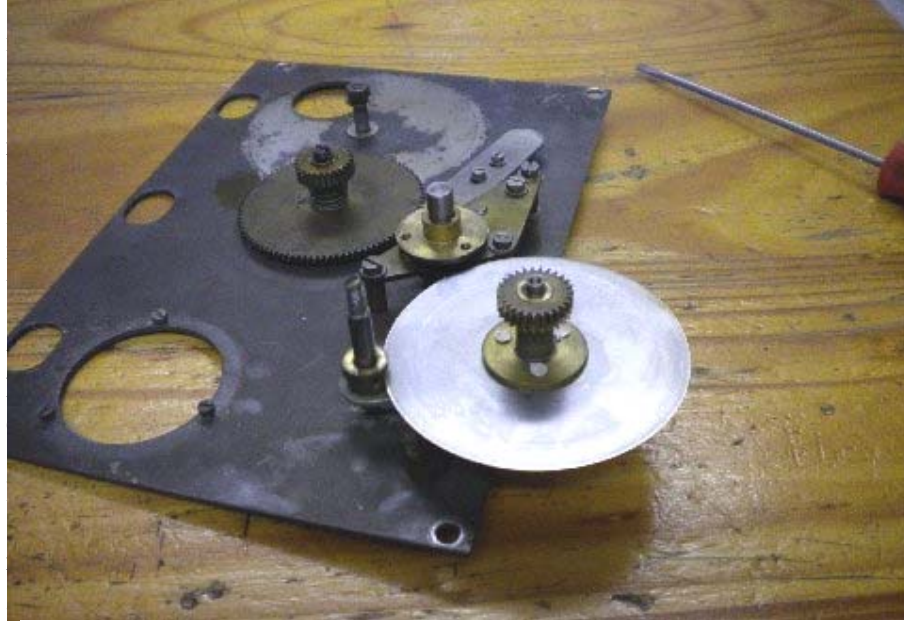
e Photo 6. Spring steel drive wheel and collar fitted.

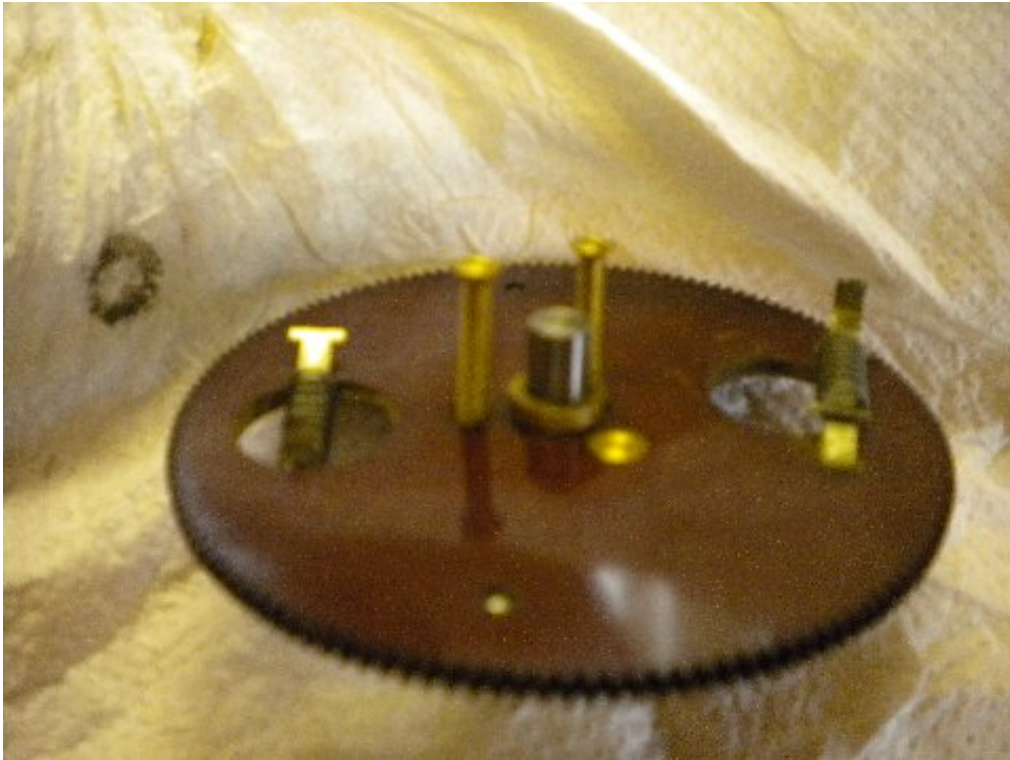
Photo 8. The large Paxolin drive wheel is in two halves - the lower half is screwed to the brass boss with three very small screws and they are each only holding by one turn. One of mine was stripped causing the wheel to run untrue, so three new brass 6BA screws were fitted and sawn off at the back . The thread was re-tapped as well.

- 17 Carefully check the large Paxolin gear as it has three hidden screws which hold the bottom section onto the brass bush: make sure these screws are secure as mine weren't, so I had to split the gear layers and put new 6BA countersunk screws in place of the old worn ones. This is done by carefully unbending the tension springs' tongues that are poking through the top gear layer. Re-bend the tongues to secure the top gear layer back on when completed.
- 18 Clean the band change indicator (carefully) with soap and water only.

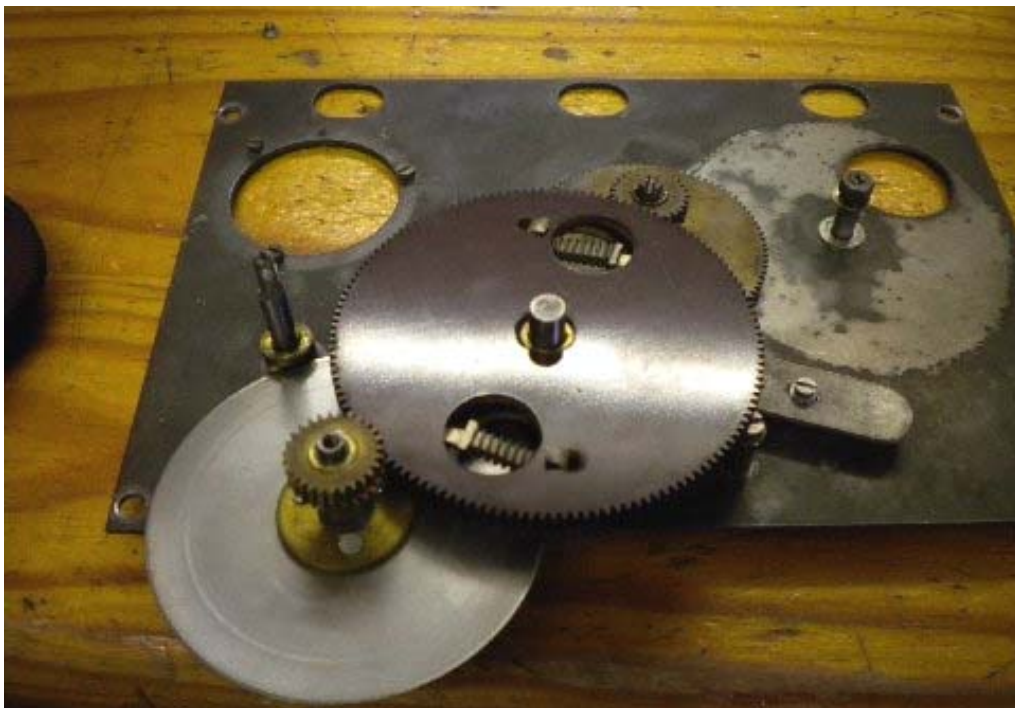
Photo 9. Final pointer drive wheel re-fitted

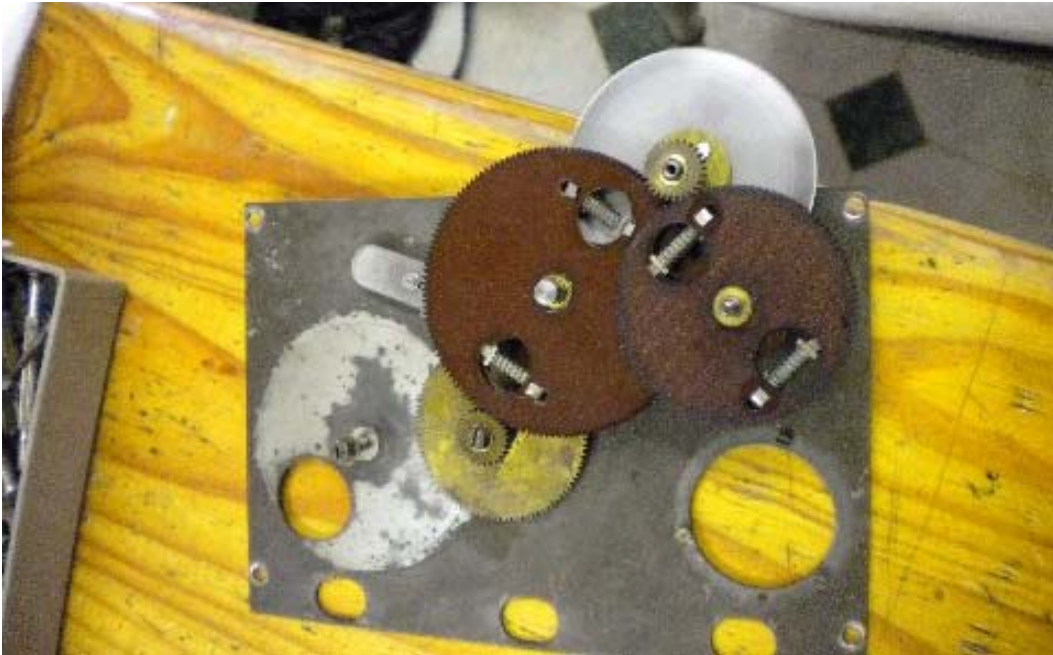
Photo 10. Six hands required for this one (see Photo 23). First the large final Paxolin drive wheel has to be tensioned and held. Then the smaller Paxolin drive wheel has to be tensioned and held. It is then slid down its shaft linking the spring steel wheel to the final drive. Once in place the anti-backlash springs can be released to take up the slack.

- 11 Refit the smaller Paxolin wheel whilst applying spring pressure between the top and bottom sections of the large Paxolin wheel, and also put a (small) spring tension on the small Paxolin wheel anti-backlash arrangement⁵.

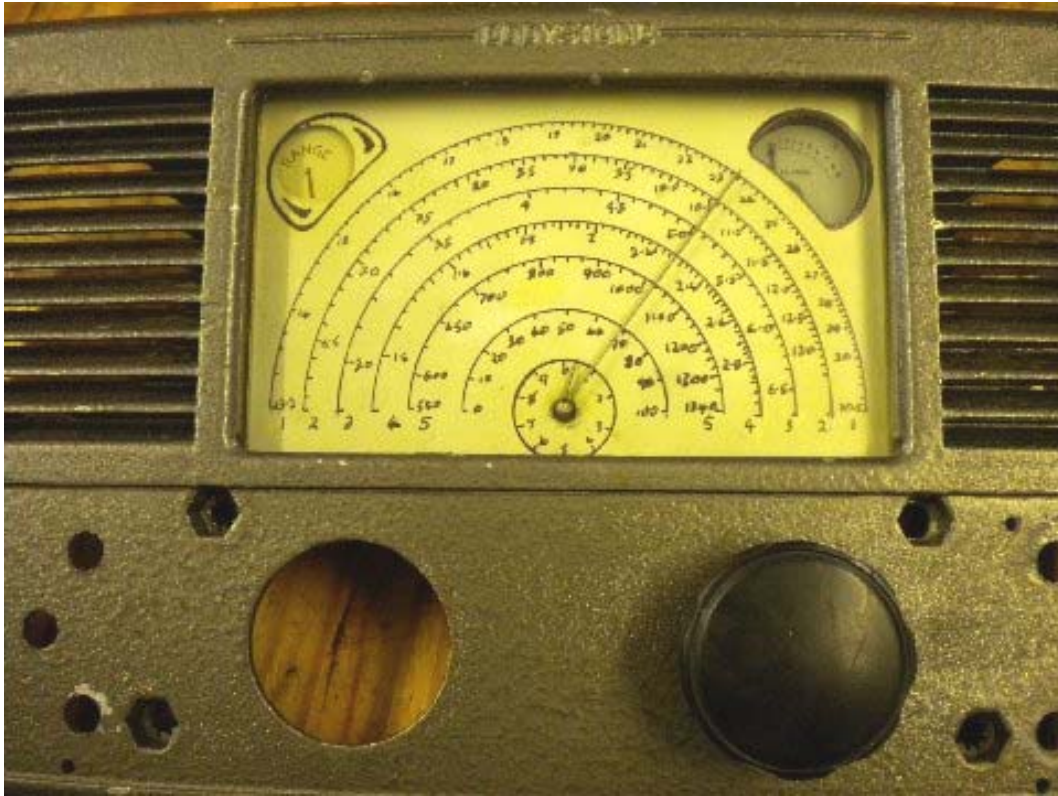
Photo 12. Front panel showing new hand-marked dial and testing the overhauled gear drive mechanism

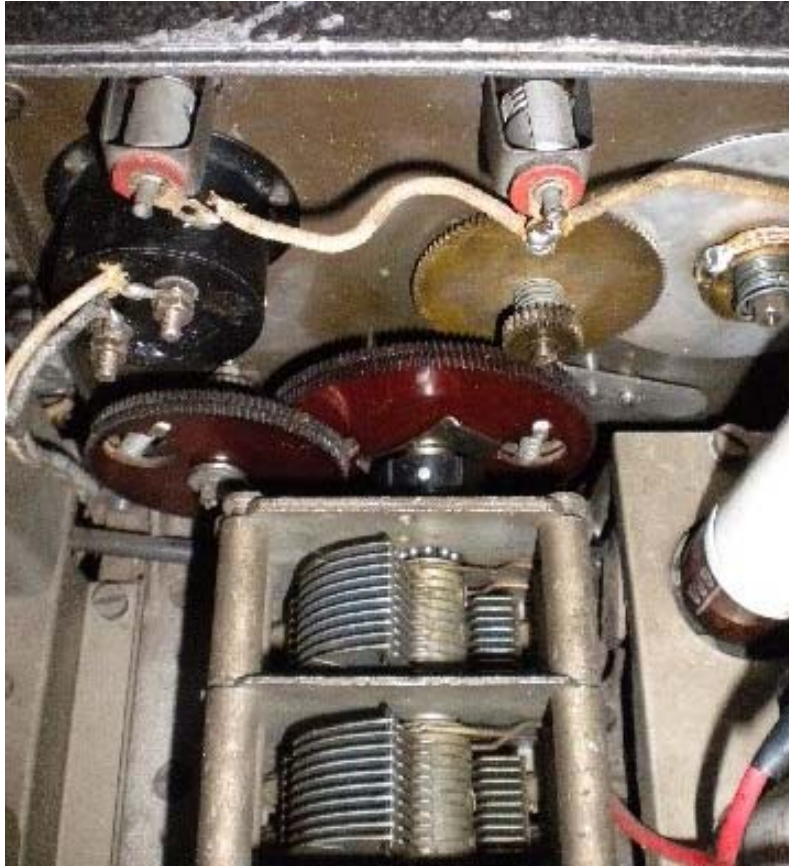
Photo 14. Dial drive mechanism installed in the S.504

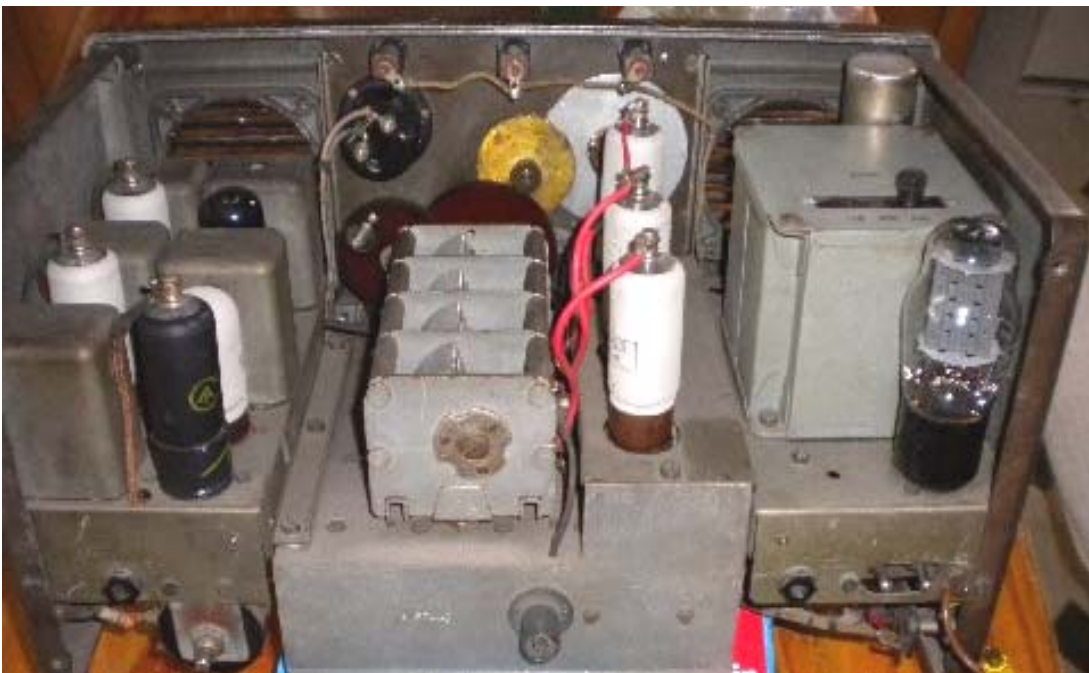
Photo 17. Rear view of the S.504 chassis

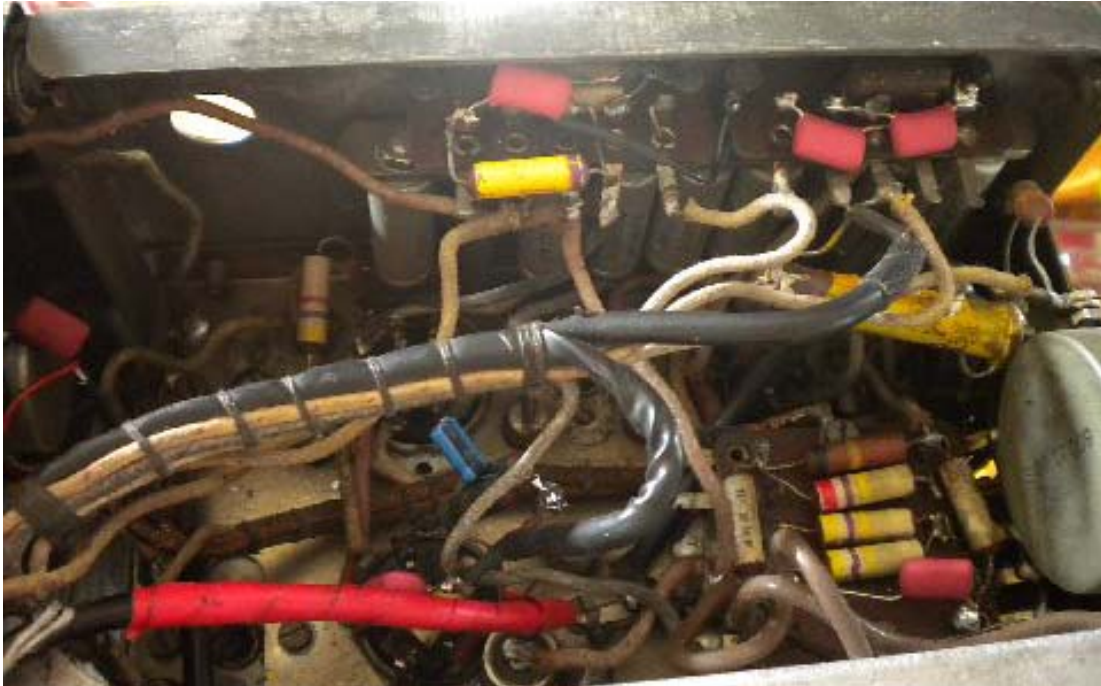
Photo 18. Re-capped IF section

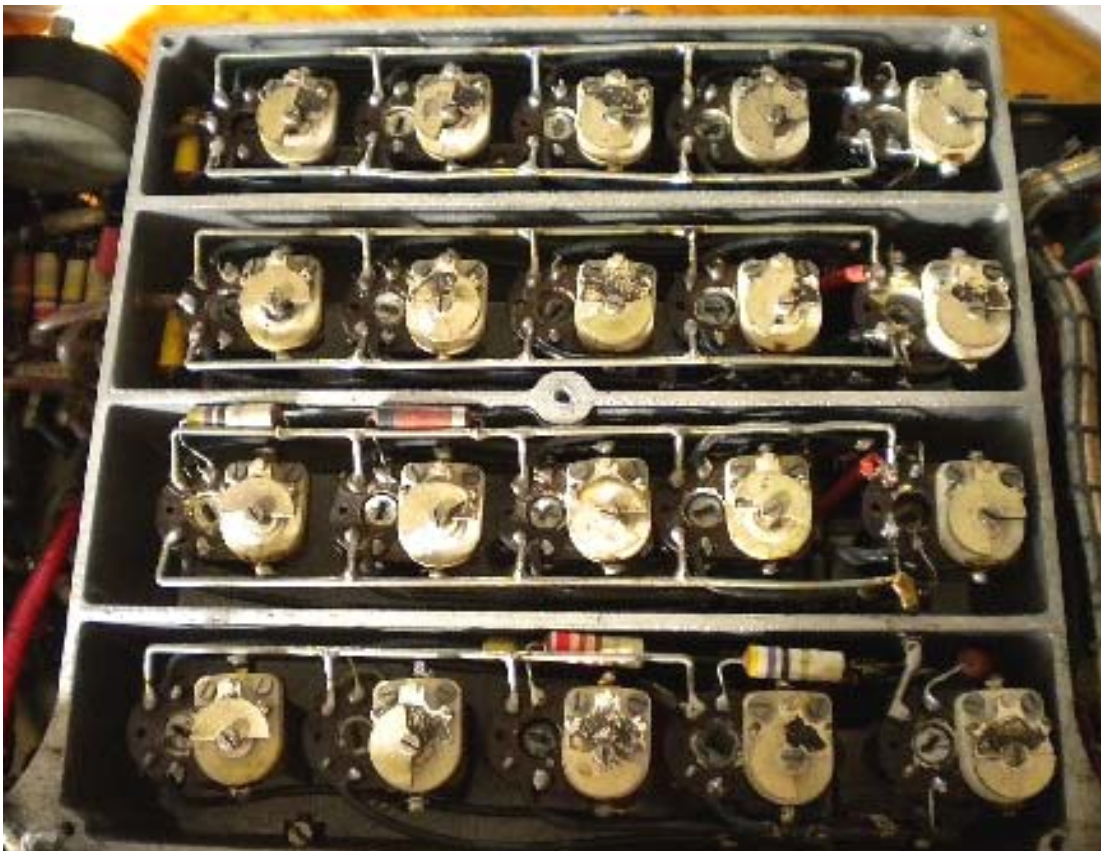
Photo 19. Coilbox – the start of an era in communications receivers...

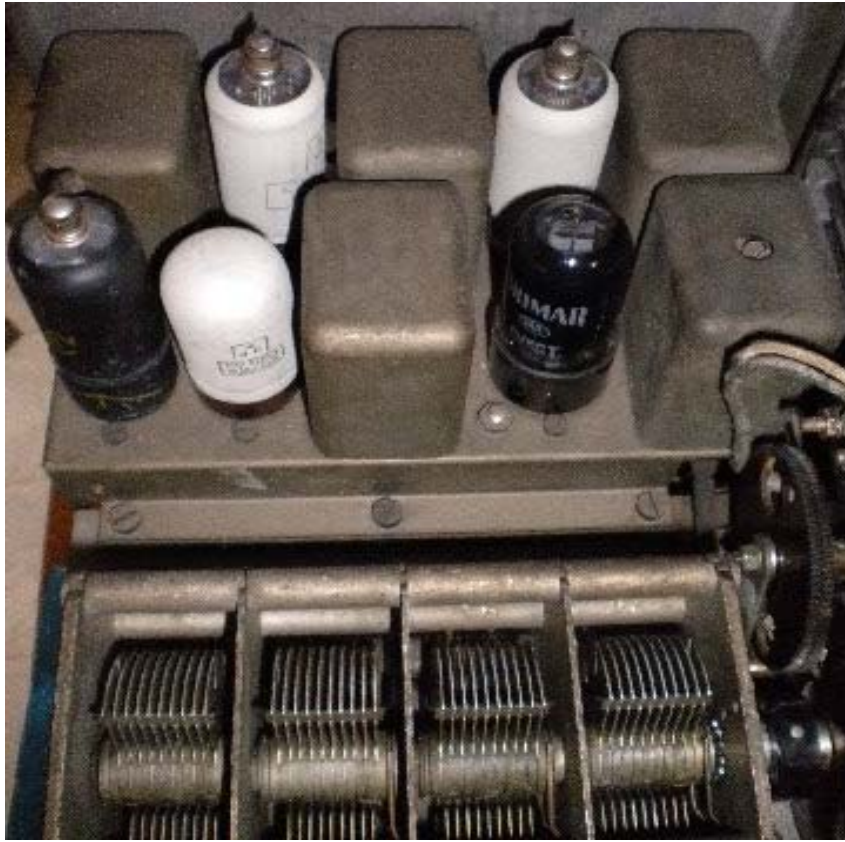
Photo 20. IF and AF section

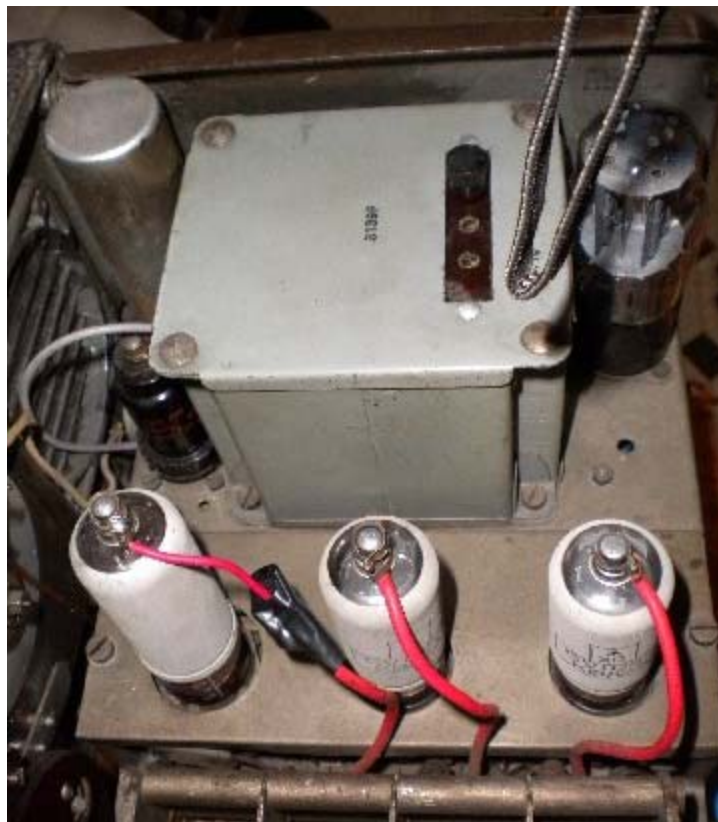
Photo 21. Power supply and RF stages
