The Eddystone S.830/4 Revisited: Fitting Some New Jewels in the Crown

Introduction

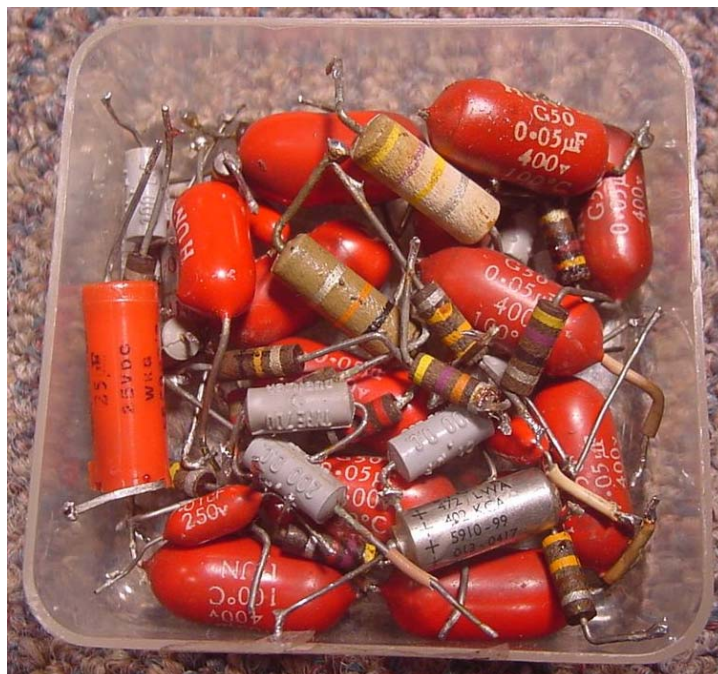
Above (upper): box of replaced components. The silver-bodied capacitor is a tantalum (at least according to the parts list in the manual). Above (lower): one of the 0.05µF 400vw 'red Hunts' capacitors (right) with the equivalent components in modern metalized polypropylene (radial top, axial below), as supplied by *JustRadios*. These are both 630vw parts

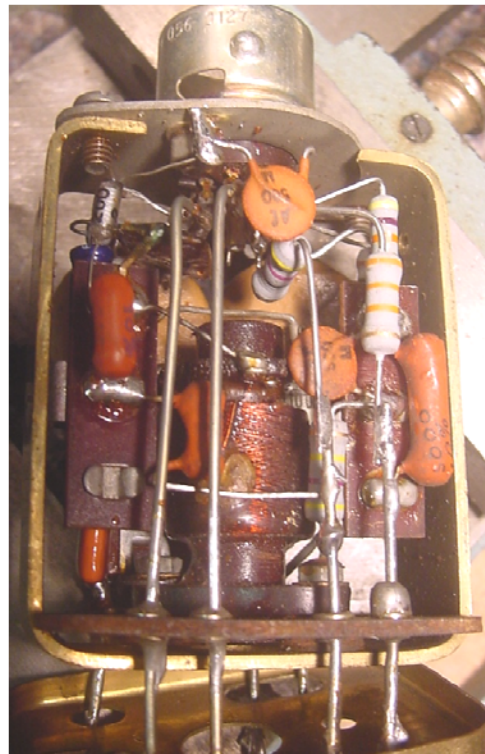
Base of previous page: before and after component replacement in the BFO/product detector unit – side 1. Left: after component replacement, side 2. Note the 'top hat' varicap diode. Above: base of the BFO/product detector unit – note seven connections need to be undone to remove the unit from the chassis

Actually, removal of the BFO/product detector unit is fairly straightforward – simply remove the connections from the base of the unit together with the two 4BA screws and its off (just make a note which wire goes where – photo on previous page). Once removed from the chassis, the can is easily removed by taking out two screws, allowing access to the delights within. I replaced all resistors and paper/suspect type capacitors – a little fiddly, but straightforward job. The original 25uF 25vw electrolytic in this unit had effectively zero capacitance and a resistance of around 20kohms.

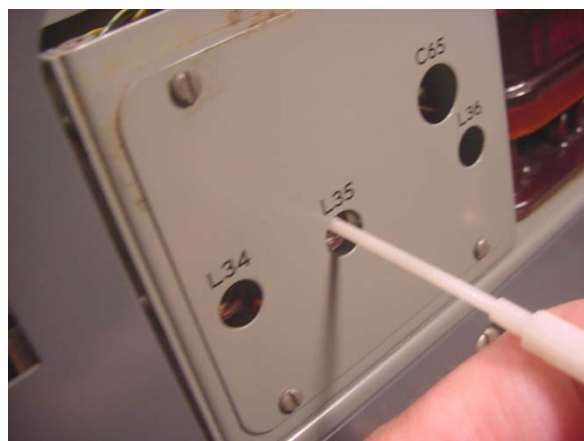
checked each 10kHz increment on the vernier scale for accuracy. Prior to adjusting, my set was quite a way out (30kHz or so) but when I had finished it was spot on. The tunable IF transformer is adjusted for tracking using L34/L35 and C74/C77 with 1260kHz and 1440kHz fed into the 1st mixer stage respectively (photos at base of previous page);

⁴ This slug was very loose in its former – the remnants of a rubber thread having fallen out. I removed the slug and coated it with high-viscosity grease ('Kilopoise') prior to alignment.

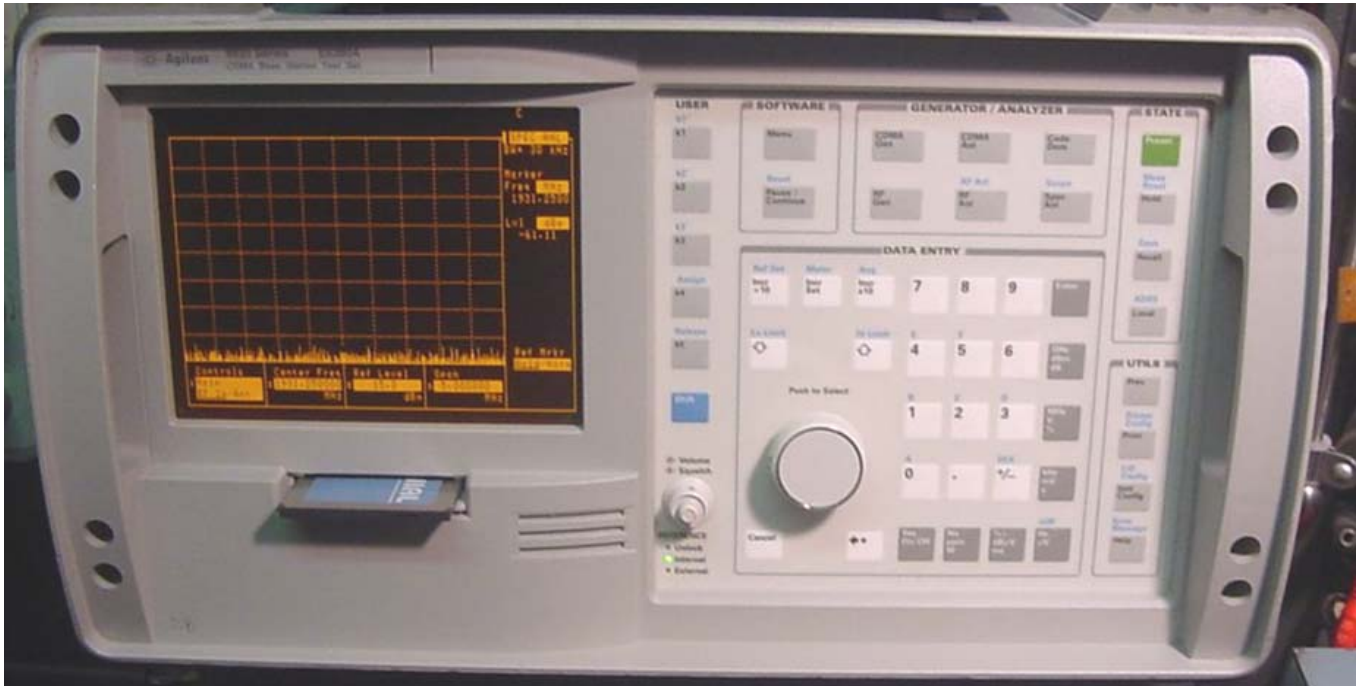
Above: the all-singing, all-dancing Agilent 8935 (Cellular) 'Base Station Test Set' – an excellent piece of kit, but with an annoying frequency gap below 400kHz in the Spectrum Analyser mode. Below: the homebrew wobblator unit based on the design published in Radio Bygones in 2003. I added a DFM and a few other enhancements – including an extra switch position for an external coil: handy when I get around to modifying this unit to include a 100kHz band...

Postscript: having read Graham Gosling's article listed above, I thought I may as well check-out the response of the 100kHz IF in my S.830/4 with the Agilent 8935 spectrum analyser – but I soon realized that the Agilent only goes down to 400kHz in this mode. Then I thought – Ah, but there is the wobulator I constructed some time ago (the design by Raymond Haigh published in Radio Bygones No. 82, April/May 2003) - but that only goes down to around 350kHz! So, I guess checking/tweaking my S.830/4's 2nd IF response curves will just have to wait – I think a modification to the wobulator should be possible to give a lower frequency range - that is for another day though.... Besides, the response from the method given in the manual seems to be fine (both in listening tests and checking signal strength at fixed frequency offsets) if some care is taken to avoid a humpy response during the alignment process.
