The Restoration of a ‘Parts Set’ Eddystone S.940: Part 1 - Cleanup, Mechanical /Electronic Repairs and ‘Jump Starting’ – by Gerry O’Hara, G8GUH

The Eddystone ‘Stop Gap’ That More Than Made The Grade

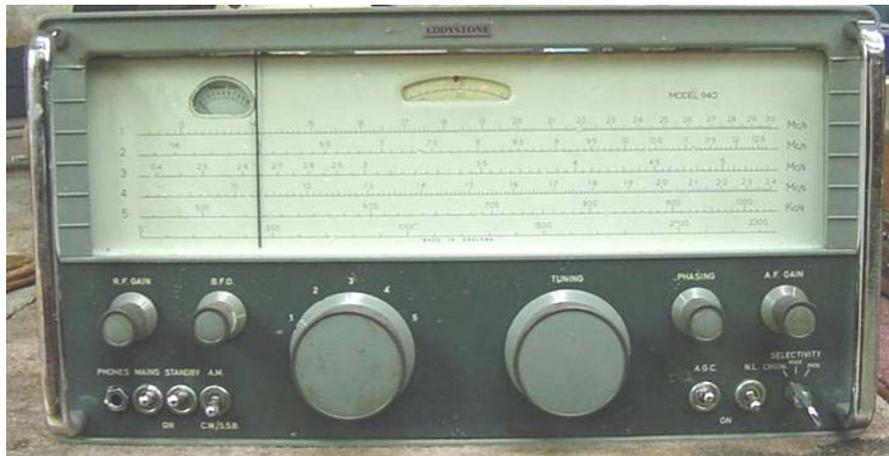
Overall, the S.940 was not in too bad physical condition, apart from being an ex-‘parts set’ and therefore missing some bits

(the most important being its mains transformer, the L4/C4 coil/capacitor assembly, the coil box cover and, of course, its case), as well as the BFO unit being removed, though in my possession, and the B7G-mounted crystal missing from the first IF can. There was not too much grime on the chassis and no sign of overheating in the power supply area (the transformer had been ok as it was removed by Pat for his S.750) and, amazingly no signs

Before the mains transformer was donated to Pat’s S.750 and the BFO and dial lamp holder were removed

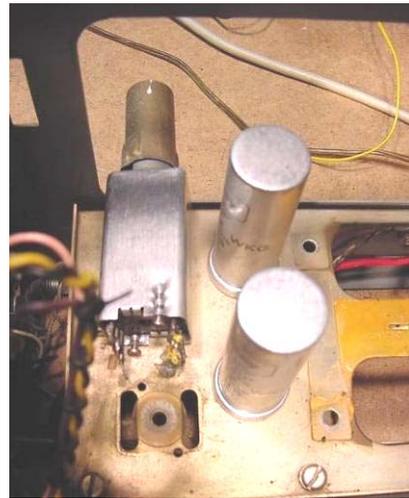
BFO unit on arrival – all present and correct but a bit detached (like me?)

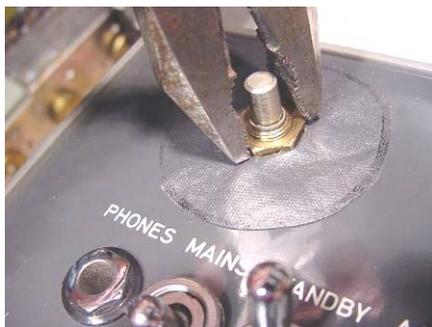
Removing the controls – note the oversized scratch guard

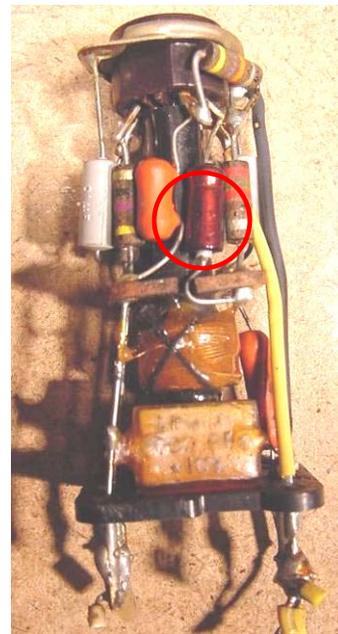
Inside the BFO unit – note C100 (10uf electrolytic) lurks in here (circled)

First I removed the can from the BFO unit and did some cursory component and pin-out checks before refitting it to the chassis and re-wiring into the circuit. While I had the opportunity I checked C72 (metallised paper heater decoupler) and found it to be leaky – replaced it (blue capacitor in photo, left).

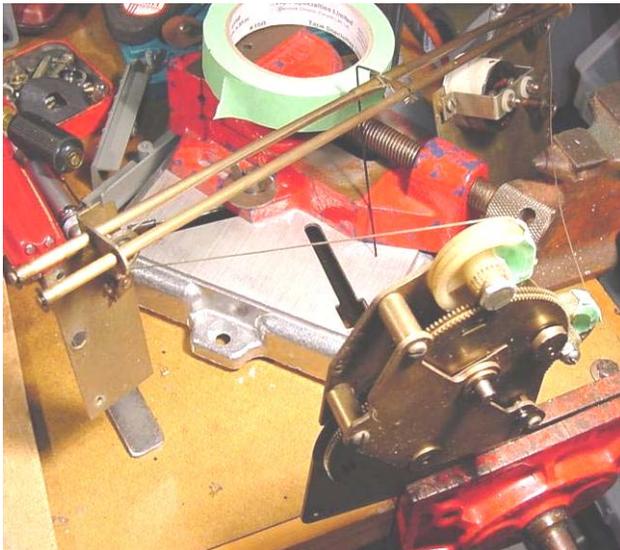
Gearbox in my bench vice for cleaning (note dial cord still attached and threaded through idler and jockey pulleys)

- I removed the round logging scale (vernier) dial plate from the gearbox front spindle (photo right) and placed the gearbox into a smooth-jawed bench vice and then painstakingly cleaned each tooth on each gear and pinion using isopropyl alcohol, a darning needle and Q-tips. I used lighter fluid to remove the more stubborn ‘gum’ and clean out the bearings. I found

that the gears were now freely-turning and I decided not to dismantle the gearbox totally, but to apply a light coating of high-quality light machine oil (not 3-in-One!) to each of the bearings and a smearing of molybdenum (‘moly’) grease to the parts of the brass gears that did not mesh with the plastic spool pulleys. I tried it out – much smoother now. The friction drive plate was cleaned using lighter fluid to remove any stray oil or grease, as was its mating surface on the tuning spindle.

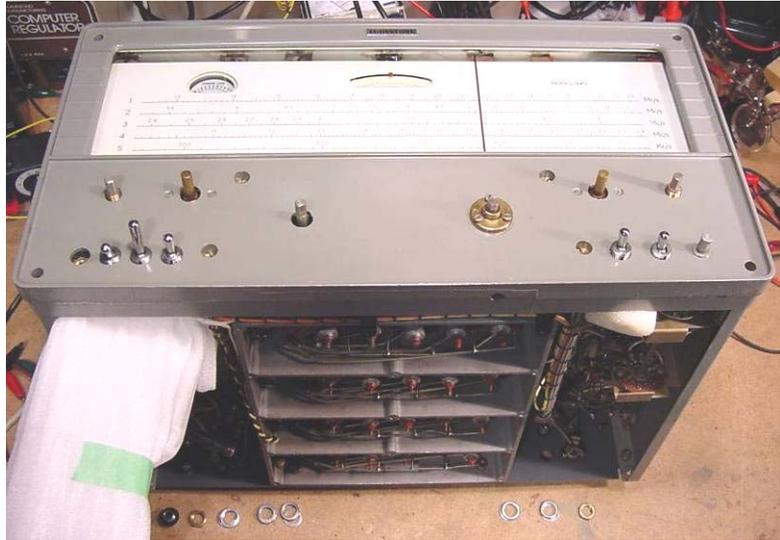
- Then I re-attached the front panel to the chassis. This is easier said than done, as getting all the switches and other controls into the correct holes at the same time takes some doing! A tip to help with this (that I meant to mention in the S.750 article) is to temporarily stuff the space beneath the switches and other controls with some packing material (see photo right) – this simple expedient holds all

the controls in place while you fit the retaining nuts (saves a lot of time and cursing).

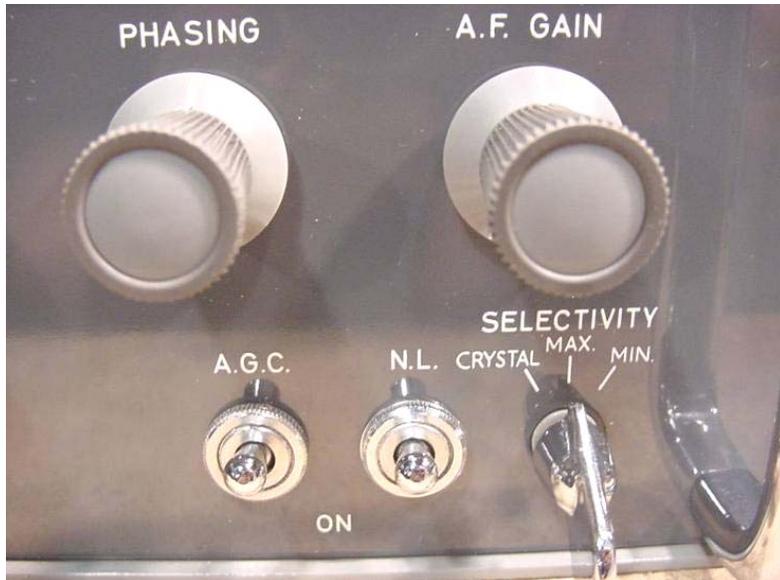
- I then fitted the replacement dial lamp holder (made originally for my S.750 to replace a bodged screw-thread one) and fitted new long-bulb #47 dial lamps – a standard in US and Canada radios – its ok to use them here as in this set the extended glass bulbs do not interfere with the drive cord.

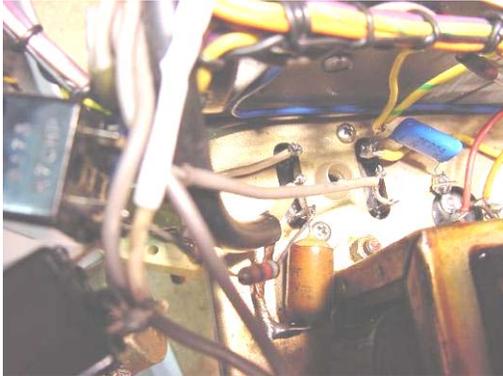
- First the obvious: re-fit the BFO unit. Not too difficult as Pat had left short pieces of the wires on the base pins that could be matched with some of the ones hanging in the radio.

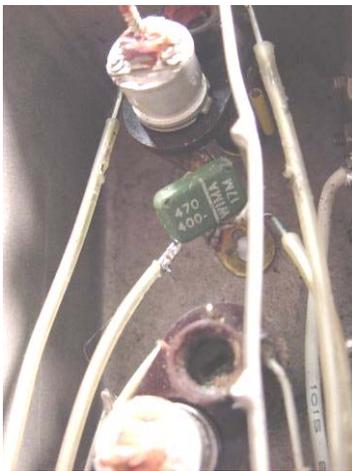
Temporary bridging cap in Band 4 aerial circuit

- As noted, the set was a bit ‘deaf’ on all bands at this point, with only signals from known local very strong stations producing movement on the S-meter, so I decided to do a full re-alignment – this would be needed anyway due to the non-standard crystal filter frequency. Before I started, I ‘bodged’ the RF coupling to V1 on Band 4 by temporarily installing a 470pf capacitor between the wires hanging in the aerial input section of the coil box where the L4/C4 combo had been removed. Closer inspection of the IF transformer and coilpack dust cores (‘slugs’) and ‘beehive’ concentric trimmers showed signs that they had been played around with as most of the red wax seals were broken (where unbroken, the wax actually looked to have been

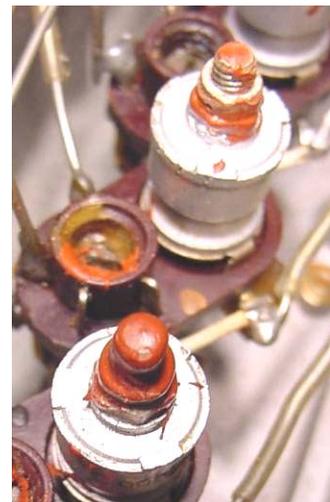
Hardened red sealing wax on the concentric trimmers and coil slugs

- During adjustment of the iron dust cores (for low-frequency settings), I first scraped off the hardened red wax covering the ends of the cores sufficient to allow the core to be turned. Fortunately all the cores were found to be in reasonable shape despite a 'twiddler' having 'had a go' at some time(s) in the past. Adjustment of the 'beehives' (high-frequency settings) was straightforward. Only two iterations of adjustments on each range produced good scale linearity.

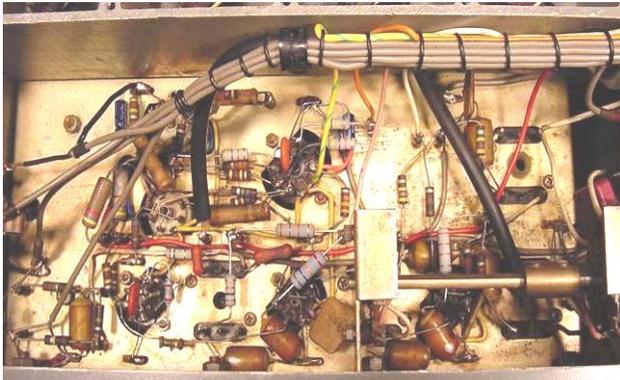
The IF/AF chassis during component replacement (annotated photo at the end of the article, Page 24)

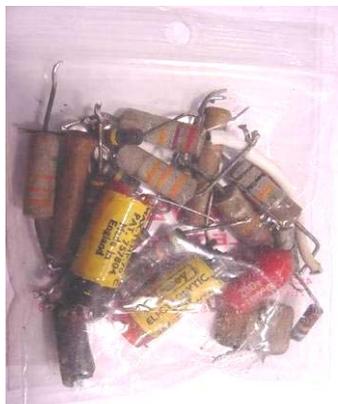
Bag of duff parts removed from my S.940... any offers?

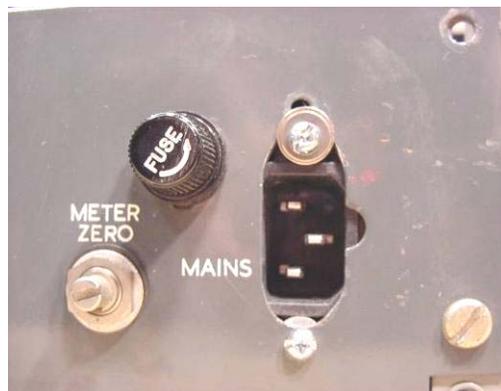
‘Euro-connector’ mains connector now fitted (not much use at present!)

- Checked the general electrical safety of the PSU unit – someone had replaced the original ‘kettle connector’ with a horrid and flimsy-looking two pin chassis-mounted plug screwed to a piece of aluminium. I decided to replace this with the Euro-connector conversion as described in my S.830/4 and S.770R articles. This done, I proceeded to check for poor connections, heat damaged wires, poor insulation etc. as well as trace the loose wires left hanging when Pat had removed the mains transformer.

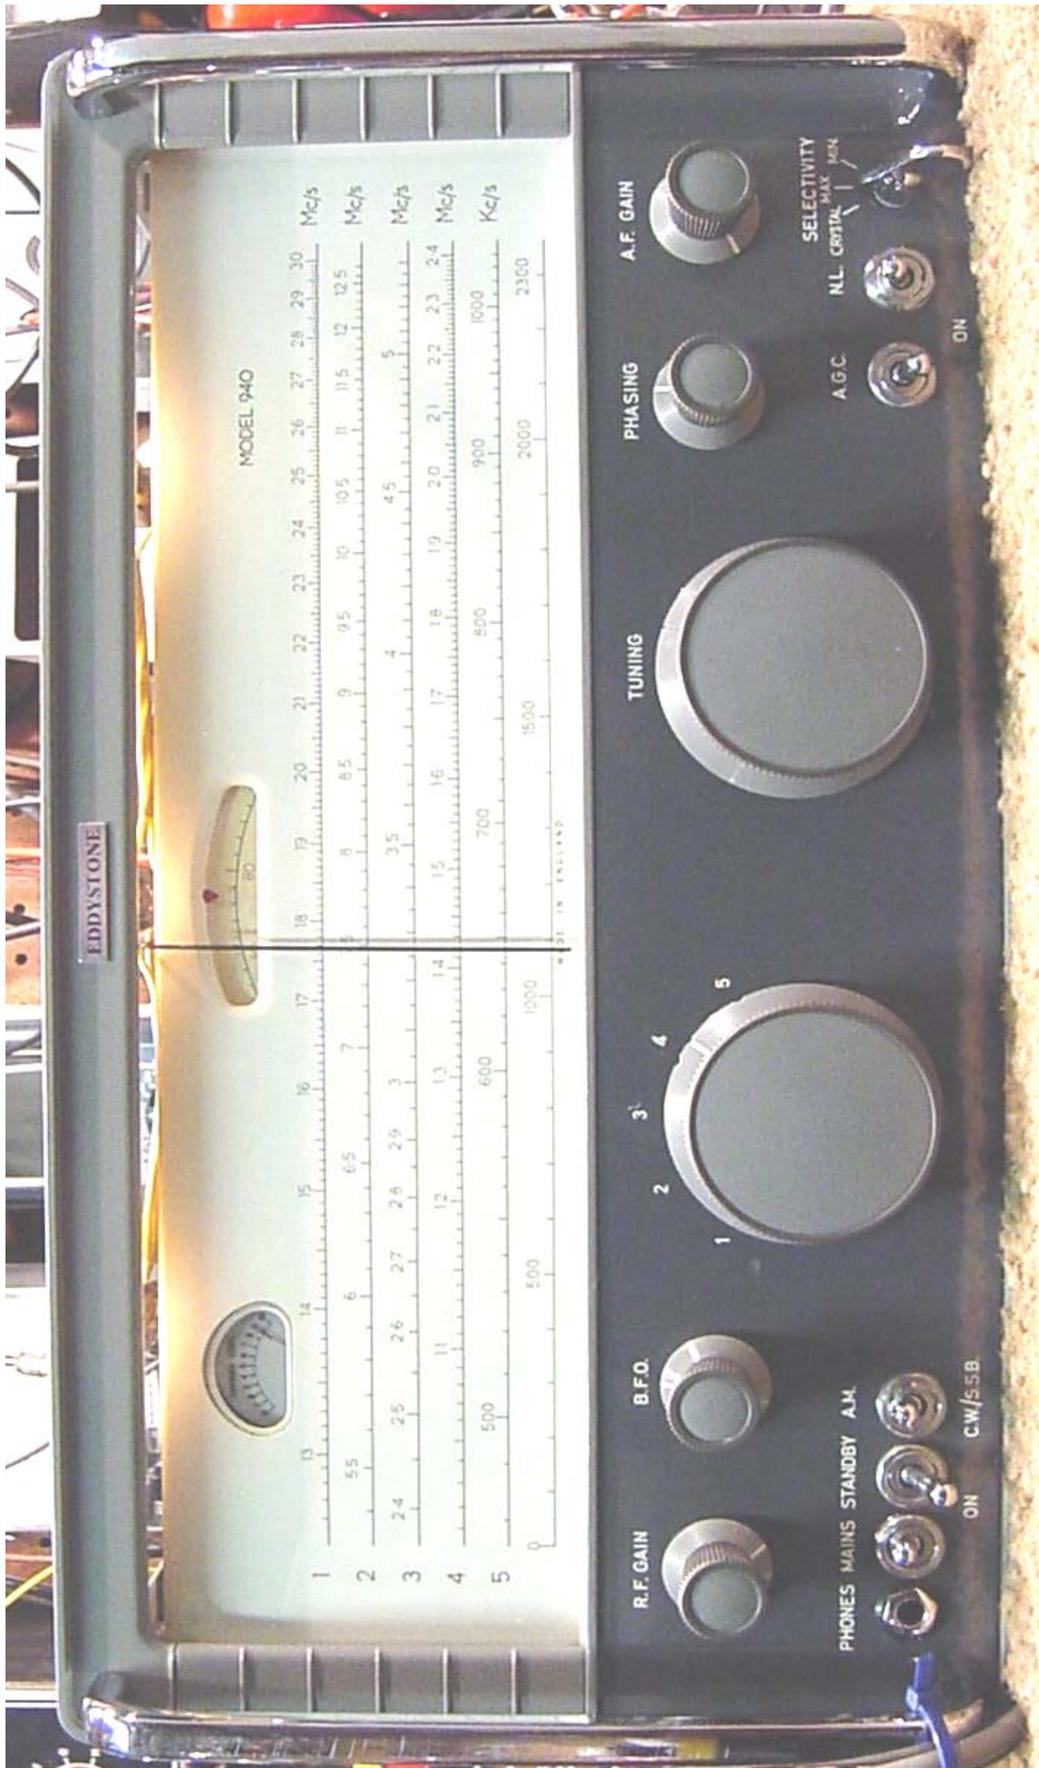
The S.940 looks pretty good from the front – I would say as good as my S.830/4 anyway. Here it is pulling in ‘Coast to Coast AM’ on 1410kHz @ 5-9+.

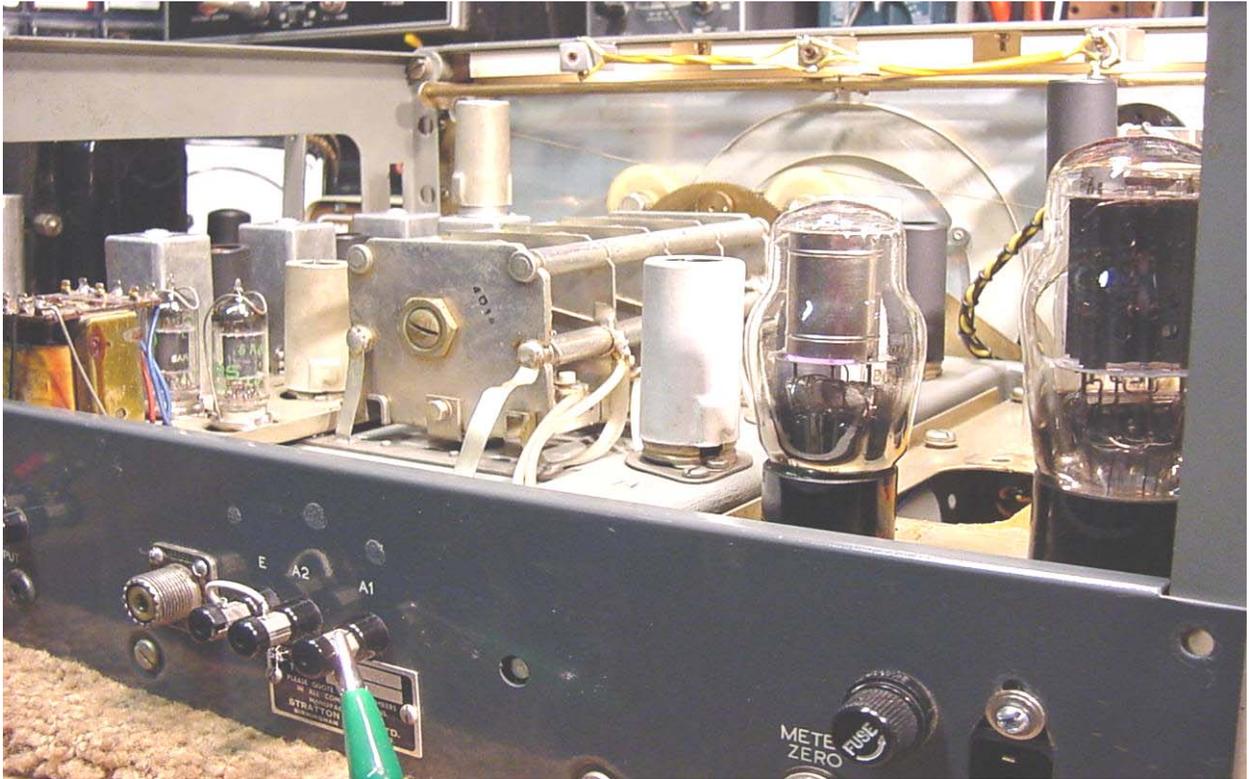
A nice shiny new 5Z4G fitted and not an electron to rectify...

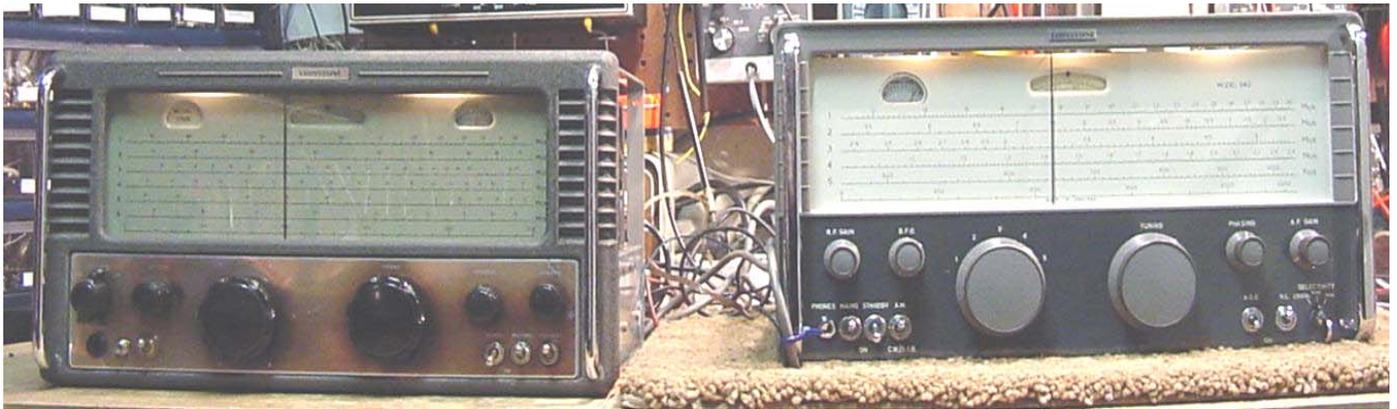
The S.940 on 'soak test' powered by the S.770R

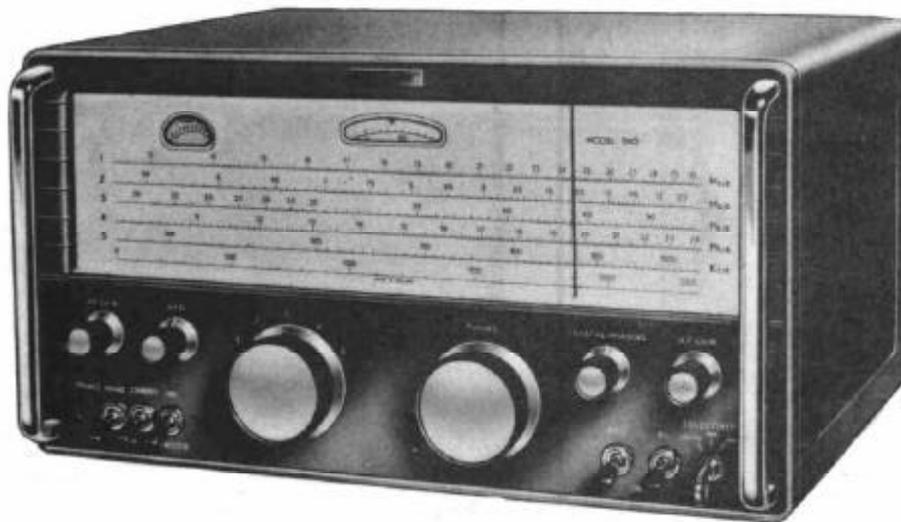
The EDDYSTONE Model 940 is a general purpose communications receiver covering the frequency band 480 kc/s to 30 Mc/s in five switched ranges. A single conversion circuit is employed and the receiver is suitable for AM, CW and SSB reception. A built-in mains pack provides for direct operation from all standard AC supplies.
