Restoration of an Eddystone S.750 – by Gerry O'Hara, G8GUH

An Eddystone Milestone (or was that Miles of Eddystone?)

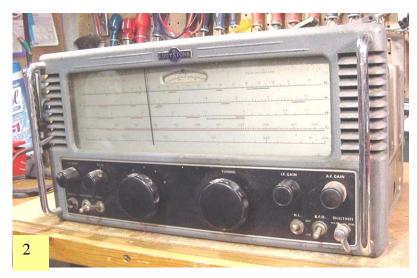
On arrival (very promptly may I add to the seller's credit), the radio had been well packed in bubble-wrap and a stout cardboard box and had traveled well, apart from the N78 output valve having come loose in the box and with badly bent pins. However, the radio actually looked worse 'in the flesh' than on the EBay listing (photos 3, 4

and 6), though a preliminary inspection revealed that with the exception of the rectifier and stabilizer valves (and obviously the case) all the main bits were indeed present and, apart from a dented 'inner handle' (the metal bars that wrap around from one front chrome-plated grab handle bolt to the other), possibly indicating it had been dropped or hit at some point in its 56 year history, no obvious mechanical damage (note: I have now

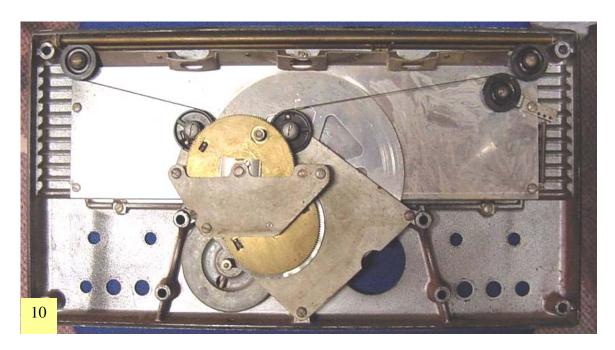
- With some difficulty, due to the mechanism being very stiff, I approximately centered the drive and prevented the cord from leaving its grooves on the spool pulleys using two

small pieces of masking tape (photo 11). Careful inspection of the gearbox revealed that nothing was binding or blocking movement of the gears and that the stiffness was due to gummed-up bearings and teeth (age-solidified 3-in-One oil I would say) and, apart from some wear on the brass gears, the only damage noted was that a tooth on each of the spool pulley gears was damaged (photo 12).

- Removed the spring-loaded idler (cord tension) pulley by loosening the pivot screw fixing it to the front panel casting, loosened the three screws holding the gearbox to the front panel casting, tipped it forwards and upwards slightly and then eased the drive cord away from the upper two idler pulleys. The gearbox was then removed with the dial cord intact (photo 11).

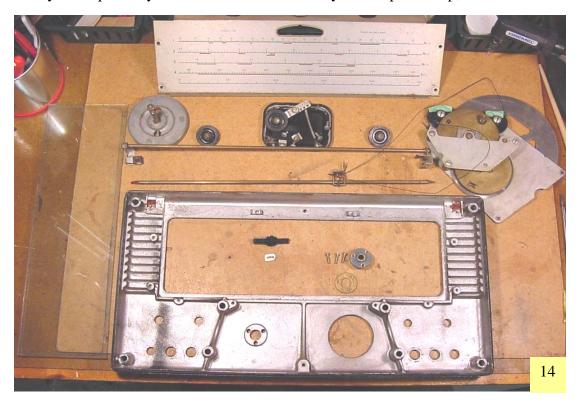
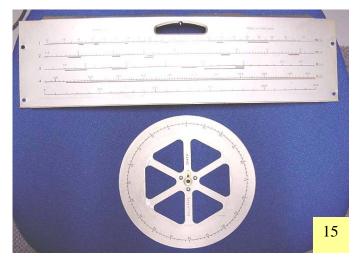
- Cleaned the dial plate and vernier dial plate using warm soapy water and cotton wool these have very delicate silk screen markings (so be very gentle) photo 15.
- I decided that the grey front panel should be re-finished in its original black crackle. One day I will probably have this stove enameled by a local paint shop, but for now I

remembered that I had some black crackle finish spray paint left over from the S.740 S-Meter/Speaker project. I cleaned up the front panel using alcohol and lightly buffed the surface and gave it three coats of the paint (photo 16).

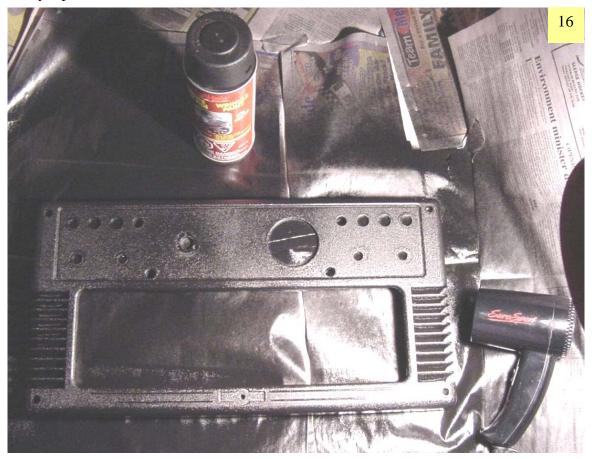
- Cleaned-up all the remaining drive components (idler pulleys, dial glass etc) and re-assembled the drive mechanism to the front panel casting, simply reversing the disassembly order (photos 17 and

18) – the finger plate temporarily held in place with a couple of strips of double-sided sticky tape.

- The tuning knob shaft was coated with moly grease prior to installation in its bushing. The tuning knob was then temporarily fitted and the completed assembly tested for that sensual 'Eddystone smoothness' – yep, it was there in spades, beautiful! - the two damaged spool pulley teeth did not seem to affect the movement – thank goodness. Now for the electronics... temporarily ignored in my eagerness to see if I could at least make

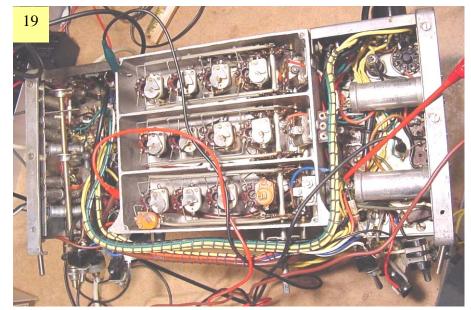
- I decided to start work on the electronics with the front panel still removed from the chassis (photo 19) as this made access to underneath the chassis front much easier: useful

if one or more of the gain controls, BFO variable capacitor or switches needed to be replaced or serviced.

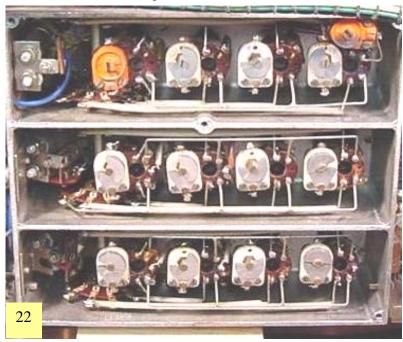
stations, so I decided to attempt a full re-alignment. Inspection of the IF transformer and coilpack dust cores ('slugs') and trimmers showed signs that the 'mad twiddler' had probably been having a field day - oh dear... (photo 22).

- The re-alignment procedure as detailed in the manual was followed to the letter. Neither of my RF signal genny's go down to the second IF frequency of 85kHz, but I found that my Heathkit audio signal genny worked a treat. The second IF transformers peaked-up nicely injecting 85kHz into the grid of V4 (outer corner pin of the first IF transformer), as did the second oscillator (1535kHz) and the first IF, injecting 1620kHz into the same point as the 85kHz – they were all found to be 'miles' out of adjustment. I then tweaked the BFO to the new (proper) IF: zero beat with the BFO tuning capacitor vanes half mesh. Straightforward so far... now for the RF stages.

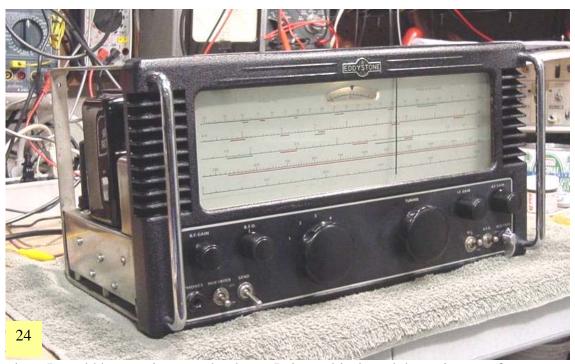
plates I would be very interested to hear. I also re-blackened the mains transformer core laminations and a couple of scuffs on the shroud using the permanent marker, carefully drawing around the part number stamped on top – looks much better (photo 25).

- At this point I would have 'boxed the set up', except I do not have a case. I am currently toying with the idea of making a Perspex case so the innards can be seen while the set is working (they are so pretty now!) this should not be too difficult to do: heated metal bar to bend the correct-radius corners and drill plenty of ventilation holes. Alternatively my S.740 could loan the S.750 its case for special occasions....
- Having no case, I settled for an external cosmetic job of simply cleaning all the knobs (with alcohol) and polishing them using "Armor-All' (plastic polish for car interiors), touched up the one or two small scratches and the tiny wear patch on the finger plate using a black permanent marker looks ok, but if anyone knows how to re-finish finger

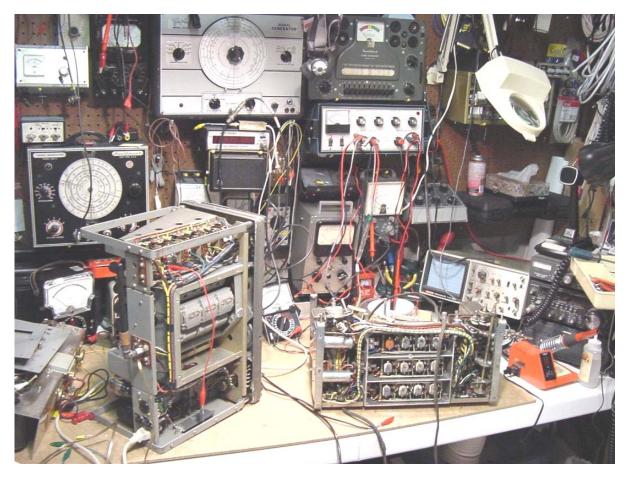
'Bath Tub fresh?' – almost...
