From Rubbish Skip To Beauty Queen Restoration of an Eddystone Model S.730/4, Serial No. 319 by Alan Crookes

730/4

THE EDDYSTONE 730/4

DISCUSSING A USEFUL
GENERAL PURPOSE RECEIVER

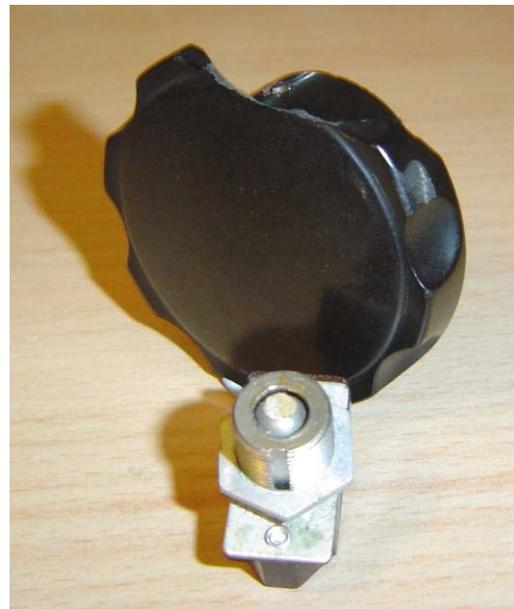
Looking down to the 3 toggle switches at the left side, the noise limiter switch had no top - it had been snapped clean-off, level with the finger panel, and the main tuning knob was broken, photo, right. This area gave me a lot of concern, as rotating the tuning control made a horrible grinding noise, the fingerplate had a scuff mark across it in this area and the cursor didn't move.

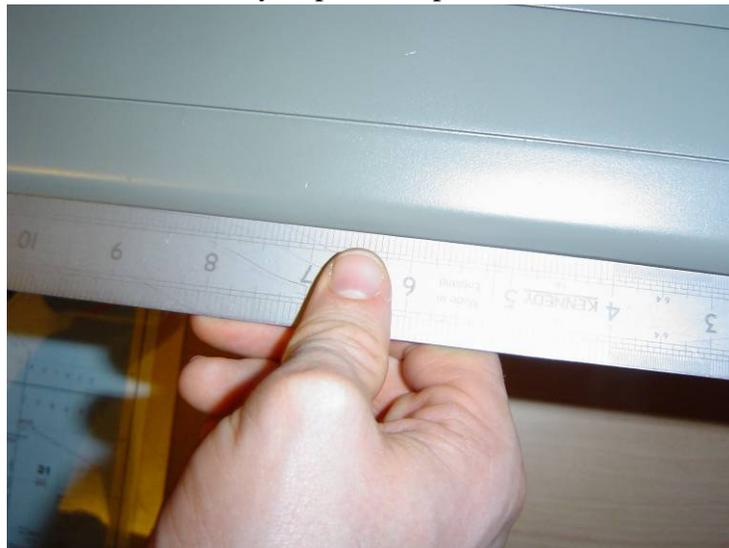
I had been working on the radio for over a week now doing bits, a couple of hours here and there, and the more I cleaned the more I found damage to the front panel area. Don't forget it was still bent along the top where the name plate is mounted, and my fear was it would snap when I tried to straighten it. One or two radio rallies were coming up, so I made the decision I would start looking for a scrap Eddystone with an identical front, then do a rebuild with the parts I could salvage. I think I would have had more chance getting 5 numbers and the bonus ball on the lotto. But strange as it seems at one of the rallies I found parts of an Eddystone gear box, but the drive shaft was missing, but other parts I did get. I now had a full set of valve screening cans picked up for 10p each, a new Eddystone tuning knob was found for £1 and it was still wrapped in tissue paper and the metal toggle switches were found in a jar at a silent key sale for 10p a piece. But alas no drive shaft, and no Crystal Phasing knob (part No 5301P), but you never know what may turn up, so if you see someone at a rally rummaging about in the boxes under the tables or going through piles of valves, odds on its probably me. Well, the tuning scale had all been cleaned, the gear box was all reassembled and free running, and I had found an article on the net showing the drive cord layout with pictures. Also, the brass cursor slides had been cleaned and straightened but the front panel was still bent. There was nothing else for it: I had to take the bull by the horns and attempt to get the front panel straight, I wasn't to keen about putting any heat on the panel, as with it being alloy/aluminium I didn't know what to expect. My plan was to lay the panel on the garage floor, support both ends with some flat pieces of wood to create a bridge effect under the bent area, which was facing upwards. Rather than trying to bend it back in one go, I would use the softly-softly method of a bit at a time, so a spacer was placed under the bent area so it could only be bent back so far. My improvised press would be a redundant 4"x4" x 5 foot wooden fence post. I stood this on the bent spot and with the weight of the post and a bit of pressure I pressed downwards. The panel started to go back into shape. I removed the spacer from under the 'bridge' and replaced it with a thinner piece which gave a bigger gap, and did the same thing again, the panel moved a little further. At this point I checked the bend with a straight-edge - it

wasn't too bad now, not straight, but a lot better. Another great help was that there was not much spring effect in the panel, so most of the corrective bend was absorbed. The final press was to get the gap under the panel just right so as the edge would regain its trueness. This was found and carried out and the panel was straight again, see photo at base of previous page and below. The bend had been just to the left of the name plate and this was a successful repair.

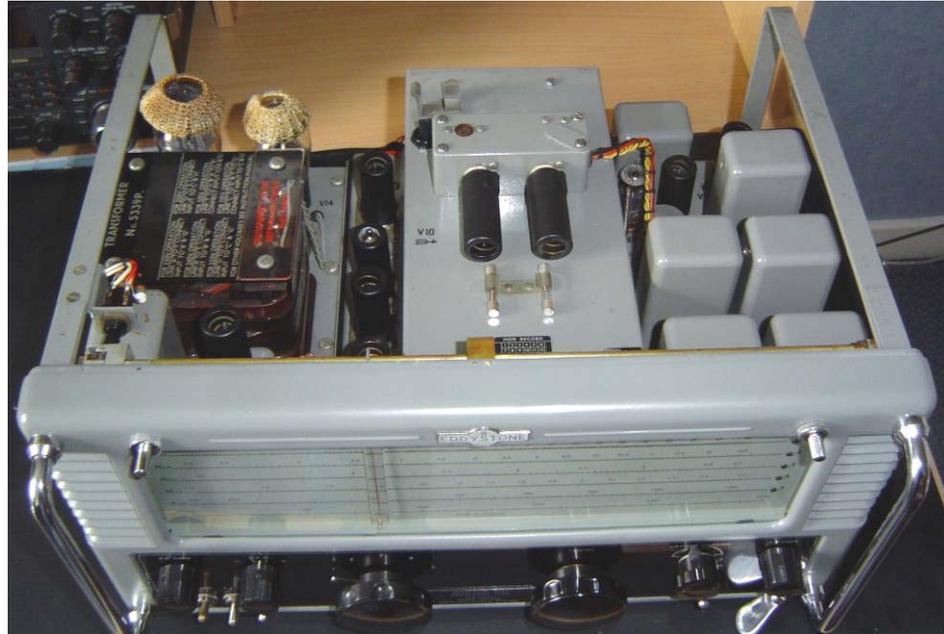
So now I took a look at the tuning drive shaft - this had a definite bow and had to be removed. The obvious way would be to heat it up and try to straighten it in the vice.

heat is applied, kinking in the rod may happen as it is straightened. Also the rod may crack, go brittle and then break. It was time to call on my metallurgical studies of my apprenticeship: the secret is to warm it up to about 250C, and at this temperature the grain structure allows it to be less rigid, but also cuts the risk of putting kinks in the rod where it is straightened. Another thing is that at this temperature any change in the grain structure is not permanent, so the rod will retain its properties when air cooled, therefore the risk of breaking or cracking when straightening the rod should not happen – anyway, that was the plan. Now to put it into practice. I warmed the rod up to just less than black hot - that's about 250C (there should be no scale appear). With a pair of pliers, I quickly put it in the vice and started to press it straight again. After a few checks on the rod the result was a complete success. When the rod had cooled at room temperature, a quick rub down with some fine steel wool to remove any discolouring, the rod looked as good as new.

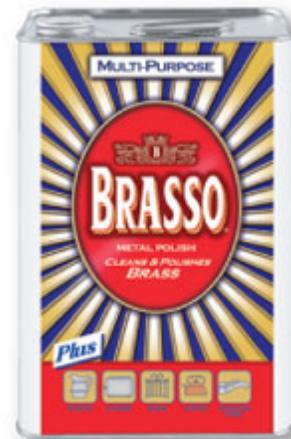
Brasso – what a marvel: it cleans, it polishes, it buffs paint, it removes blemishes from S.730/4’s... and makes your hands go black.

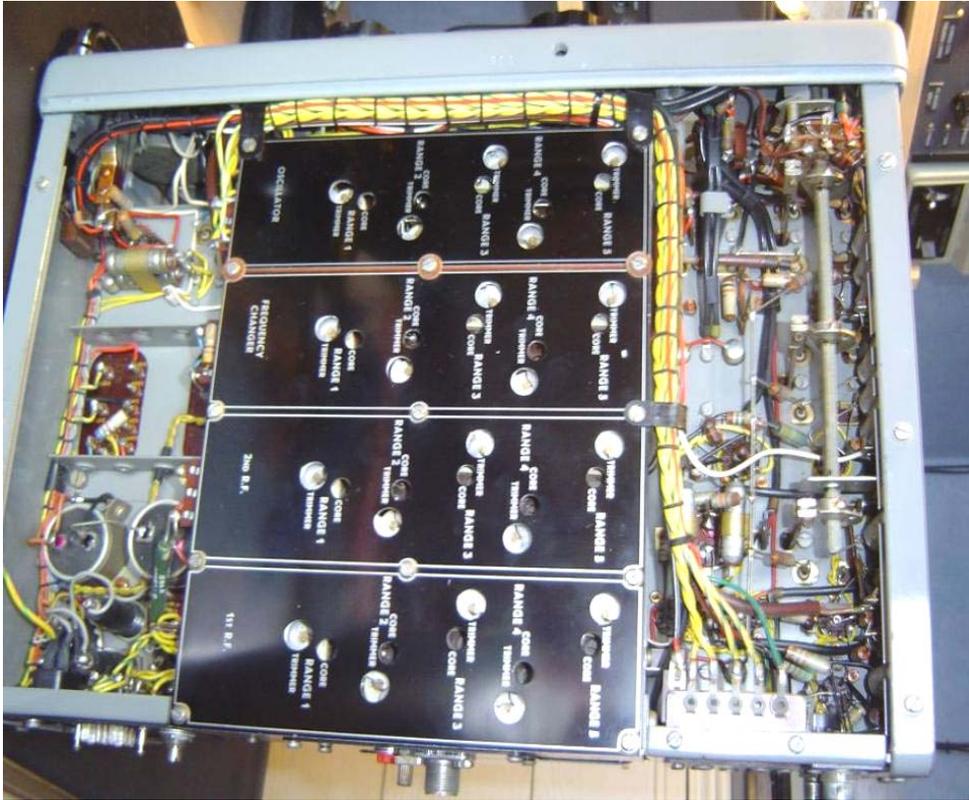
the grime, then a final polish with Mr. Sheen. This treatment was also applied on all the other covers. The replacement valve screen covers were re-sprayed in matt black. It was quite remarkable to see how well the inside of the set had come up. The under-

chassis area had also all been cleaned out (photo, above): a good examination of the components did not reveal any physical or burnt damage. The switches were all given a good soaking with Servisol switch cleaner, and the ball-bearing latches greased with graphite grease. The push/connecting rods to the IF coils were all cleaned and freed from grime and were now functioning perfectly. The valve sockets I cleaned by using tooth floss brushes - these are like a mini test tube brush, but when dipped in surgical spirit and then worked inside the valve socket, any grim within is soon removed. A quick squirt of switch cleaner finishes the job.

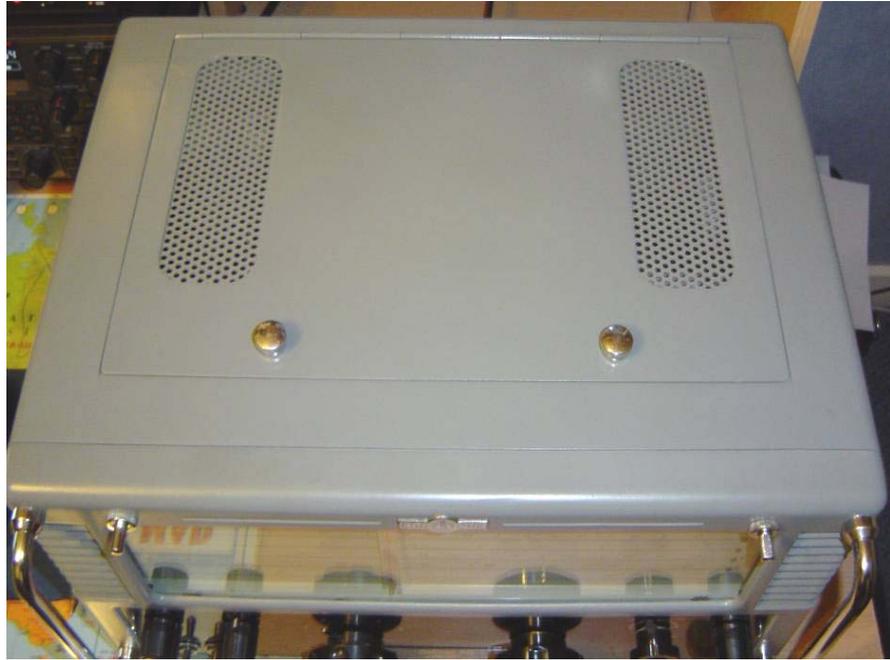
A couple of days later I was picking what colour paint I was going to spray the cabinet. I had a sample to match the shade of grey I wanted - the nearest I got to it was 'metal window frame grey', an odd name but it was the best match and it was satin finish - I didn't want that 'glassy' gloss look. Two cans of paint and two cans of primer and we were on our way (photo, below). The front panel was scrubbed with neat 'Jiff' (I know they now call it 'Ciff', to me its still Jiff). This removed the grime and took the old glaze off the surface. Just a few areas now needed more abrasive treatment and that was done with steel wool and fine emery paper. With it all blended in, the case was ready for spraying. After four coats of primer and a warm air blower to bake each coat, then five coats of paint with the same warm air blower, the case and front panel looked good, and I was happy with the results. This was now left for a week to cure and for me to go for a week away in Benidorm.

Now it was now time to give the outside case some attention. The dents had to be knocked out and I did this using a piece of hard wood, oak I think, which was about 9" long by $\frac{3}{8}$ " thick by 2" wide, with the top being flat and the edges all rounded off. This was ideal for getting to the damaged area from the inside, while supporting the case on a firm surface, I was able to panel-beat the dents out. It's a slow job, but taking your time will yield good results. The dent at the back of the case was coming out and at the same time this was bringing the top hatch back into alignment - this was due to the fact the dent was immediately at the back of the hinge and so this was pushing the door forward at that side, which in turn twisted the door. As time went on I got the door more or less back to its correct position, at the same time knocking lots of other imperfections out. At last I was happy with the shape of the case and the next day was spent rubbing it down, preparing for spraying.

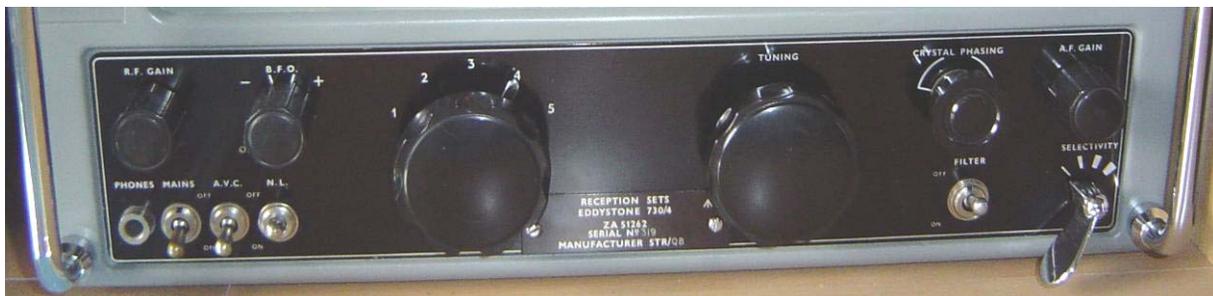
A few days after getting home the rebuild started. First the tuning scale and drive were replaced followed by the re-stringing of the cursor, making sure the scale number matched up with the cursor at the correct point, as described in the service notes, and as before were running freely. The front panel was then refitted to the main unit, taking care with the coupling to the main tuning capacitor. All the switches were replaced in their holes and the brass panel screws re-fitted and secured. The fingerplate (photo, below) had been cleaned and touched-up in the areas that were scratched - the method I use is to

use Humbrol model paint, which you can mix to get the shade required, then with a very fine paint brush, paint over the scratches and lettering. Once the paint is dry, very carefully use a soft cloth with some car polish to polish and blend the repainted area in, this has a 'T-cutting' effect on the area and gives a nice smooth finish. The fingerplate was now replaced on the front panel, and the switch lock rings refitted, along with the lock nuts for the other controls. New chrome handles (thanks again Ian) were also fitted at this point, and the front panel was now secure.

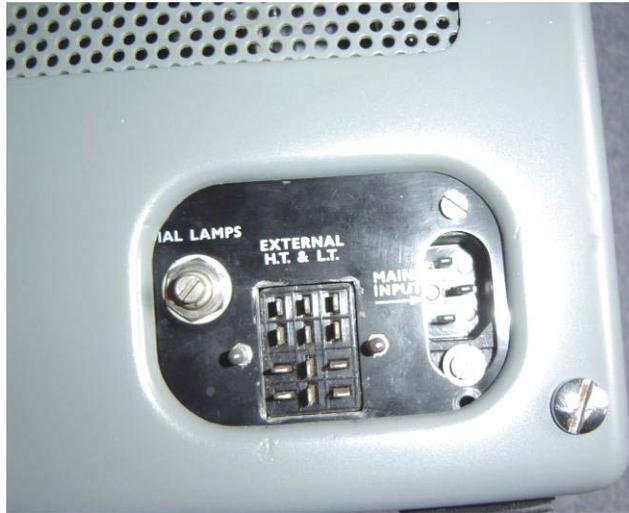
Back to the chassis. As we all know, the mains is supplied via a two pin plug and socket. I did not have the correct lead, so this was all replaced with the standard electric kettle connection (photo, right), which fitted in chassis without any chopping or cutting required. The shorting plug at the back was straightened out and repaired, and when refitted was a nice snug fit. All the valve pins had been cleaned of dark deposits and were replaced in their sockets, and one of the pilot lights had to be

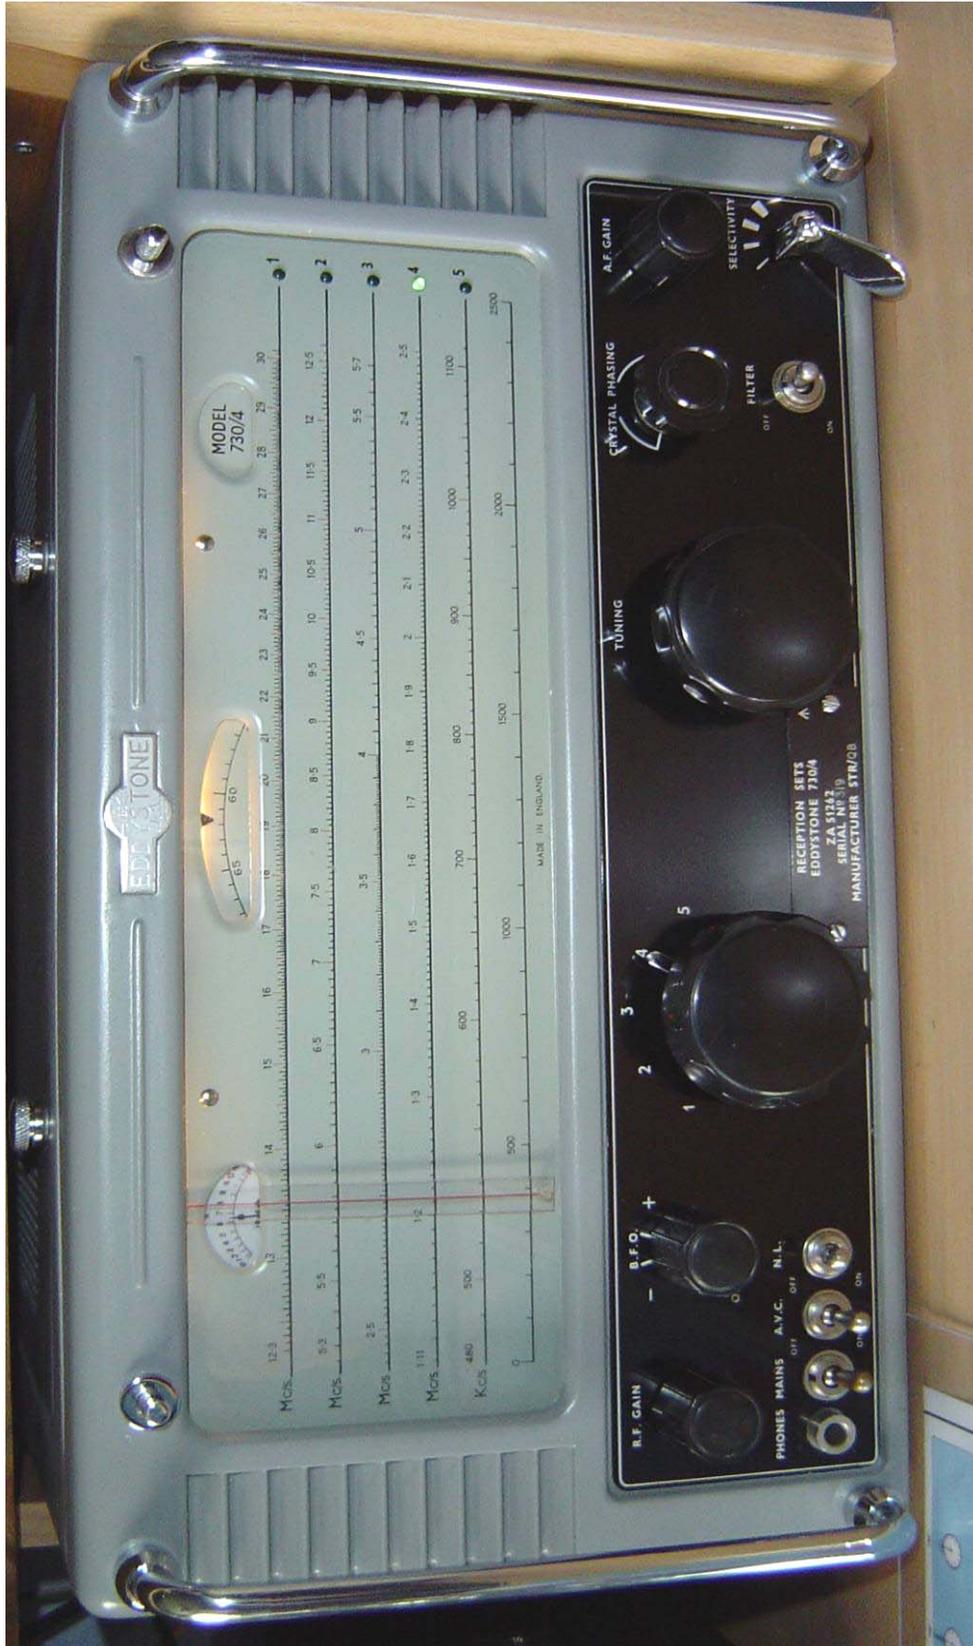
What a beauty! – not bad for a radio someone though ‘fit for the skip...

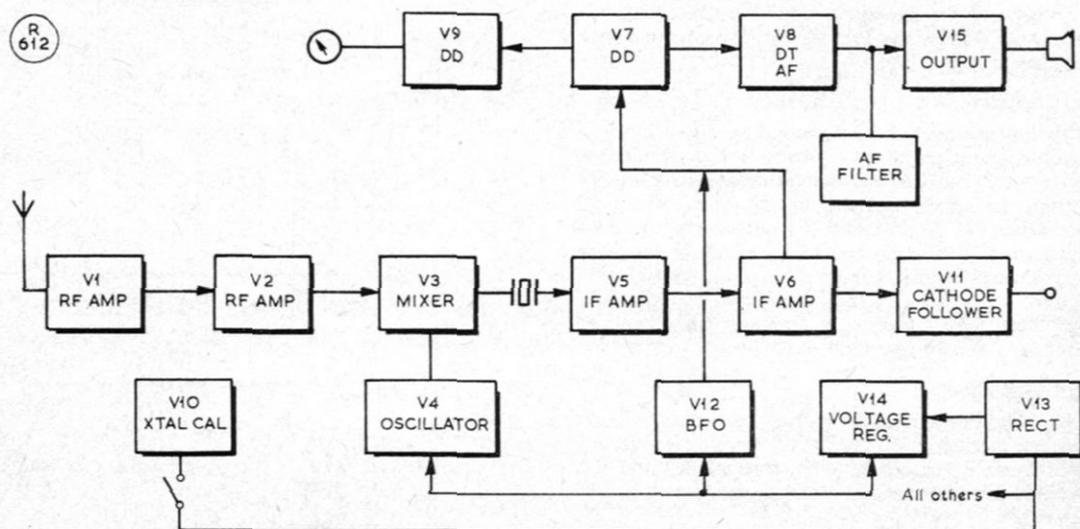
Fig.1 Block Diagram of the 730/4

Fig. 1 is a block diagram. V1 is the 1st RF (6BA6) and V2 the 2nd RF (6BA6). The use of two RF stages reduces 2nd channel interference to an exceedingly low level. V3 is the mixer (6BE6) with separate oscillator V4 (6AM6) operated from the voltage regulated supply from V14 (VR150/30).

V5 and V6 are the two IF amplifiers (6BA6's) and variable selectivity and optional crystal filter are provided. V7 is a double-diode (6AL5) used for AVC and demodulation, and V8 (12AU7) provides two stages of AF amplification. V15 is the output stage (6AM5) and there is an optional audio filter between V8 and V15.

V9 (6AL5) is a cathode follower for S-meter protection, and noise limiting. V11 (6AU6) is a cathode follower giving an optional IF output point at 70-80 ohms impedance.

V10 (6AM6) is the crystal calibrator, with means of adjusting to zero beat with the 2.5 MHz or other standard frequency transmission if required. V12 (6BA6) is the BFO, also receiving regulated HT. V13 (5Z4G) is the full-wave rectifier.

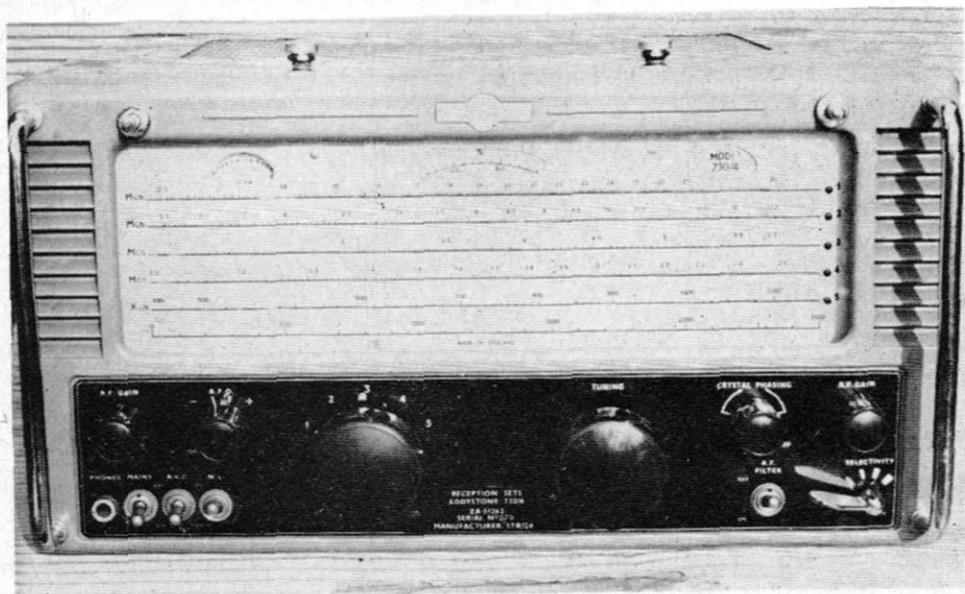
(Front.) The band in use is indicated by the small lamps to the right of the scales. The centre logging scale is read in conjunction with the bottom scale in the manner familiar to users of similar models. Controls are described in the text.

The crystal calibrator switch and cursor adjuster have been mentioned. Knob controls, from left to right, are (1) RF Gain, (2) BFO Pitch with "Off" position, (3) bandswitch, (4) main tuning, (5) crystal phasing control with "Off" position, and (6) AF Gain.

Lower, at the left, is an outlet for phones, and toggle switches for mains, AVC, and noise limiter. At the right is a toggle switch for the audio filter, and a 4-position selectivity switch.

The S-meter is fitted at the top left of the tuning scales.

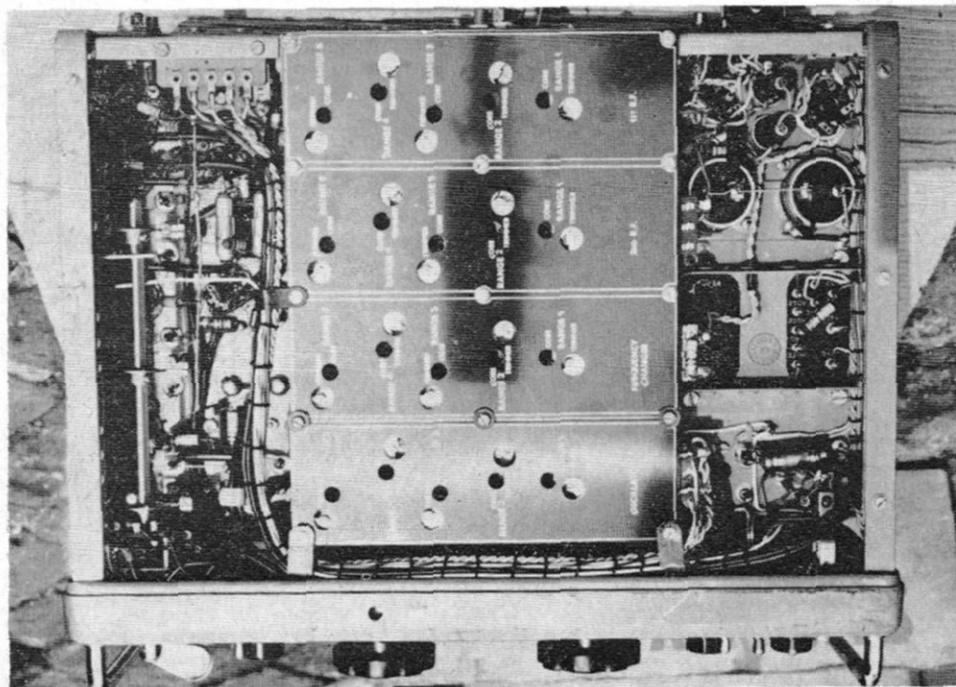
(Inside bottom.) The cast coil box is covered by a plate with trimmers and cores marked for each range. Here, the IF section and associated circuits are to the left, and audio and mains sections to the right.

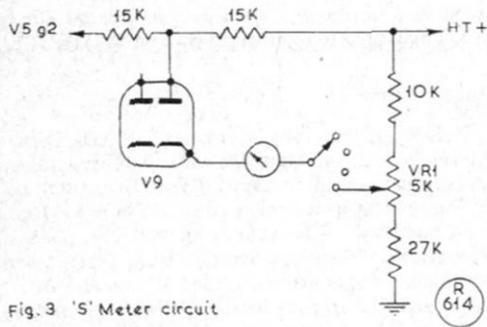
Fig. 3 'S' Meter circuit

This is calibrated at 6 dB per point, and 6, 12 and 18 dB over S9. Fig. 3 is the S-meter circuit. VR1 allows this arm of the bridge to be adjusted for zero. The presence of a signal causes a rise in voltage at G2, V5,

operating the meter. For normal readings RF gain is at maximum (and AVC on). The meter only operates at the maximum selectivity position (but with crystal in or out) as this helps separate the reading from that of adjacent carriers in a congested band.

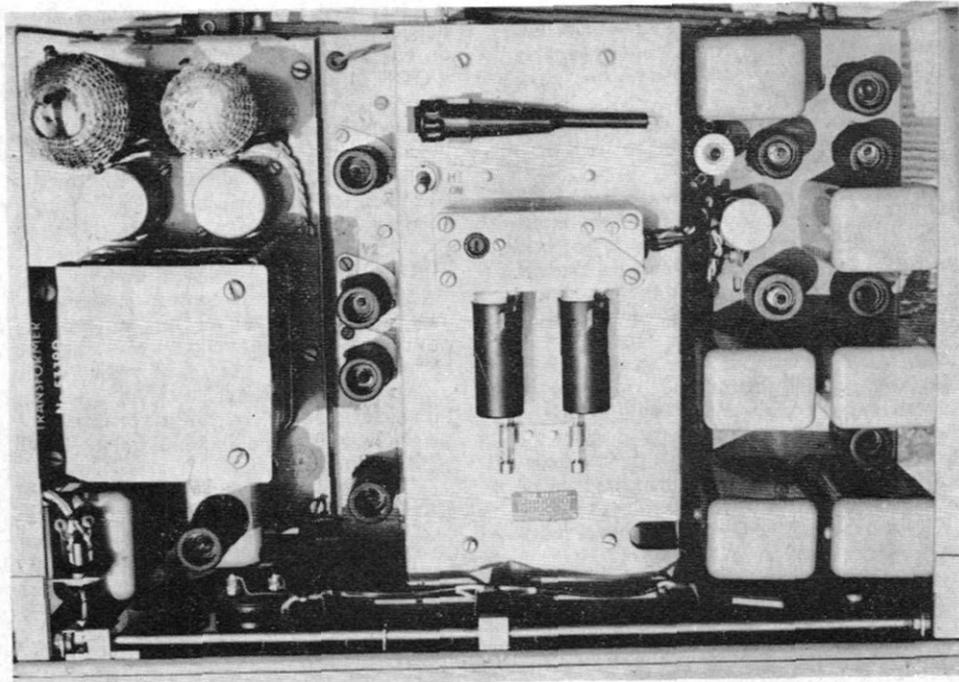
(Inside top). This clearly shows the calibrator on top of the gang cover, with tool behind. The three IFT's on the right have mechanical adjustment of coupling for selectivity purposes.
