# Restoring an Eddystone S.840A – Second Version of Stratton’s ‘Economy’ Communications Receiver, by Gerry O’Hara, G8GUH/VE7GUH

## Introduction

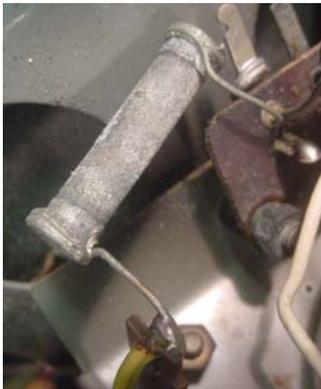
Another UAF42 (V4) serves as the signal detector and 1<sup>st</sup> AF amplifier stage, feeding a UL41 AF output valve (V5). The power supply is a fairly conventional AC/DC arrangement comprising a ballast resistor, thermistor (photo, left)/resistor for the heater chain, a half-wave rectifier, V7 (UY41), and filter circuit. Both sides of the mains supply are fused (0.5A) and the on/off switch is ganged with the tone control. A simple series (solid-state) noise limiter can be switched into the AF circuit ahead of the AF gain control. An internal speaker is provided that can be plugged into the speaker sockets on the rear panel.

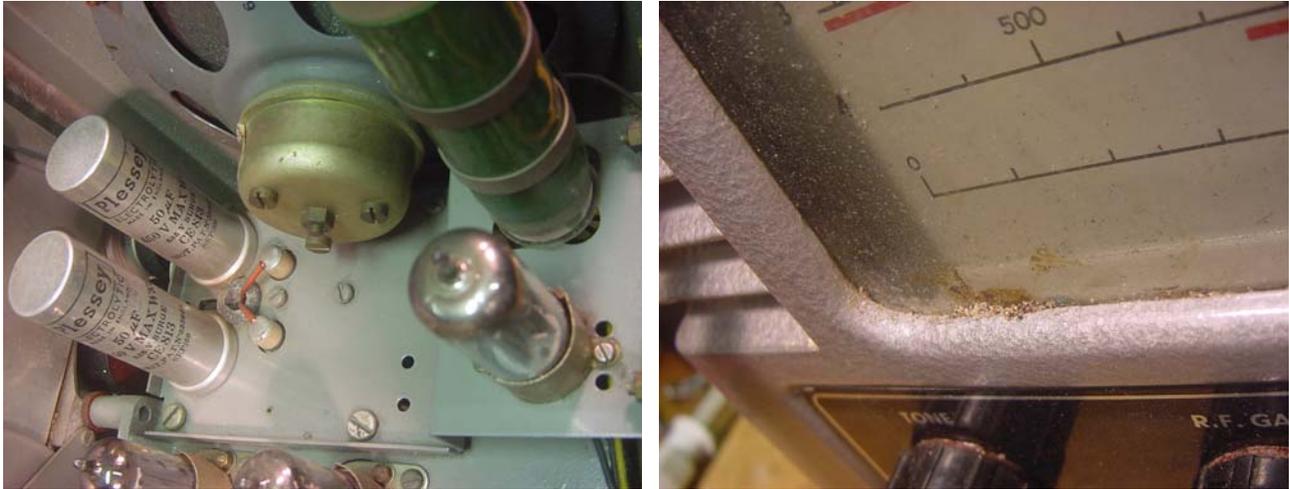
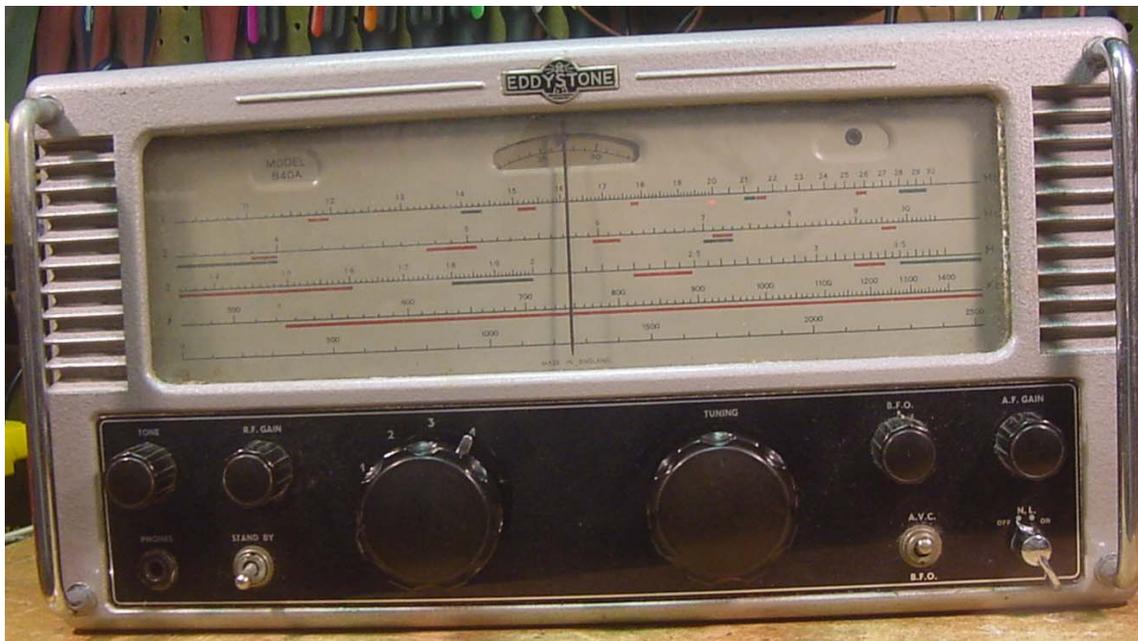
Above, left: enameled chassis offers good protection against corrosion. Note the dates on the smoothing capacitors. Above, right: corrosion and ingrained grime around the dial – impossible to clean-up fully without first removing the front panel and glass

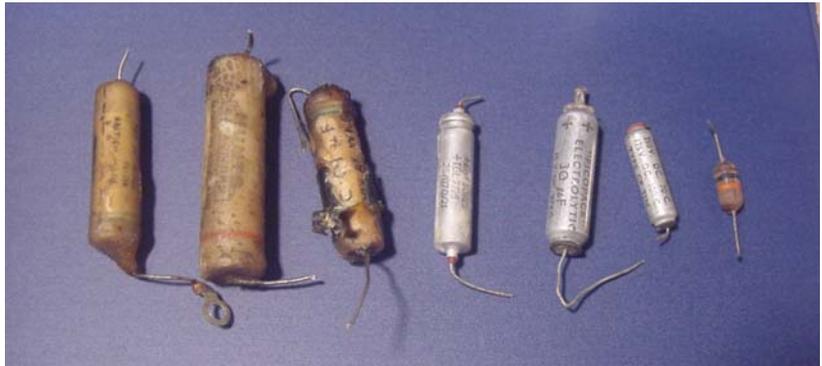
Above: Rogues gallery – line-up of replaced capacitors

As the set performed quite well, I decided to undertake a minimal part replacement program: the three waxed paper capacitors (C3, C52 and C61 – all confirmed to be leaky on testing) were replaced with 630vw metalized polyester film parts, the two low-voltage electrolytics (C51 and C53 – both leaky and low capacitance when tested) were replaced with 47uF 63vw parts (that fit the original mounting brackets), check voltages in each stage and if any looked significantly out of tolerance, check the appropriate

ceramic types. I did notice a single small 'rats dropping' capacitor, C44 on the AGC line, this measuring less than 100Kohm – far too leaky for this application, and so replaced with a new 630vw metalized polyester film part. I also tested the small radial metal TCC capacitor (C64) filtering the HT supply to the BFO – also leaky and therefore also replaced with a new 630vw metalized polyester film part. I used 1,600vw disc ceramic parts for C3 and C61, the original capacitors being rated for 600vwAC. I spot-checked several resistors and all were within tolerance. Out of interest I checked the diode in the noise limiter – found it to be reading 40Kohm forward and 1.5Mohms

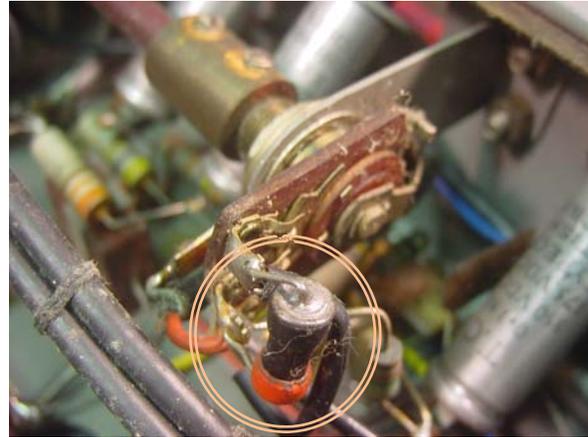
reverse with 3 volts applied to it – not brilliant but functional as a rectifier for small signals – I left it in circuit for authenticities-sake (circled in photo, right).

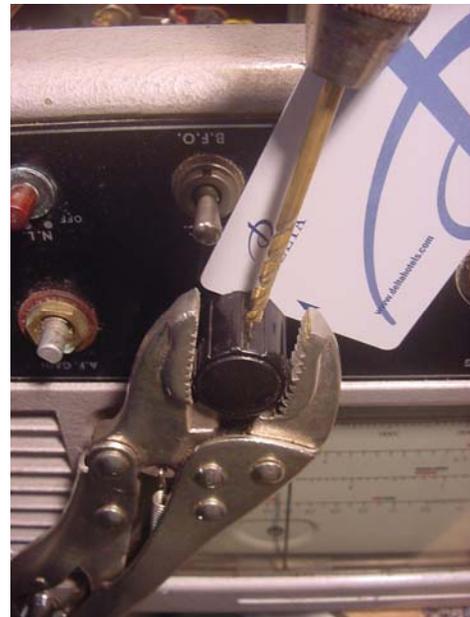
As noted above, the dial glass and scale were looking rather ‘tatty’ – grime lodged between the glass and the case, the glass grimy and the scale plate looking dull. I decided that the front panel needed to come off to allow these parts to be cleaned and, while off, to complete the chassis cleaning with the additional access this provides. Nothing is simple though – one of the smaller knobs (BFO pitch control) had a broken grub-screw – this had been sheared-off (many years ago judging by the fluff packed into the hole above it) and is likely the reason one of the previous owners hadn’t removed the front panel to clean things up. I applied some penetrating oil and waited in hope for a miracle. Not to be. Plan ‘B’ was then tried – levering the knob off the shaft by brute force, taking care not to damage the fingerplate and knob. No joy with that either. Oh well, Plan ‘C’ had to be invoked - drilling the grub screw out – almost guaranteed to damage the knob but needs must... I started with a small diameter drill bit in a small hand-drill, hoping to start a hole in the grub screw – not easy given the irregular surface and the tendency for the drill bit to wander sideways and drill the adjacent plastic or brass. I clamped the knob gently using a pair of Mole-grips (photo, right) and inserted an old credit card between

the knob and the faceplate/case to protect it in case the drill slipped. As I thought, the drill refused to drill the grub screw – at least most of it – and took a path of least resistance down the side of it. I then attacked the grub screw at an angle and managed to drill into it, using progressively large diameter drill bits until I had removed most of the grub screw. I then squirted some penetrating oil into the hole and waited an hour or so. A little gentle levering using a screwdriver against a strip of plywood allowed the knob to be removed (photos, right)– phew! I describe how to repair the knob later.

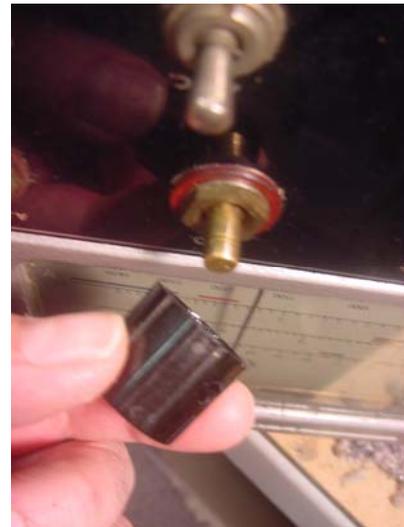
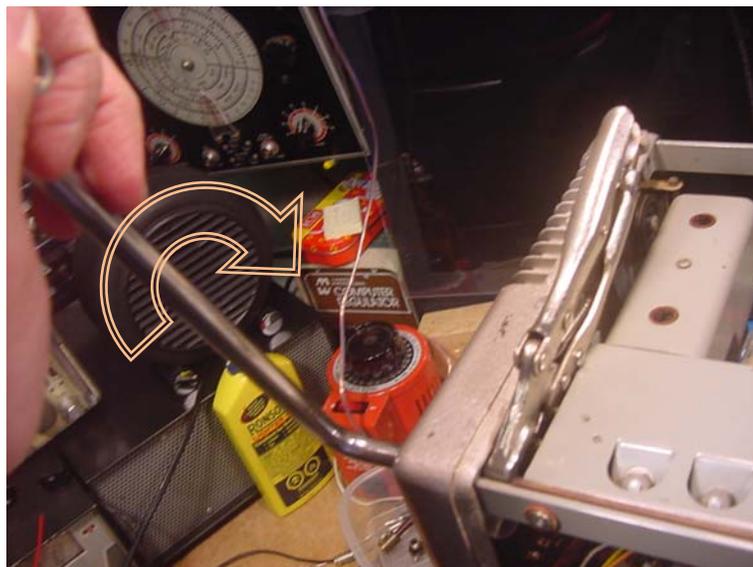
With all the knobs removed, I loosened the retaining nuts for the controls, noting where insulating washers and bushes were fitted (take photos) and being very careful not to lose any parts. The fingerplate was then lifted free of the front panel. Next, I loosened the four screws holding the front panel onto the coilbox, and then the four screws holding the chrome handles in place – one of these was locked fast (seized) and it had to be the most awkward to reach with a large screwdriver. I removed the noise limiter switch bracket to gain better access and used an extension to my high-quality driver of the correct size – to no avail. I fully removed the screw retaining the opposite end of the chrome handle and rotated the handle while holding the head of the screw with Mole-grips – a loud ‘crack’ was heard – success at last, the screw turned (photo, below).

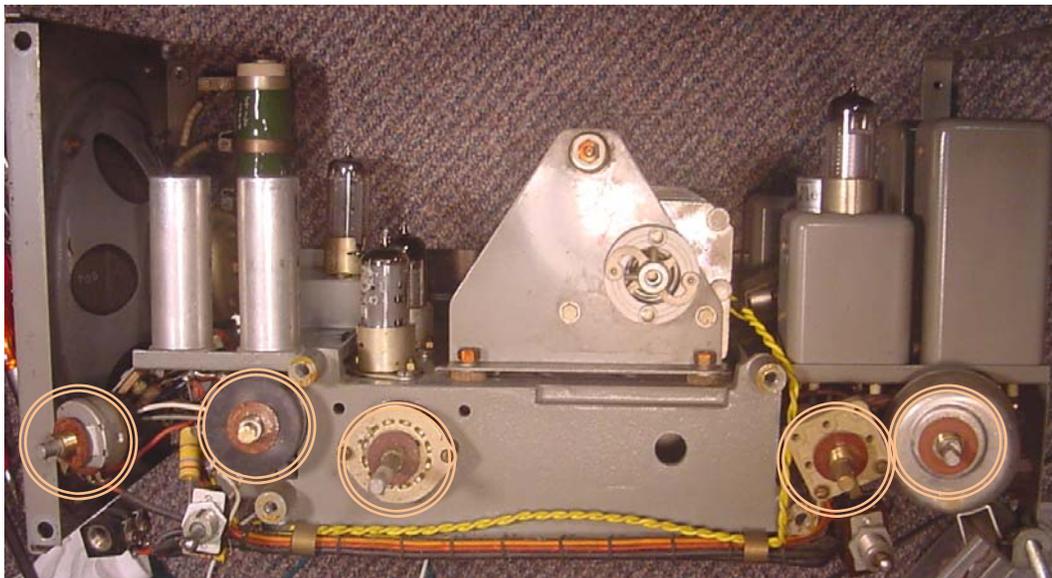
complete with gearbox and tuning pointer drive. Be careful to retain the twelve insulating washers from the four screws holding the front panel to the coilbox (photo, left) as well as those on each control spindle (the large one goes on the AF gain control, outside of the aluminium shroud) – circled on the photo below).

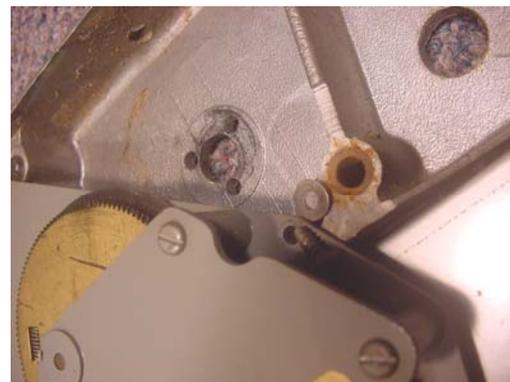
Next I dismantled the tuning drive assembly: first remove the three 6BA screws holding the tuning shaft bearing in place, followed by loosening the flywheel grub screw (through the hole in the bottom of the front panel), then the three self-tap screws holding the gearbox plate in place. At this stage, it is useful to tape the drive cord onto the spool pulleys on the gearbox. Next remove the dial cord from the idler pulleys and remove the gearbox. That done, unscrew the idler pulleys and the remaining self-tap screws holding the scale plate in place. Make a note (or photos) of where washers are located, eg. between the gearbox and front panel (photo, above).

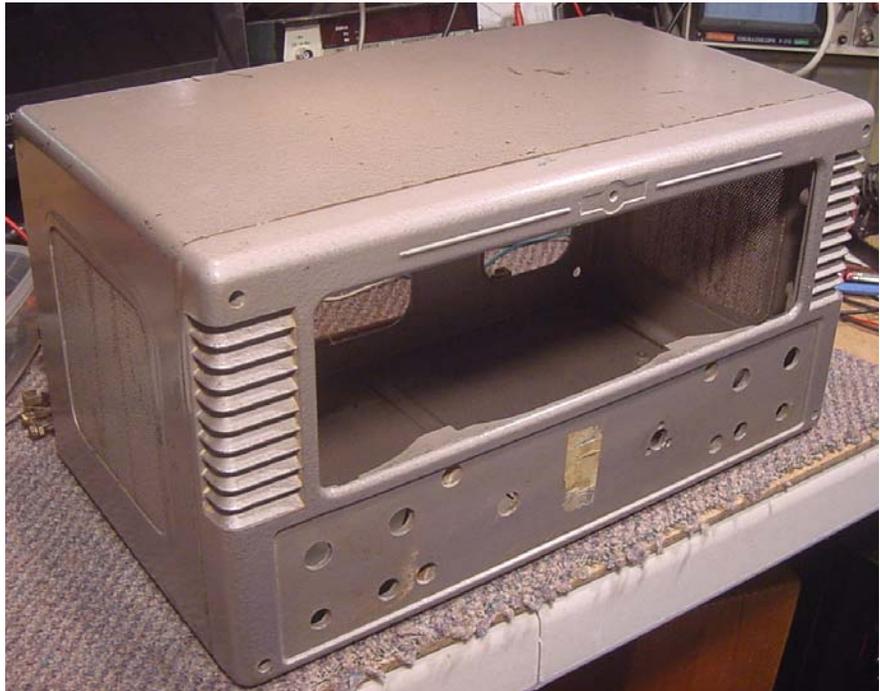
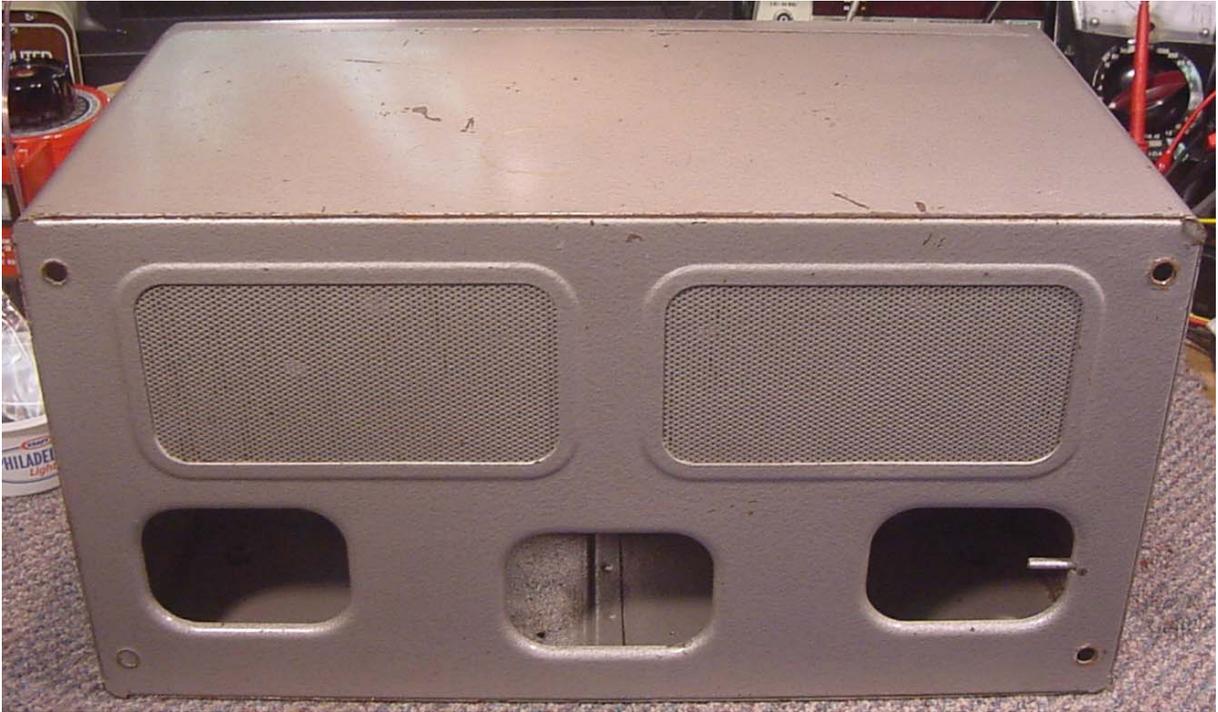
This particular set was finished in hammer-finish silver paint – not my favourite, but interestingly the case is the newer (1960's) style with perforated ventilation panels in the sides and rear rather than the louvers of the earlier style (photo, right and top of next page).

The case was showing signs of age – rust along the edges, paint lifting away from the steel etc. The cast aluminium front panel was also looking a bit tatty – the aluminium was oxidizing where the paint has been scratched or scuffed. I had cleaned it up as best I could with alcohol and rags/Q-Tips, touching-up with a silver felt pen to improve its looks, but I was not happy with it. I was undecided whether to try a re-spray/hand-paint hammer finish in

silver (or a powder coat equivalent) or to re-finish in black wrinkle powder coat – after some deliberation, off it went to the powder coaters for a new black wrinkle livery – maybe not correct with the later-style case, but my preference anyway. I suppose I could have tried it in grey enamel per the 1960's style of the S.840C, but I think the front panel would have looked odd finished that way.

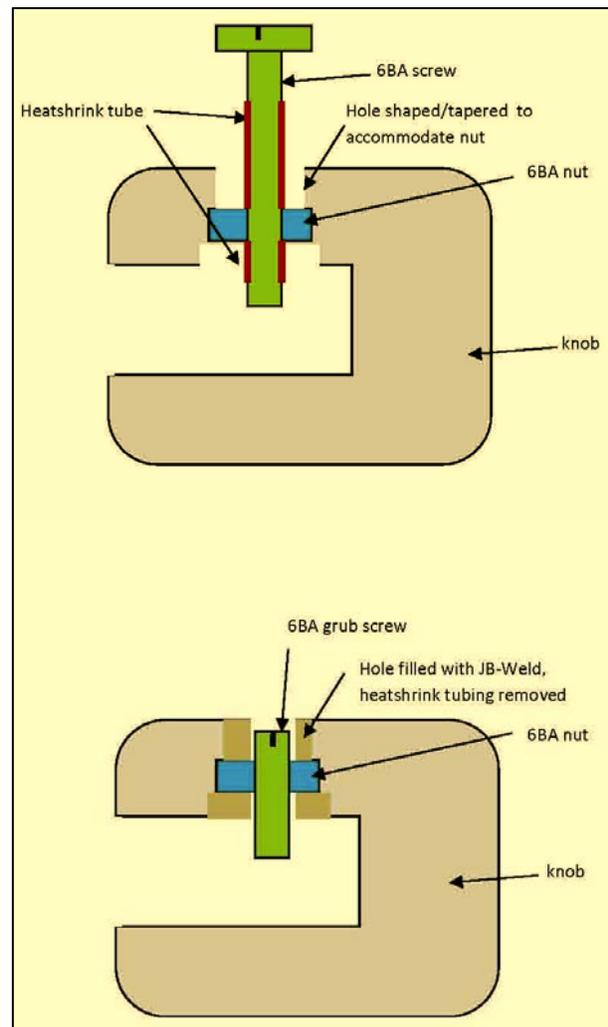
I decided on the latter solution (diagram, right). To do this I re-shaped the oversized hole to accommodate a 6BA nut (the standard grub screws in Eddystone knobs are 4BA, but a 4BA nut is quite a bit larger than a 6BA one). This was done using small warding files, shaping the hole into a hexagon, with it being wider on the inside (shaft side). I inserted a 6BA nut into the hole from the inside and then screwed a 6BA screw into it. This screw was fitted with a sleeve (actually heatshrink tubing), thinly smeared with grease. Another small length of heatshrink tubing was then slid over the part of the screw protruding into the shaft hole. The space around the heatshrink tubing was then filled with JB-Weld epoxy and left to cure for a couple of days. I then removed the screw and heatshrink tubing, tidied-up the JB-Weld with a scalpel, coloured it black to match the knob using a permanent marker and inserted a

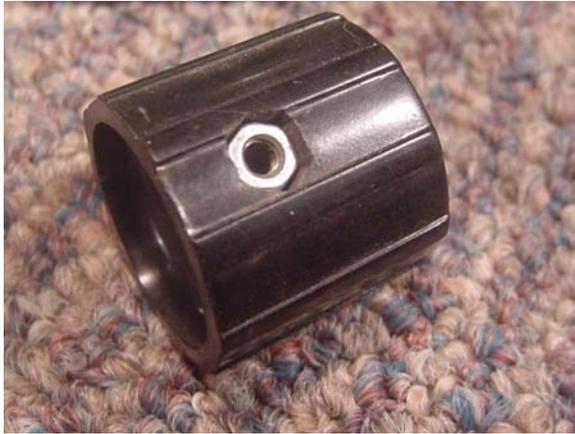
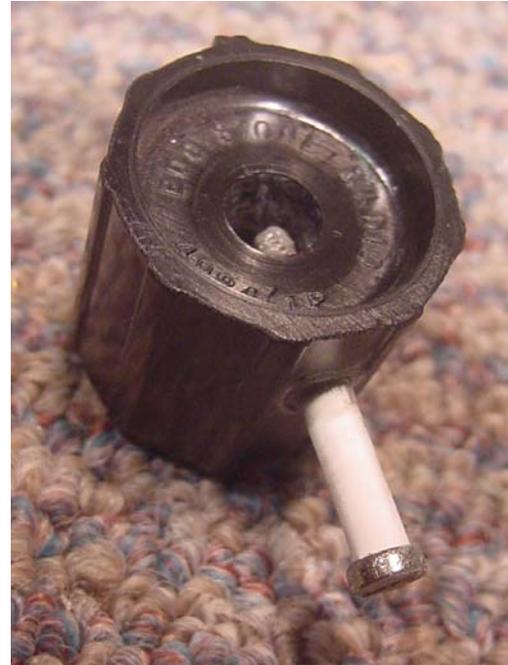
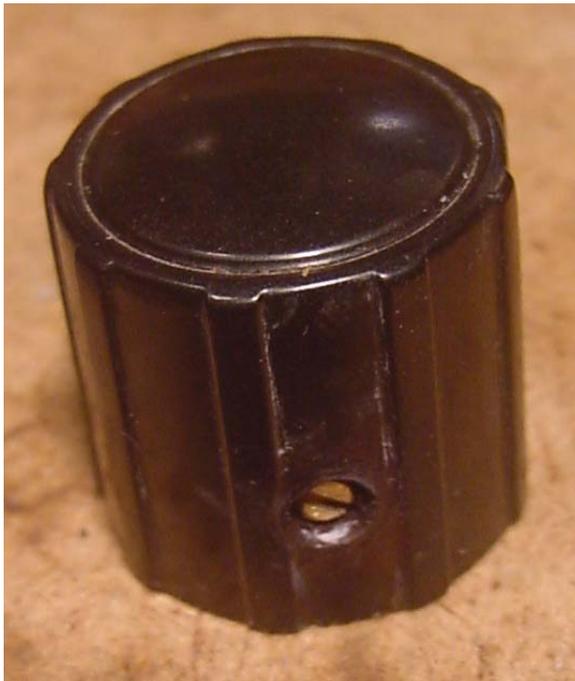
Above left: Over-sized hole re-shaped into a hexagonal shape and 6BA nut inserted from inside the knob. Above: 6BA screw with heatshrink sleeve threaded into the nut. Left: Repaired knob with 6BA grub screw installed

6BA grub screw (made from a regular 6BA screw). By inserting the nut from the inside, when the grub-screw is tightened, it is forced into the taper of

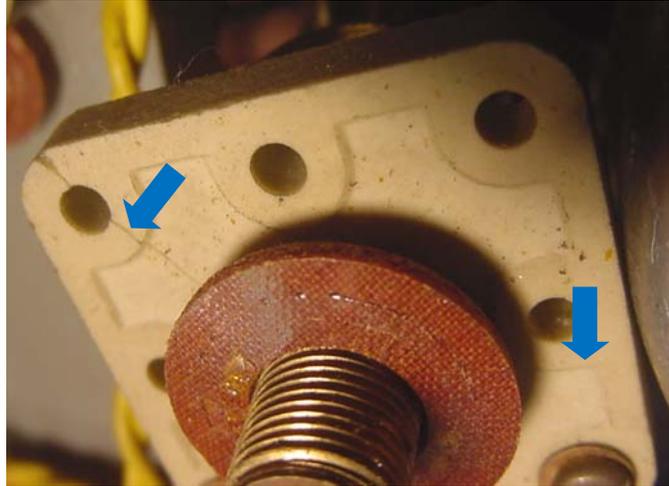
As on a couple of my other restorations, the ceramic plate of the BFO tuning capacitor on this S.840A was cracked (photo, right), though not as bad as others I had seen. The capacitor was removed from the chassis and dismantled to allow the ceramic to be glued using 'industrial strength' superglue. The capacitor was then re-assembled and installed into the chassis again.

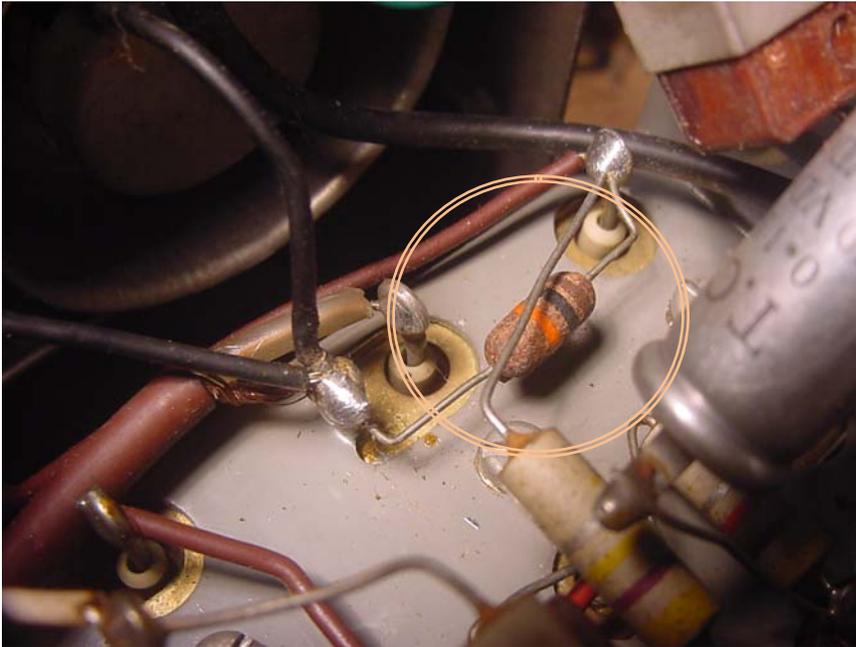
Left: 'Rat dropping' capacitor (circled) masquerading as a piece of wood with stripes painted on it – after 50 years this was really a useless piece of crap (leaky and no capacitance left – worst of all worlds on the AGC line). Below left: those TCC cans are usually fine – here a nominal 0.1uF unit testing at 0.1uF and with very low leakage. Below: nasty wax-dipped tubular paper capacitor – very leaky and low capacitance

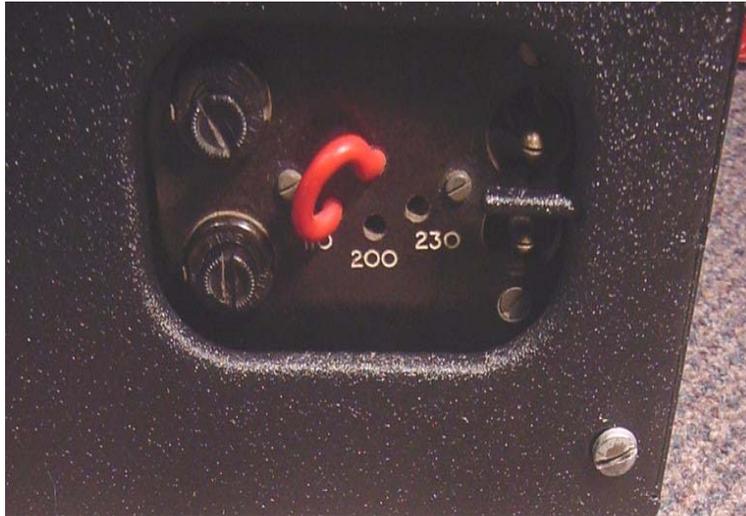
Below: Eddystone power connectors – the version at the top is polarized (one pin thicker than the other) and has a ground connection (side). The version beneath is non-polarized, having two (thick) pins of similar diameter and no ground.

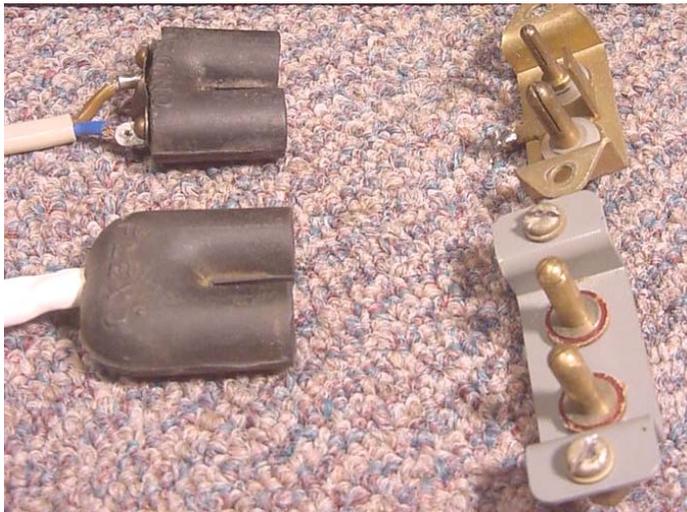
Right: This is how the in-line power socket looked when the set arrived – it had obviously failed at some time and the previous owner had cut through the rubber moulding to access the pins and soldered wires to them, with no attempt at insulating these. Bit of a death trap? – I think so!

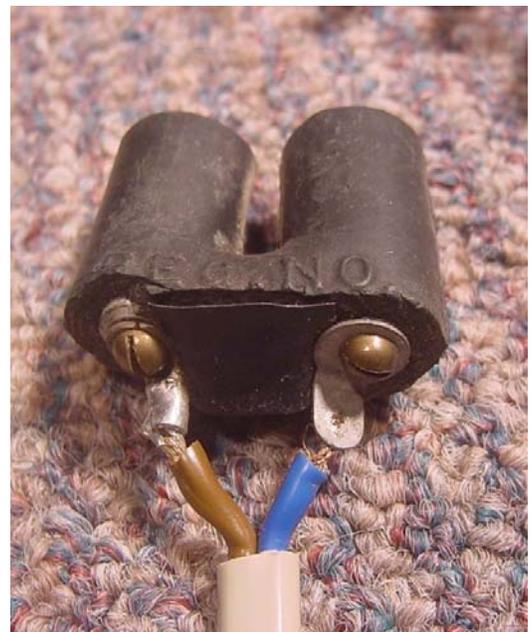
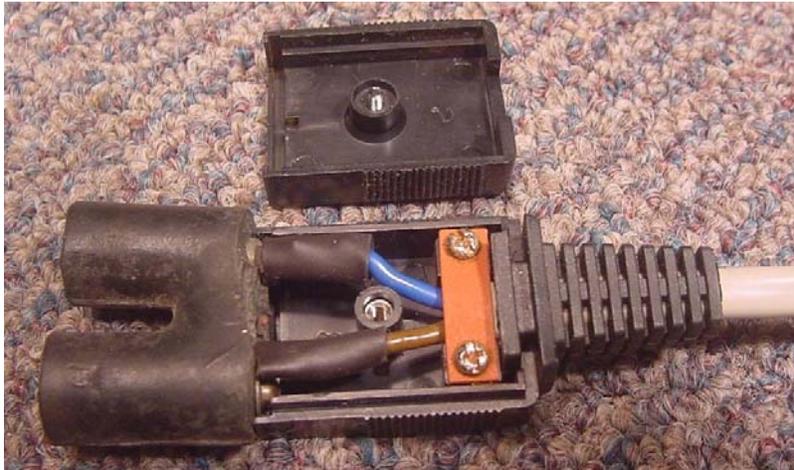
Left: Eddystone sets of this period were fitted with a 'kettle socket' on the power lead, mating with a chassis-mounted plug. On AC/DC sets this was reversible and no (mains) ground was provided for. Such an arrangement is not acceptable in these more safety (and liability)-conscious days. The S.840A is fitted with such a line-socket and chassis plug, though many of these have been removed over the years (as the wires tend to snap-off inside the rubber moulding), these often being replaced with a captive lead or an IEC ('Euro') connector. I have incorporated the IEC mod in several receivers and it works well – especially for the later AC-only sets, where no metal-smithing is necessary (see sidebar in my S.830/4 article). However, in the S.840A, such a modification would mean modifying the insulated rear apron and I did not want to do that – but I needed to do something (see photo below!) to remedy the plug safe and to be sure that the live ('hot') power lead went to the appropriate side of the AC/DC power supply.

Right: A rummage through my junk box found a 'Pioneer' brand line plug that had a suitable body. I insulated the connections to the remnants of the rubber-moulded plug and inserted it into the new plug body – the cable grip and friction holding it in place. With the plug body assembled, the wires and soldered joints are completely insulated (photo, below)

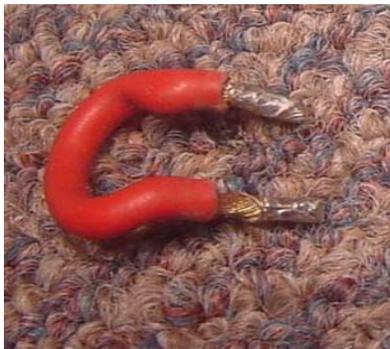
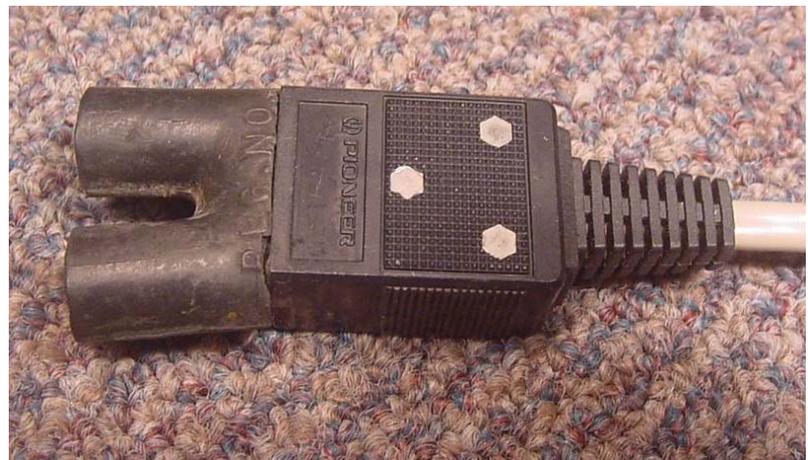
Below: But what about that equally awful voltage selector jumper on my set on arrival? (photo, page 18) – actually a piece of thick wire shaped into a loop (well, at least it was insulated...)

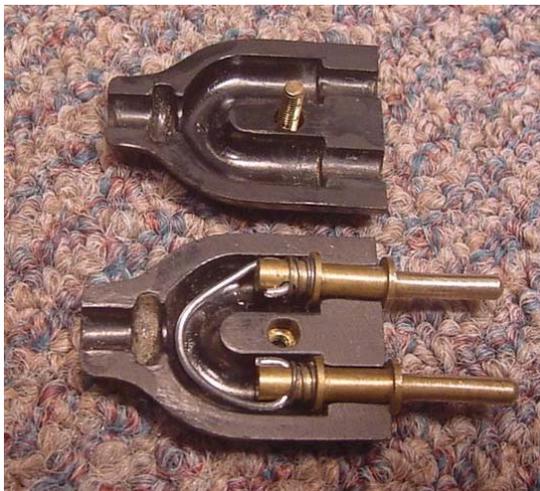
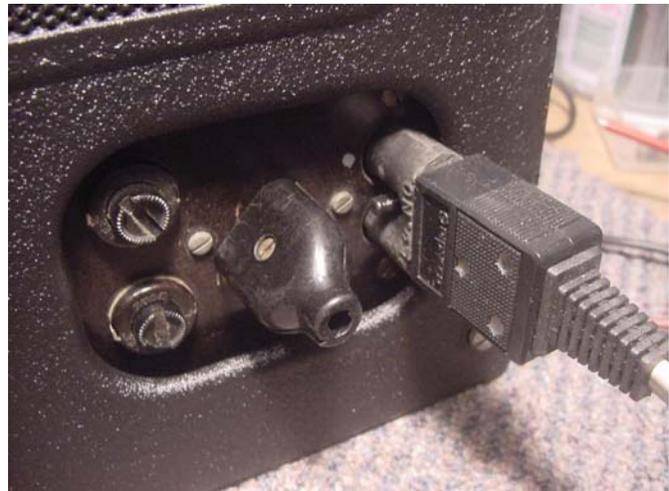
Below: Another rummage around in the junk box found a small two-pin plug with the correct pin size and spacing. This was made into a shorting link as shown here. The re-hashed power panel at the rear of the set is shown below – note the small silver spot on the chassis and plug to aid alignment

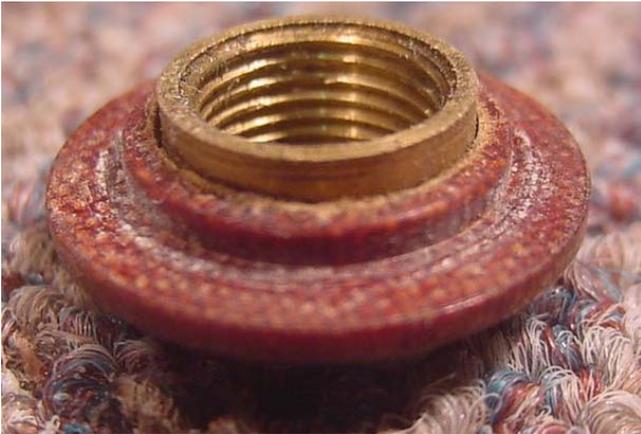
Left: A collared Paxolin washer from one of the front panel control shafts (Tone, RF Gain, BFO and AF Gain) – it is very important to fit all of these and the corresponding (plain) Paxolin washers onto the control shafts.

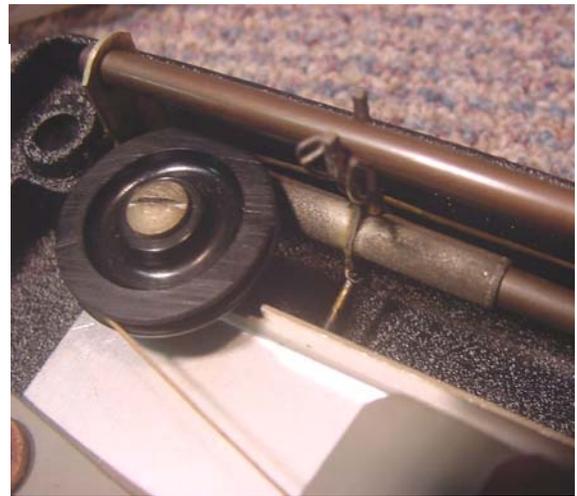
Below: Detail of pointer fixing system – a small clip that can be undone to re-locate the pointer on the cord – handy for adjusting the pointer with the vernier and logging scale set to zero

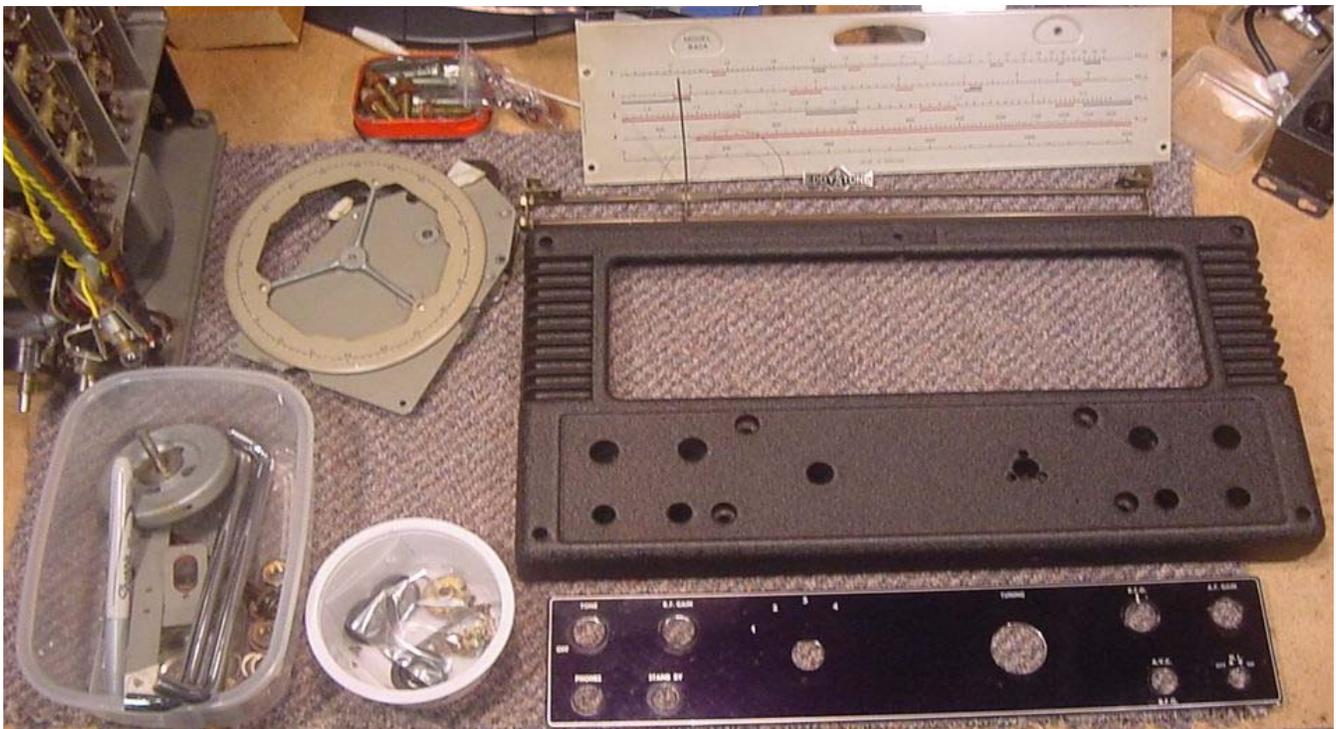
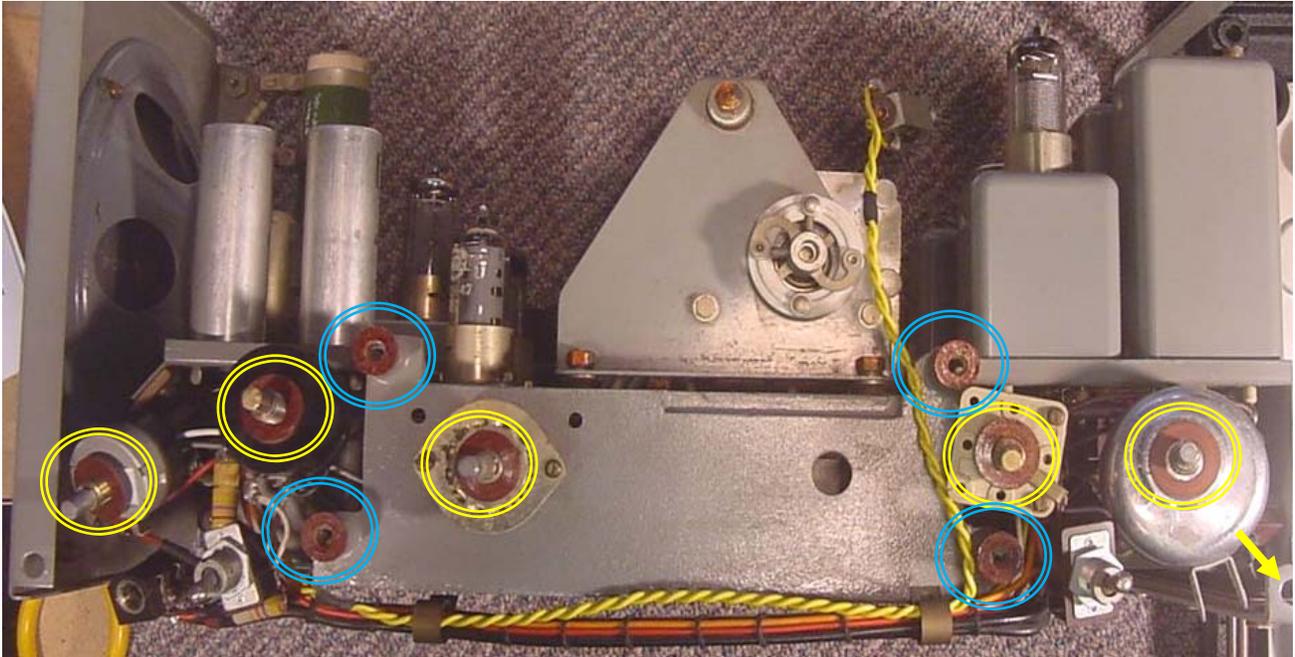
Below: Front panel components ready for re-assembly following re-finishing the front panel – keep them in labelled small bags/containers unless you plan to re-assemble right away (it was over 2 months for me). Start with the badge, then the glass, tuning shaft bushing, the pointer carriage/idler wheels, scale plate and tension idler wheel, flywheel/tuning shaft and then the gearbox. It also helps to attach the noise limiter control shaft and to slip the lower-right chrome handle fixing bolt into place at this point (temporarily hold it in place with a piece of masking tape) – these are both very difficult to fit once the panel is offered-up to the chassis

Above: Paxolin washers in place on control shafts (circled yellow) and on the four front panel fixing stanchions on the coil box casting (circled blue) ready for re-attaching the re-assembled front panel. It helps if a spot of glue is placed on each of the stanchions to hold the washers in place while manipulating the front panel and fixing bolts into place. Also, insert the chrome handle bolt into the lower right hand side hole in the chassis side bracket and temporarily hold it in place with masking tape (yellow arrow, lower right in photo)

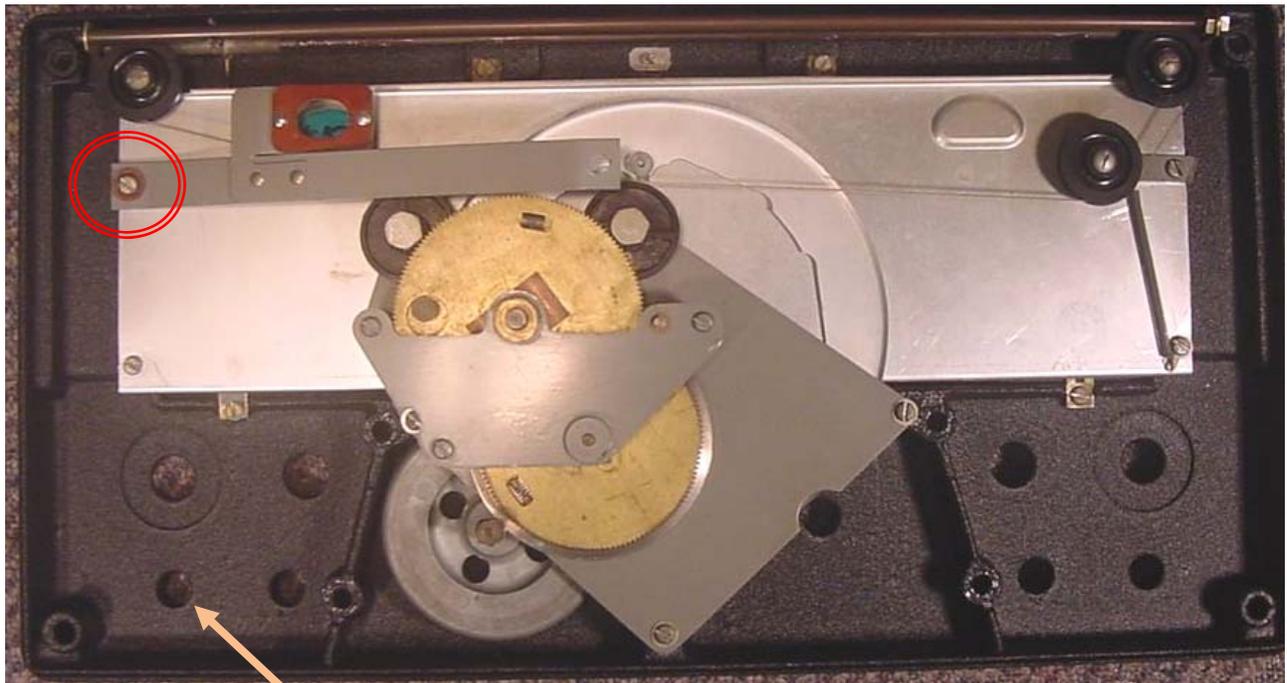
Below: Re-assembled front panel. It helps to also attach the noise limiter shaft at this stage. Note the insulating washers on pilot light bracket (circled red)

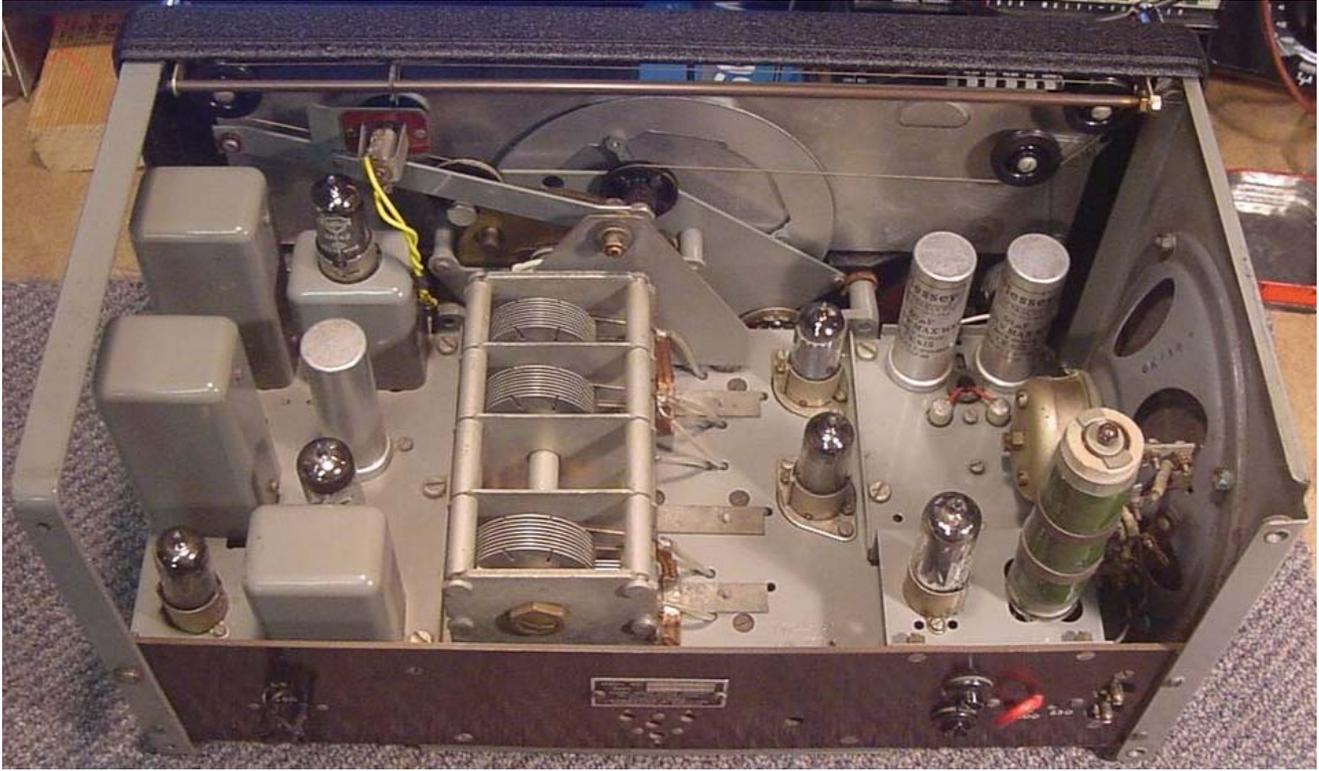
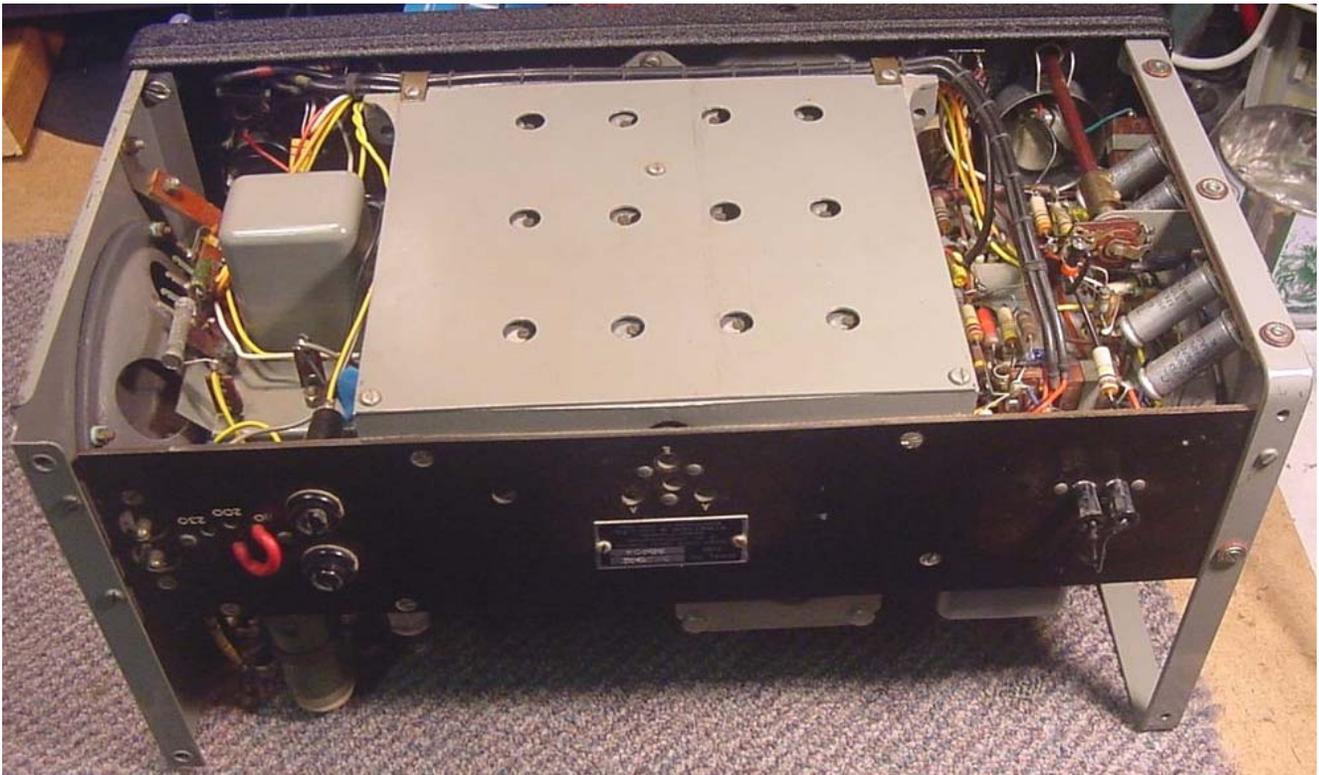
Above: Top view of chassis after re-fitting the front panel – looking ‘Bathtub Fresh’...  
Below: Underside of chassis – re-aligned and final inspection and testing completed before boxing-up

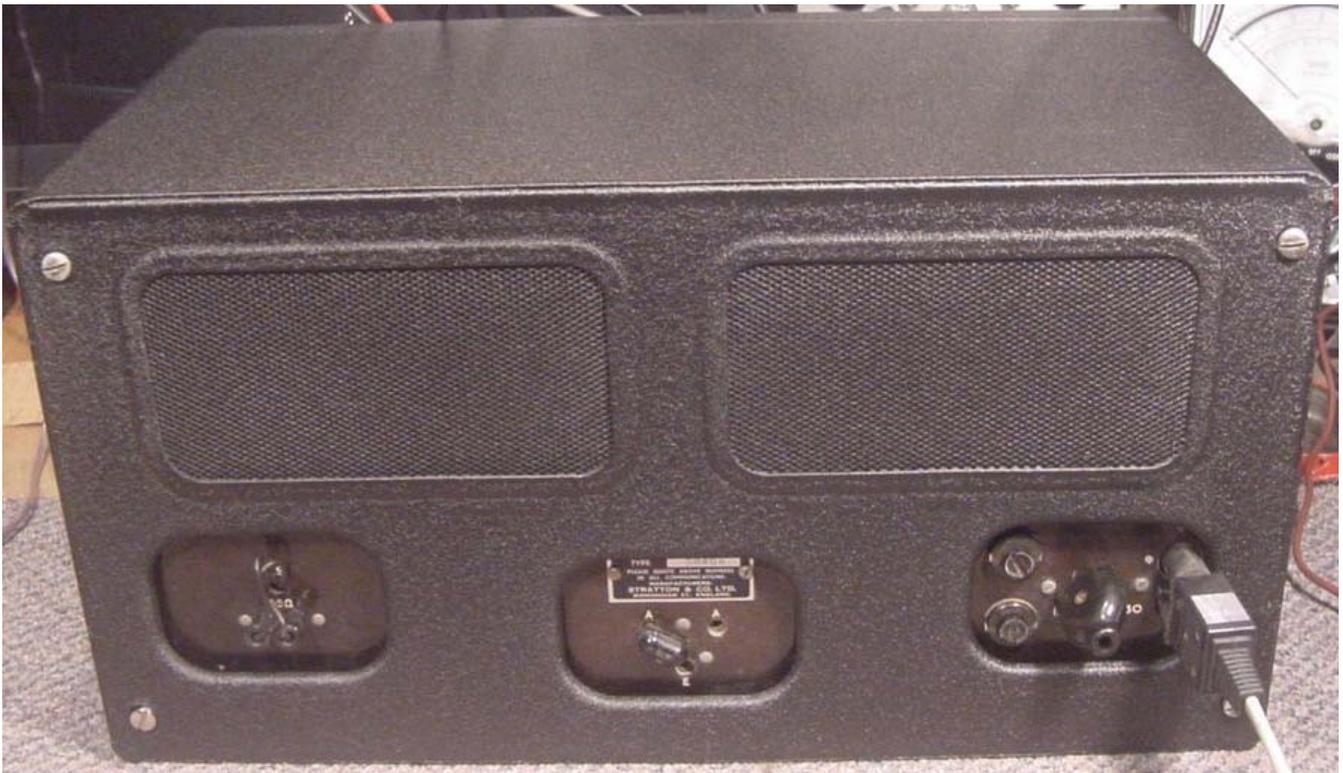
Above: Boxed-up and raring to go – a great receiver and a testament to what can be done with seven valves and some decent, solid engineering  
Below: Rear view of the re-finished cabinet. I personally much prefer the black-wrinkle finish to the silver hammer (even if its not quite correct on this cabinet style). The aerial-ground jumper (Clix) is borrowed from my S.870A until I can find another one
