“You must be Nuts...” – Restoration of an Ebay Left-over Eddystone S.770U MkI – by Gerry O’Hara, VE7GUH/G8GUH

The S770U Design

Appendix II – The 770U Turret & Coil Biscuits – Construction, Checking and Repair

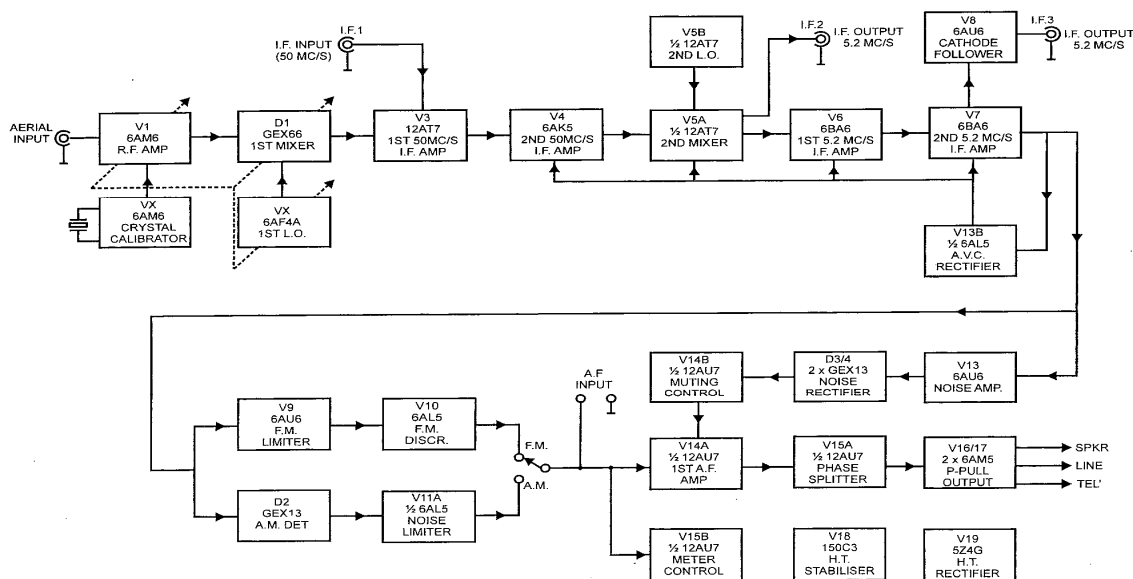
and schematics should be referenced for more detail. The block diagram for the S770U MkII is shown above, and differences between this and the MKI are described below.

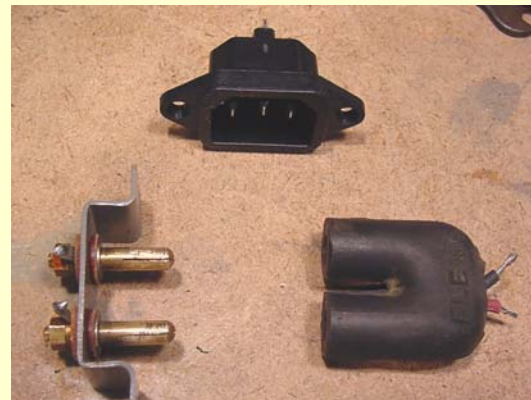
Replacement Mains Connector

I do not like using older electrical connectors if they are the least suspect (eg. frayed or perished insulation). The photo below shows the usual type of mains connector parts used in Eddystone receivers (bottom), together with a modern mains 'euro' connector (computer type).

The modern connector (male socket) can be fitted into some Eddystone sets directly behind the chassis cut-out for the older ('kettle') connector. Simply unsolder and remove the old connector and fit the replacement with a 4BA nut, washer and bolt at the bottom and similar at the top, the latter with a large washer or plate cut to cover the small gap. Solder in the new male socket and that's it. You will find that the female connector (plug) fitted to the mains lead will fit snugly through the chassis cut-out and mate with the chassis connector.

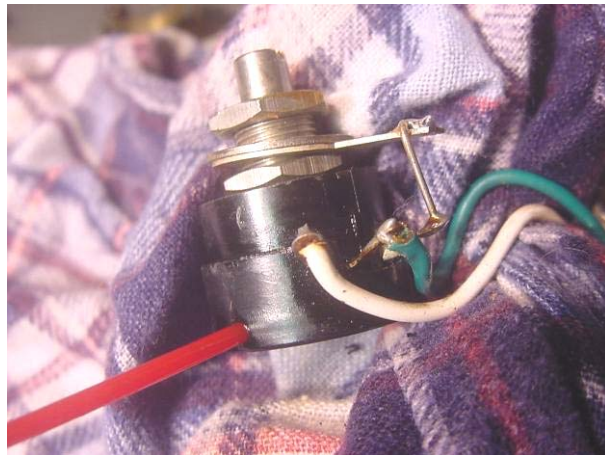
The operation of the AM and FM meter controls (pre-set pots), as well as the Muting control (Squelch) was very erratic. On checking with an ohmmeter, the resistance of each was found to be jumping all over the map. So these were removed from the chassis

and either dismantled (AM and FM pots), or a small hole drilled in the case where the control would not come apart easily (Muting pot), and De-Oxit squirted inside (photo, base of previous page). The controls were then rotated a few times, re-assembled and re-fitted. These all now worked ok – marvelous stuff that De-Oxit.

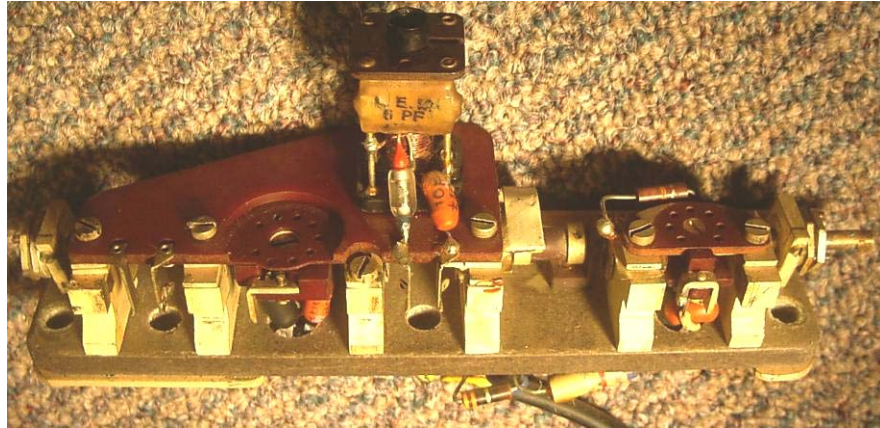
The front-end of the receiver (RF stage, 1st mixer and 1st local oscillator) is constructed on Paxolin and 'Frequentite' insulating sheets (see Appendix II) mounted on a silver-plated sub-assembly, along

with the main tuning gang and fixed contacts (photo, above – RF stage to the left, local oscillator to the right, GEX66 mixer diode visible in the centre). The valve bases are bespoke assemblies with silver-plated contacts installed in the Paxolin sheets. This entire sub-assembly can be removed for inspection and access to the components by:

- removing the bottom cover from the turret compartment (take care with the wire-loom retainers fixed by the retaining screws and make a note of where they were mounted);
- un-soldering the 150V HT (blue) and 6.3V heater (yellow) supply wires from the feed-through capacitors on the turret compartment wall;
- loosening the two grub screws affixing the flexible coupling to the tuning gang shaft (mark these so they can be aligned easily on re-assembly);
- remove the two screws holding the sub-assembly to the turret compartment;
- with the sub-assembly loose, turn it over and un-solder the coaxial aerial input and 50MHz IF output leads (photo, right).

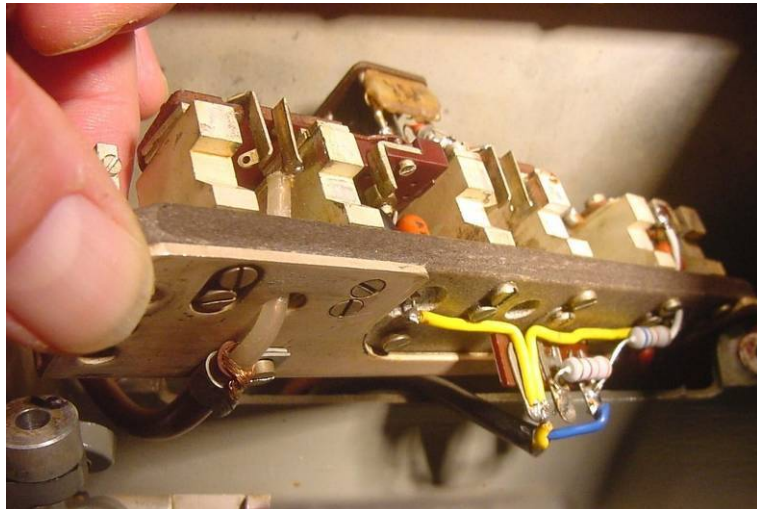
Above: the front-end sub-chassis removed, cleaned and fitted with new resistors, ready for re-installation

The front-end unit in my set was found to be quite heavily tarnished and with lots of grime present. I cleaned it meticulously with alcohol and a little 'Silvo' where the silver plate was completely blackened. On checking the resistors, I found them all to be out of tolerance, so they were replaced (I used metal film types). The discrete capacitors on this unit are all silvered ceramics and tested ok, so I left them in place.

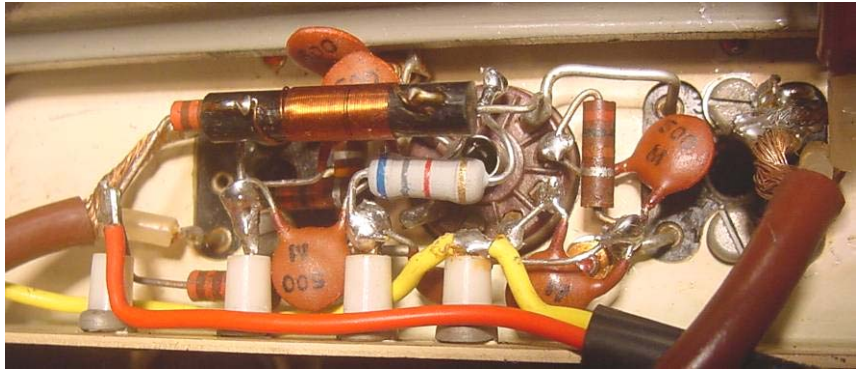
The 50MHz 1st IF amplifier can be serviced easily in-situ from the bottom of the turret compartment. This unit was populated with nasty little 500pF 'grub-like' tubular paper capacitors manufactured by TCC¹⁰. During some resistance checks I noticed that one appeared leaky, so I un-soldered one end for checking – sure enough, it was reading 250K Ω or so and had a capacitance value of 25pF. I checked another – this one had a 1M Ω leakage resistance and a capacitance of over 4500pF, and yet another a leakage resistance 300K Ω and a capacitance of <1pF. So I decided to replace all these capacitors with 500pF, 1000Vw disc ceramics. I also replaced a couple of out-of-tolerance resistors in this unit (photo above).

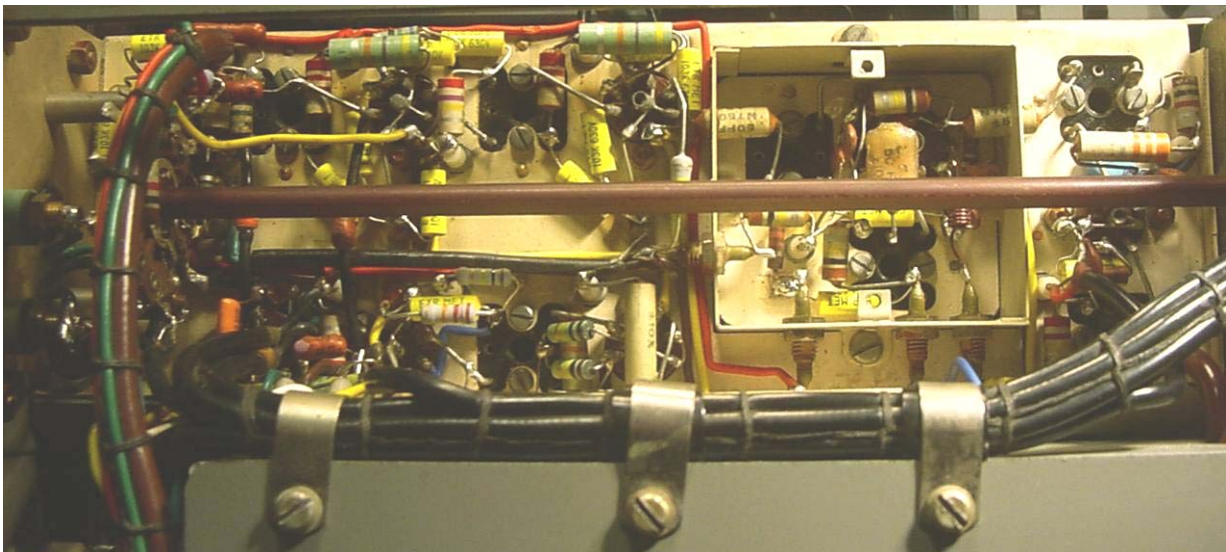
Next I took a closer look at the IF strip on the main chassis (photo, below – after re-capping). There were some ugly-looking 0.01 μ F bypass capacitors present in the IF

stages and one on the AGC line – these were slightly leaky ($>1\text{M}\Omega$) and so were replaced with new 630Vw polycarbonate axial types (yellow bodies in the photos). I also noticed more of the 500pF ‘grub-like’ capacitors in the 2nd 50MHz IF amp and in the 2nd local oscillator compartment – these were all replaced.

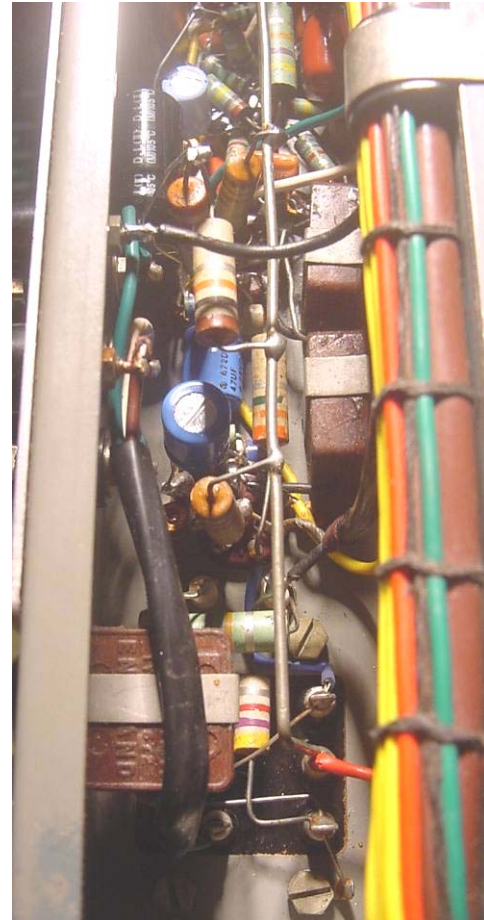
Above: The AF compartment after replacement of electrolytic capacitors (black and blue cases) – a bit like my fingers and the air in my shack after the work... (only kidding)

So, using the above techniques I replaced all the electrolytics in the AF section (took about an hour) – I did not bother testing the old ones before removal as 50+ year-old electrolytics are always suspect and replacements are so cheap. I did test them after they had been removed though – out of curiosity. Surprisingly, both of the 4uF ones were almost at their correct value, though rather leaky, and the low voltage types were double their indicated values! – again rather leaky. I used 105C temperature-rated replacements as things get a little warm in that AF compartment. On testing the set afterwards, much of the hum had gone, though there was a little remaining. I checked that this was not due to the main smoothing capacitors being weak by temporarily placing a 33uF capacitor in parallel with the ones fitted – no improvement – the remnant hum was coming from elsewhere. The usual suspect in these cases in Eddystone sets of this era is a 6AL5 duo-diode (AGC rectifier and noise limiter in the S770U) - these are renowned for introducing hum due to their heater/cathode construction. Eddystone circuit design frequently includes some circuitry to mitigate this – as in the S770U, where R68 and R69 form a potential divider across the stabilized 150V supply, providing a small (3.8V) positive bias voltage that is applied to the centre-tap of the heater supply to this valve (V14). On checking these resistors, I found that R68 (270K Ω) had increased to over 450K Ω , and R69 was right at tolerance, reducing the bias to a negligible value. Replacing these resistors cured the remaining hum issue.

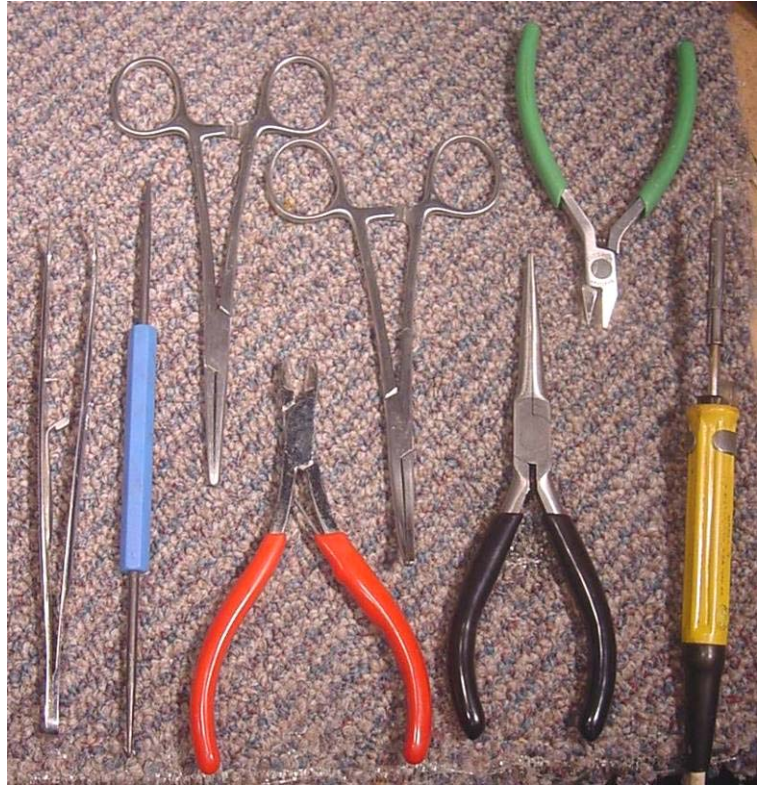
Above: Selection of tools suitable for working in politicians mouths er, I mean S770U AF compartments – hemostats (straight and curved), locking tweezers, long-necked cutters, needle-nosed pliers, angled soldering pick and that all-important 15W Antex soldering iron (this baby is 38 years old – well the handle is at least...)

tool immediately above the tip is 3/8" in diameter and makes the iron useless for applications where access within a tight space is needed – as in the S770U AF compartment. Antex make a range of low-wattage irons that have a long, thin tip that slides over a thin heating element – ideal for use in restricted spaces. I have had a 15W Antex iron since I was 16 years old (well, at least the handle is the same! – the element and tips having been replaced several times over the years – a bit like Triggers's road sweeping brush on '*Only Fools and Horses*'). Amazingly, Antex still make (almost) the same iron and replacement parts fit the old handle (I buy from <http://stores.shop.ebay.com/Antex-USA>). There are probably other suitable irons on the market, but the Antex units are readily available, low-cost, reliable and work great. In addition, the 15W size packs much more 'punch' than you would expect from such a low-wattage iron.

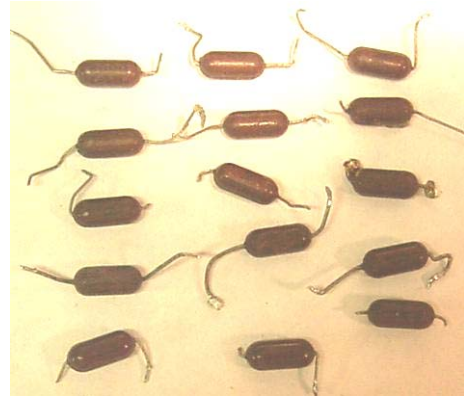
Above: I am not sure what the collective term is for TCC 'Rat Droppings' capacitors – maybe a 'poop' or 'mess' of them?

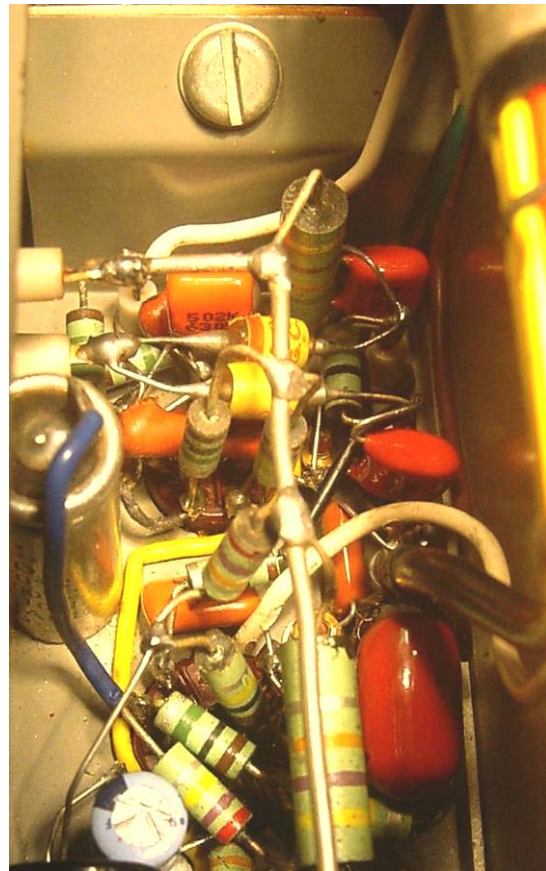
Above: The muting and first AF stages after replacing 'Rat Droppings' capacitors. Access is, to say the least, a little restricted...

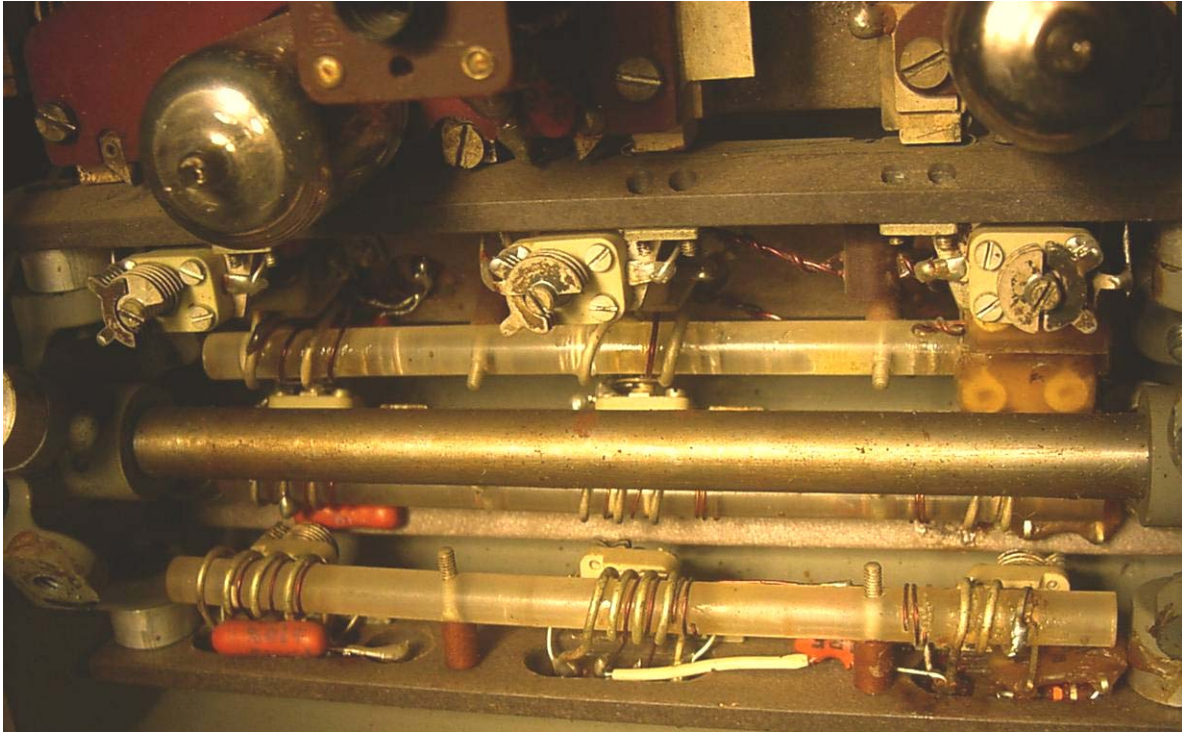
Above: The turret carousel with Range 1 and Range 2 coil biscuits removed (before cleaning)

I then adjusted the trimmers on each coil biscuit according to the instructions in the manual. This takes a bit of time – the manual notes that for each one, the preceding coil biscuit in the carousel needs to be removed temporarily to allow access to the trimmers on the biscuit that is engaged in the turret – not the best piece of design... Anyway, I found one trim tool in my kit that was able to do the job without removing the preceding biscuit and that did not affect the tuning significantly during adjustment due to stray capacitances (photo, below) – note the chamfered end on the right and small metal blade.

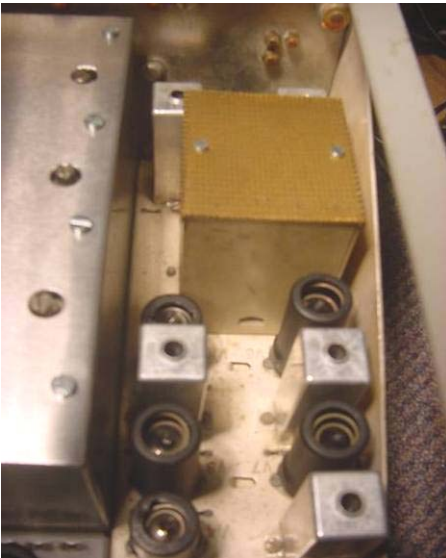
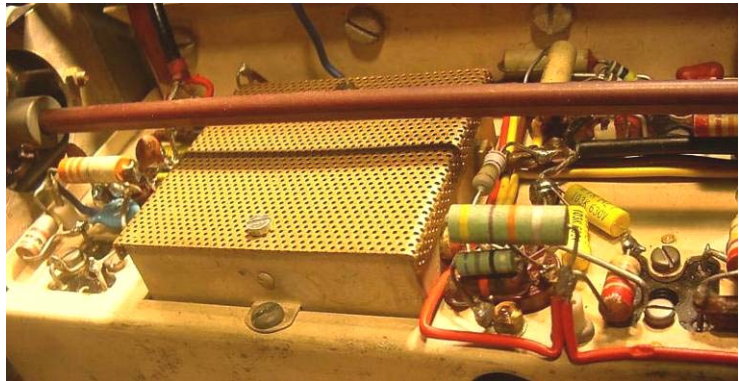
The missing covers for the 2nd local oscillator compartment were fabricated from a perforated steel loudspeaker grill rescued from a scrapped Raytheon VHF transceiver (photos below left and right) – not exactly identical to the

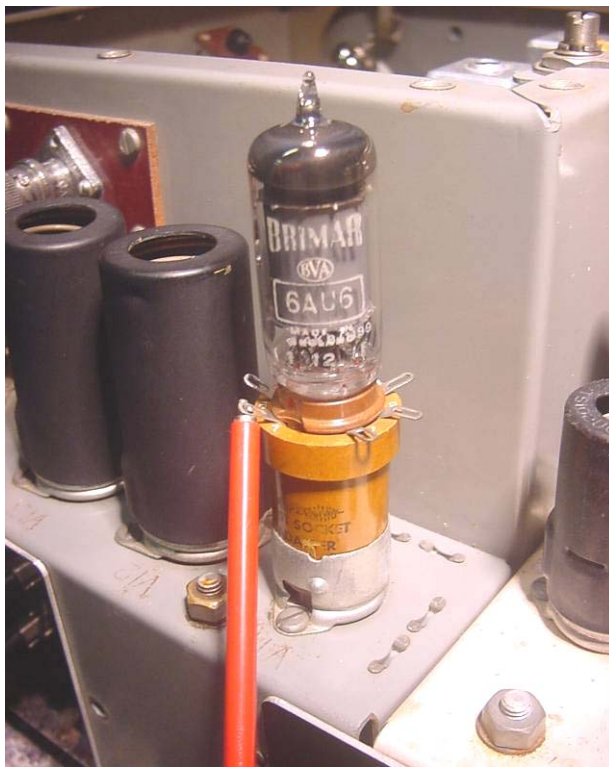
Above: A handy little gadget for measuring voltages on valve bases in that cramped AF compartment– here shown fitted to the noise amplified stage (V11) – no need to poke around amongst the cramped components under the chassis (photo, right). Right: Some very delicate surgery being performed in the AF compartment... flux swab please nurse!

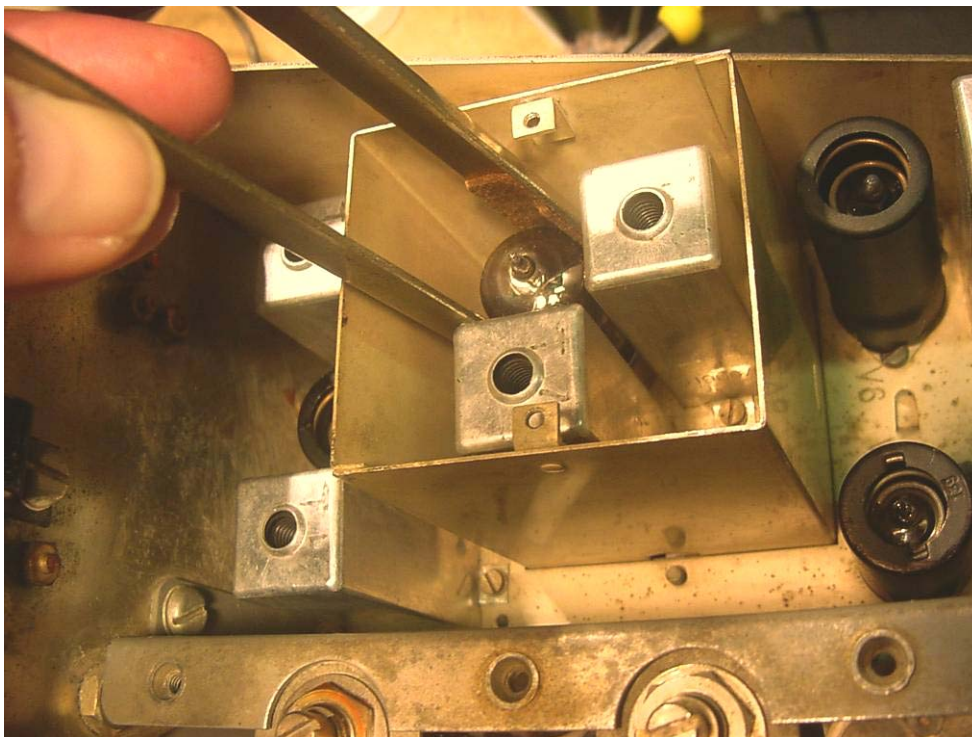
Above: Another handy tool for working on the S770U is a valve extractor – here being used to extract V5 (12AT7) from the 2nd local oscillator compartment. Below: restored turret tuner compartment (Range 1 biscuit to the left, Range 2 biscuit at top and Range 3 biscuit engaged with the fixed contacts on the RF sub-chassis at the right-hand side). Part of the Geneva drive is visible in the lower-centre of the photo

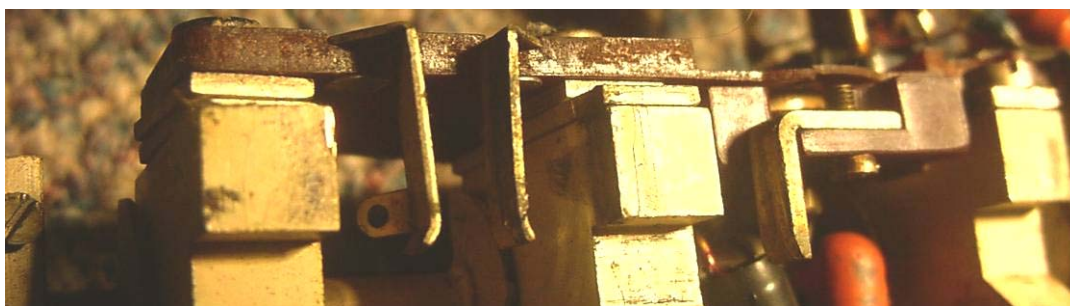
Above: The 'real' 2nd local oscillator compartment covers (borrowed from the S770U at the SPARC museum). The one fitted to the upper compartment is at the top (note the valve-retaining spring for V5). The top cover has a perforated metal ventilation screen, whereas the lower cover is a metal mesh screen. Below: close-up of the fixed contacts in the RF stage of the turret tuner before cleaning

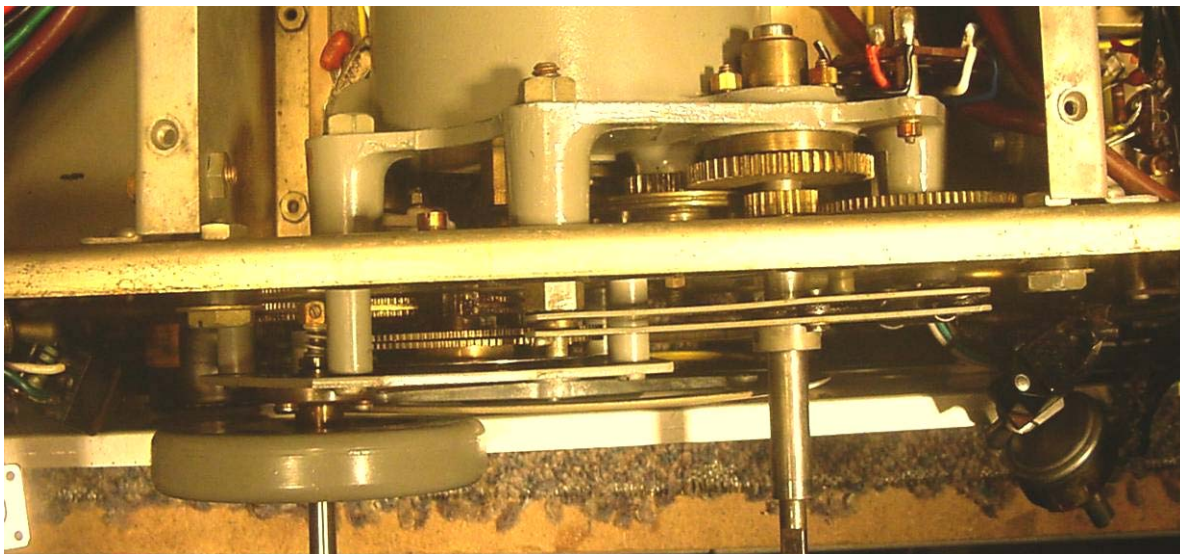
Above: The tuning (lower-left) and range-changing gearboxes viewed from below with the front panel removed. The tuning arrangement is the standard Eddystone design of the period, however, the range switch features a gear-driven Geneva drive (see Appendix II). Below: the first 50MHz IF stage (12AT7 in cascode configuration), here with the screening cans removed from the coupling transformers (T2 and T3) for inspection

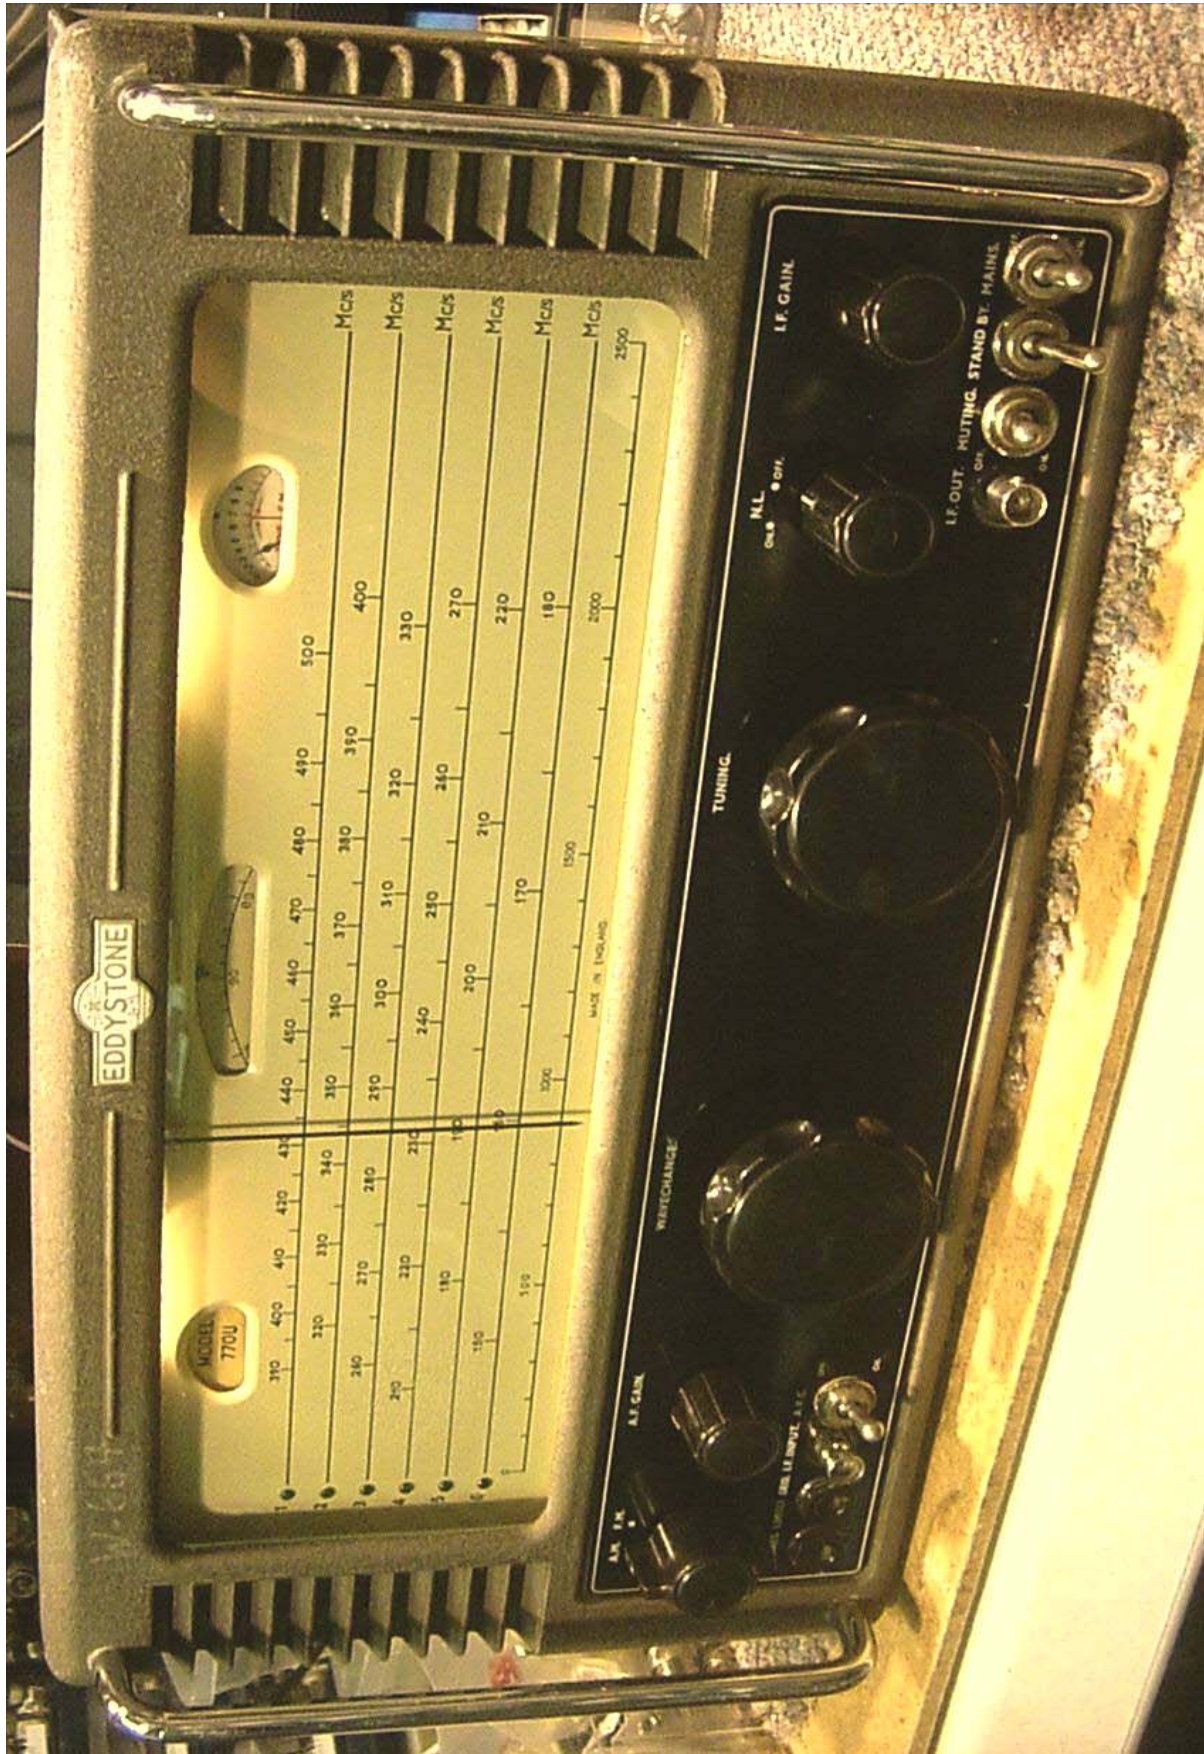
Above: Chassis viewed from beneath with lower turret compartment cover removed. Modifications/repairs to the psu can also be seen (discussed in text)

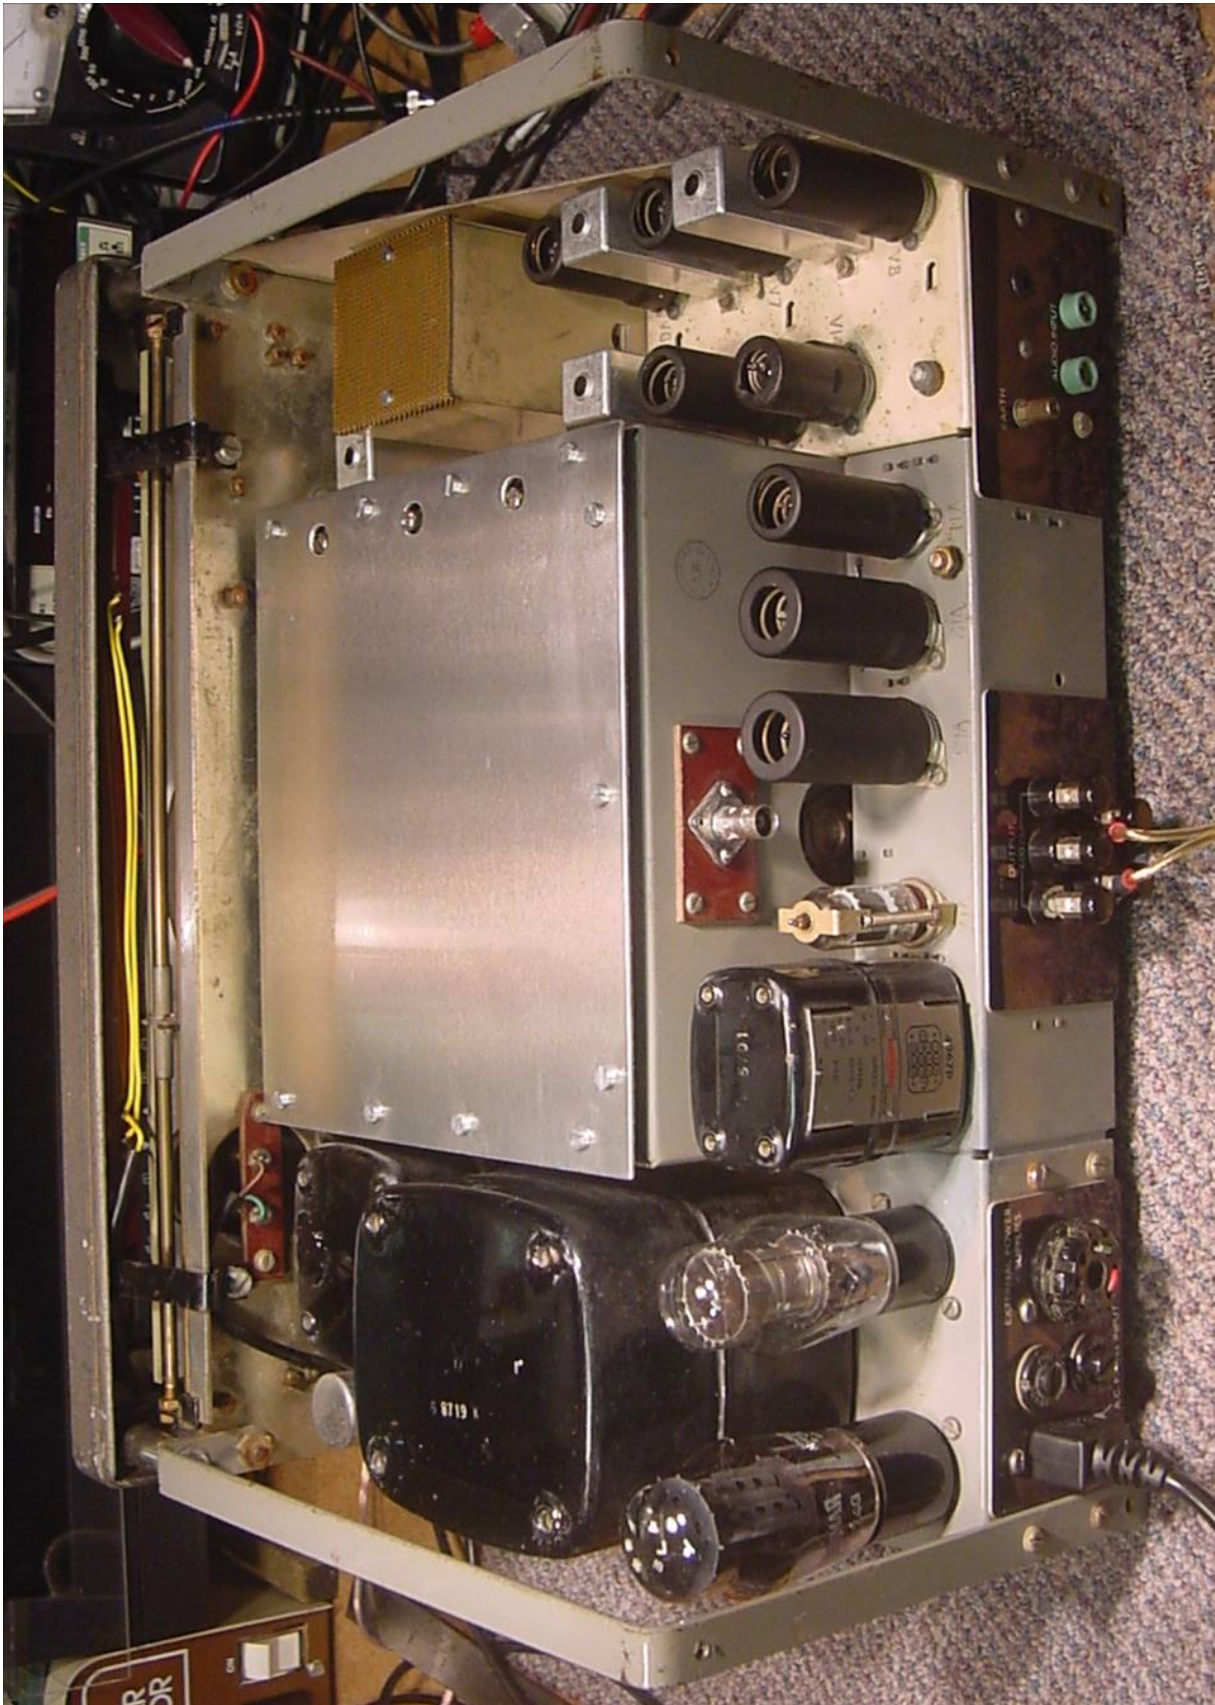
Above: Chassis viewed from rear with the restoration nearing completion

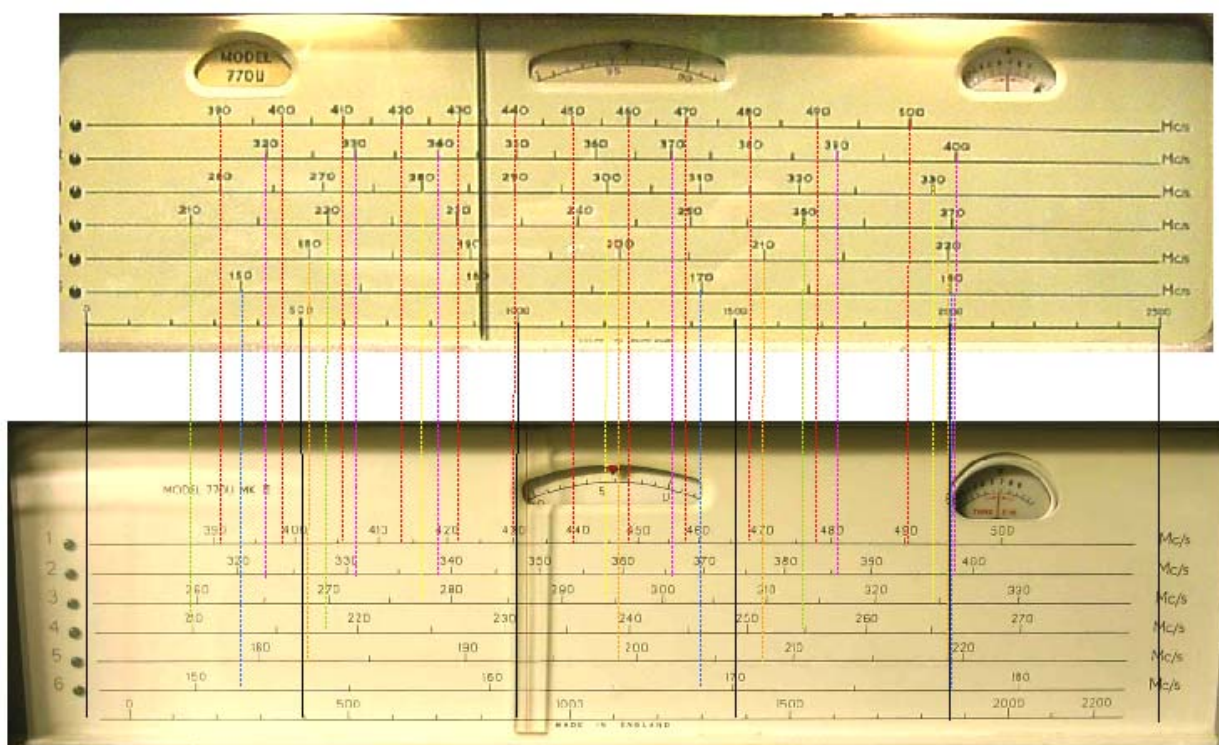
Above: Comparison between the scales of an S770U MkI (top) and MkII (bottom). Using the MkI's scale as a reference relative to overall scale length (visual), vertical lines drawn are black (logging), and at select 10MHz points for each range: red (Range 1), violet (Range 2), yellow (Range 3), green (Range 4), orange (Range 5), blue (Range 6).

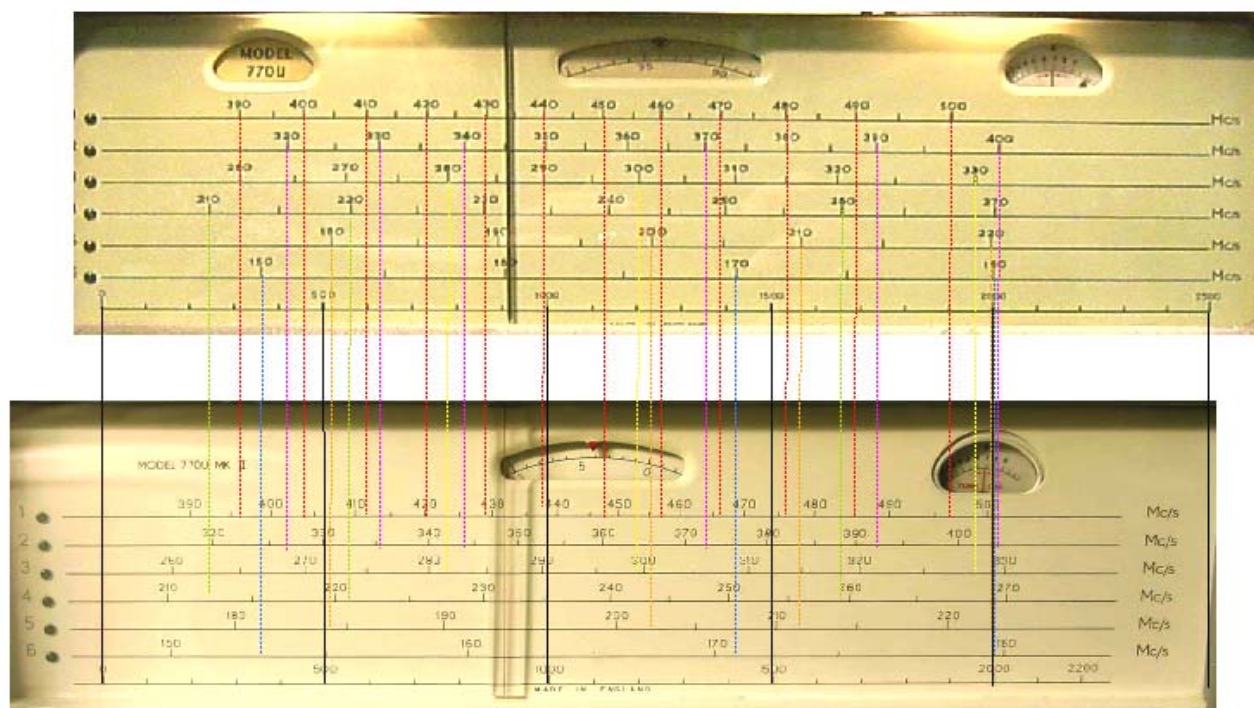
Above: Comparison between the scales of an S770U MkI (top) and MkII (bottom). Using the MkI's logging scale as a reference, vertical lines drawn are black (logging), and at select 10MHz points for each range: red (Range 1), violet (Range 2), yellow (Range 3), green (Range 4), orange (Range 5), blue (Range 6). Note: the logging scale is 12" (205mm) long from 0 to 2500 on the MkI and from 0 to 2200 on the MkII.

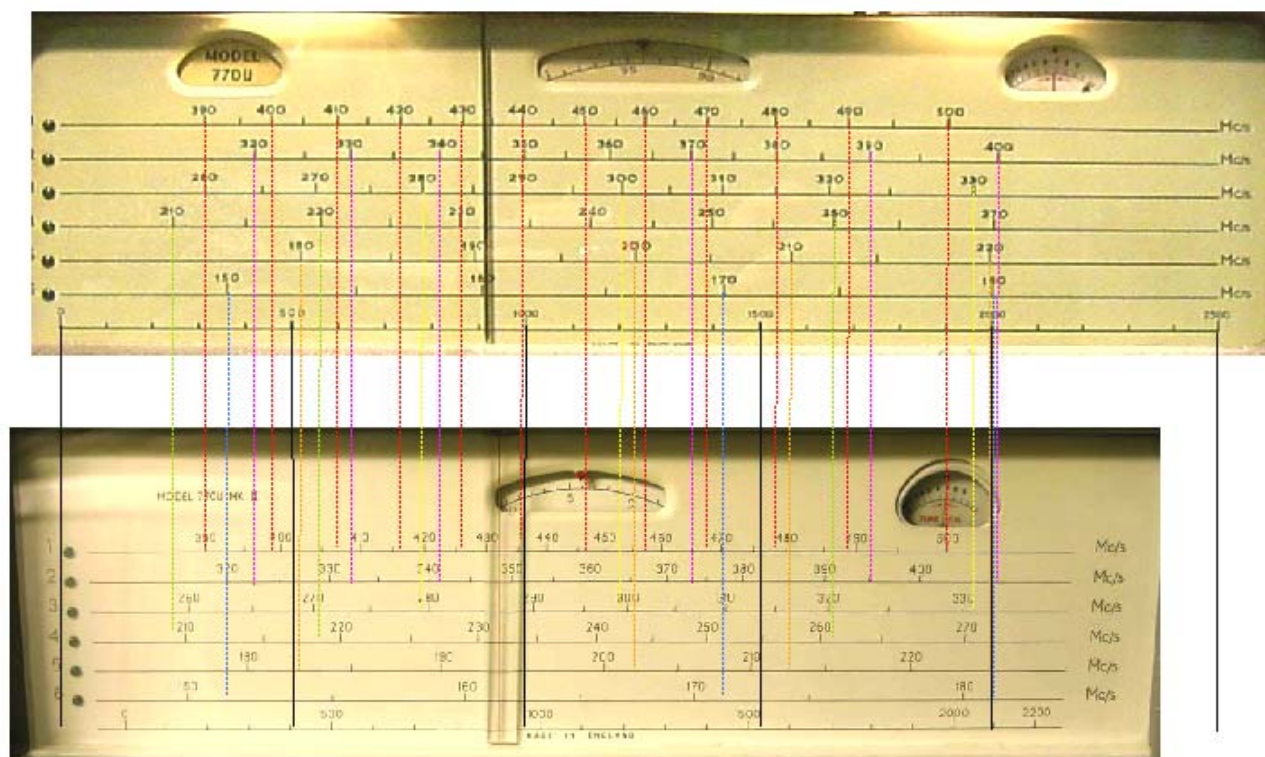
Above: Comparison between the scales of an S770U MkI (top) and MkII (bottom). Using the MkI's Range 1 scale (10MHz markers) as a reference, vertical lines drawn are black (logging), and at select 10MHz points for ranges: red (Range 1), violet (Range 2), yellow (Range 3), green (Range 4), orange (Range 5), blue (Range 6).

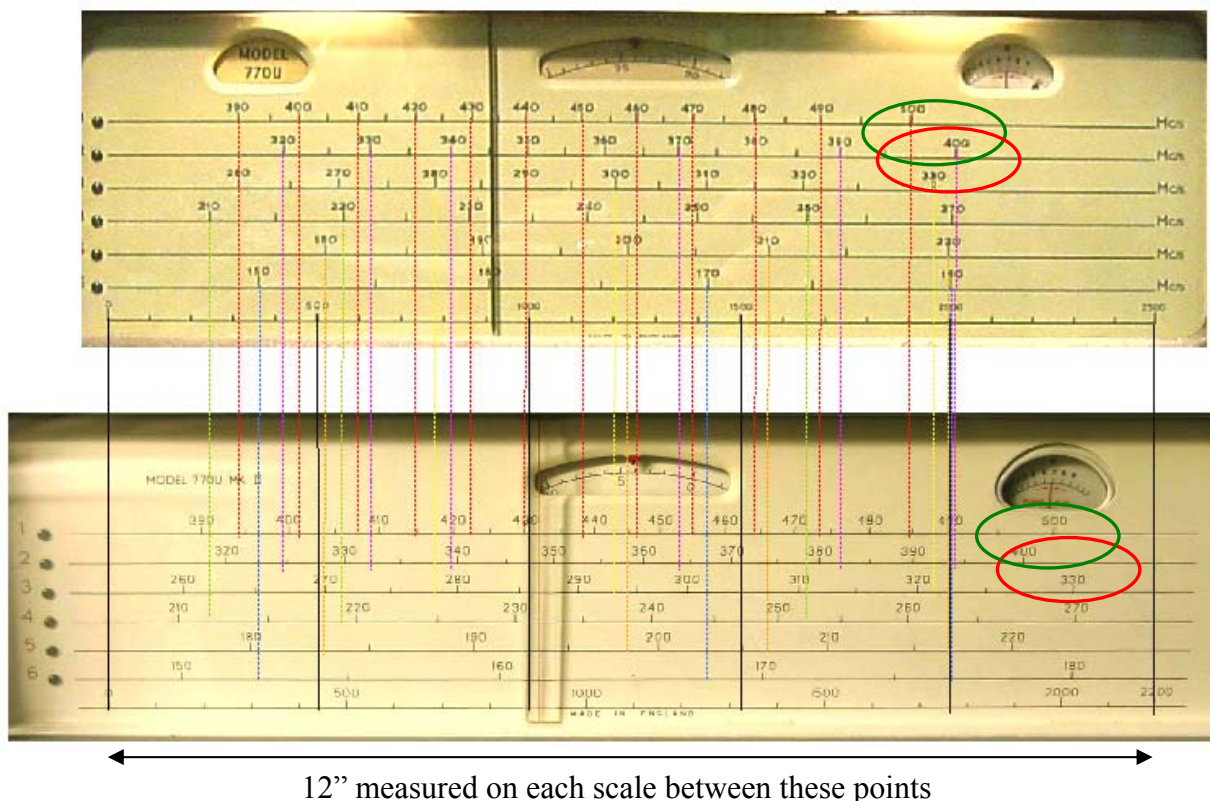
Comparison between the scales of an S770U MkI (top) and MkII (bottom). Using their logging scales as a reference, each set to coincide at the measured 12" between 0 and 2500 on the MkI and 0 and 2200 on the MkII, vertical lines drawn are black (logging), and at select 10MHz points for ranges: red (Range 1), violet (Range 2), yellow (Range 3), green (Range 4), orange (Range 5), blue (Range 6).

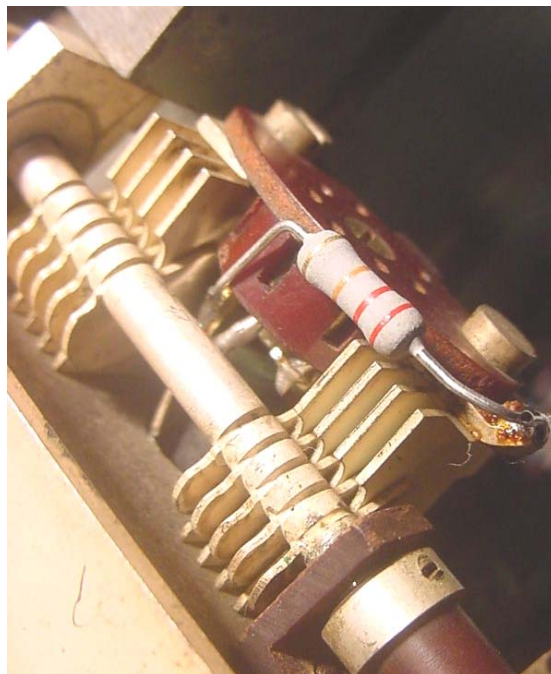
Above right: Close-up view of two sections of the specially-designed tuning gang (this section is the local oscillator). Below: "...for goodness sake Gerry, I know its all probably for the good, but please leave me alone as I really have had enough for today!")

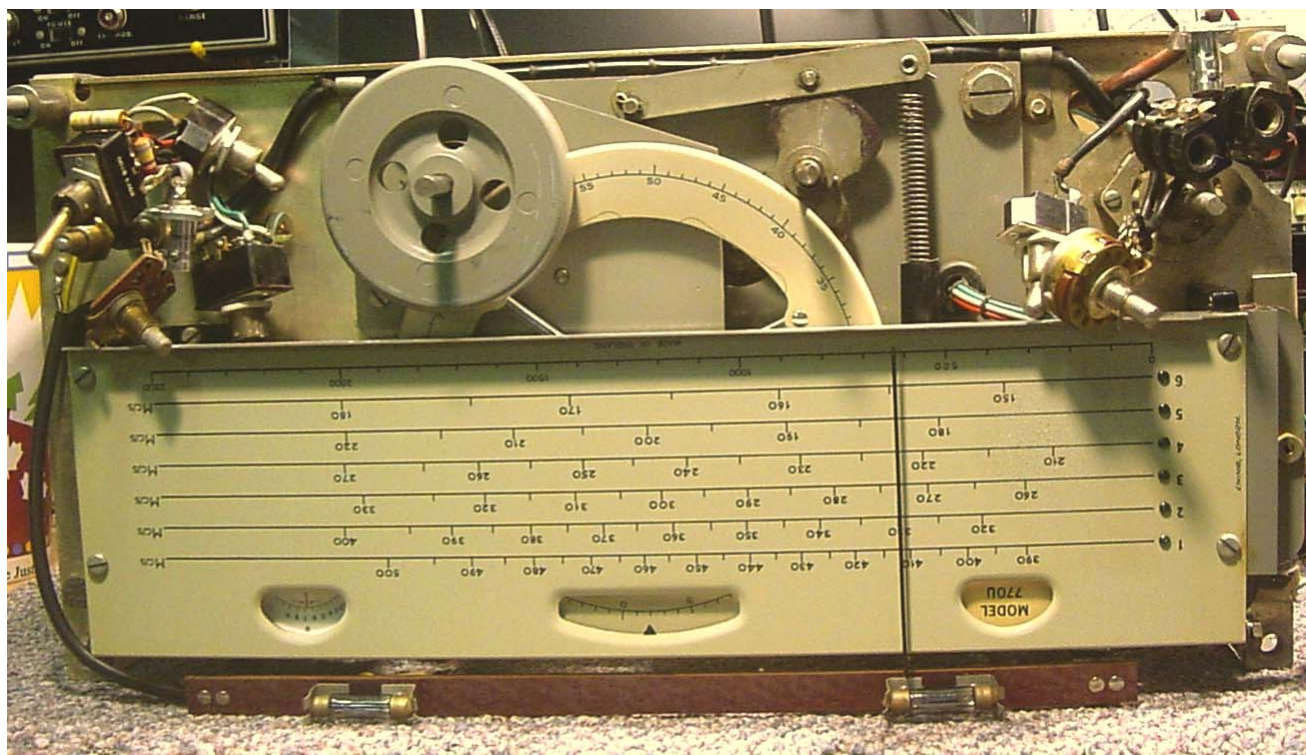
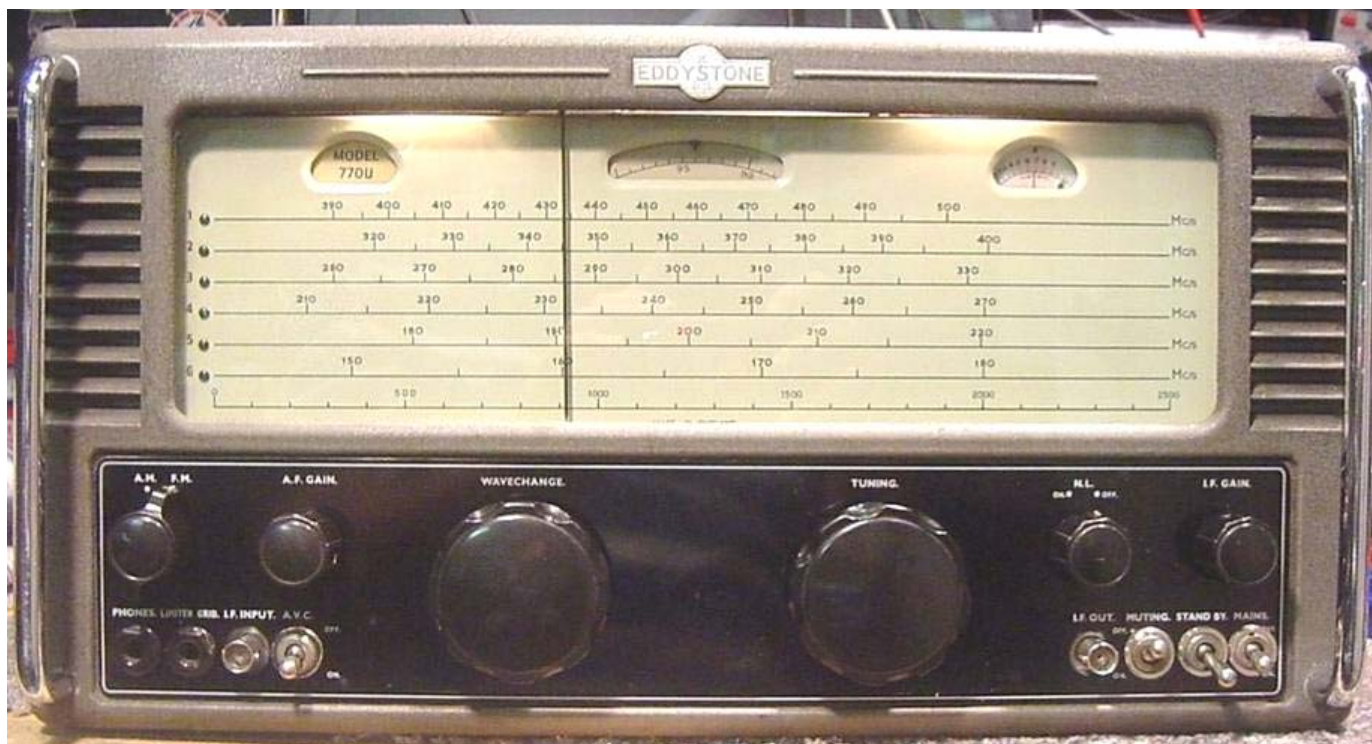
Above: Front panel of my S770U MkI. Below, front panel of Mike Cassidy's S770U MkII – note differences in the scale and front panel layout when compared with the MkI, in particular the location of the limiter grid and phones socket, inclusion of the 'Cal' switch and 'scale adjuster' (upper right of panel), and absence of the 'IF out' socket (moved to rear panel). Also, the cut-out for the model nameplate is absent in the MkII, with the model number being silk-screened directly onto the scale plate. The scale frequency designations are in 'Mc/s' on both – not a 'MHz' in sight...
