“You must be Nuts...” – Restoration of an Ebay Left-over Eddystone S.770U MkI – by Gerry O’Hara, VE7GUH/G8GUH

The S770U Design

Appendix II – The 770U Turret & Coil Biscuits – Construction, Checking and Repair

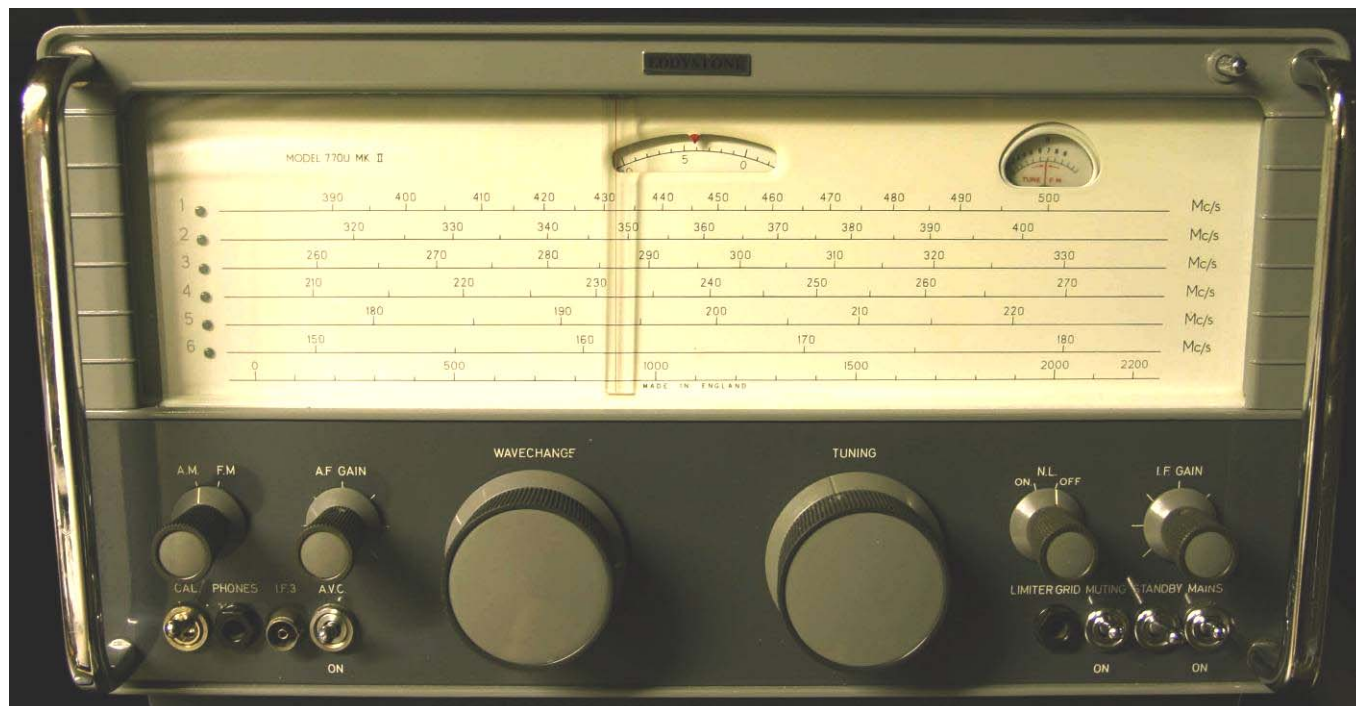
Above: Front panel of my S770U MkI. Below, front panel of Mike Cassidy's S770U MkII – note differences in the scale and front panel layout when compared with the MkI, in particular the location of the limiter grid and phones socket, inclusion of the 'Cal' switch and 'scale adjuster' (upper right of panel), and absence of the 'IF out' socket (moved to rear panel). Also, the cut-out for the model nameplate is absent in the MkII, with the model number being silk-screened directly onto the scale plate. The scale frequency designations are in 'Mc/s' on both – not a 'MHz' in sight...

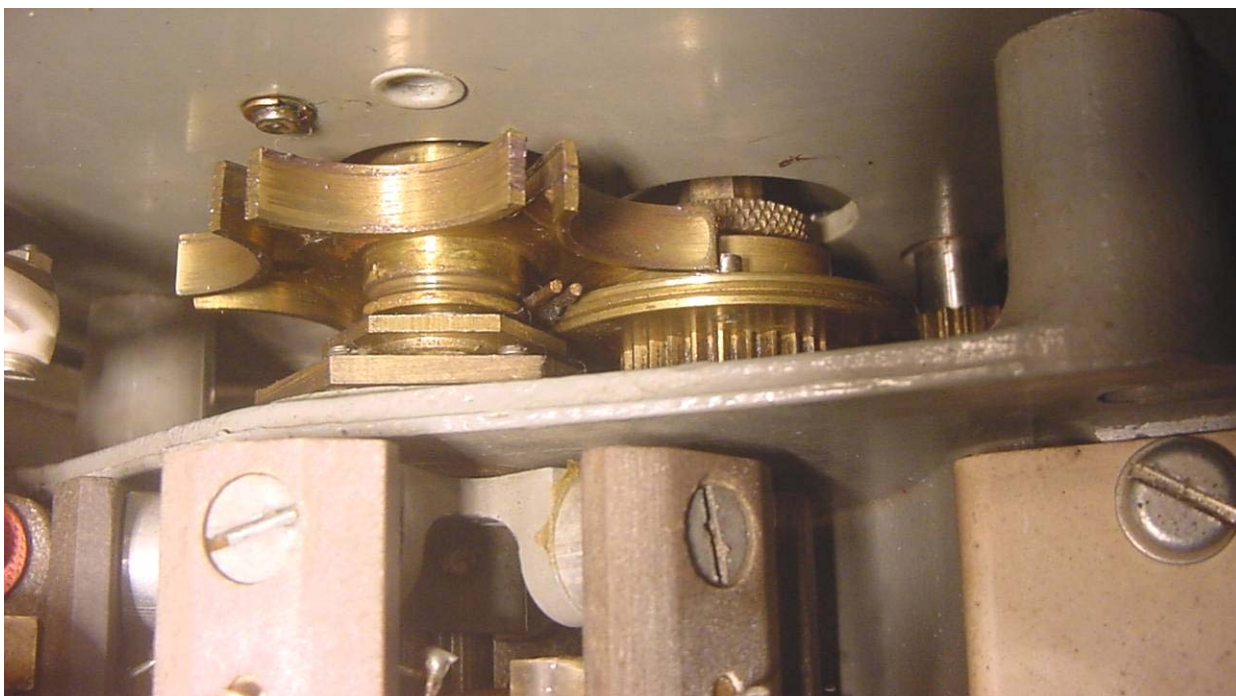
Above: Geneva drive mechanism viewed from above – input (drive) wheel to the right, output (driven) wheel to the left. Compare with the sketches on the previous page

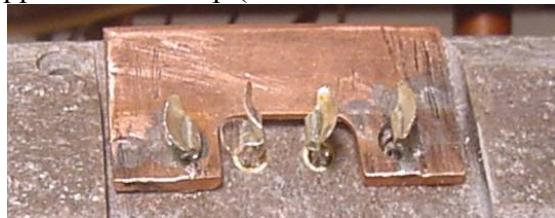
The contacts (part No. 5025P, photo, left – note mica washer) must be positioned precisely in terms of height above the biscuit and angle (the shank of the contact must be vertical and aligned such that the contact face is parallel to the fixed contacts when rotated through the turret)¹⁶. Great care is needed in securing the contacts to the brass strip: the contacts and brass strip must be soldered together. To do this reliably, considerable heat must be applied to the strip (I used a 260W Weller solder gun) and, at the right time, just sufficient solder introduced to effect the joint but without flooding the small well in the brass strip surrounding the flexible part of the contact shank (photo, right). If too little solder (or heat)

is applied, a poor contact will result and if too much is applied, the well at the base of the contact may flood with solder that can solidify the flexible part of the contact shank – this is undesirable as the moving contact must flex each time it mates with the fixed contact during turret rotation. I managed to get the first one right first time, but it took me two attempts to get this just right on the second contact. Also, before soldering contacts into place, make sure that the contact surfaces are facing the correct way!

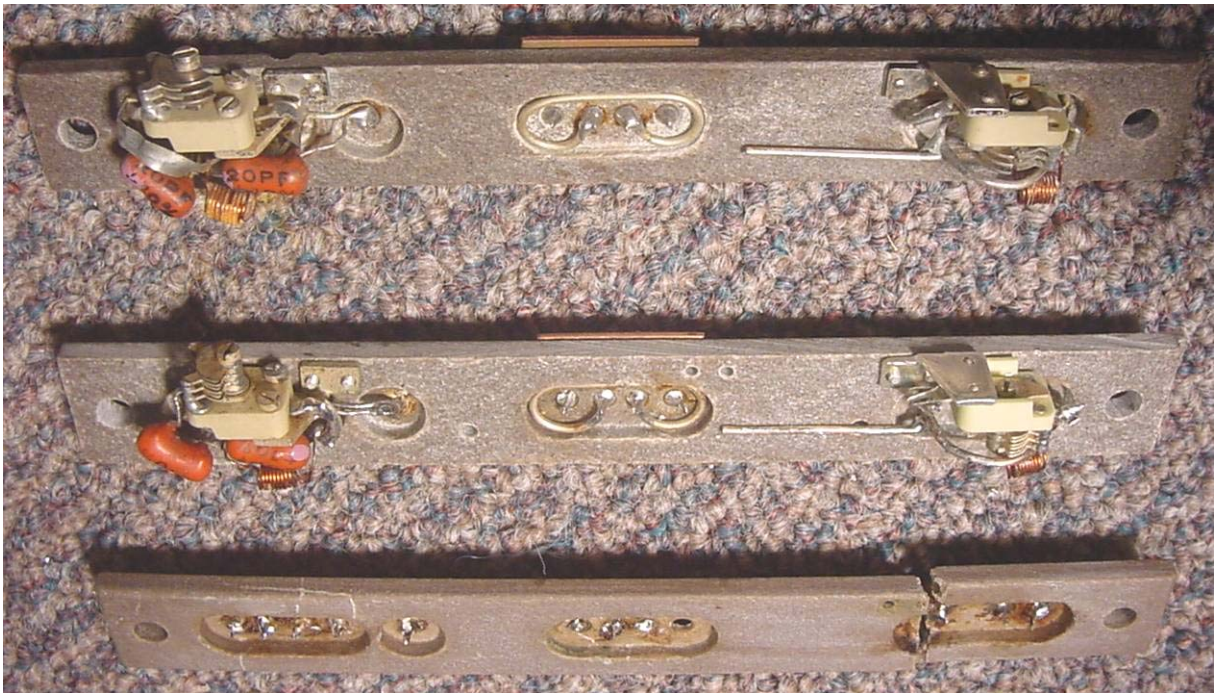
Above: the Range 1 biscuit from the SPARC Museum set (top), my re-manufactured Range 1 biscuit (centre) and the stripped-down broken Range 1 biscuit (bottom)

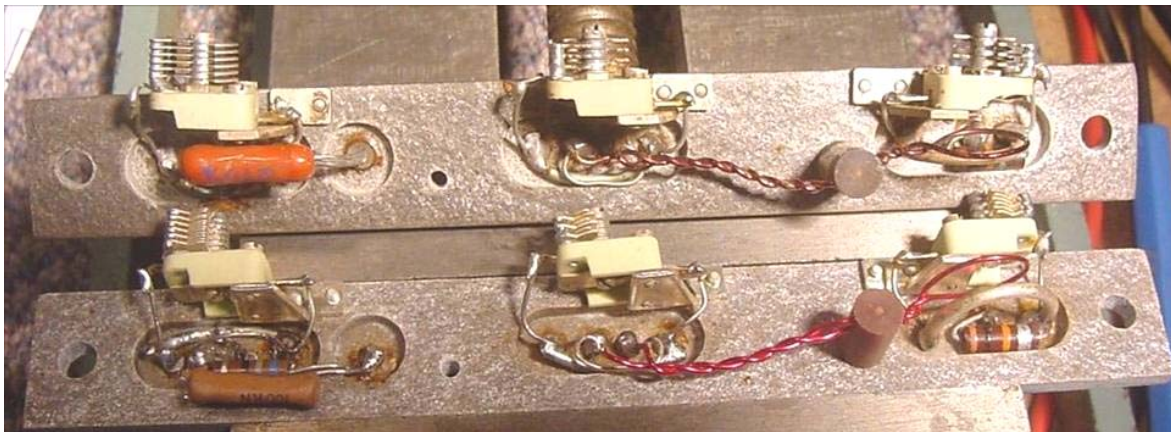
Above: the Range 2 biscuit from the SPARC Museum set (top) and my re-manufactured Range 2 biscuit (bottom)

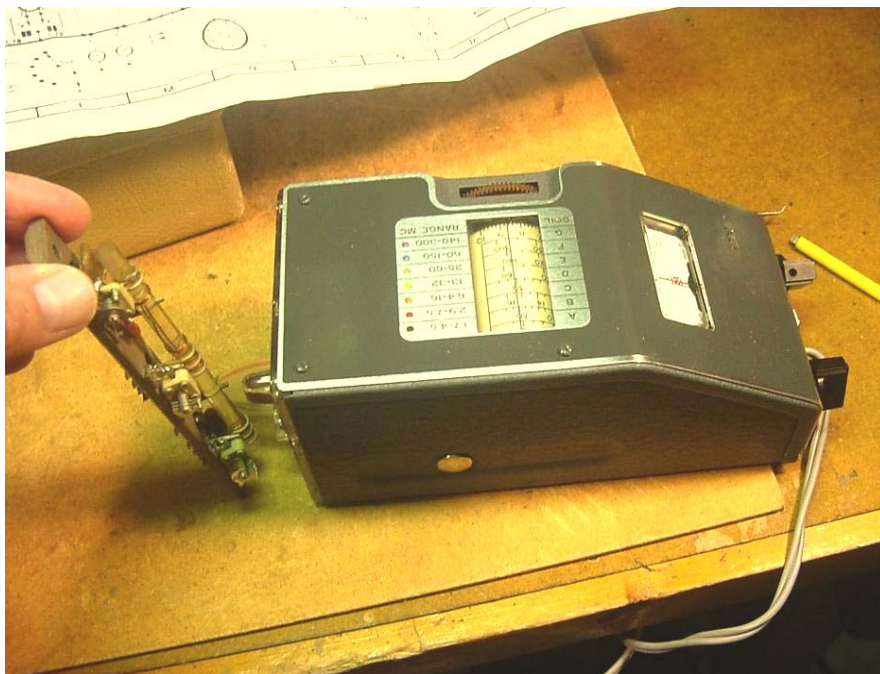
Right, using a GDO to function-test a coil biscuit,
Below: Close-up of the Range 2 oscillator tuned circuit (remanufactured biscuit on right)

3 through 6 could be checked this way. One or two of the tuned circuits failed to resonate – a problem found to be due to either misaligned (shorting) trimmer plates - slight adjustment needed to cure - or Silvo residue (removed with alcohol-soaked Q-Tip and stiff fine bristle brush).

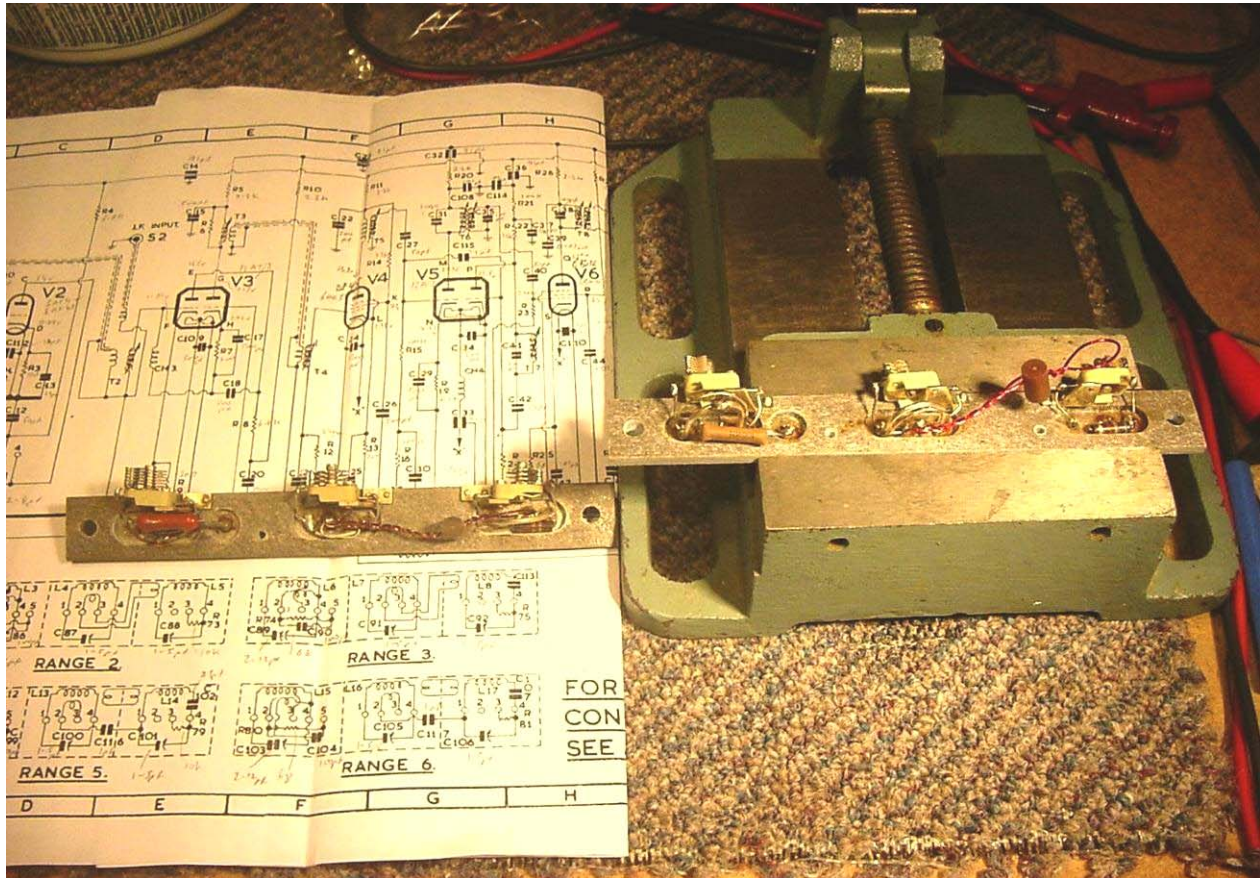
Above: Part-way through the Range 2 biscuit re-manufacture. Below: using a de-soldering pump to suck solder from the contact recesses during contact replacement in the local oscillator stage of the Range 3 biscuit

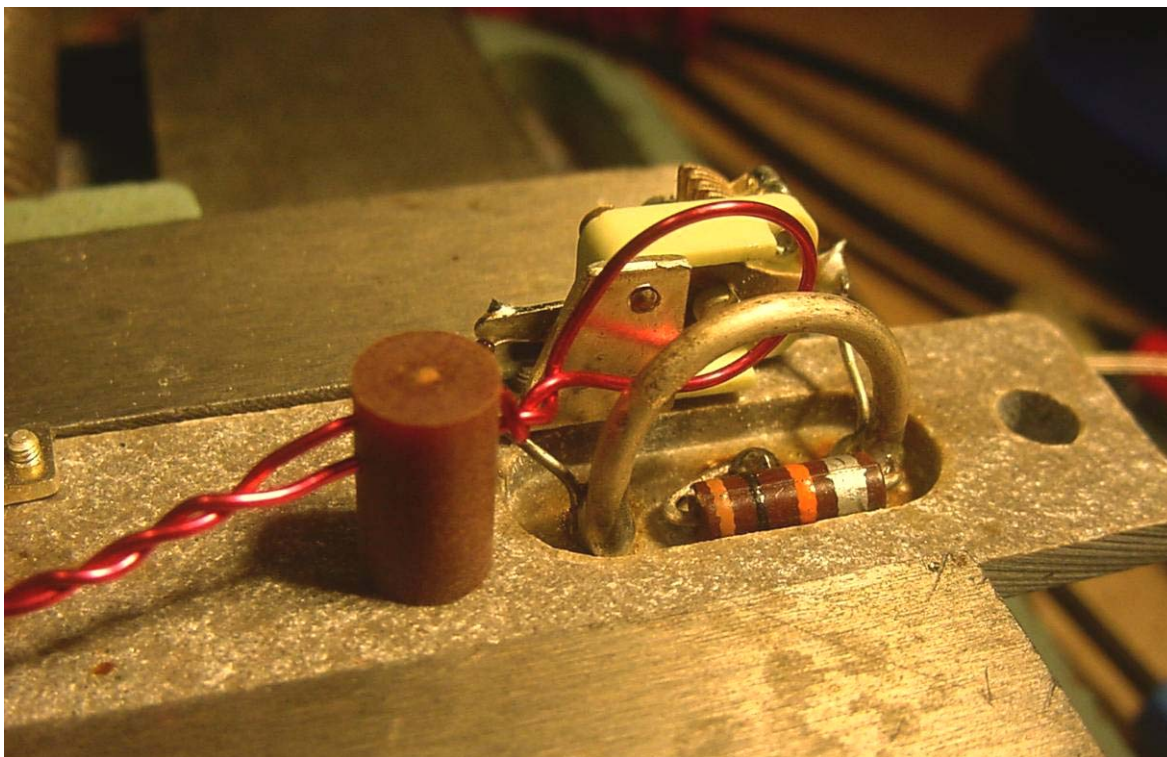
Above: Another close-up view of the re-manufactured Range 2 local oscillator tuned circuit – note the enamel-covered coupling wire supported on a Paxolin post. Below: Close-up of the Range 2 mixer tuned circuit (re-manufactured one to the right). Note the enamel-covered and twisted coupling loop wired to the local oscillator section. All other wire in the tuned circuits is silver-plated to improve 'Q'

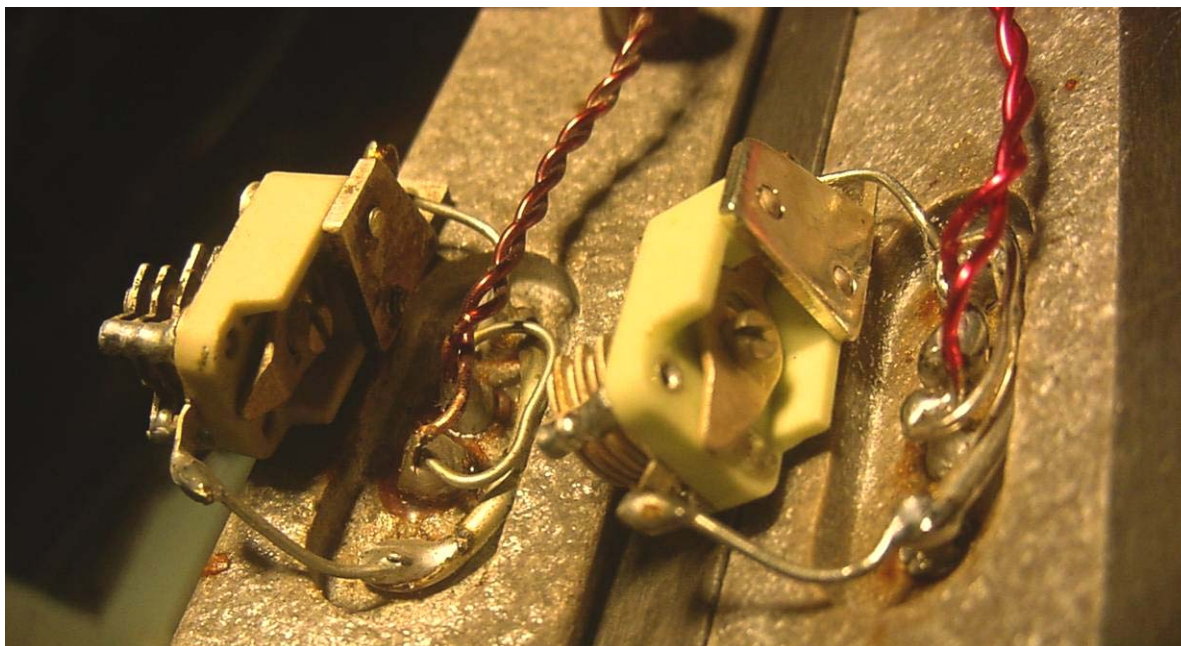
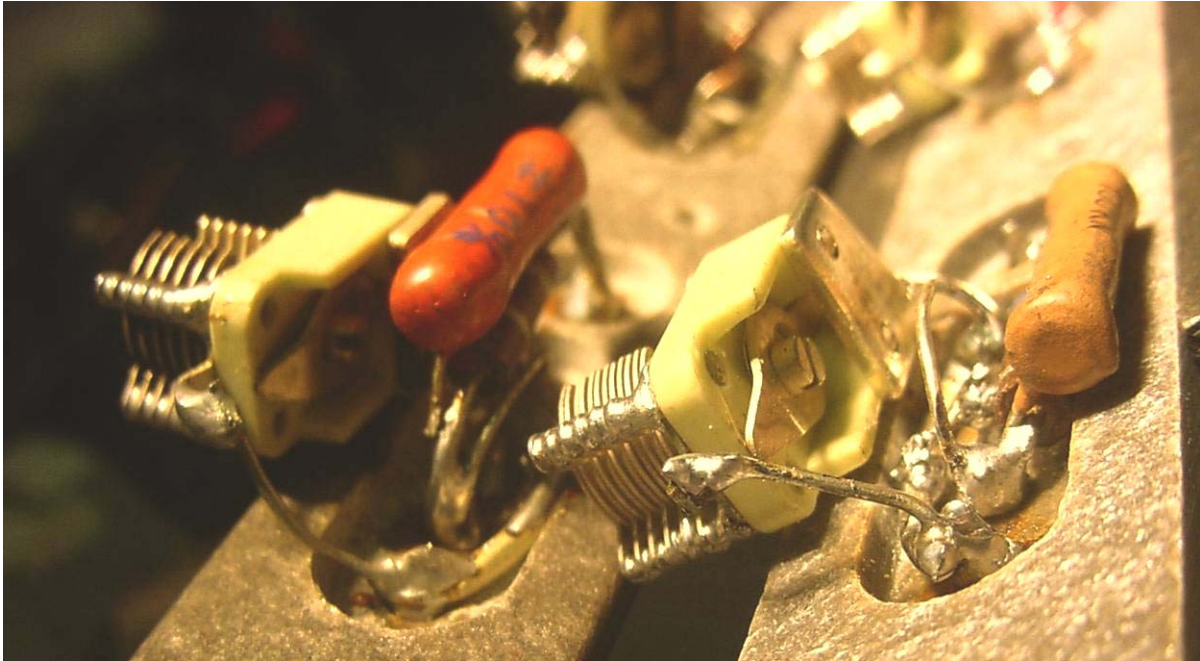
Above: Close-up of the Range 2 RF tuned-circuit under construction (re-manufactured one to the right). Below: The Range 1 RF tuned circuit under construction (the re-manufactured one below)

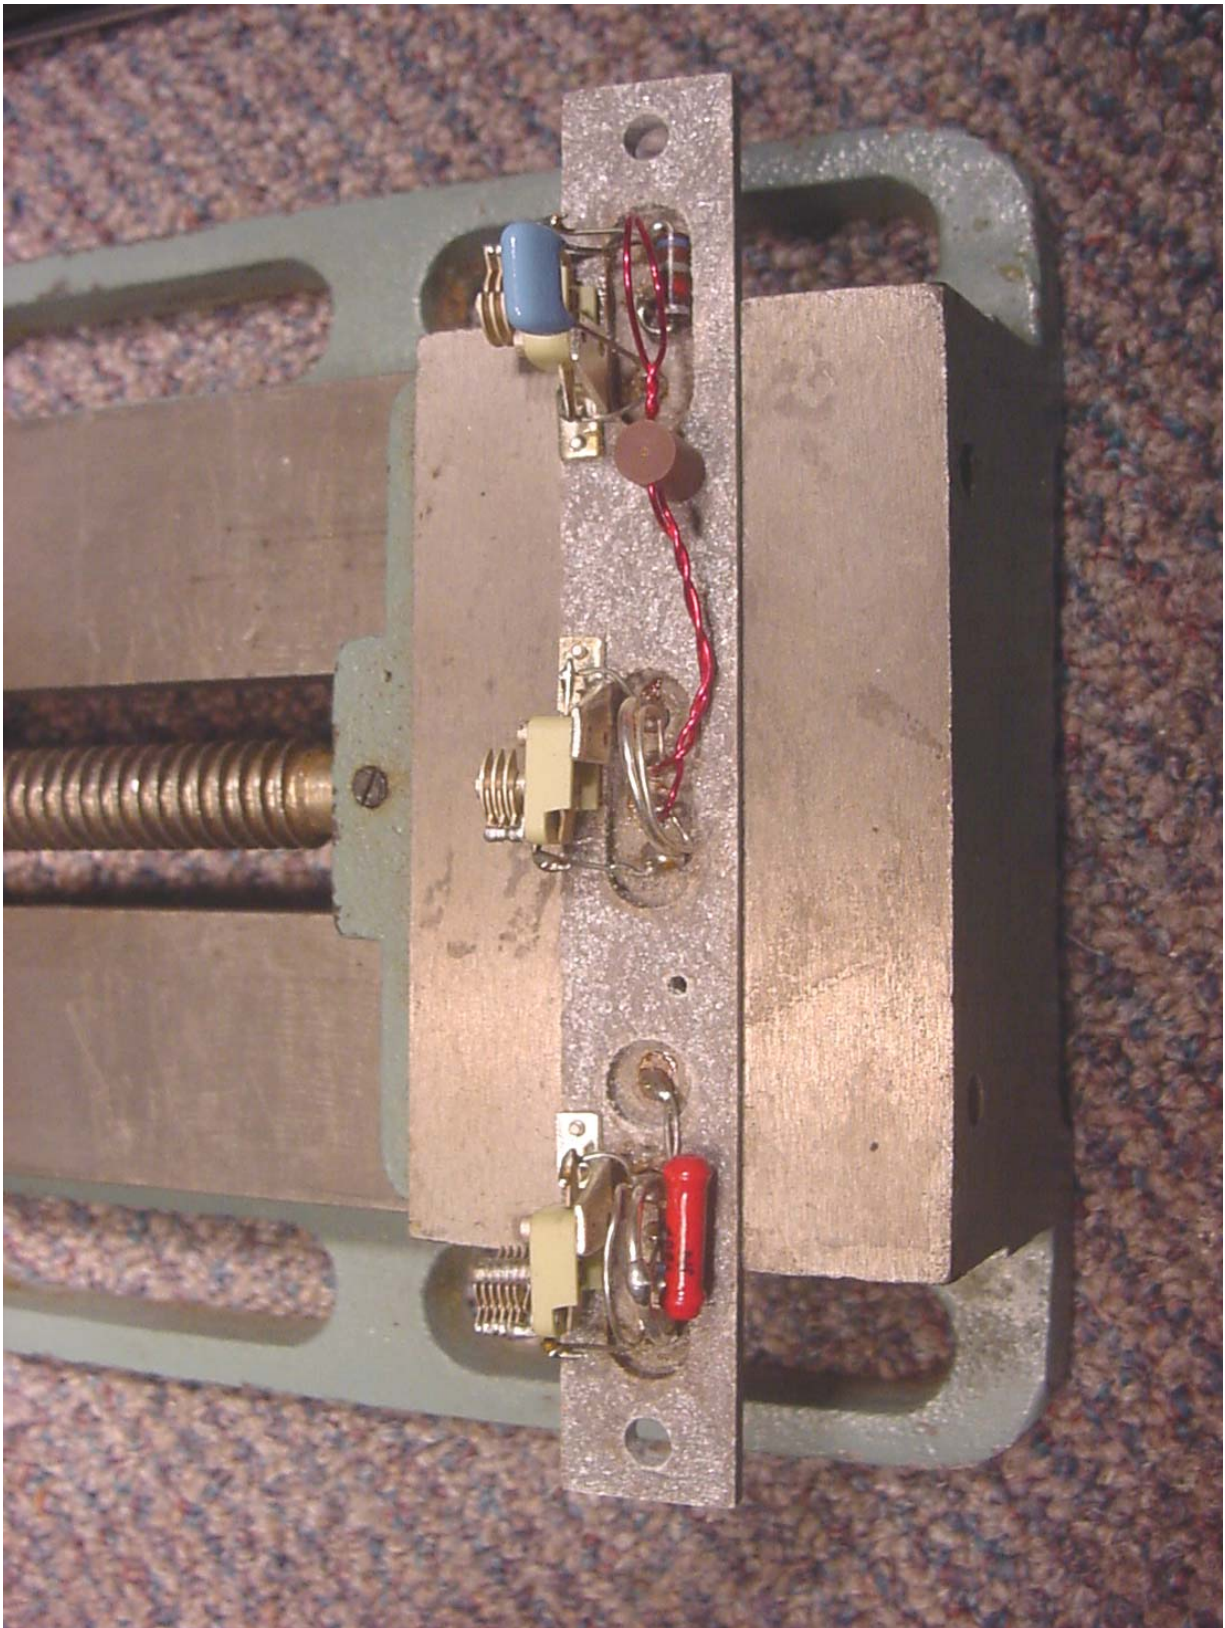
Above: One of the NOS Range 3 coil biscuits before disassembly. The RF tuned circuit to the left, mixer in centre and local oscillator to the right. Note the twisted enamel-covered wire coupling loop between the local oscillator and mixer sections

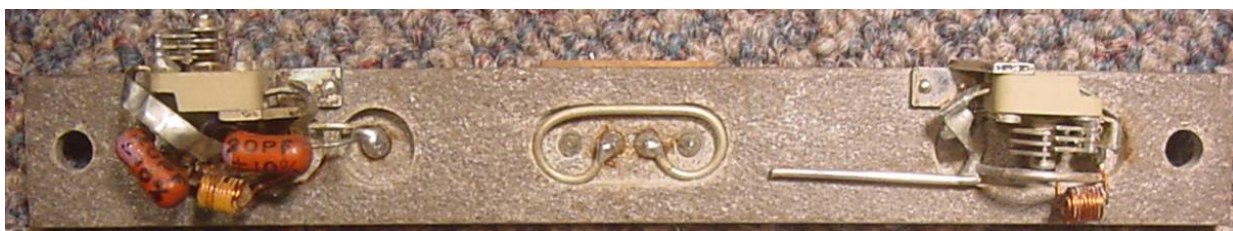
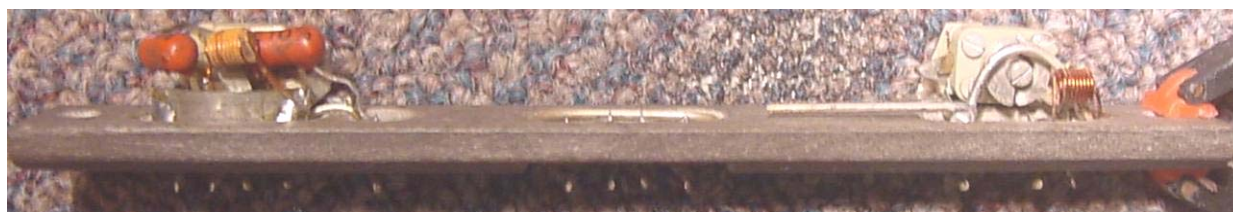
**Notes on Range 1 Coil Biscuit**

'L' – curved silvered brass strip linking contacts 1 and 4. Form from 6mm x 25mm strip

Ch5 & Ch6 – each comprises 9 turns close-wound, 3mm ID, 22g enamelled copper wire

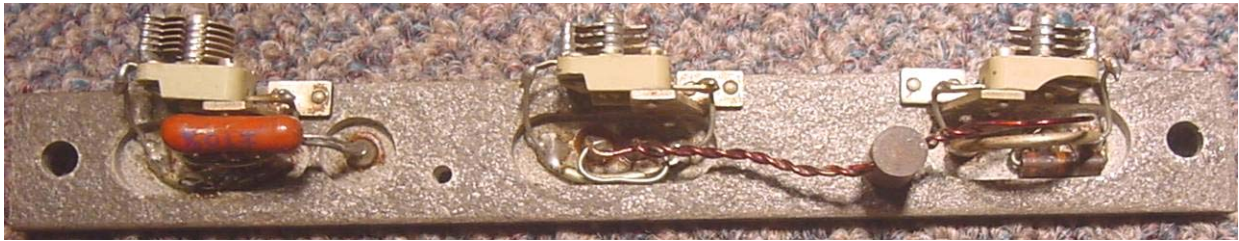
**Notes on Range 2 Coil Biscuit**

L3 – L3a is 16g silver-plated copper wire, use 22mm length shaped in a shallow curve linking contacts 1 and 4. L4a is tapped around a third-way along its length from contact 4, linking to contact 3. L4b is 22g silver-plated copper wire, use 22mm length linking contacts 2 and 4 shaped into a half-loop normal to the biscuit

L5 - 14g silver-plated copper wire, use 30mm length shaped into a half-loop connecting contacts 1 and 4

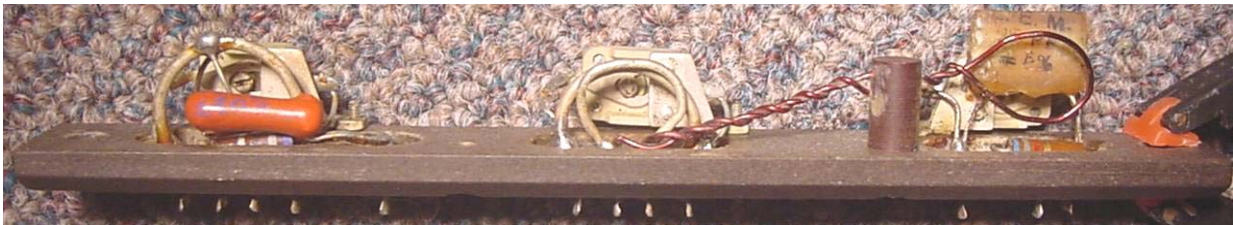
**Notes on Range 3 Coil Biscuit**

L6 – L6a is 16g silver-plated copper wire, use 36mm length shaped in a shallow half-loop linking contacts 1 and 4. L6a is tapped about half-way along its length (slightly further from contact 4), the tap, made from 22g silver-plated copper wire, linking to contact 3. L6b is 22g enamelled copper wire, use 28mm length linking contacts 2 and 4 shaped into a half-loop normal to the biscuit, spaced nominally 3mm from L6a, located between L6a and the trimmer (C89)

Mike Cassidy and myself corresponded on installing a NOS Range 3 biscuit. The biscuit as-supplied did not work at the correct frequency – the leads of the 25pF silver mica capacitor (C113), comprising L8, had to be trimmed to bring the local oscillator within range. In my case the leads were trimmed from a supplied length of 16mm in 2mm increments until they were 8mm long, whereupon the trimmer (C92) could tune as required to align the set on Range 3. Mike also noted that the position of the capacitor affected the frequency (bending the capacitor body at right angles to its leads decreases the resonant frequency).

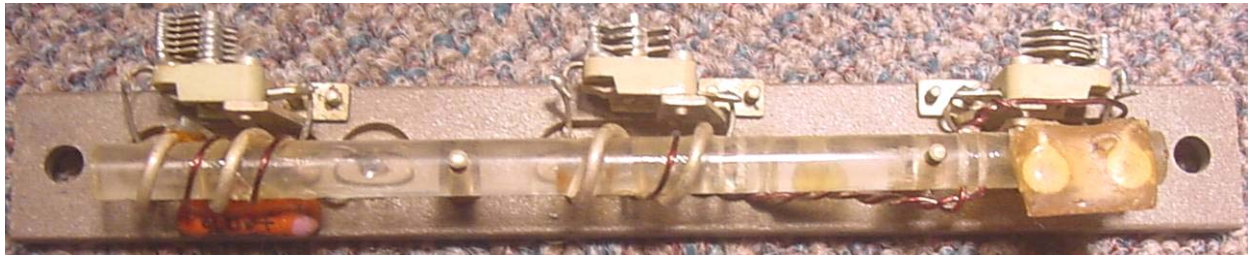
**Notes on Range 4 Coil Biscuit**

L9 – L9a is 16g silver-plated copper wire, use 68mm length shaped in two turns around the Perspex rod, spread over 16mm, linking contacts 1 and 4. L9a is tapped about a fifth way along its length from contact 1, the tap, made from 18g silver-plated copper wire, linking to contact 3. L9b is 22g enamelled copper wire, use 64mm length linking contacts 2 and 4 shaped in two turns around the Perspex rod, spread over 16mm, located between L9a turns

The Perspex rod is supported by two 7.5mm high 4.7mm diameter Paxolin spacers.

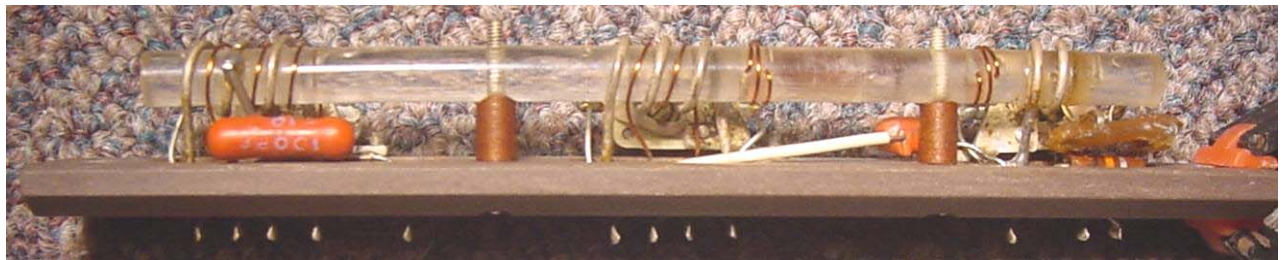
Notes on Range 5 Coil Biscuit

L12 – L12a is 18g silver-plated copper wire, use 104mm length shaped into three turns around the Perspex rod, spread over 16mm, linking contacts 1 and 4. L12a is tapped about half way along its length, the tap, made from 18g silver-plated copper wire, linking to contact 3. L12b is 22g enamelled copper wire, use a 100mm length linking contacts 2 and 4 shaped into three turns around the Perspex rod, located between L12a turns.

The Perspex rod is supported by two 7.5mm high 4.7mm diameter Paxolin spacers.

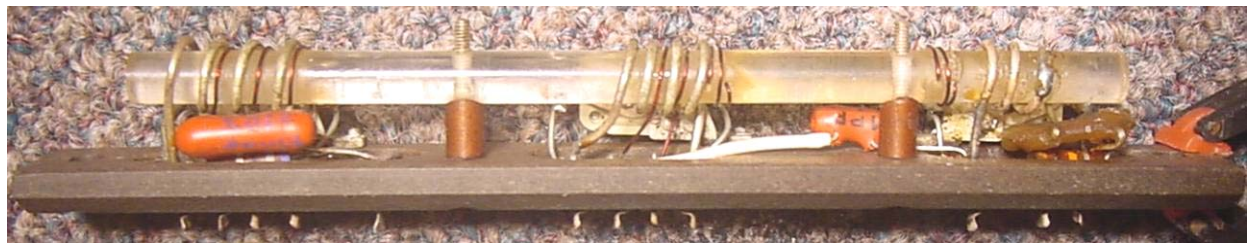
**Notes on Range 6 Coil Biscuit**

L15 – L15a is 18g silver-plated copper wire, use 130mm length shaped into four turns around the Perspex rod, spread over 16mm, linking contacts 1 and 4. L15a is tapped about a third way along its length from contact 1), the tap, made from 18g silver-plated copper wire, linking to contact 3. L15b is 22g enamelled copper wire, use 105mm length linking contacts 2 and 4 shaped into three turns around the Perspex rod, spread over 16mm, located between L15a turns. L16 – L16a is 18g silver-plated copper wire, use 125mm length shaped into four close-spaced turns around the Perspex rod, spread over 10mm, linking contacts 1 and 4. L16b is 22g enamelled copper wire, use 100mm length linking contacts 2 and 4 shaped into three turns around the Perspex rod, located between L16a turns.

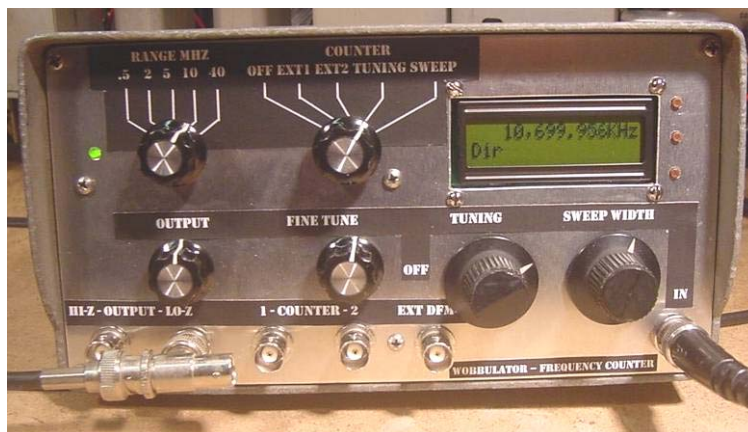
Looking out for something more suitable, I found a simple but versatile wobbulator circuit designed by Raymond Haigh in the April/May 2003 issue of 'Radio Bygones' magazine (back-copies and printed circuit boards available from <http://www.radiobygones.com/issues.html>), and so I decided to construct it, adding a frequency counter into the same box for convenience.

The standard wobbulator circuit ranges for this design cover from below 400KHz to over 14MHz, but could be modified for lower or higher frequencies (eg. I needed a range around 37MHz for another project I am working on – see below). I had previously made-up a DFM from a kit (an 'FCC-1' from Norcal, <http://www.norcalgrp.org/fcc1.htm>) that works up to around 50MHz or so, and this seemed ideal for the purpose of setting the centre frequency of the swept oscillator.

I recently constructed a combined wobbulator and digital frequency meter (DFM) unit to assist in the alignment of sets¹⁸. I have been using a Wavetek Model 164 sweep generator for this purpose - a very nice and versatile instrument - but found it not to be very stable on the higher IF frequencies (eg. 5.2MHz and 10.7MHz).

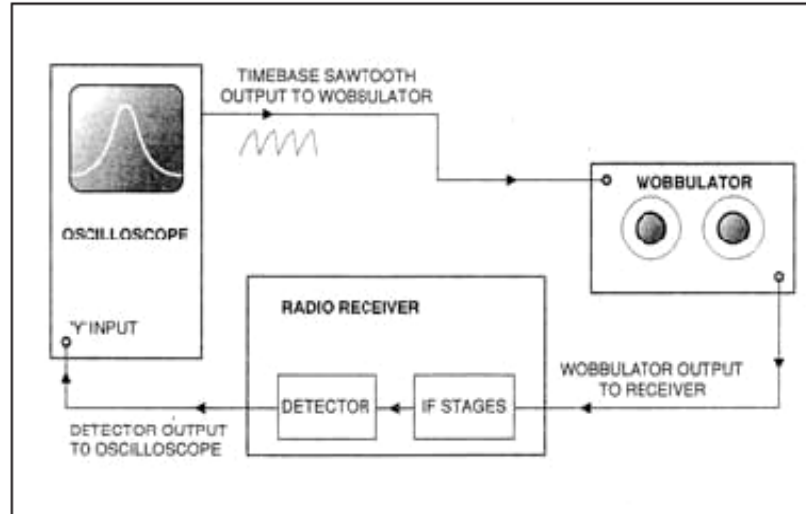
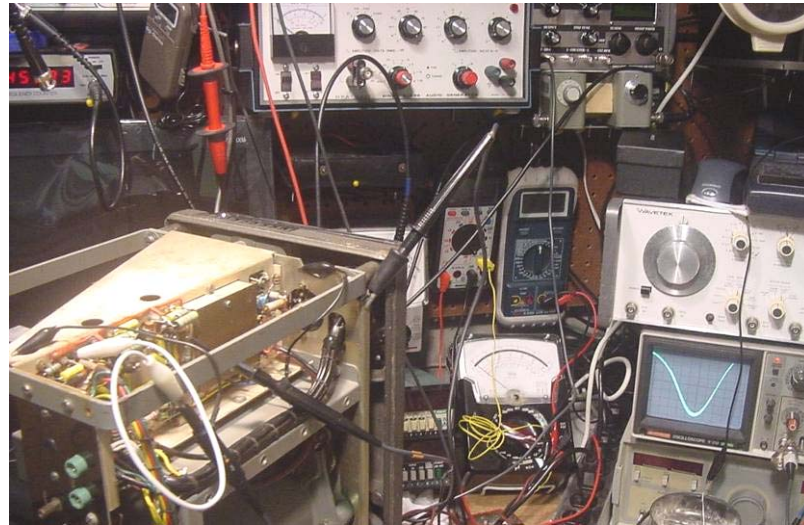
The scope traces obtained were very encouraging, both symmetrical about the centre frequency and showing that the bandwidth specifications provided in the manual were almost being obtained - a bit narrow if anything (which could be corrected by stagger-tuning the second IF tuned circuits) - but not enough for me to be concerned about. Given this performance I decided not to re-visit aligning the 2nd IF stage of the receiver.
