'TECHNICAL SHORTS'

by Gerry O'Hara, G8GUH

AC/DC Set Lore

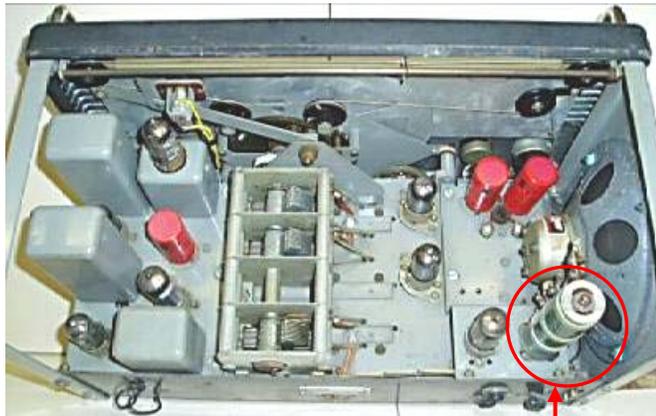
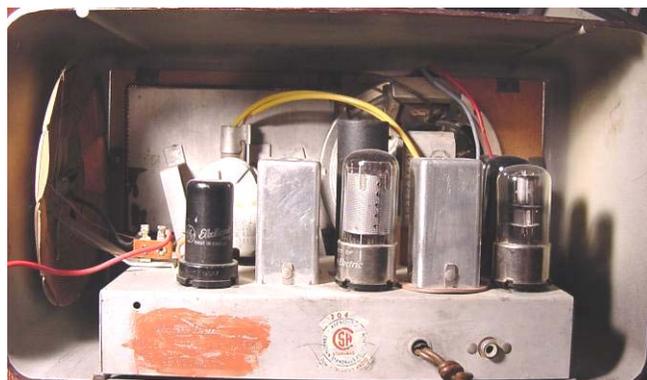
Above: an S.840 chassis: better than your typical AC/DC set construction... below: my Northern Electric 'All-American-Five' (much more typical)

Multi-tapped ballast resistor

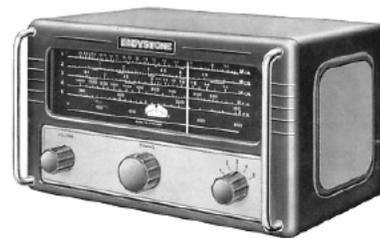
MODEL "870A" RECEIVER

The EDDYSTONE Model 870A is a high performance receiver designed primarily for personal use in situations calling for compactness and wide coverage. The receiver tunes the long, medium and short wave bands, has an internal loudspeaker and may be operated from any standard AC or DC mains supply. Ease of tuning is assured by the gear driven drive mechanism which is provided with a vernier bandspread device for accurate station logging. Troublesome mains borne interference is reduced to a minimum by an extremely efficient internal filter circuit not normally found in receivers of this type.

The receiver may be used in all areas regardless of climatic conditions and this feature together with the small size of the unit makes it particularly suited for cabin use aboard ship.

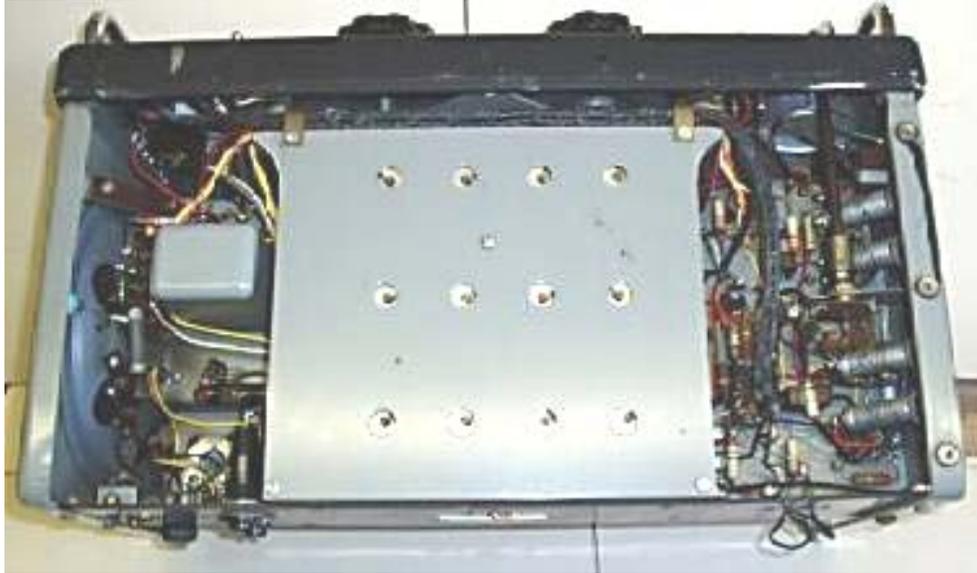
Underneath an S.840A chassis – very similar construction to an S.740 AC-only set...

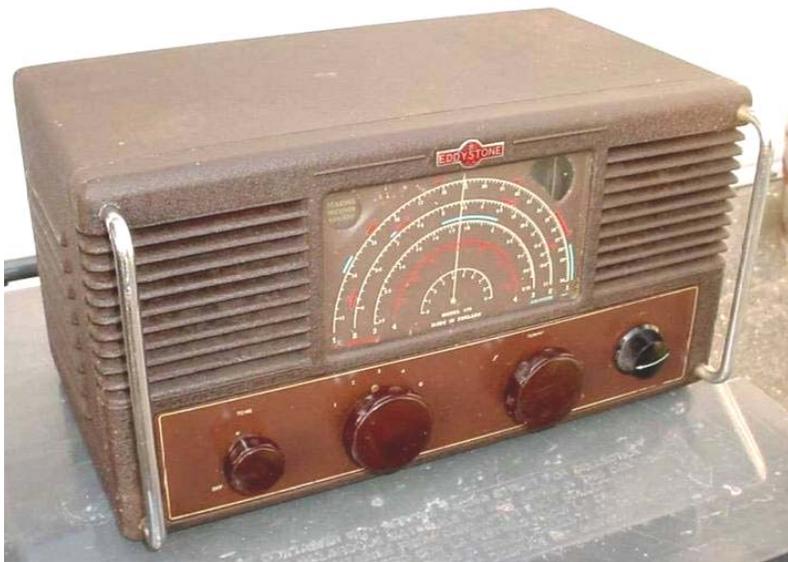
An S.670 inside and out: note the finned selenium rectifier (circled) beneath the multi-tapped dropper resistor (this set is missing its circular logging scale plate and has a 'mongrel' knob)

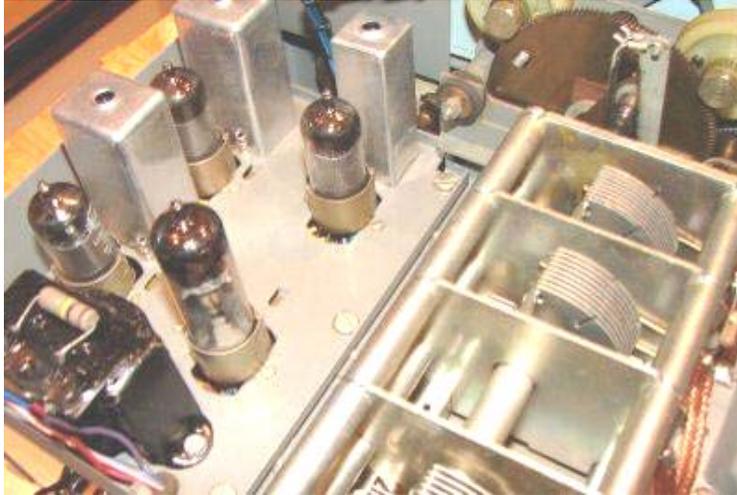
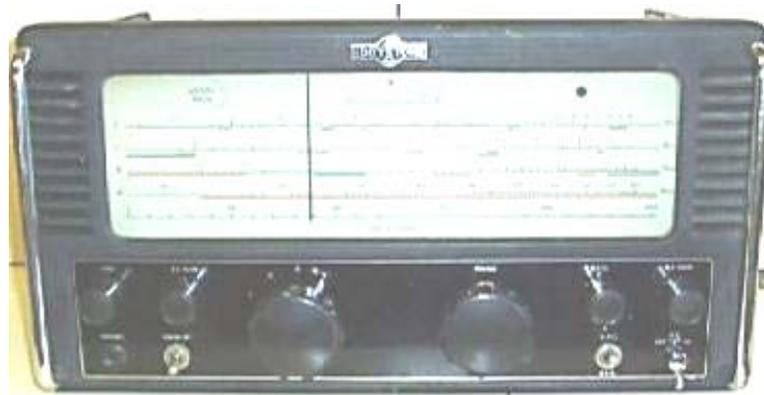
Above: a 'pristine' S.840C chassis and below: an S.840A looking as good as it did in ~1954 (alas, neither are in my collection)

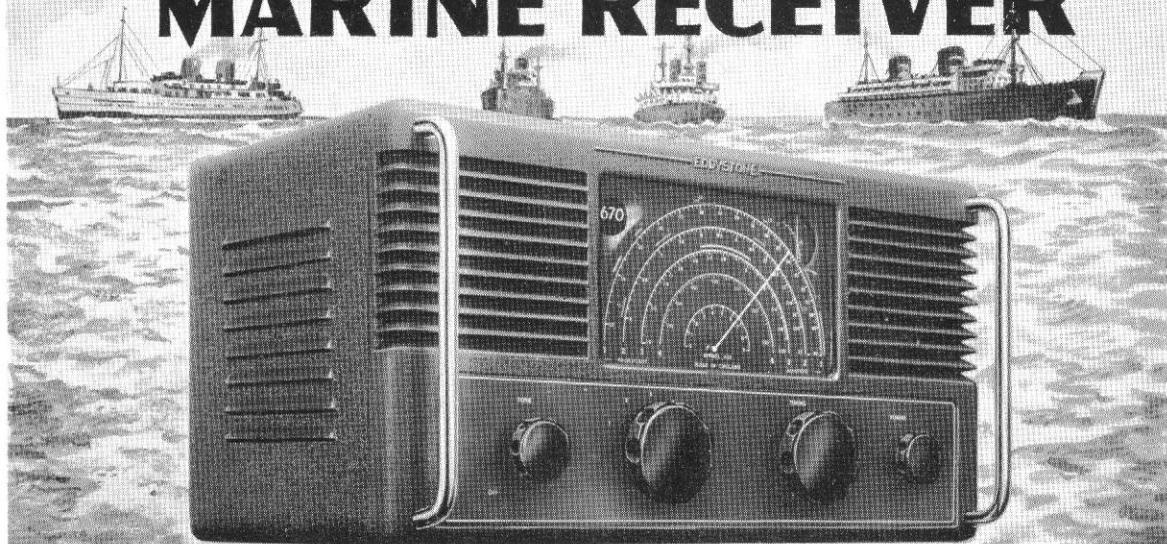
FOR PERSONAL CABIN USE

PROOF of the efficiency with which the Eddystone "670" Marine Receiver fulfils the Seafarer's particular requirements for a radio receiver is amply demonstrated by the many congratulatory letters which are reaching us from users who have installed this set on board ship. The following are typical examples:—
