Eddystone 888 Restoration

This article is not a definitive instruction in restoring a historical radio receiver, it is a guide as to what can happen, what can go wrong or go right.

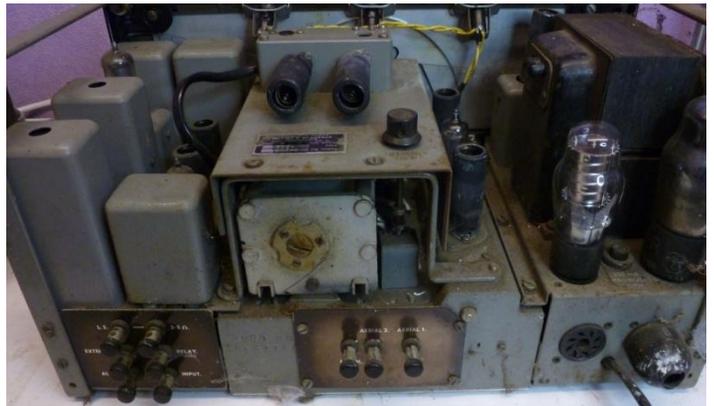
Internal view showing rust

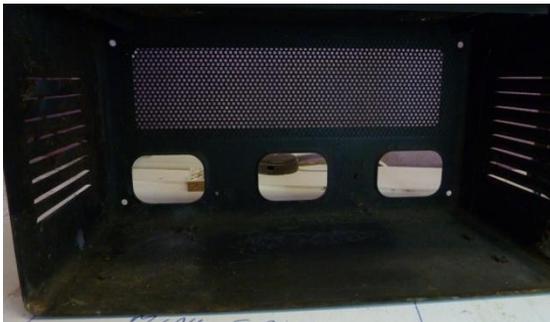
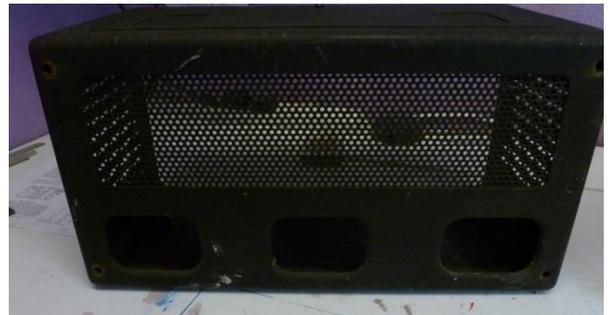
Views of cabinet back before restoration

The metal case was taken to a local metal finishers, who can “bead” blast and powder coat.

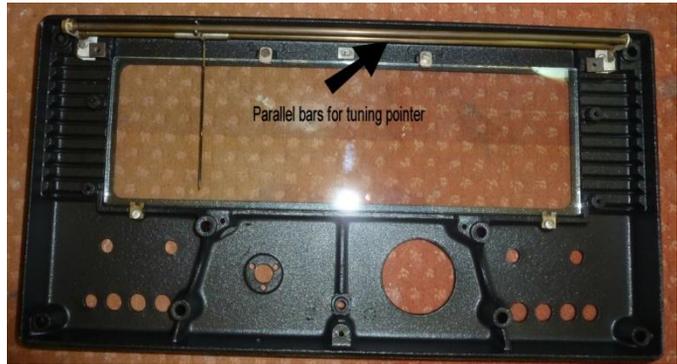
Part assembled front panel with dial glass and tuning pointer fitted

One thing that caused me a problem on the 750 was the round bar at the top of the dial, that carries the tuning pointer. It was bent, making the dial pointer very jerky. It took a bit of straightening, but it can be rotated to allow the dial pointer to run on the parallel bars.

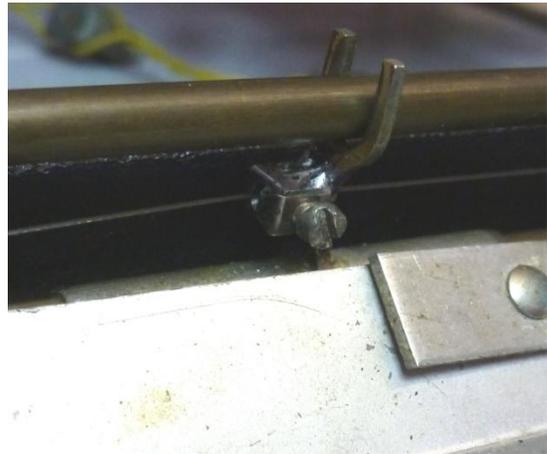
The dial drive cord was old waxed “string” and was certainly not original. I obtained some 0.5mm multi stranded stainless steel coated wire that jewellery makers use. However this is impossible to solder and it needed to be clamped to the dial pointer.

I removed the dial pointer and soldered a wire clamp from a pcb wire terminal that uses one screw, threaded the dial cord through the hole and clamped with the screw. This allowed great accuracy setting the dial pointer.

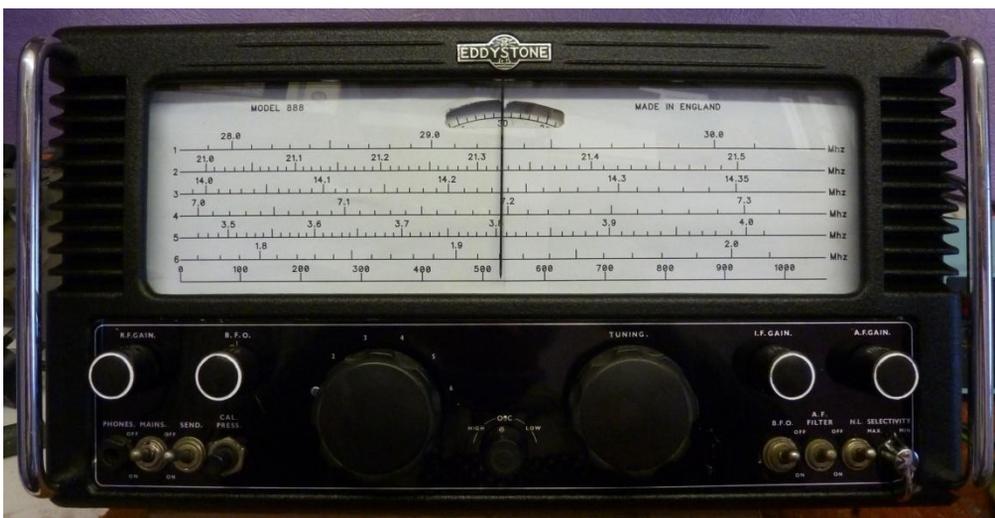
The tuning scale and the 0 – 100 segmented circular dial were in a poor condition. Way beyond cleaning. Nicotine staining and storage had taken their toll, thus I copied the artworks on my PCB cad software. Now the purist would use a drawing package, but I was not willing to spend time learning how to use software that I did not know, thus I used my pcb design software. The BIG problem was that the dial scale is much larger than A4. As my printer is A4, I had to make the drawing full size and then make two copies, over lapping. Using the “X” and “Y” co ordinates on the software, and a pair of dividers, I was able to make the Main scale and a copy of the rotary dial.

When removing all the control knobs, nearly every grub screw was seized. Fortunately they drilled out without too much damage or effort and metric threads and screws were fitted. The smaller knobs were relined with white paint.

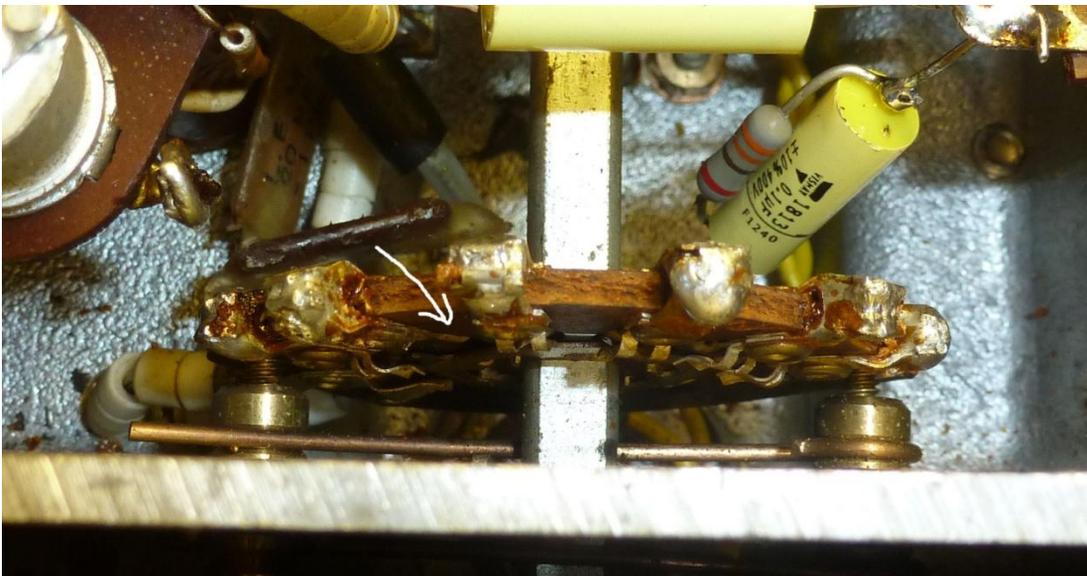
On other ranges the analyser showed a nice peak, as expected, however on 15 M there was no peak and low gain. Slightly rotating the wave change switch, showed the correct result, thus a close inspection of the mixer input select wafer, showed the 15M switch contact had disappeared.

As can be seen from the photo above, it is quite crowded, I removed all the coil connecting wires, BOTH ends....I also replaced the polythene wire coatings with fabric systoflex insulation tubing. All the switch wafers in the 888 are double sided. One side is a normal 6 way single pole, and the other side is a 6 way SHORTING switch. On my switch it was a select contact that was broken. See photo below

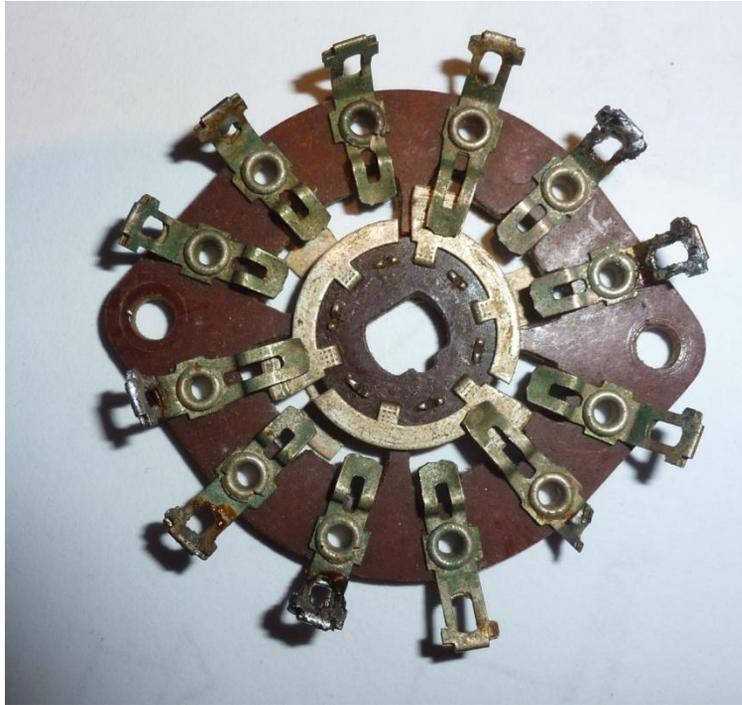
As can be seen from the photo above the contacts are held in place with “holed” rivets . I used a small drill in a modellers power drill to carefully remove the rivet head. That released the TOP contact, however due to the mechanics of riveting , the body of the rivet will spread and fill the hole, thus great care is needed to remove the rest of the rivet. Remember these switches can be over 50 years old and the switch material is weakened with age.

After successfully removing both contacts “Only one may need replacing”, fit the new contact in position. To hold the contacts in place, unless you are skill full with a rivet inserter I suggest using a 2.5mm Set screw and nut, preferably with a spring washer.

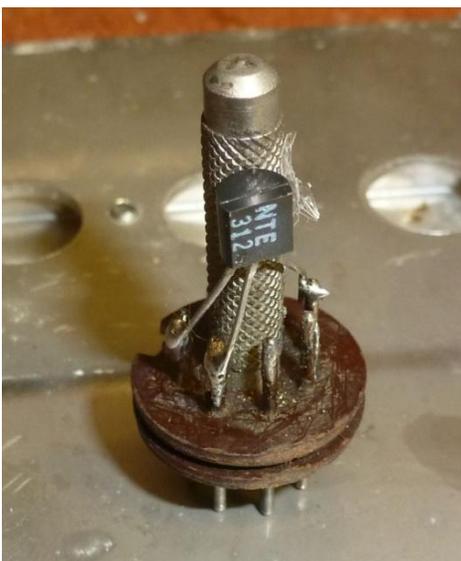
Initially I replaced the anode load resistor (22K) with a 100 uH choke, potted down the HT to +12V DC and fitted a FET as the photo below, using a B7G valve plug.

The FET used is a NTE312, similar to a 2N3819 but more modern and better.

However I had a device failure and noted that the PP Voltage on the drain was 40V PP. This is much too high, thus the supply voltage was reduced to 6.2V DC. This dropped the voltage to a more manageable level, and no failure.

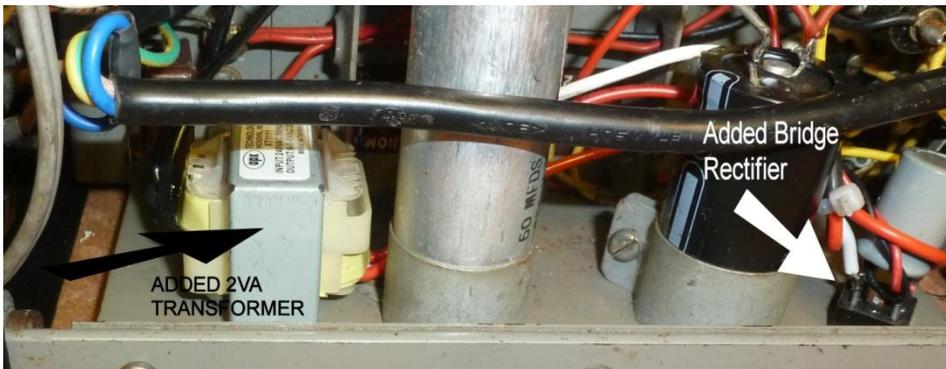
Now to supply the Local oscillator. This was more difficult than was thought. You can “pot” down the +150V from the VR150. This was tried, using 14K and a 6.2V zener, however the heat loss was too high, and one of the reasons to do this modification was to lower the heat generated not increase. Another idea tried was to use the 6.3V ac Heater supply. This is not as simple as it sounds, as the heater winding is tapped and grounded. If you remove the ground tap, yes you can get 6.4V DC via a bridge rectifier, but an audible hum from the output stage. The end result was the purchase of a 2VA 6-0-6 transformer from Maplins. This was fitted in the power supply section of the chassis... See photo below

Yes I know.... You do not use a bridge rectifier with a 6-0-6 V transformer, but as it was fitted I used one half of the transformer, as only 10 mA was required and the bridge was already fitted.
