Restoring an Eddystone Model S.750 – Gary Albach, April 2019

This article documents how a simple weekend project expanded into the return of an Eddystone S.750 to its original factory condition, including restoration of the RF stage, the oscillator/mixer stages, the BFO wiring, the dial cord, and cosmetic touch-ups in addition to the usual leaky capacitor and out-of-tolerance resistor replacements.

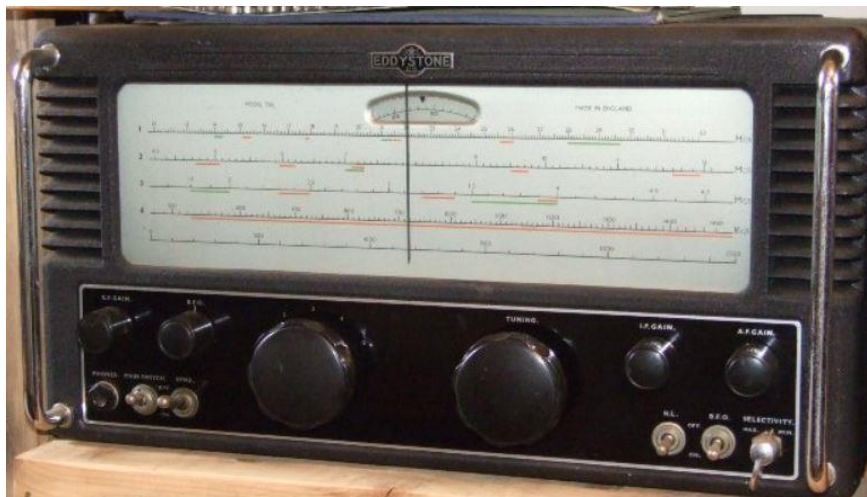
Figure 1: Eddystone S.750

The Eddystone Model S.750 is truly one of Eddystone's classic receiver designs (see Figures 1 and 2). First introduced in 1950 as a successor to their earlier pre-war models, it sold for an impressive £45 in 1950 (\$1,500 Canadian today!). The S.750 was their first true dual-conversion

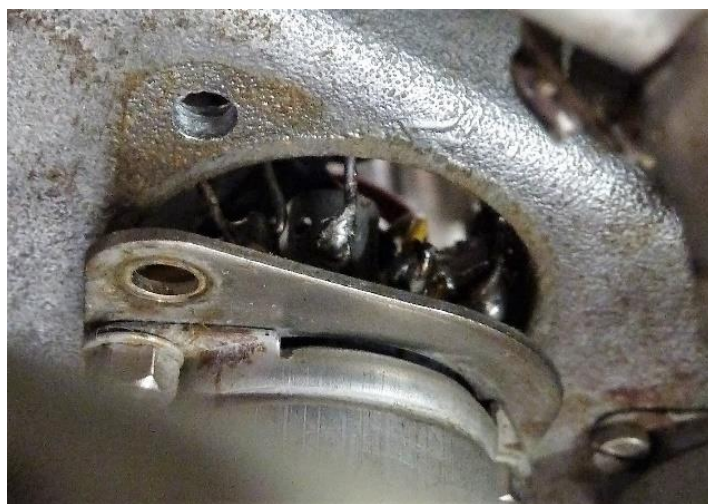
Figure 8: Rewiring tube socket from above

As with the RF section, this rewiring was done from the top of the chassis by leveraging the tube socket slightly out of the way (Figure 8).
