## Installing a 500KHz Crystal Calibrator Unit in an Eddystone S.940 – Gerry O'Hara

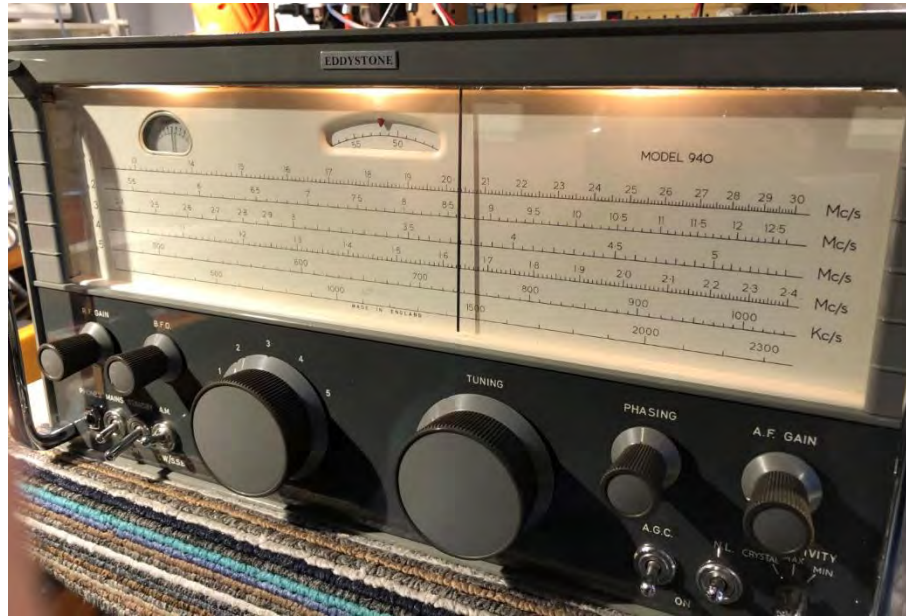
While I was raking about in my Eddystone spares box looking for the S640, S750 and S940 parts, I came across a small, grey diecast box with no lid that had two valve sockets mounted on it, a few components inside, including a coil and variable capacitor, and a pigtail of wires hanging out of one end. Next to it was a small cardboard box containing a valve (6AM6) and a 500KHz crystal mounted in a B7G

valve envelope wrapped in cotton wool, together with two valve shields. I realised these belonged together, and what I was looking at was an Eddystone crystal calibrator unit (photos below).

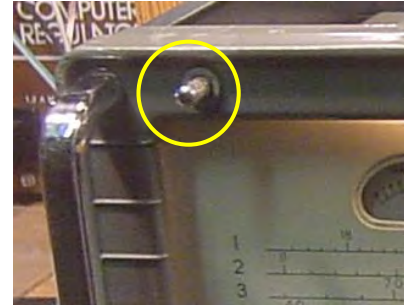
Best use is made of a calibrator when the relative pointer-scale alignment to be can be adjusted 'on the fly', as in the Eddystone S730 and S830 series, with a small mechanical adjuster (circled yellow on photo, right, here on my S830/4). This facility allows the pointer to be moved relative to the scale by a small amount to bring it in-line with the calibrator signal,

thus bringing the section of dial in use into higher accuracy. The S940 does not have this 'refinement' (its really a kludge), but a calibrator can still be usefully deployed to check the scale accuracy during listening sessions.

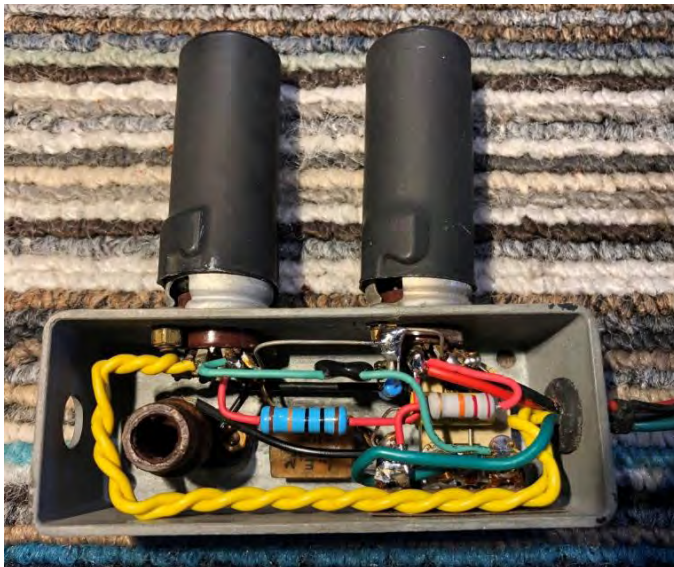
My S940 was still on the bench after [installing the new vernier scale and fixing the BFO/product detector](#) unit. I decided to jury-rig the calibrator unit to the S940 to check its functionality. First, I checked the components and, although they were not perfect – the resistors had drifted high in value and the tubular paper capacitor was leaky, I decided they were good enough to test the unit out. So, I connected the heater (yellow) lead to the heater supply, the HT+ (red) lead to the 240vDC ('HT1') supply, ground (black) lead to the chassis, and the output (green) lead to the antenna. There was actually two heater leads (both yellow) in the pigtail: as one side of the 6.3vAC heater supply in the S940

is grounded, I simply connected one of the yellow wires to the black (ground) lead. Doing this would allow a 4-pin connector to be used during installation in the receiver.

On powering-up the S940, sure enough, the calibrator unit was working, with distinct markers at 500KHz intervals. These were strong at lower frequencies, but faded out around 15MHz. On checking the output lead in the diecast box, I realised it was merely wrapped around the 100Kohm anode resistor of the 6AM6 valve, ie. an extremely low level of coupling – probably less than 1pF. I decided to rebuild the unit, replacing the three resistors and one paper capacitor (in

the S730 parts list this is given as a moulded mica type – it was not – and it measured more like a 100Kohm resistor...). I also added a 10pF 500v silver mica cap from the anode of the 6AM6 to the output lead to increase the available calibrator output signal (photo, above).

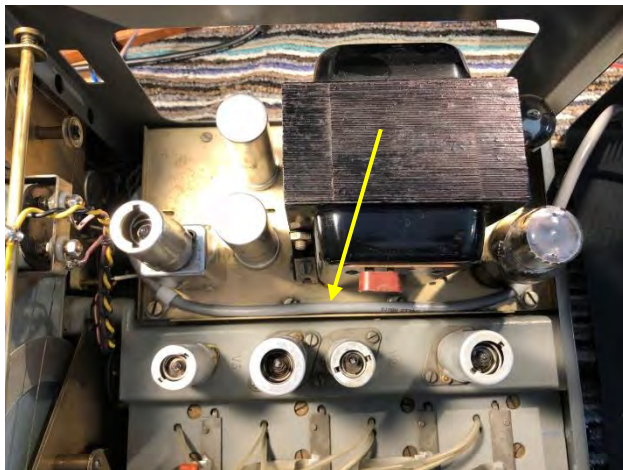
Although the wires forming the short 'pigtail' of wires exiting the calibrator were cord-tied, I installed a length of heat-shrink over the pigtail to provide additional support and protection. I then connected the pigtail from the calibrator unit to a polarized 4-pin 'Jones' ('Cinch') plug, noting that the pin-out was 1) ground, 2) heater, 3) HT+ and 4) output (signal). Luckily I had some of these connectors in my junk box, along with some suitable multi-core cable. The line plug was mounted onto the calibration units' pigtail,

and the line socket mounted on the multi-core cable from the chassis so no 'live' connections would be exposed when it was disconnected. An adequate length of cable was used such as to allow connection with the plug on the calibrator pigtail when installing the chassis in the cabinet. I installed an (open) 'P-clip' on the inside of the rear panel so any excess cable length could be secured once the Jones plug/socket had been connected and the chassis was in the cabinet. The multicore cable was run along the top of the chassis (follow arrow in photo, left), secured by two more P-clips, then to underneath the chassis (power supply

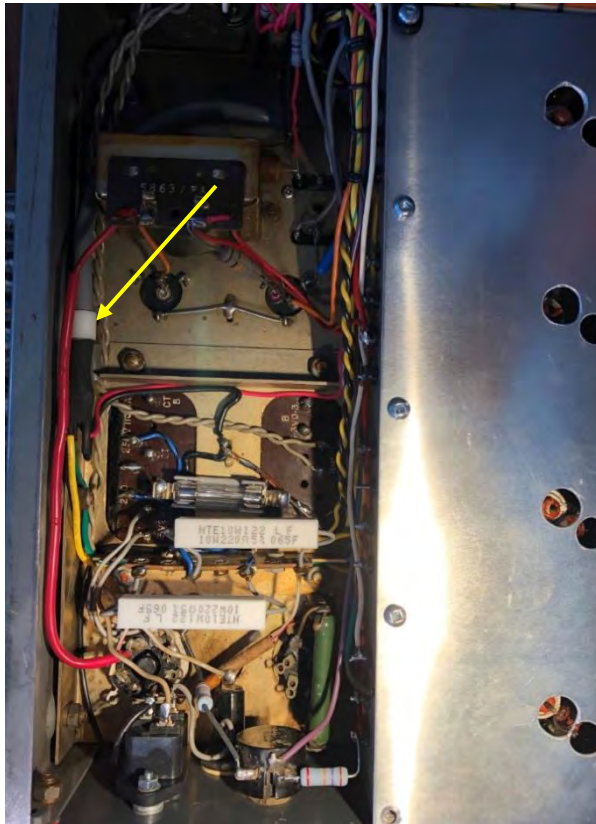
compartment) via the gap between the front of the chassis and the rear of the front panel, and secured under the chassis with another P-clip (arrow in photo, left). The wire colours in the multi-core cable were different to that used in the calibrator unit (standard Eddystone colour code: ground/black, heater/yellow, HT+/red and signal/green). I therefore connected wires of these colours to the wires in the multi-core cable corresponding to these colours in the calibrator unit, so they matched the colour-coding of the receiver chassis, the joins being secured and insulated with heat-shrink. These wires were then run under the chassis, connecting to the appropriate points: black (ground) to a nearby chassis ground lug, yellow (heater) to the 6.3vAC heater tap on the power transformer, red (HT+) to the calibrator on-off switch, and green (signal) to the injection point in the coil box (see below). I checked that the additional heater current (0.3A) would be handled ok by the transformer – it was, but just (4.065A v. 4.2A rating on the 6.3VAC tap used), but that's ok – I was assured by Bill Cooke

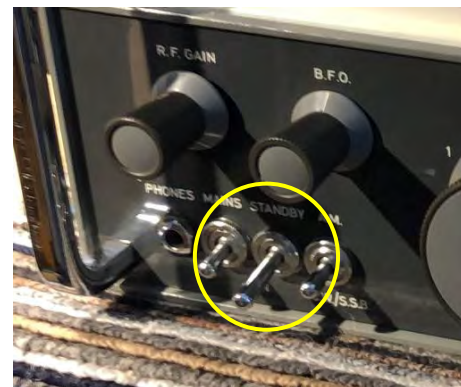
Having given the options I listed above for a switch to operate the crystal calibrator some thought, I first tried fitting a small push-button switch through a hole in the rear apron of the chassis (vacated when someone had installed a jack socket audio input instead of the original terminal posts). I used this to function-test the calibrator now it was installed in the receiver – it was working ok, however, I felt a switch in this location was too inconvenient for use while operating the receiver. Another of my ideas was then considered – that of replacing the AF gain control with one that had a push-switch incorporated on its shaft. However, the only control I had like this was a 1Mohm unit, and the S940 specifies a 500Kohm part. While the 1Mohm part would likely have worked ok, while I was considering this, I had another thought – why not use the ‘Standby’ switch for this purpose? (circled in photo, right). This switch is a double pole double throw switch, which uses only one pole to de-sensitize (mute) the receiver by switching in a 47Kohm resistor into the cathode circuits of the 1<sup>st</sup> and 2<sup>nd</sup> RF amplifier stages and the 1<sup>st</sup> IF stage. The other pole on the switch is unused as supplied by Eddystone to the customer, but could be connected such as to operate a relay or other circuit to switch a transmitter on and throw a transmit/receive antenna relay when in the ‘Standby’ position. To re-purpose this switch to operate the calibrator, I simply added a shorting resistor across the 47Kohm resistor so the receiver would not be de-sensitized when the calibrator was switched

on (switch thrown to 'Standby'), connected the red (HT+) wire from the calibrator and from the receiver HT+ (240vDC supply) to the other pole of the switch, such as when the switch was thrown to 'Standby', the HT+ was connected to the calibrator. A 2.4Mohm resistor was connected across the HT+ connections at the switch to both provide a small leakage current to the calibrator when the HT+ is switched off, to mitigate 'cathode poisoning' of the 6AM6 valve during long periods when the calibrator is not in use (heater on with no HT applied to the valve), and help protect the switch contacts by reducing arcing of the switch contacts. The value of this resistor is not critical – anything from 1.5 to 3.5Mohms should do the job (a resistor like this is used in the S730/4 – see schematic on page 2).

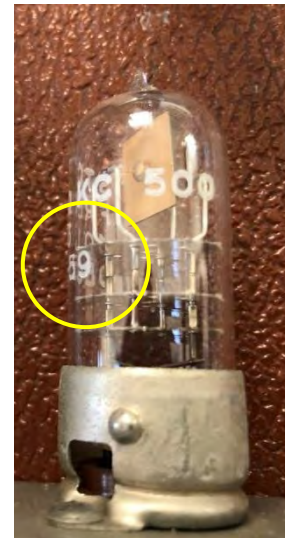
- I then added a length of 26 gauge enamelled copper wire ('magnet wire') to the end of the calibrator signal wire and wrapped a couple of turns of the enamelled copper wire around a resistor wire connected to the valve grid, secured with a spot of nail polish - the enamel coating

insulating the magnet wire from the grid wire. With this closer coupling, I could easily hear the 500KHz harmonic market pips right up to 30MHz. However, with an antenna connected, marker pips above around 20MHz were often difficult to locate amongst the noise and signals (I live in a very noisy location);

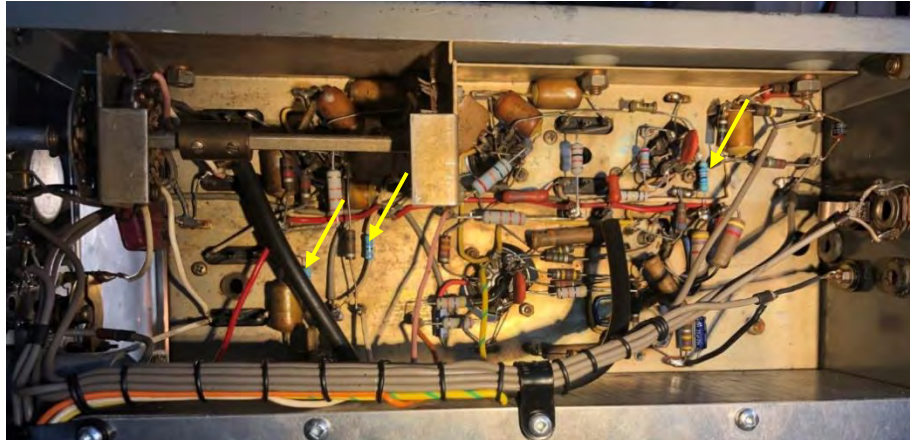
- I measured all the 470Kohm and 270Kohm grid resistors, they had all drifted high, some 270Kohm parts to

well over 300Kohms, and 470Kohm parts to over 550Kohms. This would not affect the AGC performance, and I would normally have left them in place, but I decided to change them out anyway (photo, above, with the arrows showing the grid resistors changed out in the IF/AF compartment). As expected, this made no change to the AGC voltage, but at least I felt like I had done something! Hmm – time to ‘think outside the box’ Gerry...;

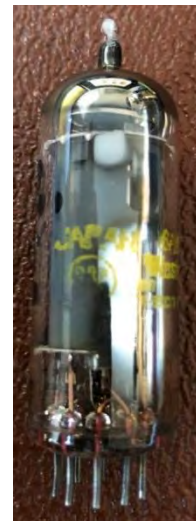
- I reconnected the AGC diode to the AGC line and the set was now generating almost -9vDC on a strong signal and the distortion was gone. This fault was a first for me. The 6AJ8 removed, a Westinghouse branded one of Japanese manufacture – photo, right, tested very good on my tester,

but obviously had an internal fault, possibly some form of secondary grid emission, that was causing the strange IF 'mystery voltage' issue.

- I decided to check the valves first: all the RF and IF valves tested ok on my tester. Having been caught out by this before, ie. a valve testing good on the tester and still having issues, I decided to sub each valve with another known good NOS one. The 6BA6's (2<sup>nd</sup> RF and 1<sup>st</sup>/2<sup>nd</sup> IF amplifier stages) were subbed first – no change, the voltage was still present on the AGC line. Then I subbed the ECC189/6ES8 (1<sup>st</sup> RF amplifier), again, no change. I left the NOS 1<sup>st</sup> RF amplifier valve in place as I had noticed the ECC189/6ES8 that had been in the set was a little low emission on one of its triodes. Last, I subbed the Mixer (6AJ8) valve for a NOS ‘International’ (Sylvania) one – that was it, now there was no voltage on the disconnected AGC line;

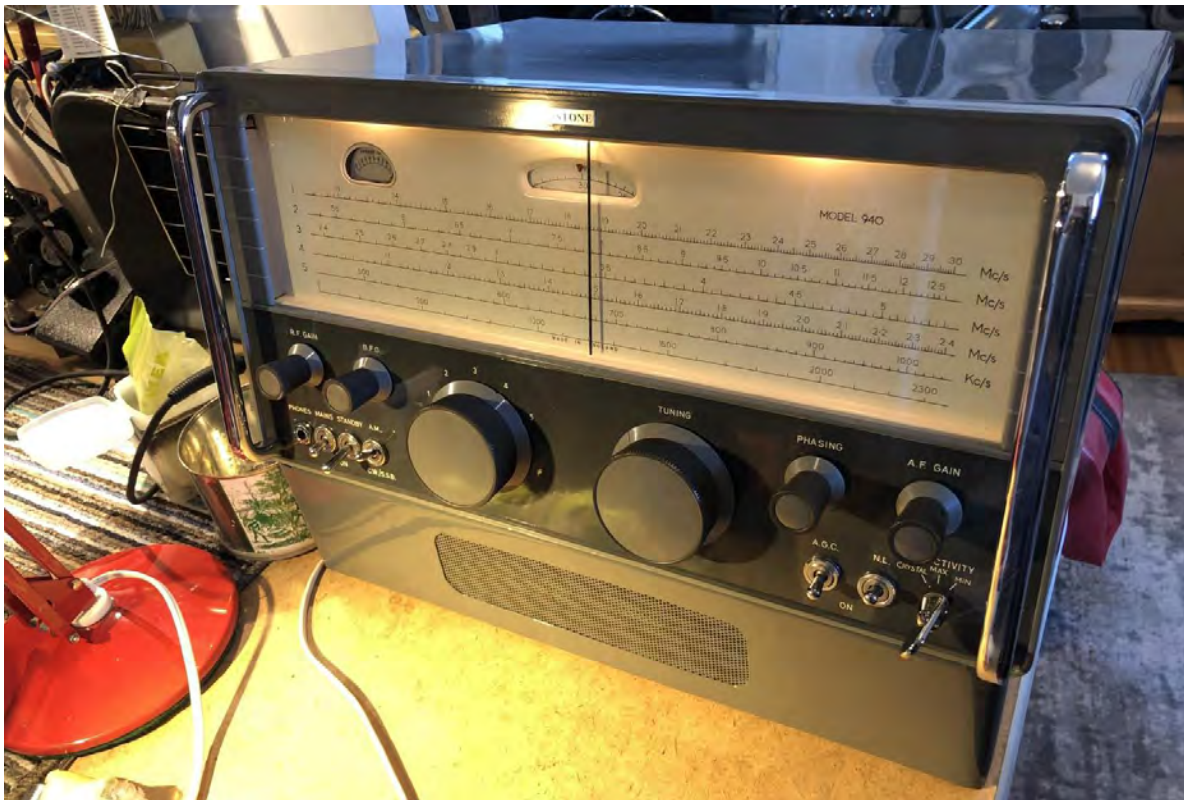
That done, the receiver was 'boxed-up' and is now doing stalwart service again, albeit on the corner of my workbench for the time being at least (photo, below). The calibrator is a definite improvement to
