## My Eddystone S.750 Revisited – Gerry O'Hara VE7GUH

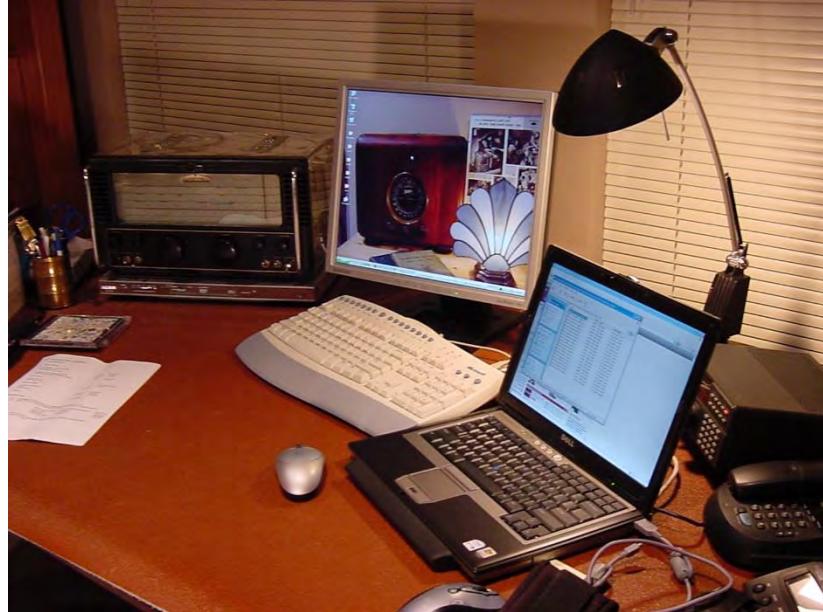
Way back in October 2006, I wrote an [article on 'restoring' an Eddystone S.750](#). In retrospect, it was more of a 'refurbishment' than a restoration. Since then, this set sat on my home-office desk (photo, right, taken in 2006) until a house move in 2017. It was used almost daily for about a decade prior to the move. At the new location, this set is one of six Eddystone sets that reside in my office-cum-radio workshop room (the others are an EC10, an S.870, an S.870A, an S.820 and a 1570/1), the rest reside in my garage workshop. The S.750 ended up on a shelf in a bookcase, along with its S-Meter and speaker, so has not been used as often since.

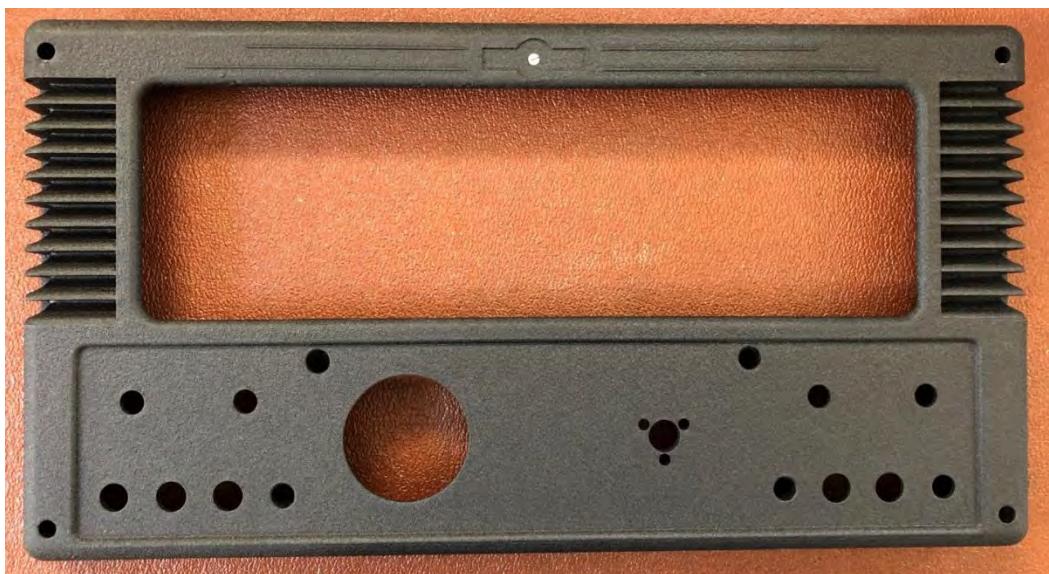
I had painted the original (silver hammer finish) front panel in 2006 using black wrinkle finish spray paint (can) as the original finish was in poor shape. Shortly after doing that, and putting the set back together, I was given an S.750 front panel by a friend at the SPARC Museum in Coquitlam, BC (from a parts set). I had this one sand-blasted and re-finished in black wrinkle powder coat (photo, below left), planning on changing it out for the re-painted one as the powder-coated one looked really great. Changing the front panel out on an Eddystone set of this style only takes about an hour or so (if you

know what your doing), but as I was a busy guy and the one that I had re-painted looked ok, albeit not as good as the powder coated one (and not as durable), I decided to pack it away and one day I would 'get around to it'. Of course, I never did...

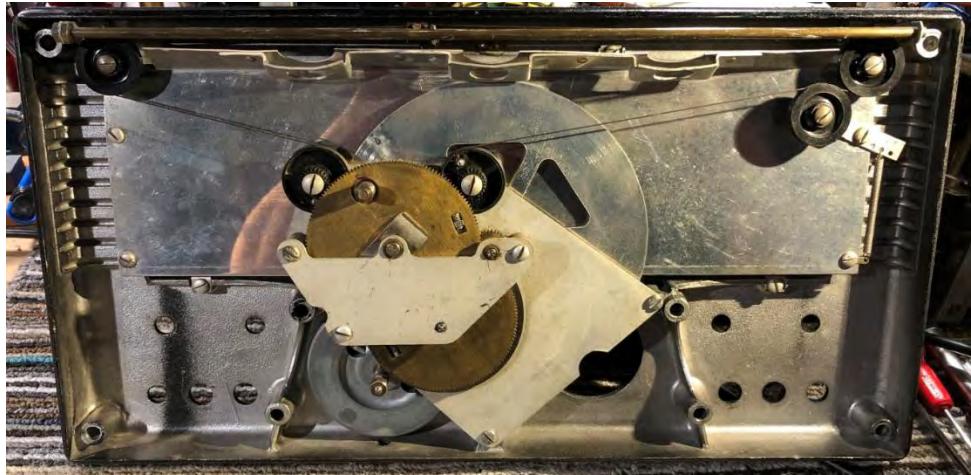
Off came the front panel (photo, right) – this is a fairly straightforward operation – remove the knobs, remove the nuts and threaded rings from the control shafts, pry-off the metal fingerplate (its secured with double-sided sticky-tape),

remove the handles and four tapered bolts securing the front panel casting to the chassis, and pull the front panel away, taking care that the ratio arm frees itself from the spigot on the tuning drive mechanism. This exposes the front of the chassis, with all the controls hanging loose on their respective wires, so it looks a bit of a mess. However, this also gives good access to the BFO unit and the IF gain control.

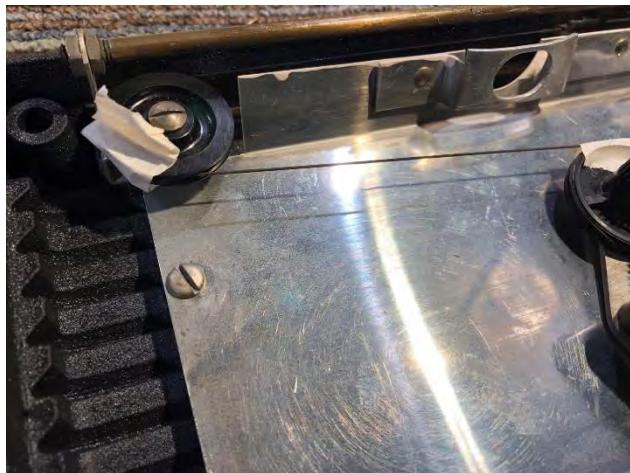
First though, I needed to transfer the drive mechanism/gearbox and dial to the replacement front panel. This is a fairly straightforward process – the main thing to be aware of is to use some small pieces of masking tape to temporarily hold the dial cord onto the four pulleys (photo, left) - two spool pulleys and two idler pulleys – if this is not done, it means a lot of cursing and wasted time while you try to do this from scratch when re-assembling.

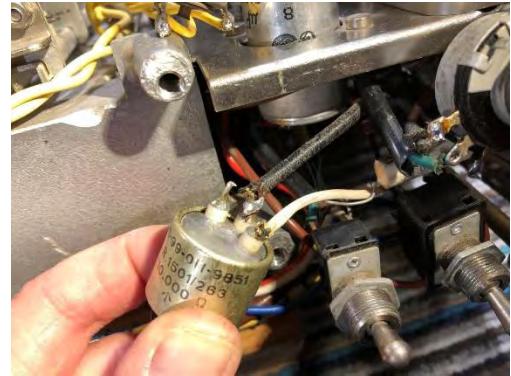
Next, I checked the IF gain control. This is a wire wound 10Kohm pot, used as a rheostat, which changes the bias, and hence gain, of the second (85KHz) IF stage. I am not sure about this pot, but the RF gain control pot on these sets is not a linear taper, rather it is anti-log taper – unusual for a wire wound pot. Eddystone used specially-wound pots to provide the required taper. Of course, these are ‘unobtainium’, so I had replaced this IF pot with a linear taper pot 14 years ago – a British-made military grade one

manufactured by 'Colvern' (photo, right). On testing this now, I found that it had become erratic in action over the first part of its travel – this, combined with it likely being of incorrect taper, was causing the control problem I had noticed. I found a new wire-wound linear taper pot in the 'junk box'. Connecting a fixed-value resistor between the slider and one end of a linear pot alters its taper depending on the ratio of the fixed resistor to the resistance value of the pot – it's a neat trick – see article [here](#). Of course, this also affects the overall value of the pot/resistor combination, so care needs to be taken when doing this to select the appropriate component values to best-suit the circuit. I decided to install the linear pot without a taper-compensating resistor as a first step, then, if the control proved too 'one-ended' (all the control action near one end of the track), I would experiment with different values of fixed resistor.

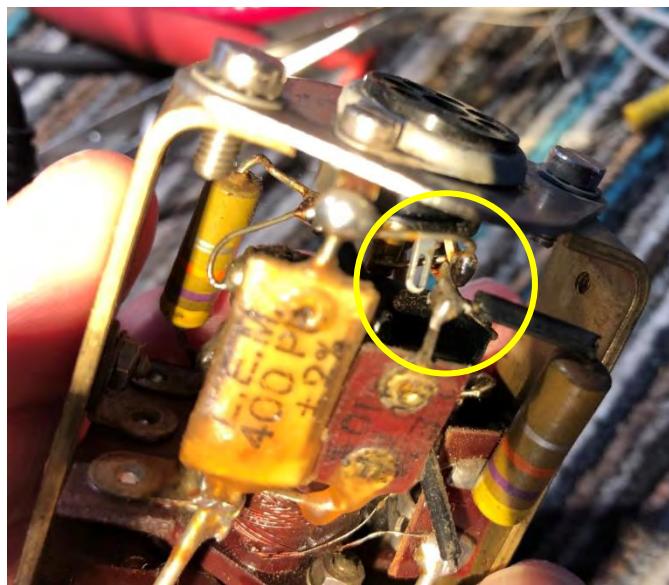
socket (circled yellow in photo, above). It had been like that for the last 70 years... and working ok, up to now. The grid pin was cleaned, some liquid flux applied and the joint made good. I guess it must have been Friday afternoon in the Bathtubs' BFO assembly department back in July 1950...

With the new pot fitted, I moved on to the BFO unit. The can includes all the BFO components, not just the BFO coil, ie. a couple of resistors, three tubular paper caps and two silver mica caps. The various connections to the can were unsoldered, the can removed from the chassis and the frame removed from the can. I found the cause of the intermittent during a close visual inspection – an un-made joint. The grid pin (1) of the tube socket had never been soldered to the grid leak resistor and the silver mica grid cap: the resistor and the cap were soldered together, but this joint was just resting against pin 1 of the tube

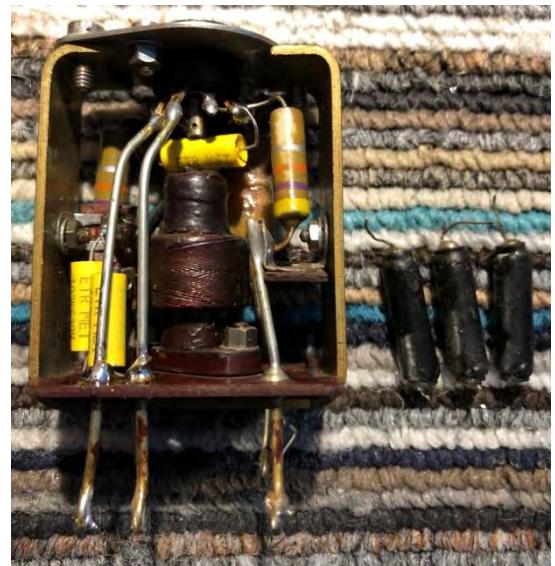
While I had the BFO unit apart, I tested the resistors – these were both within 5% of nominal, so were left in place. However, I decided to replace the three tubular paper caps as a precautionary measure (photo, right), though left the silver mica caps alone as these were likely ok. I re-assembled the BFO unit, re-installed it on the chassis and connected it back into the circuit. I also

took the opportunity to replace another two tubular paper caps located near the front of the chassis.

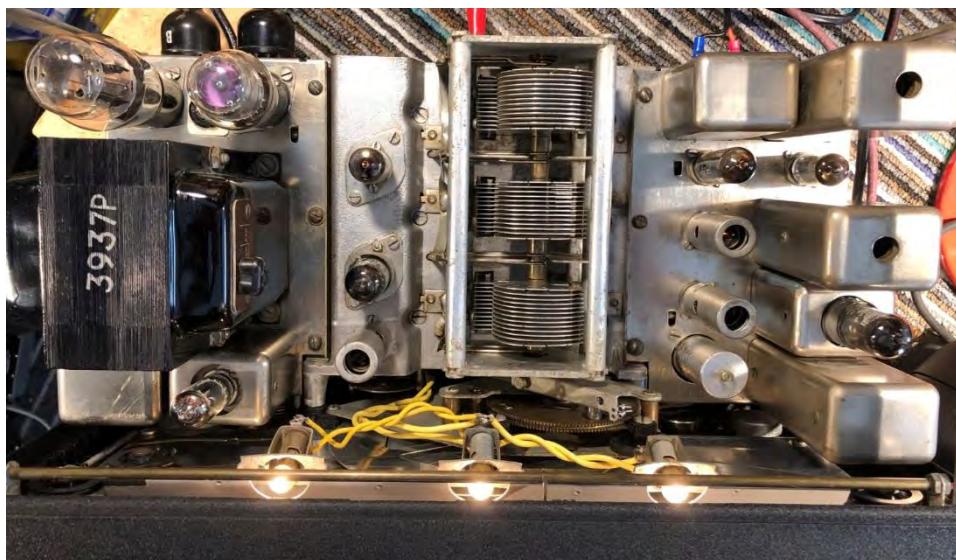
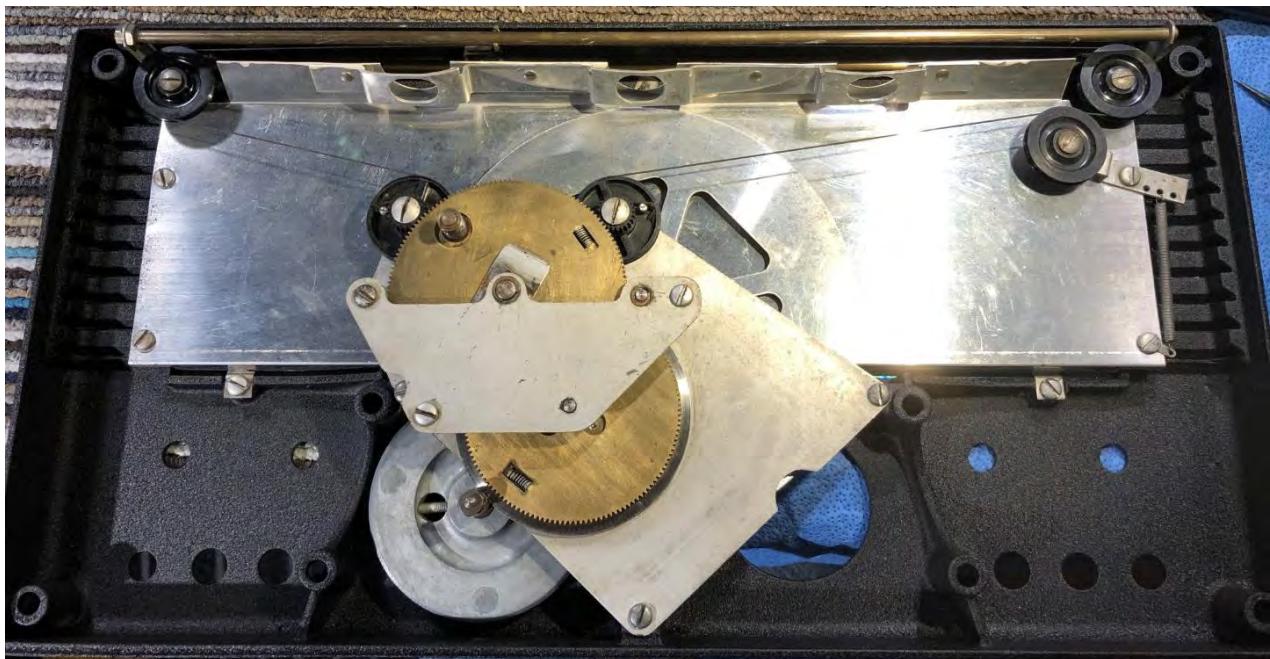
Left: Top view of chassis with the replacement front panel installed. Below: Replacement (powder-coated) front panel with scale plate and tuning mechanism/gearbox installed

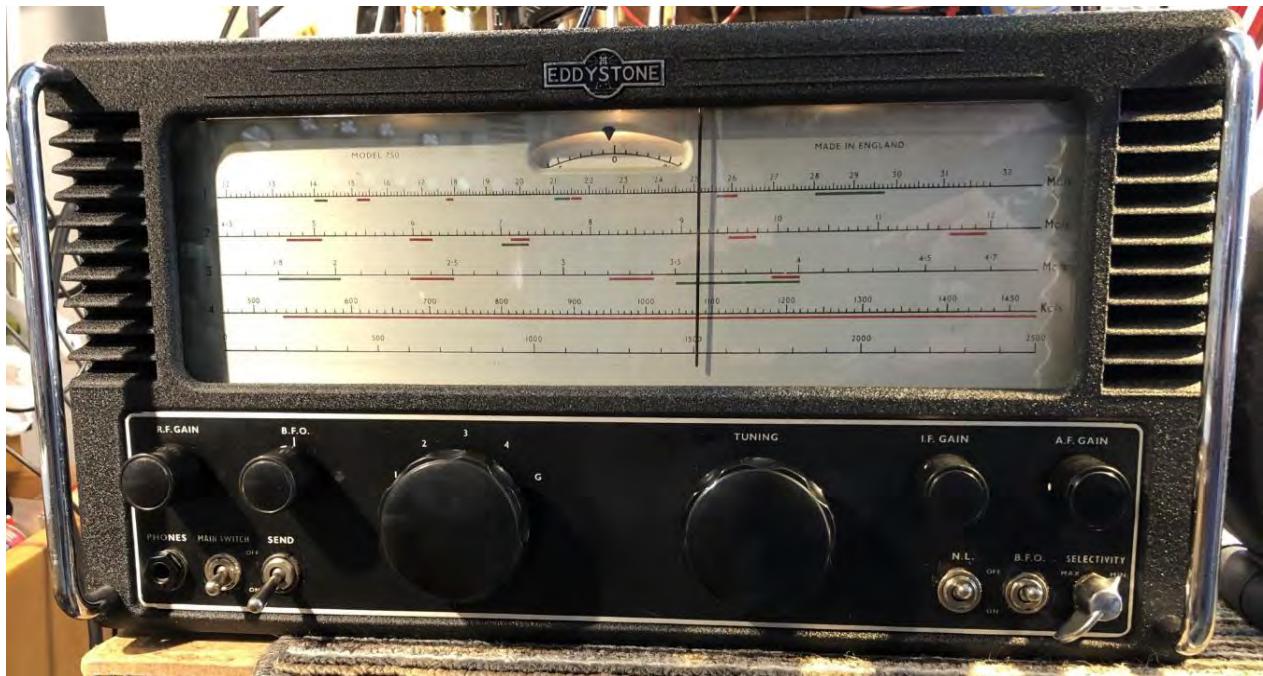
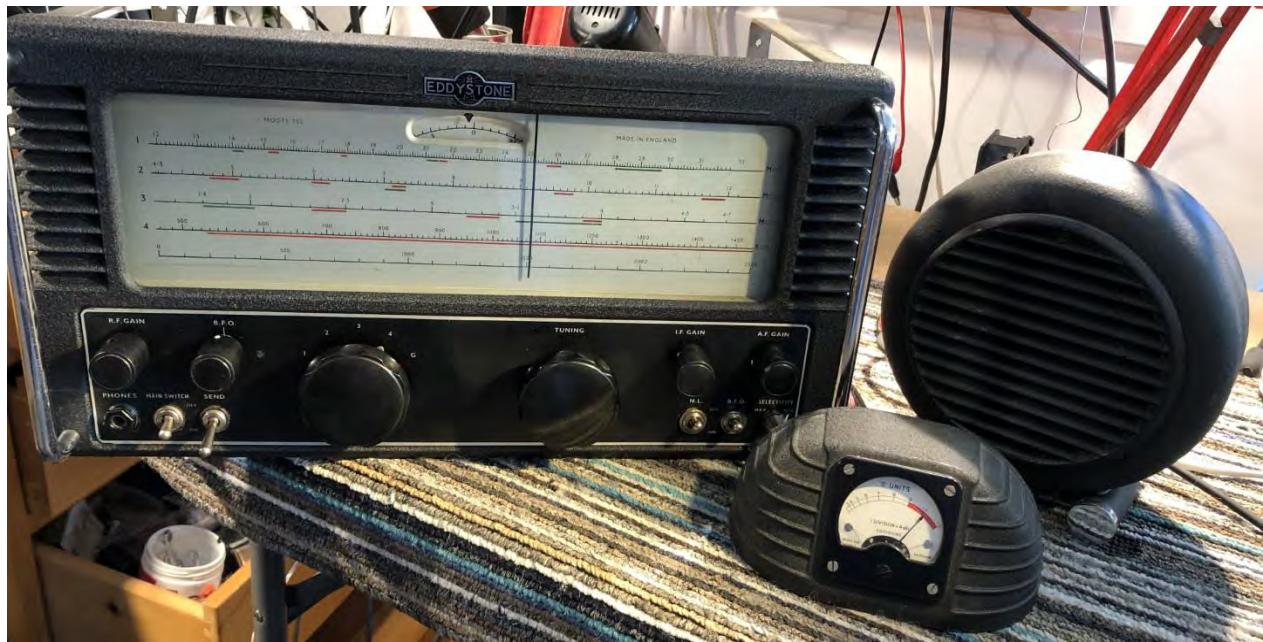
Above: The powder-coated front panel fitted to the S.750. The fingerplate was given a polish with Novus #1 and the knobs with Novus #2 to complete the 'spruce-up'. Below: Sitting on the bench with its matching S-Meter and speaker

The front panel was then re-installed onto the chassis – a bit more of a fiddly job than its removal, as the various controls must be teased through the corresponding holes in the front panel, the screw-holes lined-up and care taken not to nip any of the wiring between the front panel and the chassis. This done, I gave the receiver a try out – short video [here](#), then ‘boxed it up’ in my home-brew Plexiglas cabinet (I have the metal cabinet, but its fitted to another Eddystone set, an S.640).
