## My Eddystone S.940 Revisited – Gerry O’Hara VE7GUH

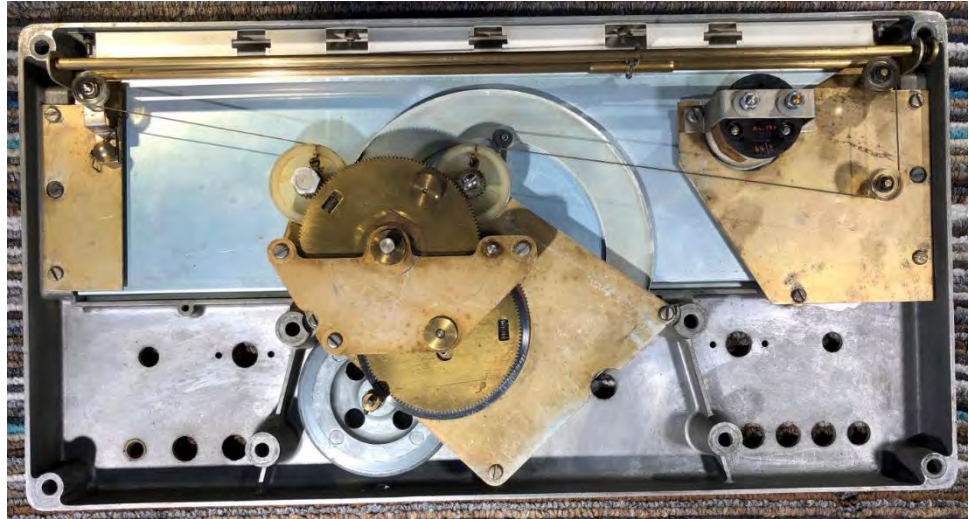
and the 6BA screws securing the BFO and crystal phasing variable capacitors. Next I removed the panel light holders, disconnected the wires from the S-Meter, loosened two of the screws securing the flexible drive to the tuning gang, and finally removed the four tapered screws tapped into the coil box casting. This allowed the front panel casting, complete with tuning mechanism, to be removed (photo, above).

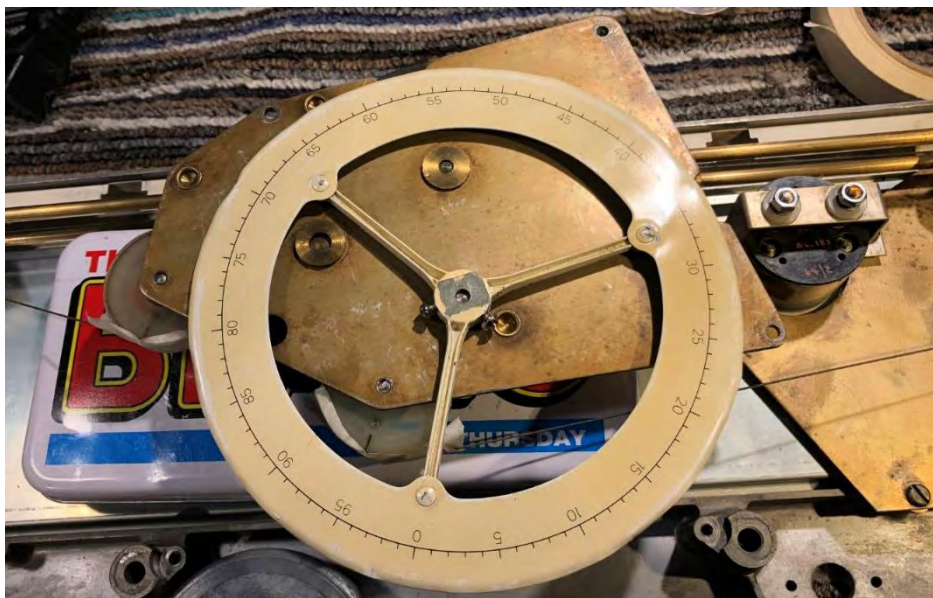
friction drive plate disengaged from the spring-loaded clutch on the tuning shaft, and the gearbox assembly flipped over to gain good access to the vernier scale. I placed a box (a 'Beano' comic box!) under the gearbox to support it and prevent any damage to the rear of the scale plate (photo, left). Before the original vernier was removed, I

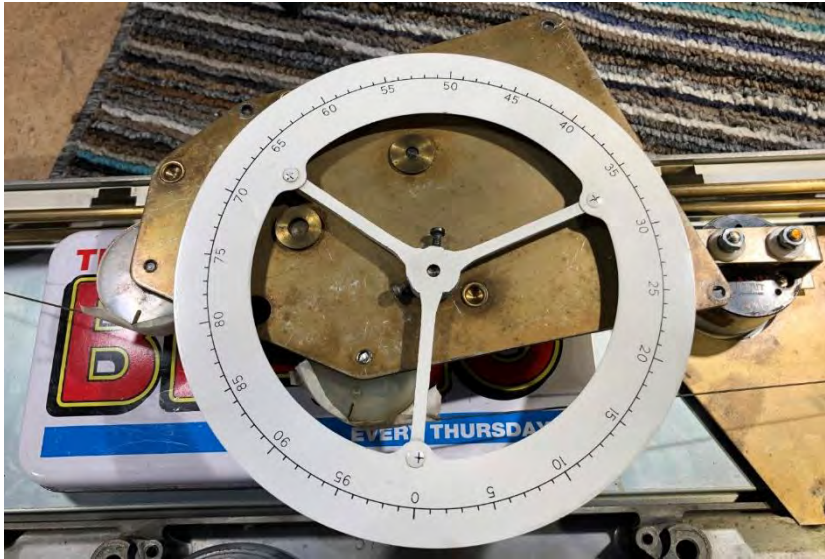
marked on the front plate of the gearbox where the '50' point of the vernier was at, so the new vernier could be set at the same point. The two screws securing the vernier were loosened, and the vernier lifted away from its shaft on the gearbox (needed prying a little). The shaft and washer under the vernier was cleaned and the bearing point given a small drop of light machine oil, the new vernier oriented to match the '50' point on its scale to the mark on the gearbox, then placed on the shaft and pushed home, and its screws tightened (photo, above).

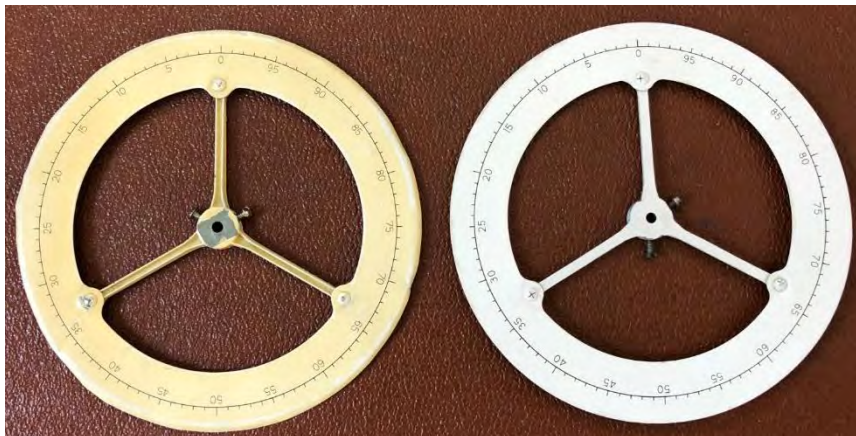
The gearbox was then flipped over, the friction drive re-engaged with the spring-loaded clutch on the tuning shaft and the three self-tap screws replaced. Just how discoloured the original vernier was can be seen in the photo, left).

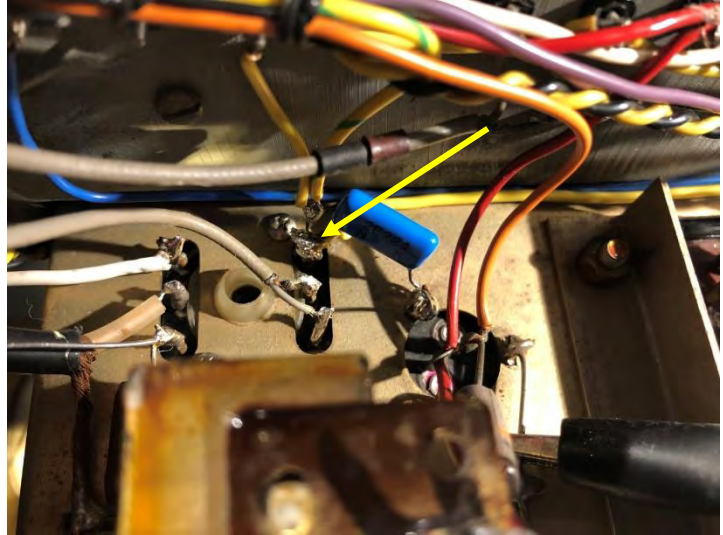
On checking the receiver again on CW/SSB, what had been an intermittent fault (that I thought I had cured by wiggling the tube to re-seat the pins) was now constant: all I could hear when the product detector was switched in was a hum. Checking under the chassis, I identified the fault as an intermittent connection to the heater in the BFO/product detector can (follow yellow arrow in photo,

above) – poking this would bring the product detector back on. I re-made the connection a couple of times, but the fault persisted.

I decided that I would take the BFO/product detector can off and investigate (this is the second time in a week I have had to take an Eddystone BFO unit apart!). This is a fairly straightforward job on the S.940: unsolder six connections, remove two screws and out it comes. The screening can was then removed by bending four lugs on its base and lifting off. I re-made the connection to the heater pin from the inside and it now seemed ok. I also took the opportunity of checking the components contained in the can as I could not recall doing this back in 2007 (photos, left).

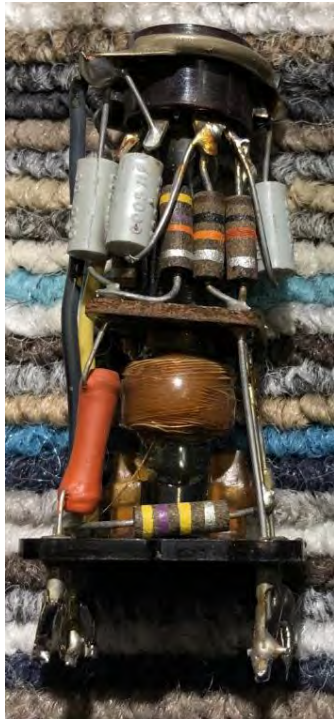
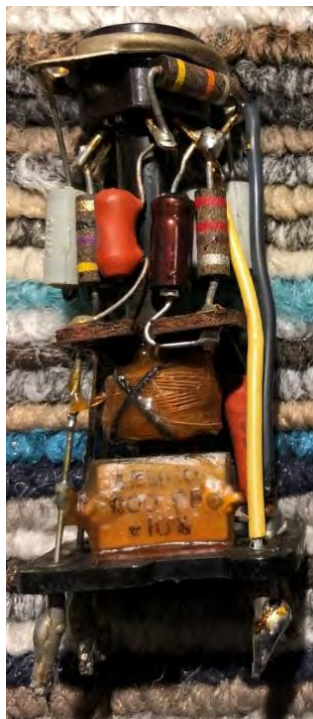
Not surprisingly, the low voltage 10uF electrolytic had failed and the 0.01uF capacitor was very leaky. That had caused the screen resistor to bake slightly and its value was over 50% higher than nominal. Three of the other resistors had also drifted out of tolerance.
