## My Eddystone S.640 Revisited – Gerry O’Hara VE7GUH

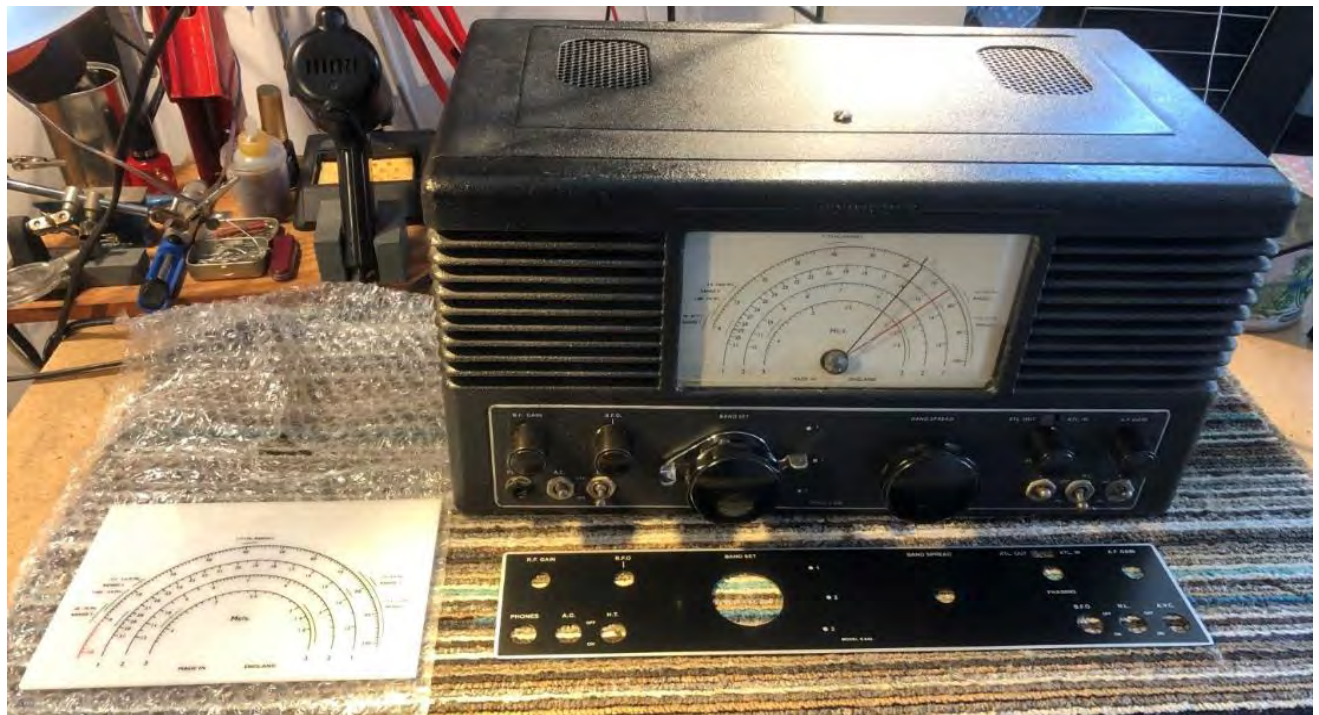
But, I figured that now was the time (‘now or never!’) – so, the S.640 (which sports the metal case off the S.750 by the way), along with the repro fingerplate and dial, was hauled off a shelf in the garage and into the upstairs workshop in the house (photo, below).

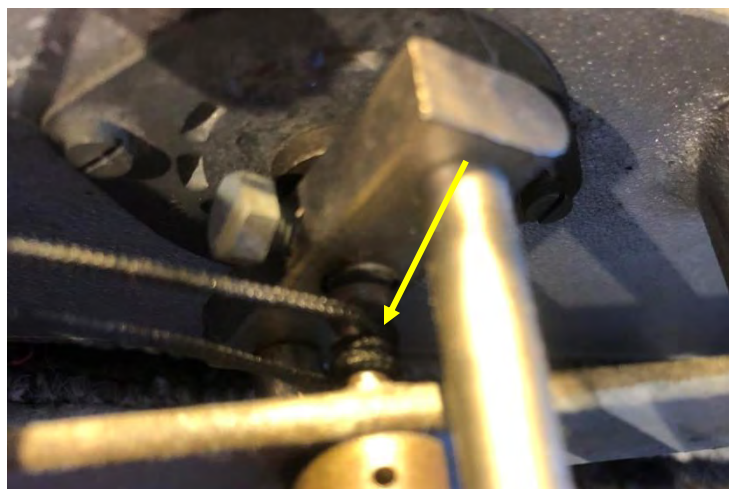
Before starting on the 'Bandset' dial cord replacement, I operated the mechanism several times (photo, right – arrow pointing to the thick dial cord on the Bandset mechanism) to see where the cord was binding. As I suspected, it was binding on the tuning shaft (arrow in photo, below): there are 2.5 turns of the cord around a thin dual-tapered section of the tuning shaft.

The cord I had used 10 years ago (as it was all I had in stock when I was working on the S.640) was creeping towards the ends of the taper on rotation of the tuning shaft, and, once there, the steepness of the taper combined with the thickness of the cord resulted in the end turn of the cord 'flipping' onto the previous turn, thus causing momentary binding/slippage until the next turn of the shaft. I surmised that the taper was designed to work with a much thinner dial cord – which I now had several thicknesses and types in stock (photo, right). I selected one of the thinnest I had, with a physical appearance similar to that on the 'Bandspread' mechanism, though I

The thicker dial cord was removed, along with the tensioning spring. A length of the thin dial cord was then cut, adding around six inches to the length (34"), i.e. an approx. 40" length was cut. There should be a small eyelet and hook on one

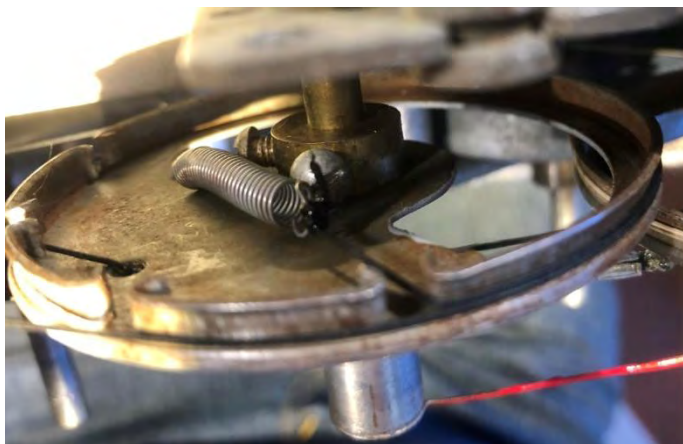
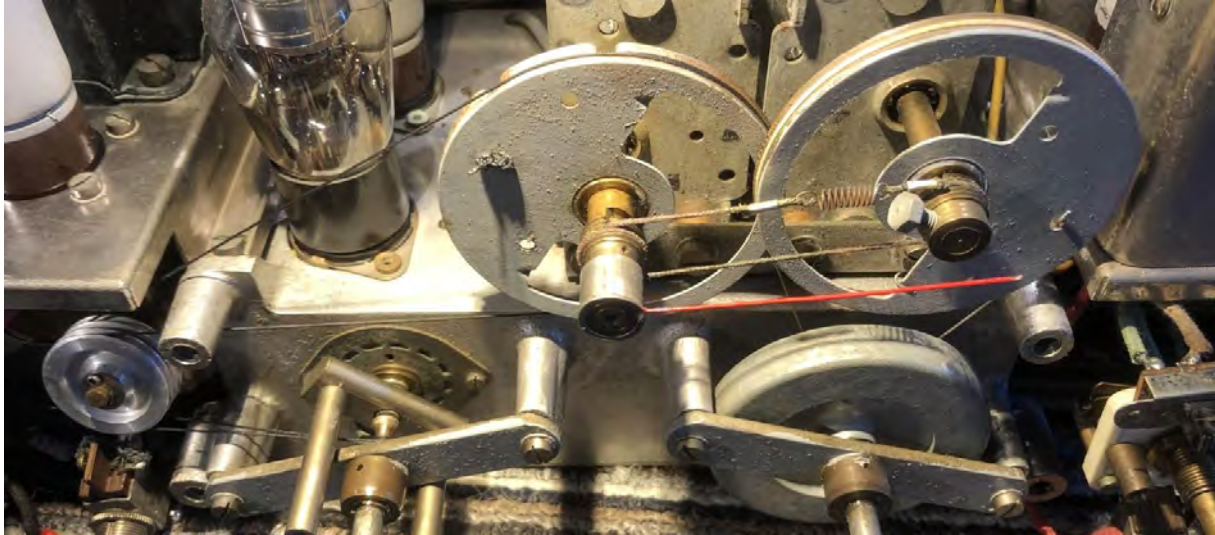
end of the dial cord – this eyelet is missing from this set, so, instead, I improvised, as I had before, by tying a large knot in one end such that the knot would not pass through the holes in the large pulley on the tuning gang shaft. With this knot made, I threaded the cord through the correct hole ('A' in upper left diagram, above), and then re-strung the dial as per the diagram. Holding the cord taught around the pulleys and temporarily holding this in place on the idler pulleys and large pulley with pieces of masking tape, I secured the tensioning spring to the end of the cord with a slip-knot so the final length of the cord could be 'fine-tuned' such that when the other end of the tensioning spring was secured in the correct hole in the pulley (photo, left, and 'B' in the upper left diagram, above), the spring imparted sufficient tension on the cord. The slip-knot was then secured by adding a couple of additional knots at that point and the pieces of masking tape removed. The ends of the cord were then

cut and fraying prevented by touching each with a hot soldering iron to melt the fibres. The knots at both ends of the cord were then given a spot of polystyrene cement for additional security.

The mechanism was checked for bind-free operation numerous times – all seemed well. A short video of this can be seen [here](#). I took the opportunity to add a small drop of light machine oil to the bushing the Bandsread dial pointer attaches to, where it sits over the main tuning gang shaft, and to the idler pulleys shaft. The re-strung dial mechanism is shown in the photo, above.

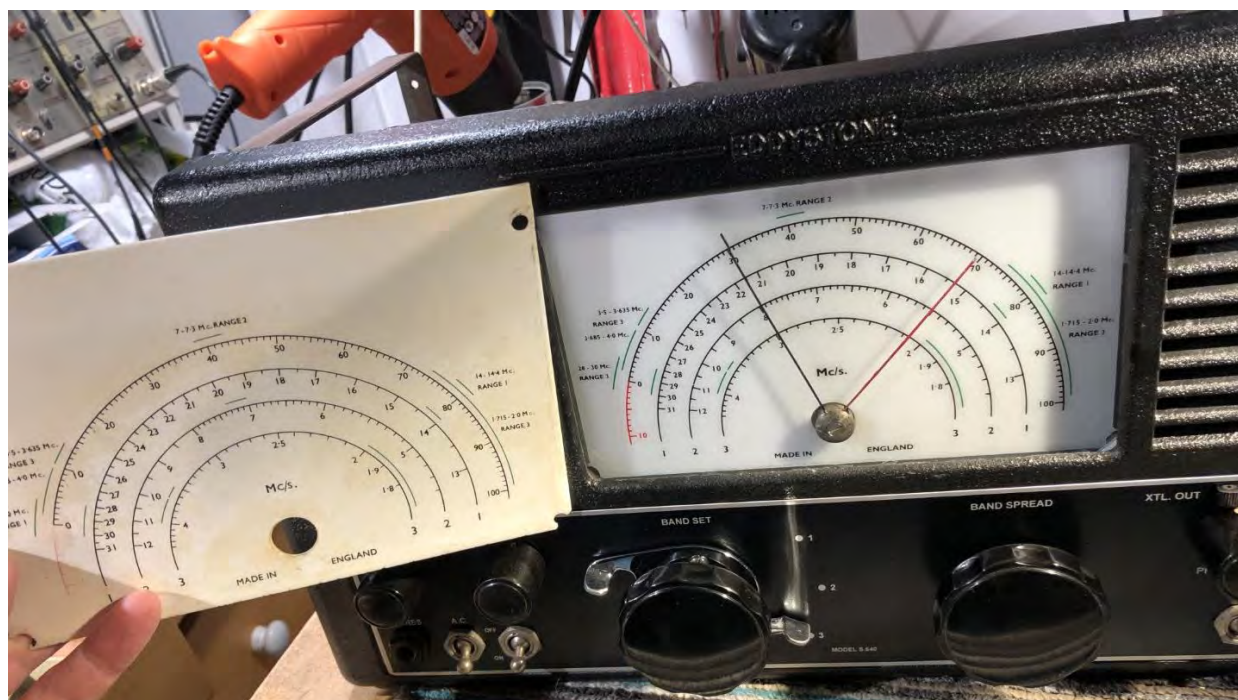
Replacing the front panel on an S.640 can be a bit of a time-consuming job. I have found it best to angle the receiver on the bench, roughly at a 45 degree angle, by placing a wood chock under the coilbox. This allows the serrated washers to be placed on the switch and pot threads without them falling off as the front panel is offered up to the chassis. The various switches and control shafts can then be maneuvered through their respective holes in the front panel. At this stage, as each is inserted, I temporarily secure it with its nut to prevent it popping out as the other controls are inserted. Next, the two variable capacitors and slide switch are secured using 6BA taper-head screws. Once all the controls are in place, and checking no wires have been nipped, the front panel can be held by partly inserting the lower two tapered screws.

This allows the top of the panel to be tilted forwards slightly, allowing access to install the dial glass, and then angling the front panel back into place, inserting the remaining tapered screws<sup>1</sup> and tightening these to fully secure the front panel to the coilbox. The four screws holding the sides of the chassis/brackets to the front panel are then installed. The dial is then carefully located into its correct orientation, the side plates/bracing strips installed, and secured with screws. The dial bulb

<sup>1</sup> I found that I needed to include a washer between the front panel and the threaded standoffs that the tapered screws install into to prevent binding of the front of the pointer shaft and the dial glass. The dial glass on my set seems very thick and may be a replacement(?) - this would not be an issue with slightly thinner dial glass

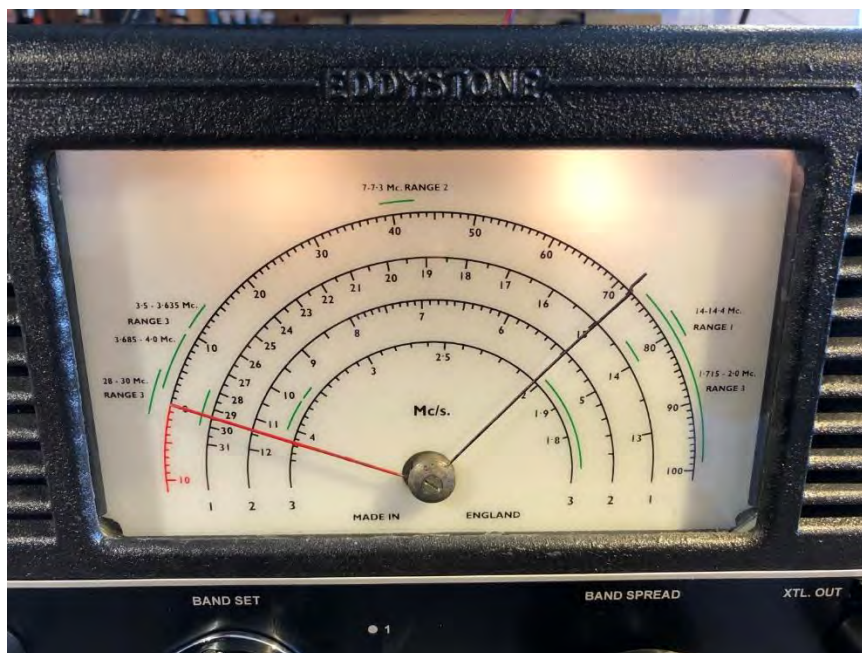
mounting bracket can then be installed and the dial bulb holders inserted. The installed reproduction dial is shown in the photo above, and comparison with the original dial in the photo at the bottom of page 6.

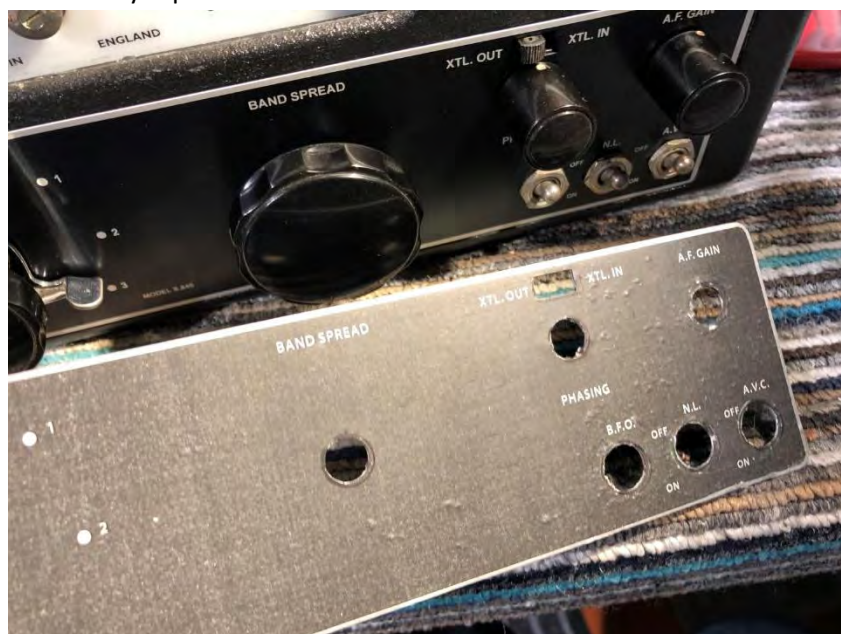
The photo, left, shows the reproduction fingerplate installed on the set and the paper 'temporary' one in the foreground – ten years had taken a bit of toll on its paper finish...

The reproduction fingerplate was then prepared for installation by adding three vertical strips of dual-sided sticky tape to its rear side. The nuts were then removed off the switches and pots, the fingerplate

placed over the control shafts/switches and secured by the tape with a gentle push on the fingerplate. All the nuts securing the controls were then replaced and tightened gently using correct-sized sockets, the band change lever installed, and, finally the knobs.

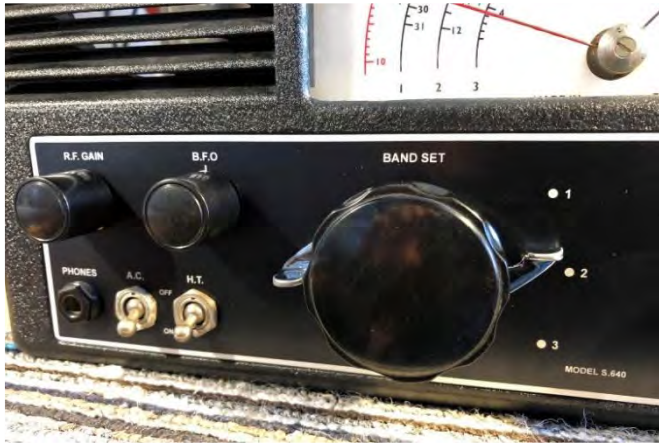
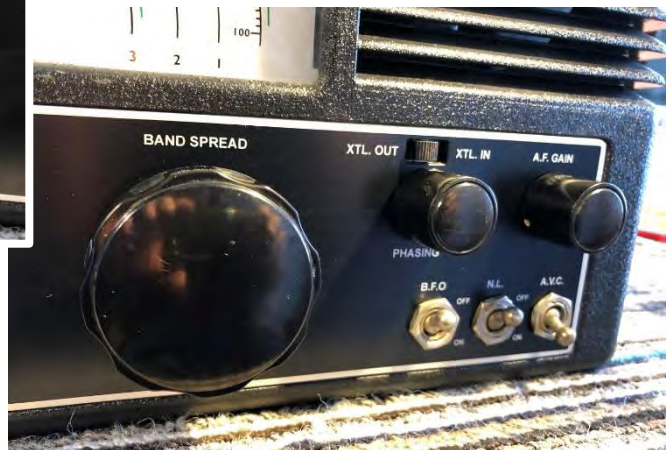
Above left: Bandset end of the reproduction fingerplate. Right: Bandsread end of the reproduction fingerplate. Below, and pages 9 and 10: the S.640 with the reproduction dial and fingerplate installed – looking (and working) good!
