# **‘Little Boy Blue’... Fixing-up an Eddystone S.870, by Gerry O’Hara, G8GUH/VE7GUH**

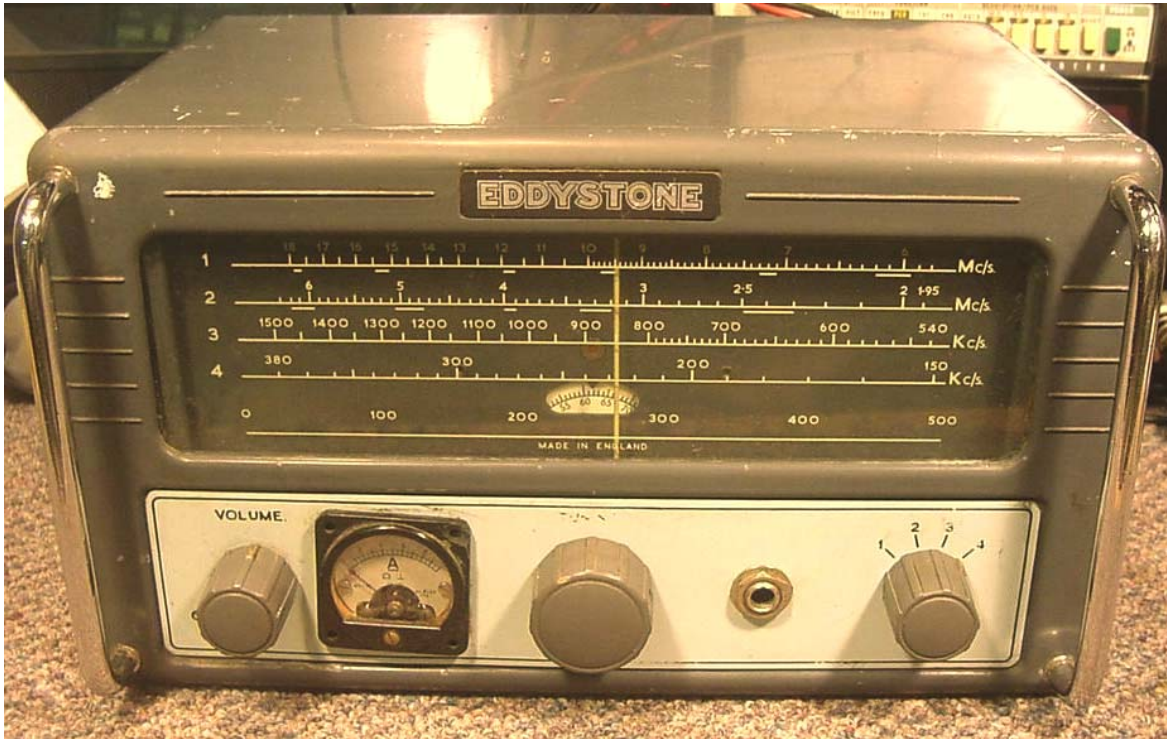
On opening up the package, I was greeted by a very dull (almost matt-finish) case, with the worn-out fingerplate sporting an ugly meter (actually a 0 – 10A meter! – a prior owner must have been anticipating strong AGC action...) and a headphones socket, fitted in a very crude fashion (photo, above) – the holes in the front panel and fingerplate were complete with huge burrs and bits of metal clinging on to the edges. The good news was that the meter was not wired into the circuitry at all, but the headphones socket had been wired into the secondary of the speaker transformer.

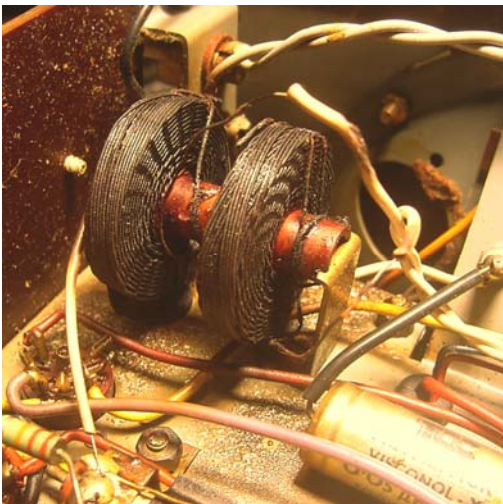
Once the cabinet was removed from the set, the full horror of the power supply section was revealed – the twin filter chokes had become so hot at some point that the (enamel)

paint on the underside of the chassis above the chokes had burned-off/wrinkled and gone brown (photo, left), much of the nearby wiring insulation was charred, one thermistor was absent and the other just had its ends present, still clinging to its connection wires. An ugly 220ohm 'sand' resistor had been installed – probably as a dropper for the heater string.

I then decided to clean-up the chassis, re-paint the section beneath the filter chokes and re-insulate/re-wire where the insulation had been singed. With the filter choke removed

(two screws), the old paint was removed with a small wire brush and I used some grey Humbrol enamel over the affected area – I was not too bothered about having a good colour match as this area is beneath the chassis and will never be seen (also, the adjacent original chassis paint was fairly discoloured anyway). This done, I removed the old insulation from the filter choke wires running to the chassis, insulator and power switch and replaced with white heat-shrink in keeping with the original. I also replaced some of the original wiring to the rectifier and output valves that were also singed (photo, right).

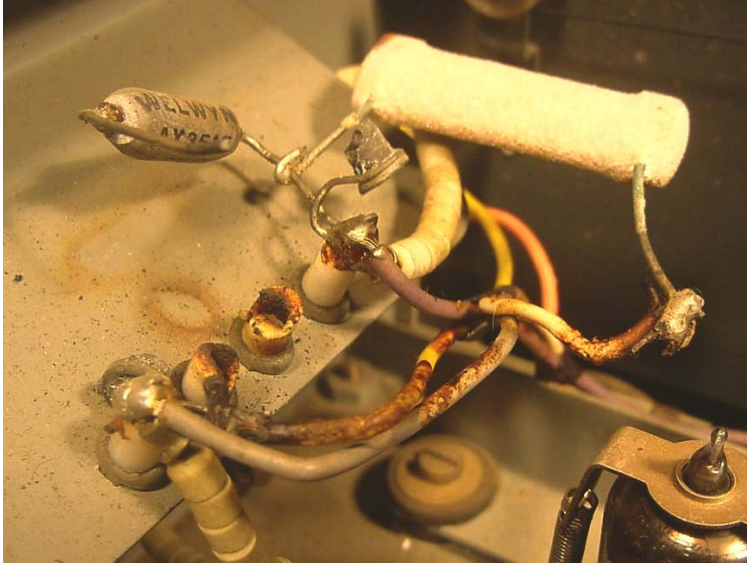
Once the above dismantling was completed, the two central ceramic stand-offs were removed (photo, below), along with the sad remnants of a thermistor, the 'sand' resistor and R21. The area was cleaned-up and the dial lights taken out of circuit, re-wiring such that the power was applied to the valve filaments through a 150ohm (5W) resistor connected across the remaining ceramic stand-offs. This done, the remaining wiring in the power supply was given a check-over (found to be ok, albeit not very aesthetically appealing due to its insulation being a bit singed – I decided to replace this, but not until I had tested the set).

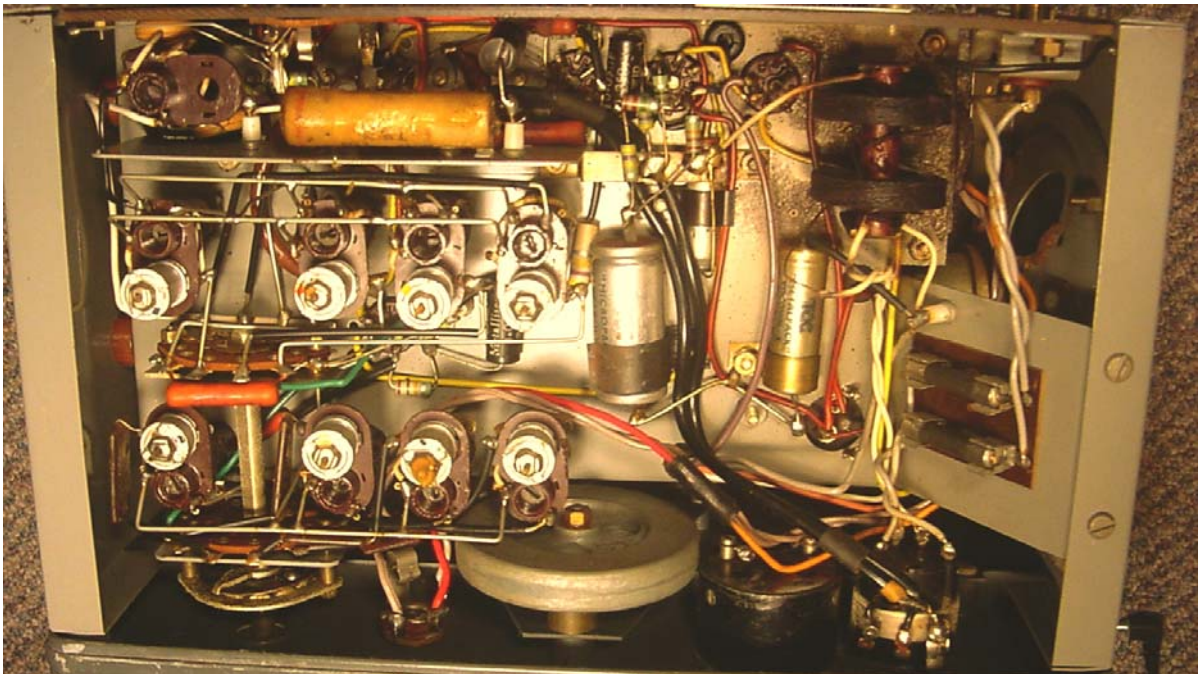
Before I re-installed the valves, I decided to replace all the Hunts paper capacitors and check the electrolytics – photo, above. The large 'waxy' is the all-important capacitor between chassis and the ground/cabinet (C4). This and all the small Hunts capacitors were leaky (several megohms) and showed a slightly low capacitance on test. I replaced

C4 with a regular 0.01 630vw polyester film, but will replace it with a 0.01uF Type Y2 safety capacitor (on order at time of preparing this article). The twin 32uF 350vw filter capacitor and the 4uF decoupler in the anode circuit of V3 tested ok – capacitance within tolerance, fairly low leakage and low ESR. As they tested ok, I decided to retain them for aesthetics. However, the small (30uF, 15vw) tubular electrolytic capacitor on the cathode of the output valve had high leakage and virtually no capacitance and was therefore

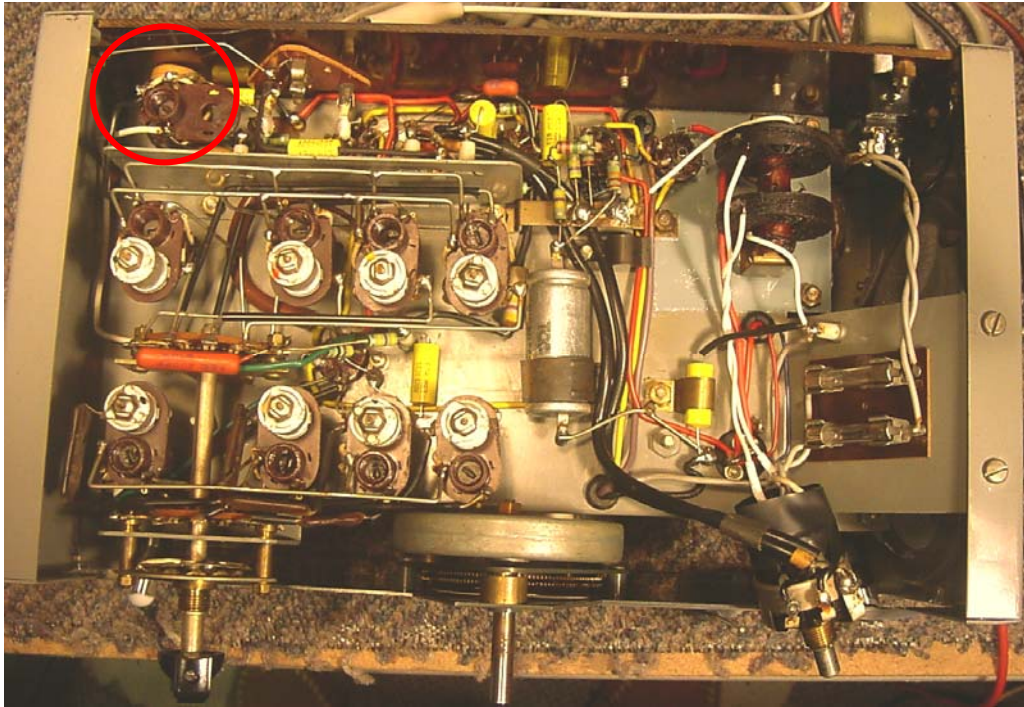
replaced. The only awkward capacitors to work on are the two (C12 and C16) located beneath the IF trap (circled red at the upper left on photo of the re-capped/re-wired chassis above). I unsoldered the upper connections to the IF trap and moved it out of the way to gain good access. All resistors were checked and found to be within tolerance (10%) and so were left in place. I also checked all the valve filaments for continuity – surprisingly they were all ok and so were re-installed.

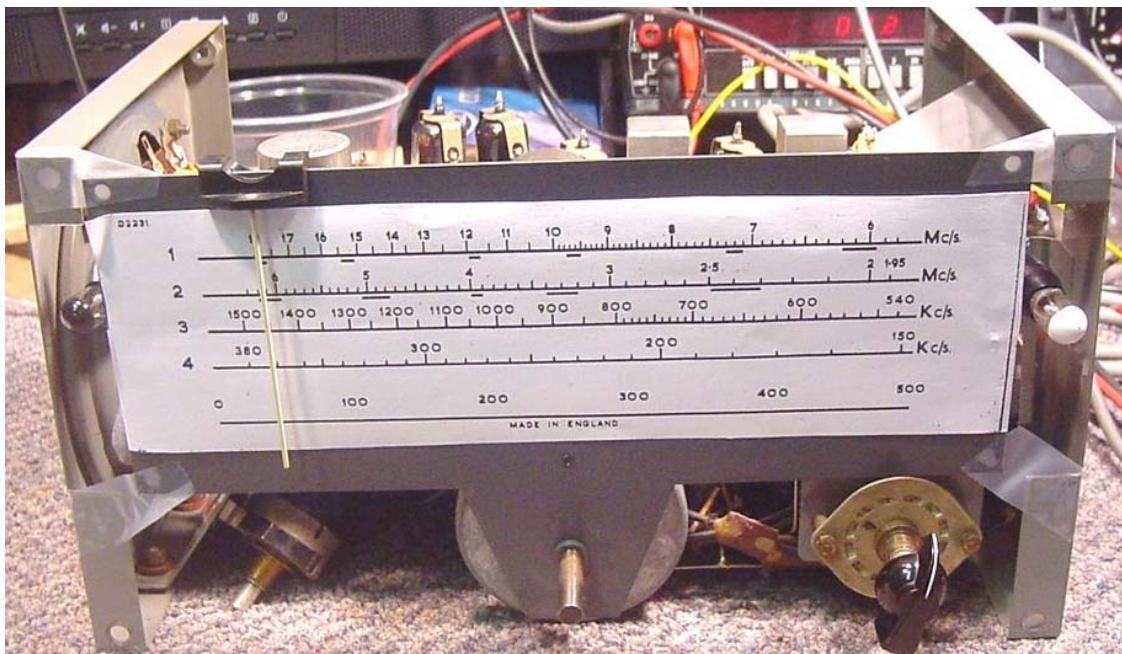
Above: the S.870 chassis rigged-up for testing. Note the 60v dial light bulbs poking out from either end of the dummy scale.

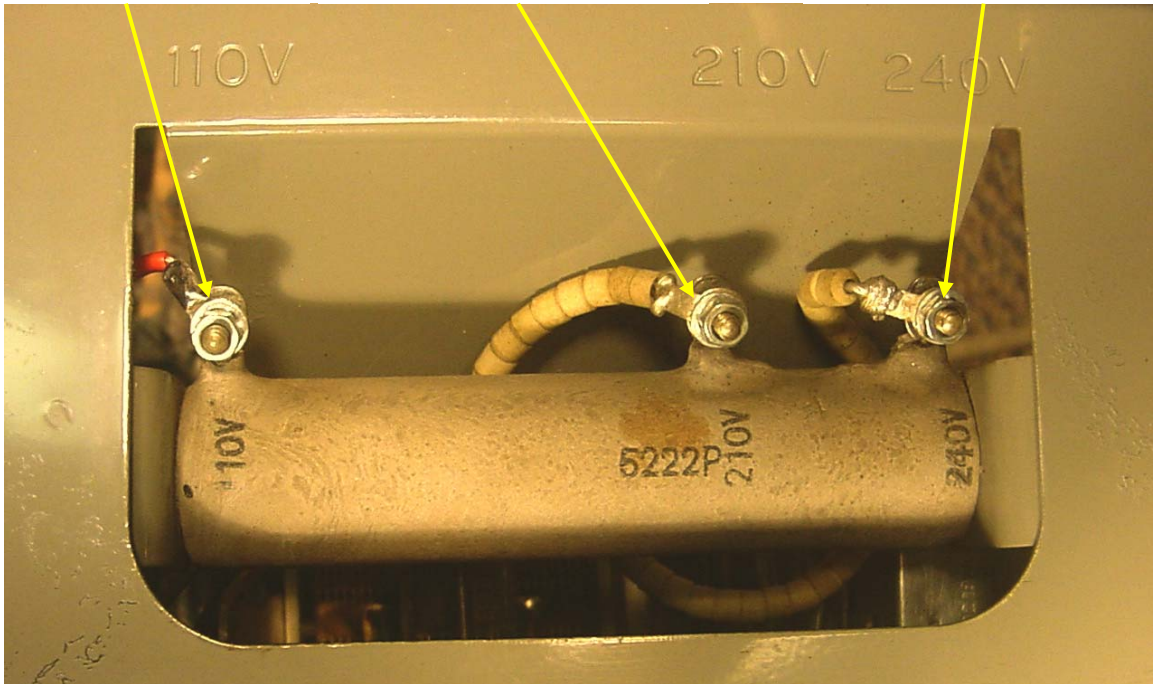
To dial lights (2 x 60v)

From power switch (120v)

To valve filament string (V5)

Above: the 40W mains dropper re-wired for alternate service in my S.870. Its only dissipating around 4W at one side and 1.25W at the other - judging by the colour of this resistor and surrounding paintwork I doubt that it has ever seen any service and that the set was used exclusively on a 110/120v supply – at least now it is seeing some service but its still an easy life for this guy...

my set was not in use as I was not working from a 210v or 240v supply. I surmised that the set would never be used on such a supply and so why not use the two sections of this for both the valve filament dropper (the 240v-220v section is 180ohm) and use the other (460ohm) section as dropper for the two dial lights to dim them a bit? I re-wired the power supply slightly to allow this and it worked ok – giving 47v across each bulb (and hence a more authentic glow and longer bulb life), and the filament string was now at 89v – a tad low but still within acceptable tolerance. Quite a neat solution, but it will need a warning on the set that it is wired such that it can operate only on a 120v supply. Around the time I completed this mod, Tor Marthinsen sent me a thermistor – so if I ever feel like changing it all back to its original configuration I can do (almost) – thanks Tor!

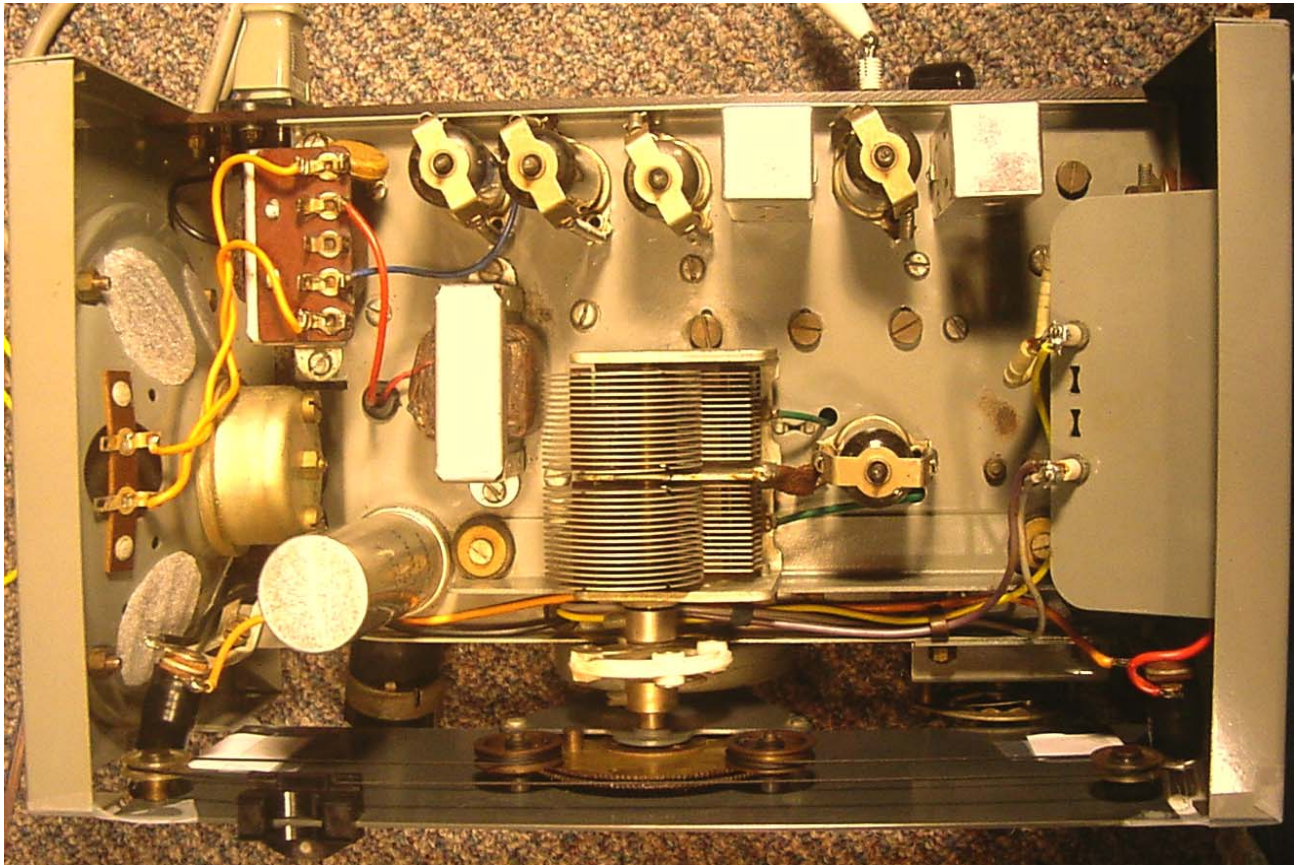
Above: above-chassis view after clean-up and re-wiring efforts were completed. The tuning mechanism is temporarily fixed in place with 'magic tape' to allow a rough alignment check at this stage.

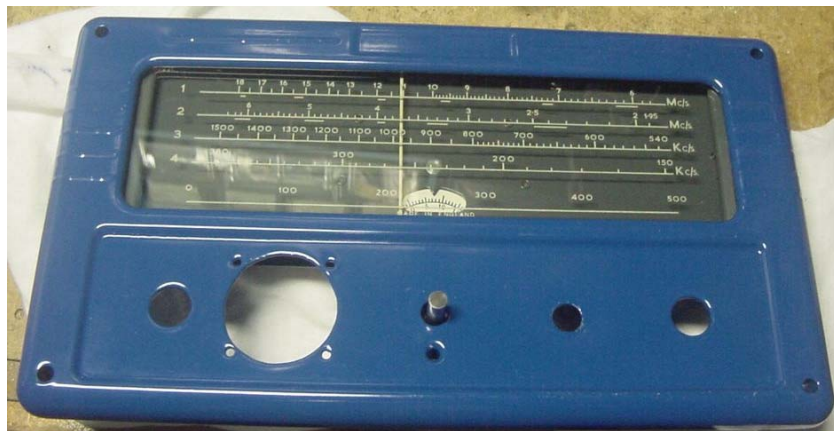
with the four self-tap screws and the 4BA tapered-head screw located at the bottom of the dial drive mechanism (the nut for this can be a little awkward to fit as it is located behind the flywheel) – photo, below.

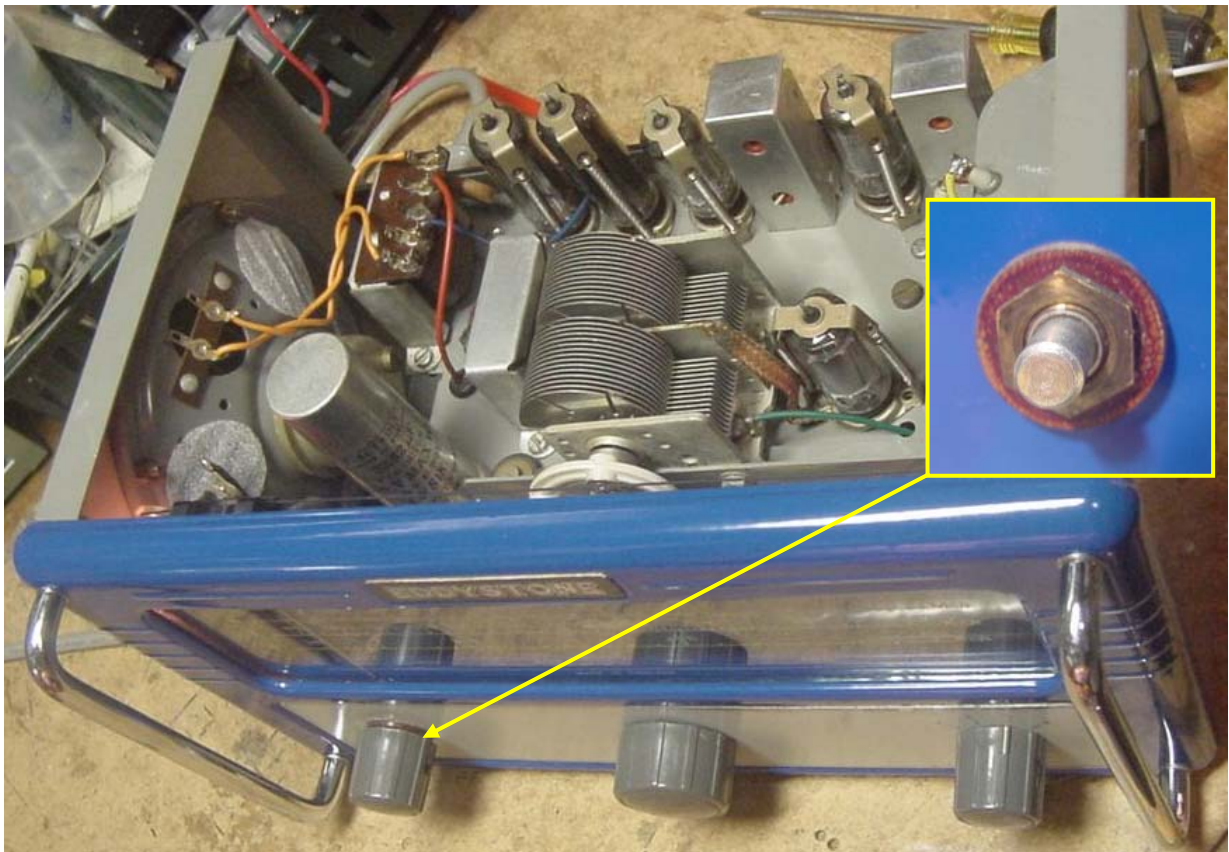
The volume control was then installed, making sure that the insulation washers were in place (plain one at the rear of the panel, rebated one in front – inset on the photo below).

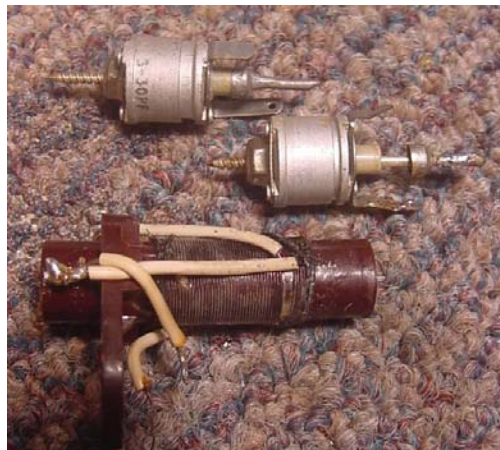
there. Moving to Band 2, I noticed that the concentric (Philips beehive) trimmer on the Local Oscillator was intermittent in operation – the cause was a loose threaded spigot (circled in photo, above). The trimmer was removed and replaced with a new part (upper unit in photo, right). I always knew those Philips beehives would come in useful one day – I actually recall buying them at the Granby Halls in Leicester in 1973(!) along with a 'halo' and a mag-mount 5/8 whip for 2 metres (at this rate I will be about 96 before I use another one). To do this, three wires

needed to be unsoldered from the coil former and the former removed from the set along with the trimmer. With the NOS replacement fitted and the coil re-fitted into the chassis, Band 2 aligned ok. No problems with Band 3 (Medium Wave or Broadcast Band, depending on which side of the pond you are from), but there was nothing at all on Band 4 (Long Wave). I checked the operation of the Local Oscillator on another receiver and confirmed that it was not oscillating. Nothing much to go wrong – either a faulty converter valve (unlikely as it was working ok at higher frequencies), an open-circuit coil

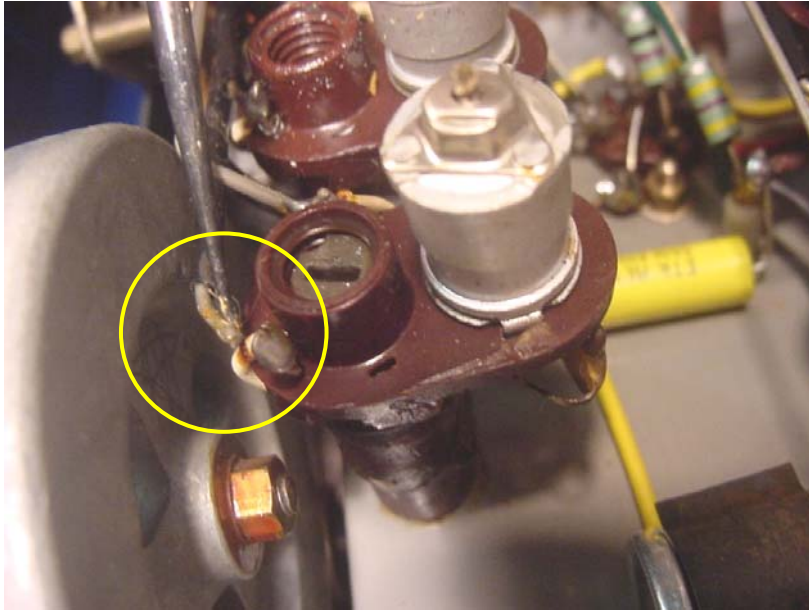
I finished the RF re-alignment per the table in the manual, sealing the Philips trimmers with a small dab of nail polish (photo, right), and then I finally tweaked the IF trap – job done.

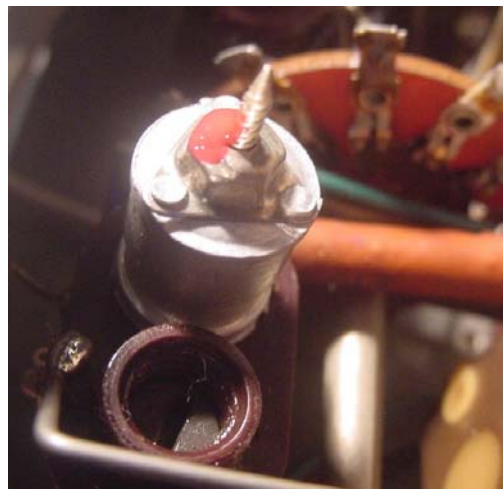
This done, very carefully, I could see that that all three arms of the spider were broken (photo, right) – no wonder the voicecoil was not centered! What to do? – try to repair this speaker – not an easy task, or find one that would fit? I removed the dome that covers the front of the spider using a scalpel and soon decided that it would be a very difficult and time-consuming job to repair (or replace) the spider and then centralize the voicecoil (and I have repaired several speakers before), so instead I decided to find a replacement speaker.

A trip to the SPARC museum the next day identified a couple of likely replacement speakers – both were 4 ohm units, tested ok and fit well, even having the same fixing hole centres. I selected the speaker with the larger magnet, made a cardboard gasket and fitted it in place of the original (photo, left) – sounds fine.

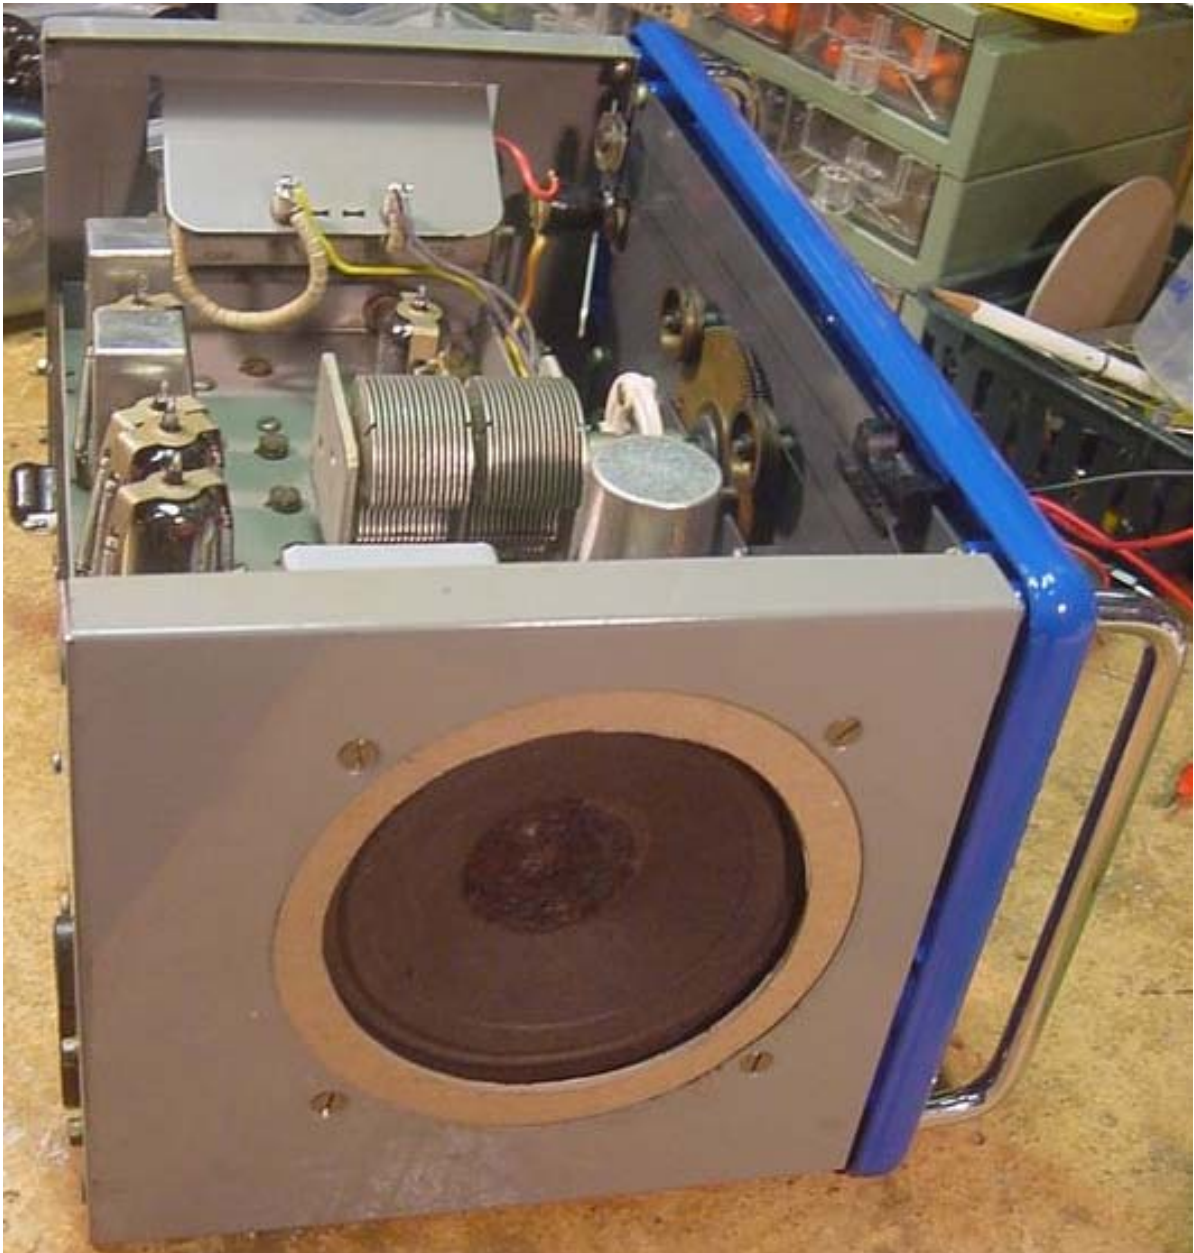
Above: replacement speaker fitted into the S.870

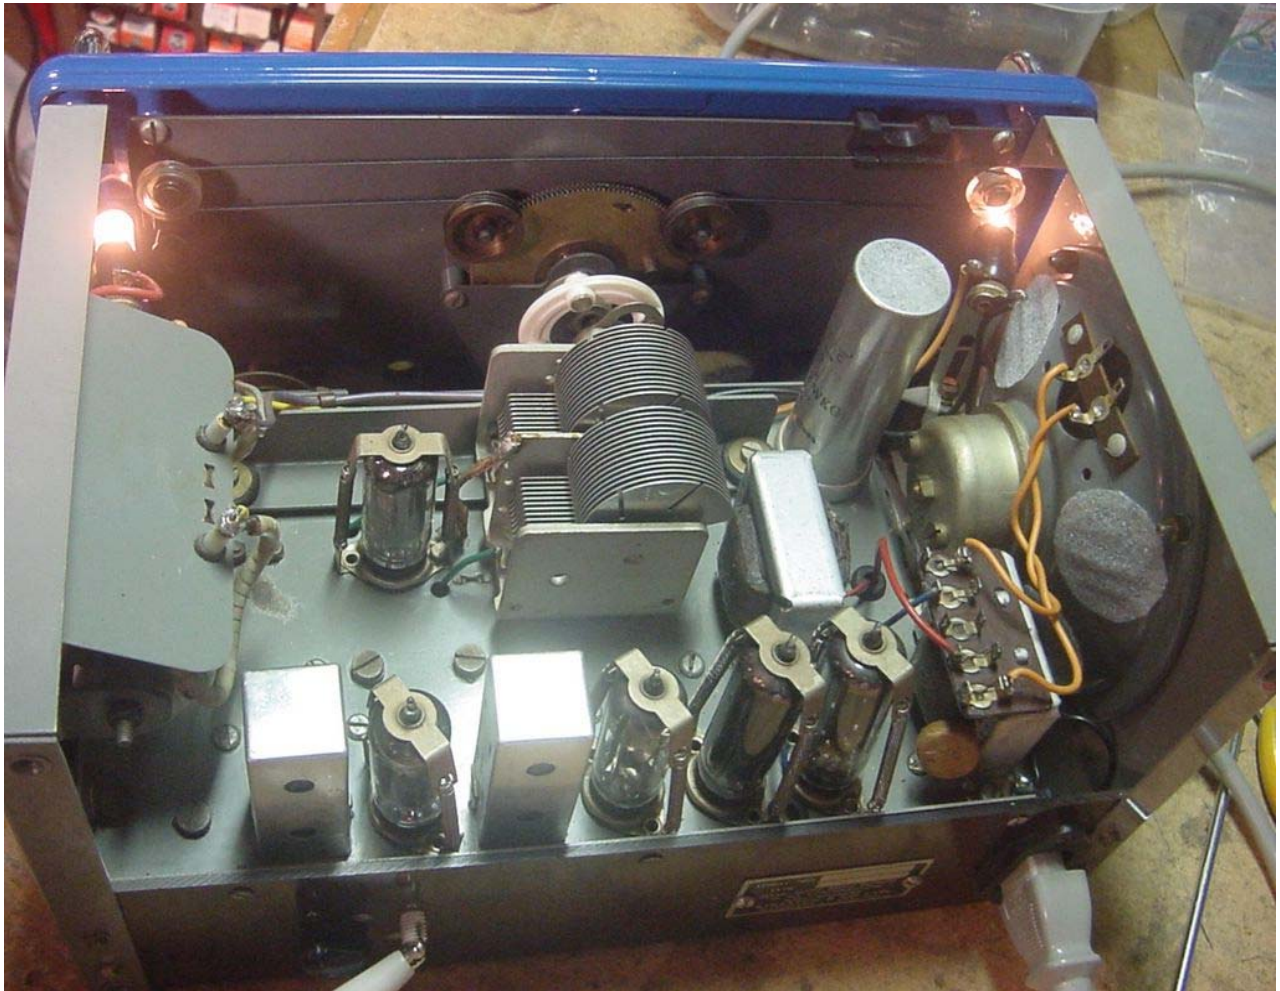
Above: all aglow and working well – apart from the lousy loudspeaker, subsequently changed-out. Below left: the UK Royalty label re-affixed to the bottom of the cabinet – details matter even in less-than-original restorative work. This was originally riveted in place but I found some tiny self-tap screws in the junk box that did the job nicely. Below right: IEC power connector

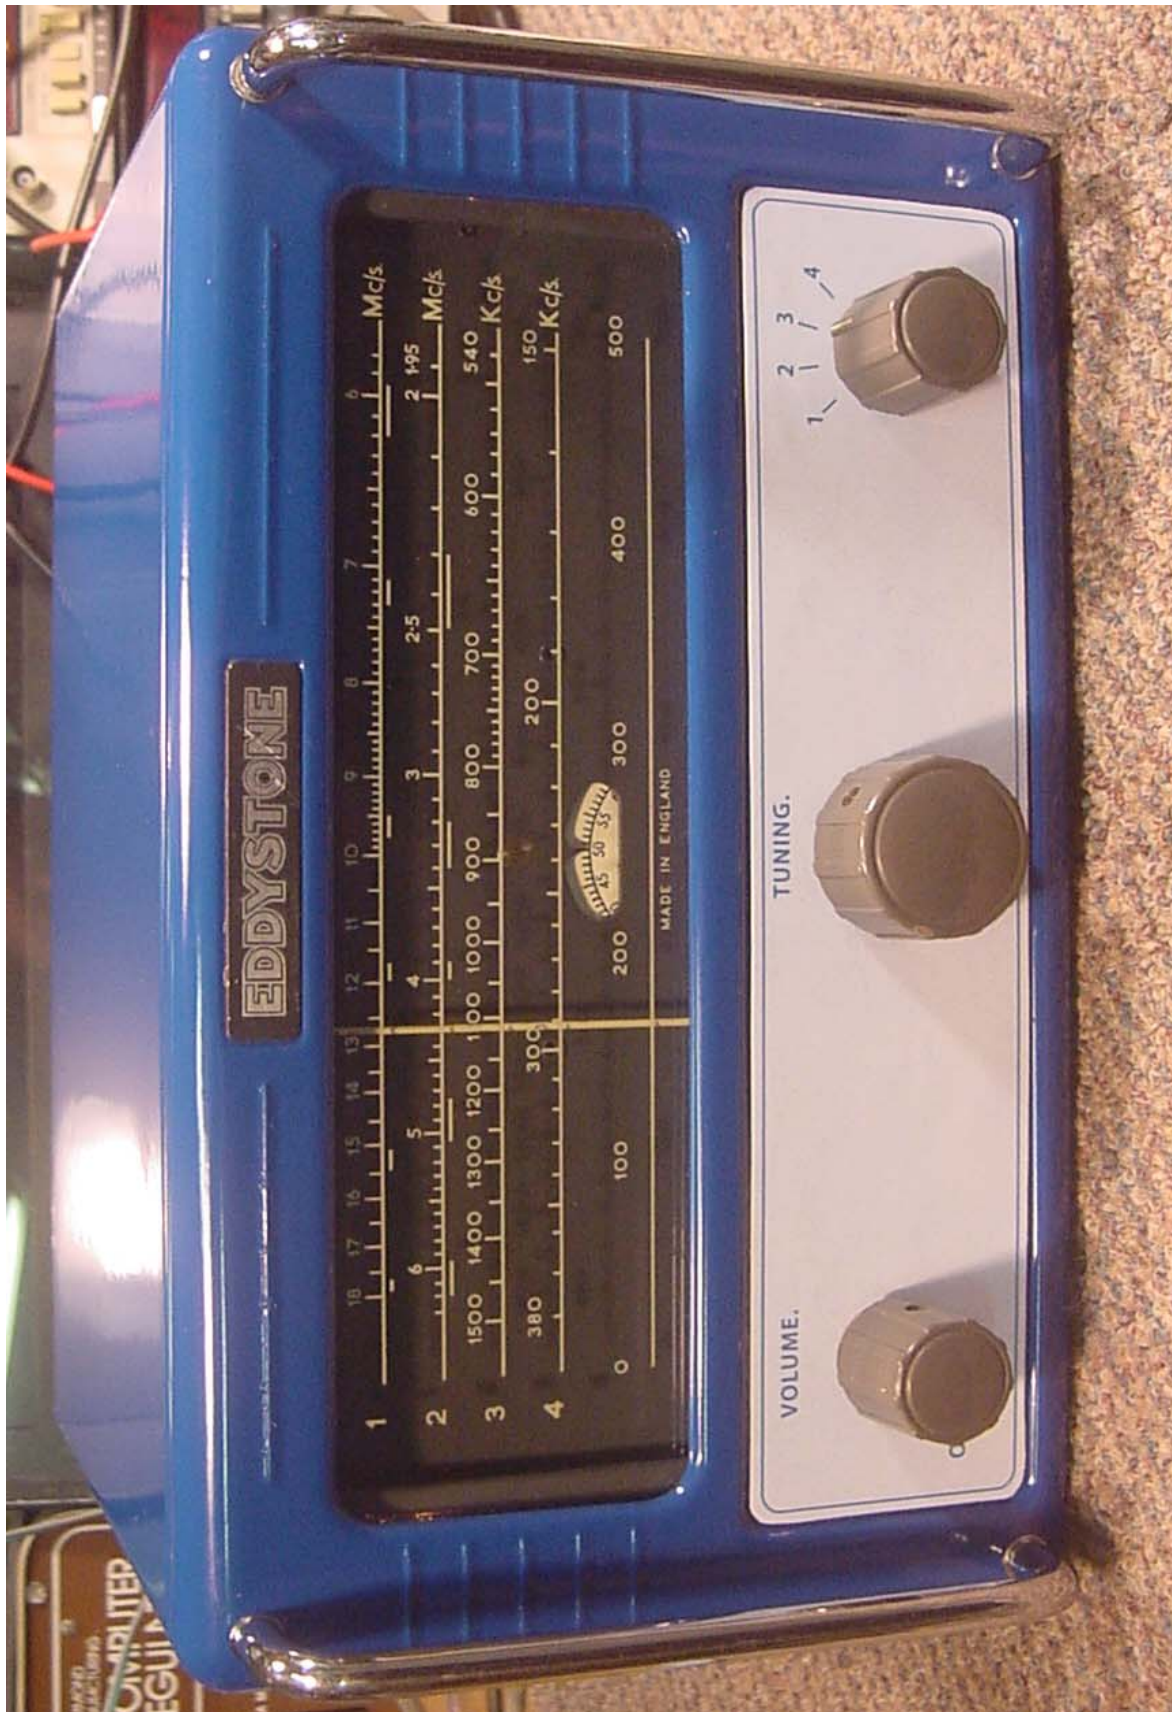
Fingerplate artwork for the S.870 and S.870A (downloadable from the EUG website)

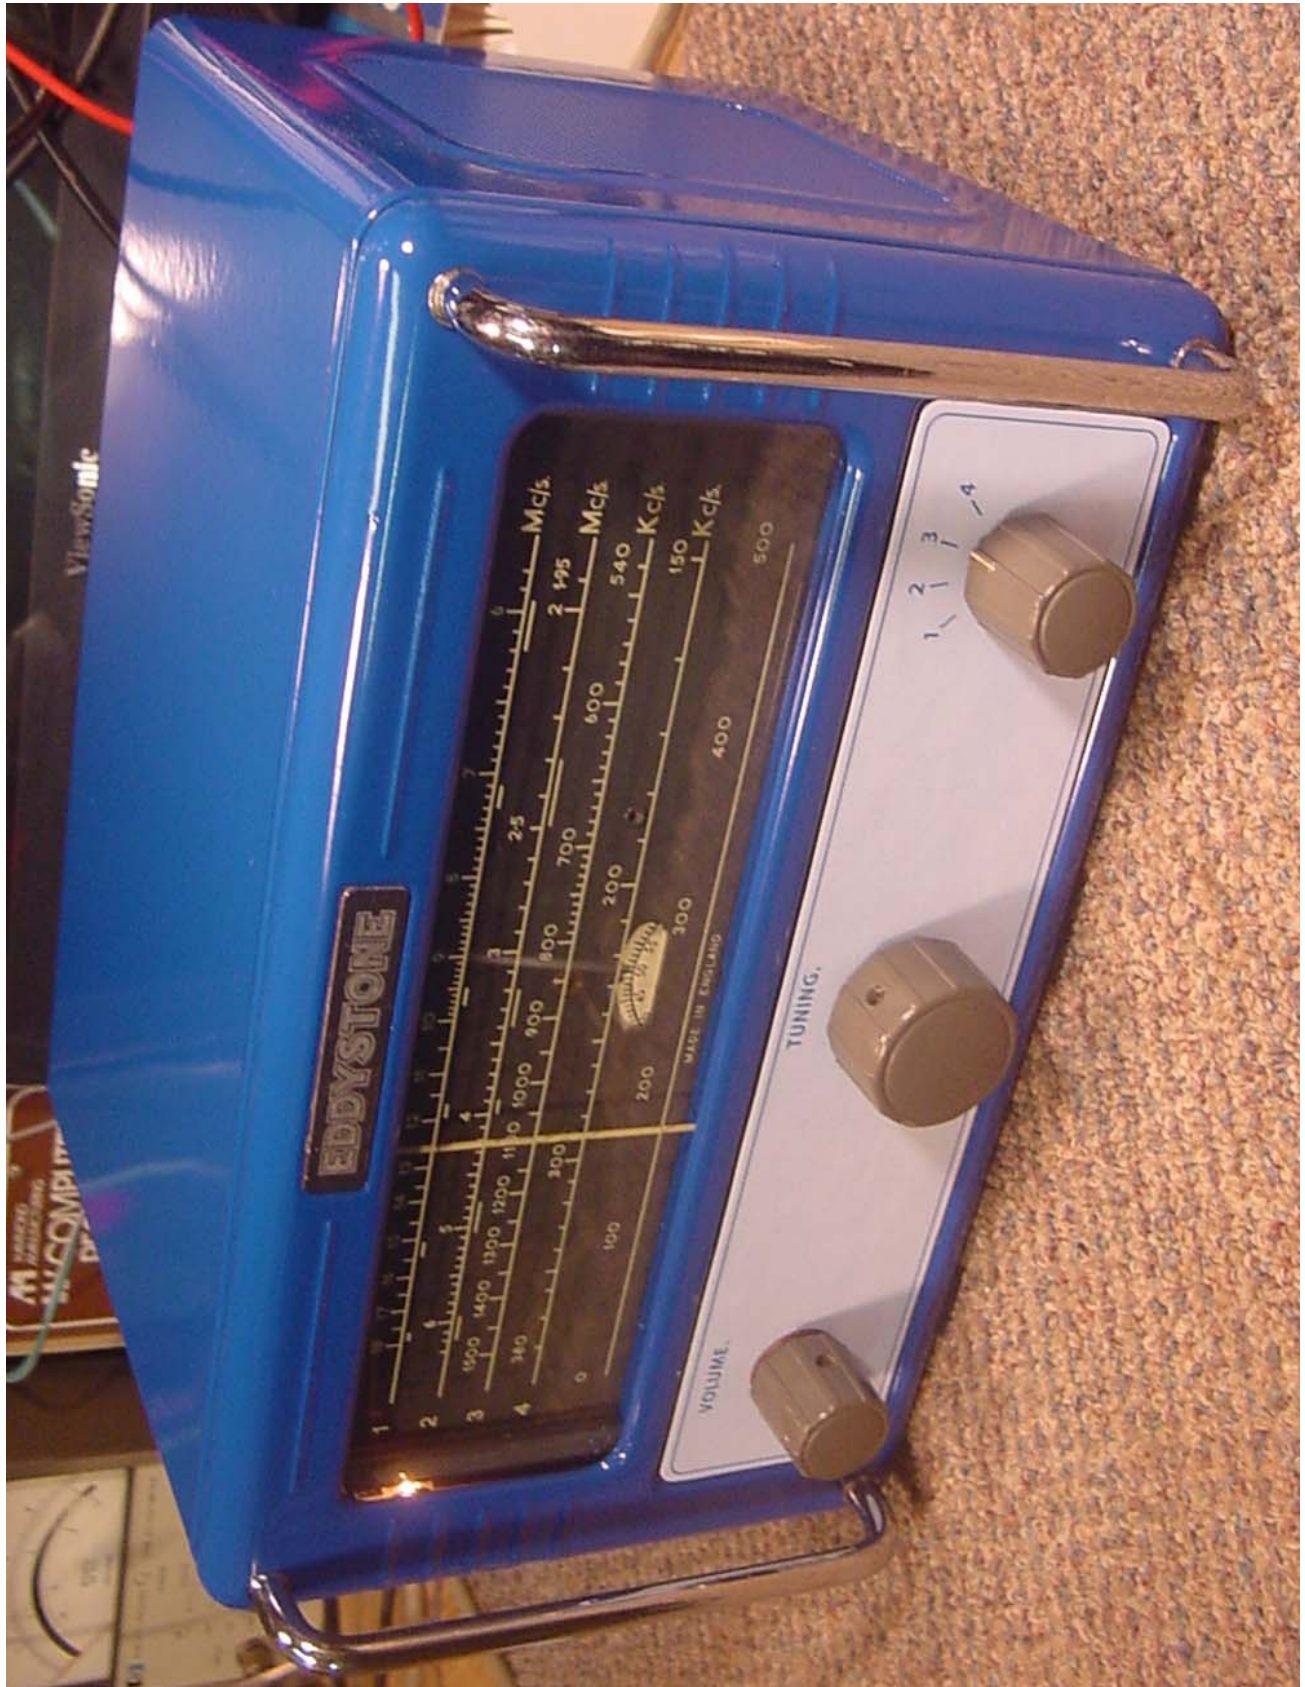
Above: S.870 with artwork fitted to the fingerplate – this was finished in a light blue with lettering in darker blue, printed on semi-gloss paper
