Eddystone 958/5 Repair

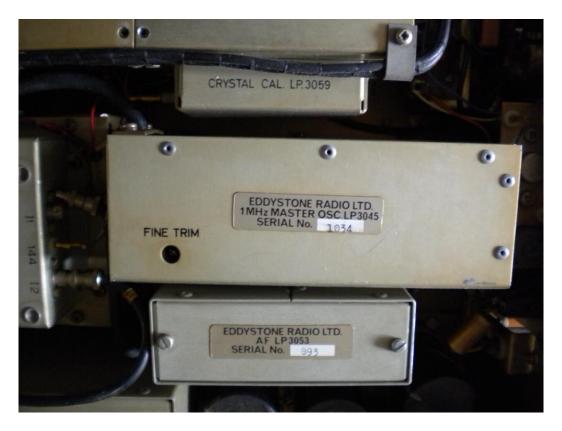
Now the master Osc unit looks formidable however after examining the manual there are only four voltage connection and two RF outputs.

The RF outputs where disconnected and checked for RF which was non existent so confirming my fear that this module had failed. The four voltages feeding the module where checked and found to be correct.

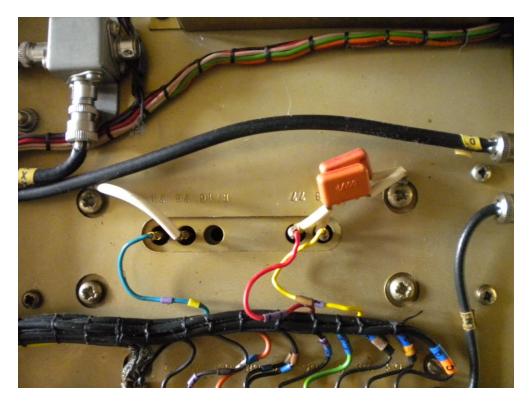
Therefore there was no alternative but to extract the module for further examination. Reading the manual the voltage connections where unplugged from the base of the unit. Coax plug "I" was unplugged and coax G was further unsoldered from within the RF box. The 4 x 6 Ba screw holding it in place where unscrewed and the module came out no problem.

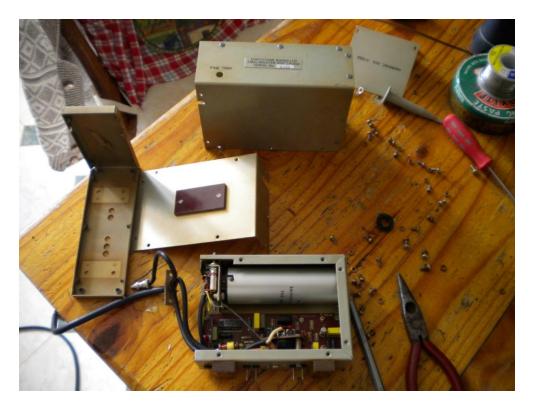
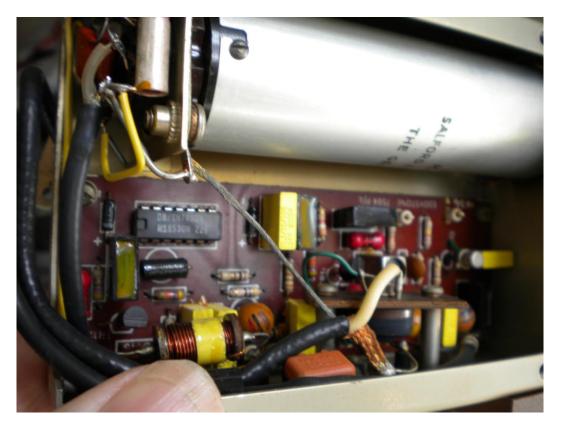
Now we can see the GEC temperature controlled crystal osc in its long can along with the divide by 10 circuit and pulse circuits.

Applying power again showed that there was no output from the GEC Crystal Osc. To obtain access to the crystal osc first you have to remove the holding plate at the end with $4 \ge 6$ ba screws, then with a small screwdriver prize the crystal osc. can through the hole.

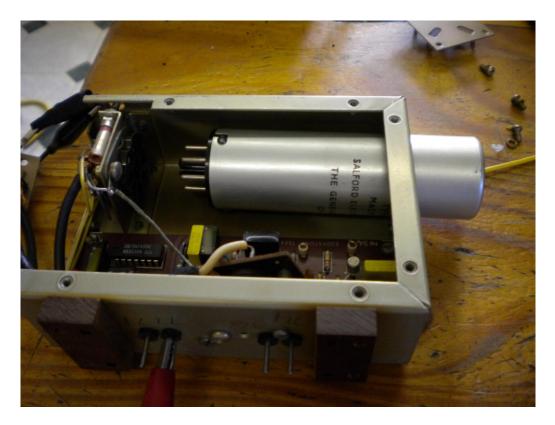
You will now have the commercial crystal osc can in your hand.

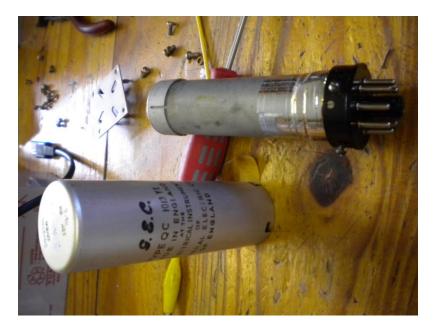
Ok so lets get into it. At the base are 4 small self tappers which need to be released, then the outside can, can be firmly rotated until it unlatches from the base. Remove the can. You will now have a metal can in your hands with a spilt sided cap at the top.

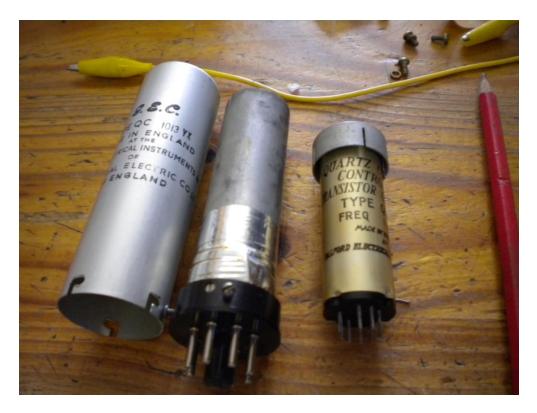
Gentle but firmly pull the split cap away from the base and you will have the actual Crystal osc can in your hands .

Now in my case the pins to the 9 pin B9A socket were badly oxidised so hopefully a good clean will get it working but NO it didn't . So investigation further deeded. With a small screwdriver ease up the 4 crimps about the base of the inner can.

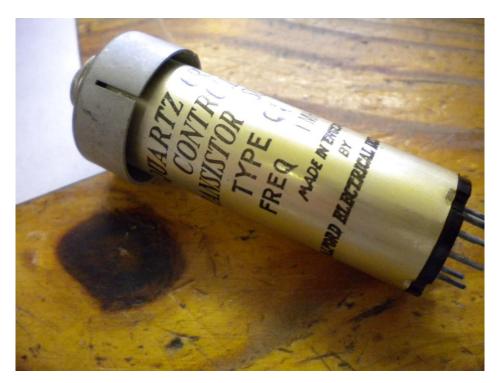
and slide it off the PCB inside.

This will allow you to see the simple PCB within the 1 Mhz Crystal PCB and a ZTX312 transistor . Examination of the components will identify the fault which in my case turned out to be the larger 2200pf polystyrene capacitor had gone short circuit and the 100 K resistor at the top was 174k. Both were replaced and the unit tested with success.
