Eddystone Model S.750, Serial Number FB0472

The S.750 is one of my favourite Eddystone sets. This one is my second S.750 restoration - the first already being documented in an article on the Eddystone User Group (EUG) website. This S.750 was kindly donated to the *Society for the Preservation of Antique Radio in Canada* museum (SPARC) in Coquitlam, BC, back in January, 2009 by Fred Kapogines in Guelph, Ontario.

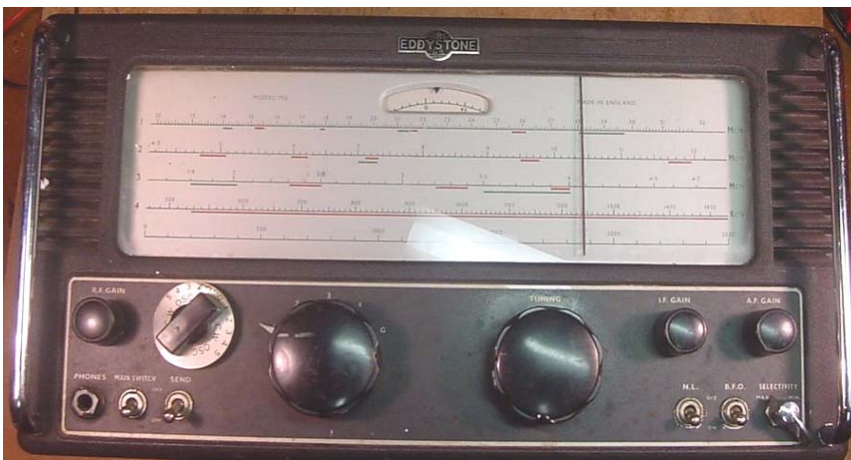
The QRG notes that this set was one of a production run of only 79 model S.750's built at the 'Bathtub' fitted with a 110v 25Hz

power transformer. This variant on the standard production was needed to suit the Ontario mains power system in the 1950s. According to serial number information in the QRG this 25Hz set dates from February, 1954.

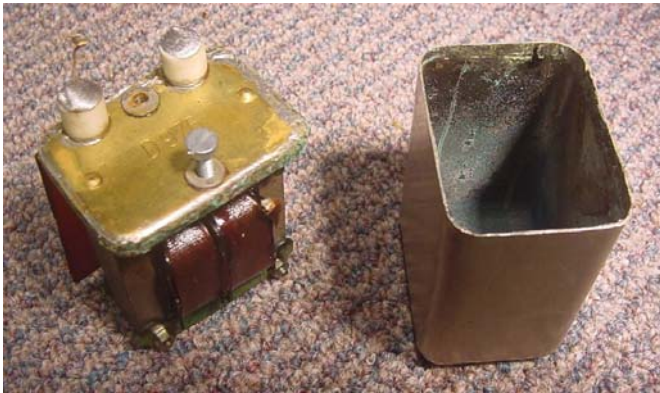
This S.750 was not working on arrival due mainly to an open-circuit HT choke, now repaired: the fault was a corroded wire internally on one of the connection posts. I found that the choke can

be opened-up quite easily by cutting the solder seal with a knife blade and then re-sealed by soldering and/or with epoxy. I re-formed the electrolytics, changed-out the dropper resistor to the VR150 voltage regulator (incorrect resistor value fitted as a previous repair) and the cathode resistor in the RF stage (68 ohms had risen to 230ohms) and re-soldered a silver mica capacitor that had come undone in the coilbox.

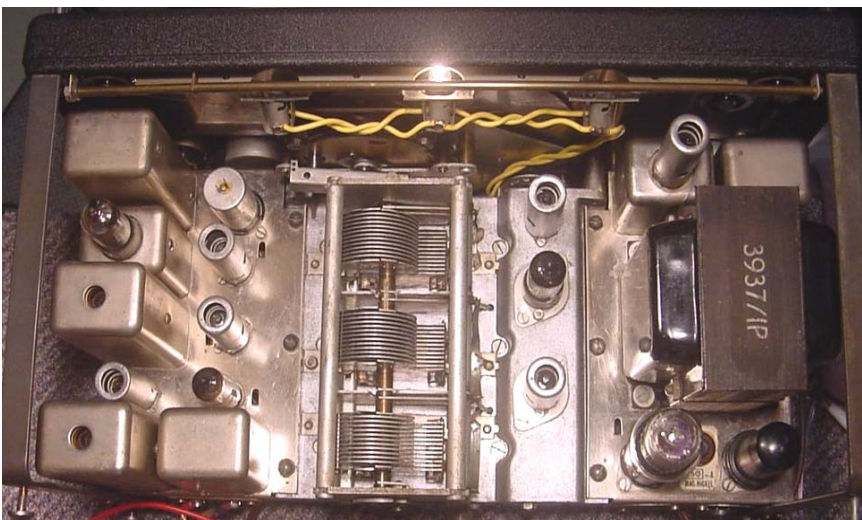
While I was aligning the set I noticed that the AGC line

was going positive by a couple of volts with no signal applied to the set. This also had the undesirable effect of increasing the HT current draw by several mA under weak/no signal conditions. Having checked the AGC line passive components, which were all ok, I suspected that one of the RF or IF valves could be faulty - replacing a 6BA6 (V5) in the 85kHz IF stage cured this.
