Restoring an Eddystone Model S.750

Gary Albach, April 2019, Victoria, Canada

This article documents how a simple weekend project expanded into the return of an Eddystone S.750 to its original factory condition, including restoration of the RF stage, the oscillator/mixer stages, the BFO wiring, the dial cord, and cosmetic touch-ups, in addition to the usual leaky capacitor and out-of-tolerance resistor replacements.

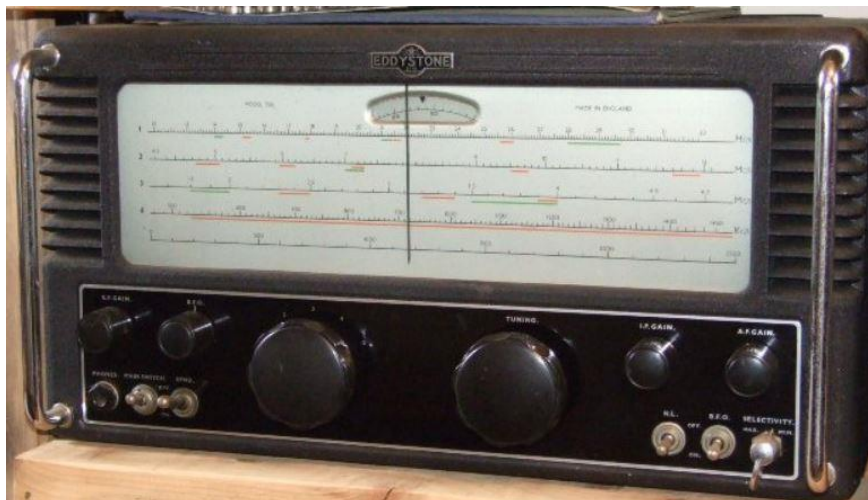
Figure 1: Eddystone S.750

The Eddystone Model S.750 is truly one of Eddystone's classic receiver designs (see Figures 1 and 2). First introduced in 1950 as a successor to their earlier pre-war models, it sold for an impressive £45 in 1950 (\$1,500 Canadian today!). The S.750 was their first true dual-conversion

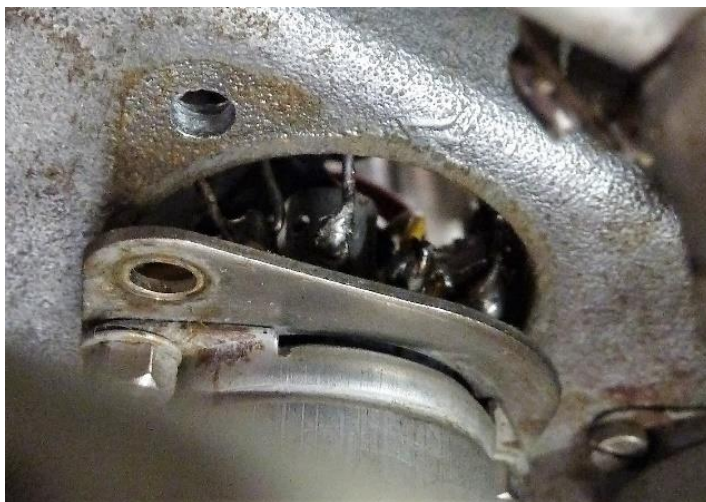
Figure 8: Rewiring tube socket from above

As with the RF section, this rewiring was done from the top of the chassis by leveraging the tube socket slightly out of the way (Figure 8).
