I obtained this 1830 receiver in 2005, and have just carried out some work over a period of about a month.

My 1830 Type 1 receiver was built in 1976 and was used as a Technician monitoring receiver for ATC HF and MF services in Australia.

This article is about renovation, repair and alignment, and is not in general a review of design.

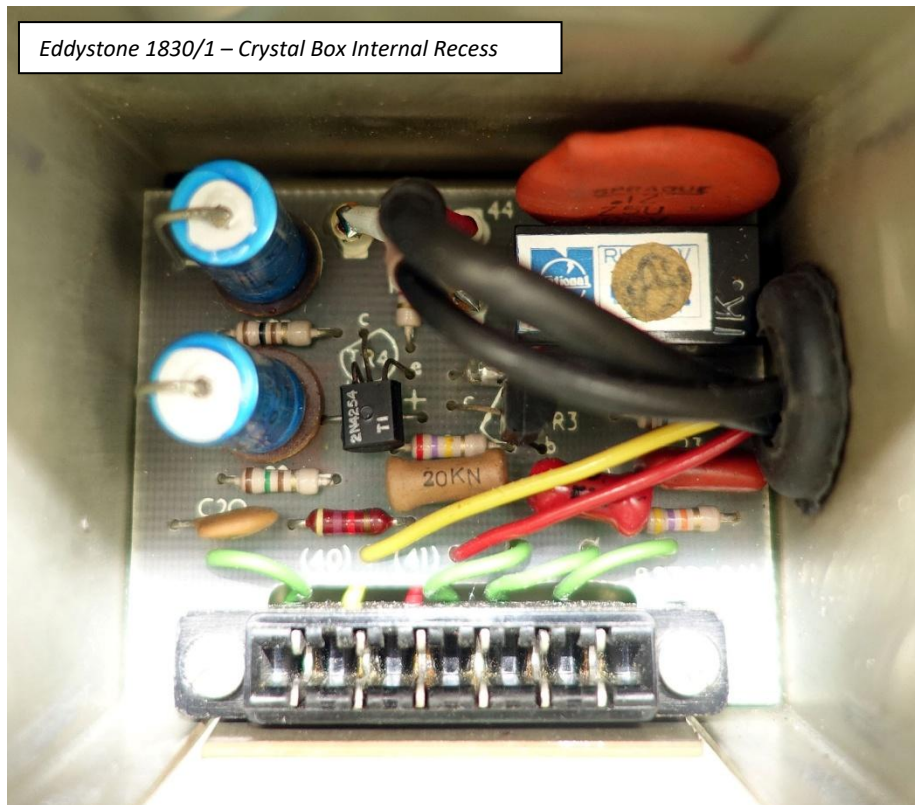
Eddystone 1830/1 – RF Peak Control PCB

After RF alignment, my RF Peak Control peaks up at all frequencies on all bands, and all within 45 degrees of control centre, and mostly within 20 degrees. It “feels” to have “a certain symmetry” of control, which probably infers that all varicap diodes are functional.

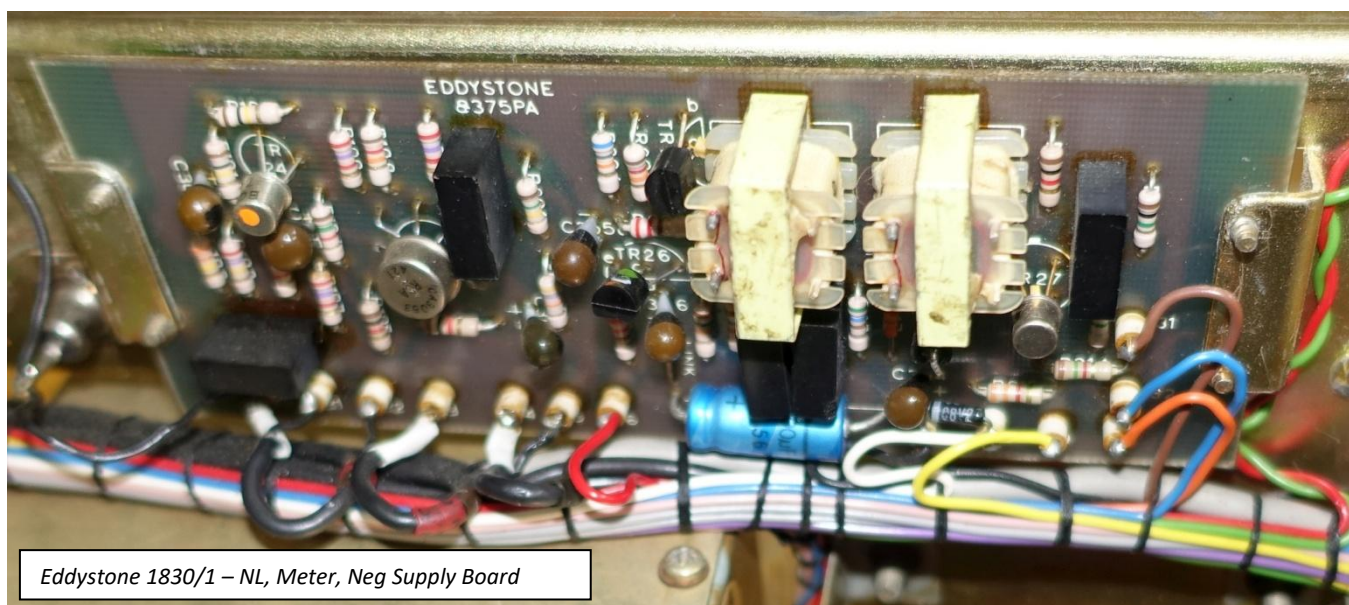
My 1830 Negative DC output was 7.8 VDC with 20mV pk to pk (approx 400Hz) ripple at “WP128”.

The Signal Strength Meter was adjusted OK for “meter zero” with antenna removed, and on mid tuning range of Band 4. Use the control pot on rear panel.

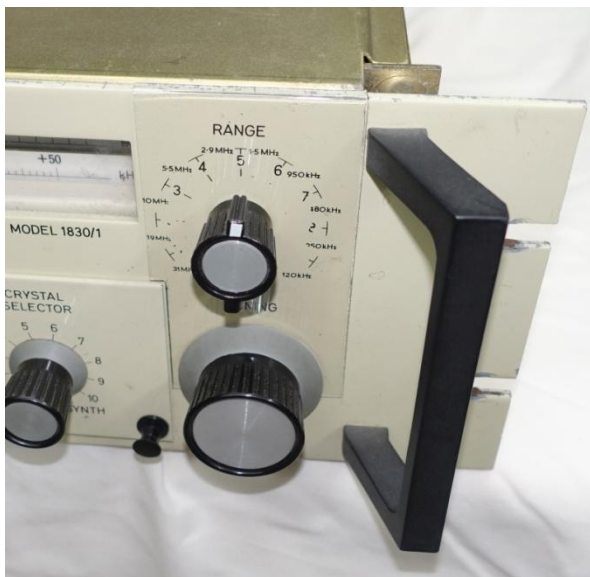
I have added a piece of clear acrylic plastic to protect the Front Panel Band Range painted labelling.

I used a 0.8 mm thick piece cut from a tabletop display holder. It is held in place behind the band change switch nut and washer. The top edge has a 2.5 mm lip at 90 degrees to fold over the receiver front panel. Photo shows size and place.
