My Eddystone S.888A Re-visited – Gerry O’Hara VE7GUH

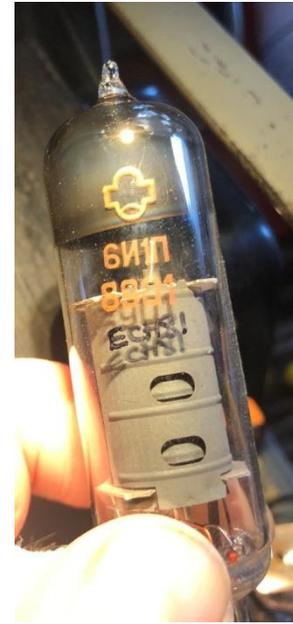
know they can fail). Several of the tubes are Russian-made equivalents, including the two ECH81s (6AJ7s) – photo, right. I recalled the previous owner mentioning that to me, and that he found them to work well. Then I noticed that whoever had done the work had missed a tubular paper cap that was hiding beneath two large resistors in the IF/AF compartment. Then I took a look in the coilbox, and noted that they had missed a few paper caps in there also – these are ones that I refer to as ‘ratshit’ caps as that is what they look like – small ovoid caps, sometimes with colour code bands, sometimes not – just brown. The photo, below left, shows a colour-coded one and also the internal construction. They are usually lower-capacitance values (500pF – 0.01uF is typical) and are low voltage, maybe rated up to 150vDC or so. They are often used as heater circuit RF bypass caps, snug against the tube bases (as in the S.888A RF section), but sometimes are used for screen or cathode bypass also. From experience I know these caps are invariably ‘leaky’ (measuring between a few tens to a few hundreds of Kohms), or open circuit, and their capacitance can vary

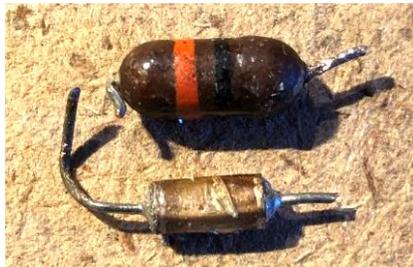
First, I changed the larger paper capacitor in the IF/AF compartment (circled yellow in the photo, right), hidden by the two resistors.

performance. So I changed these three bypass caps out: two in the coilbox and moderately difficult to access – circled yellow in photo, above, and one in the IF compartment and much easier as noted earlier, circled green in the photo at the bottom of page 2.

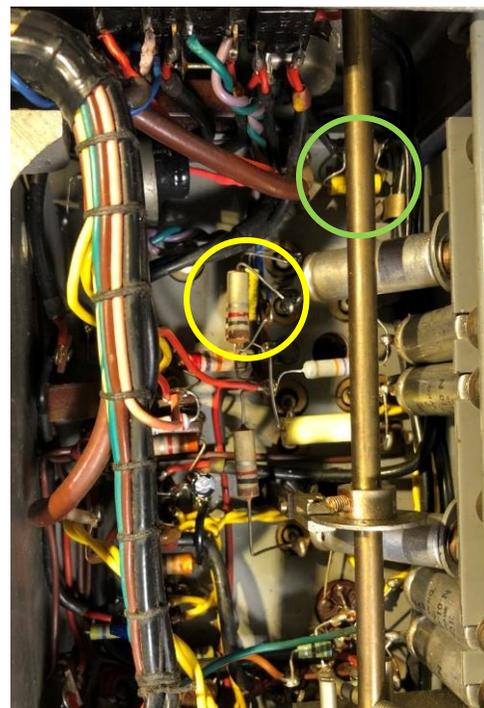
I then moved onto the coilbox. Here, the ‘ratshit’ caps are used for heater bypass on the local oscillator tube (one either side of the heater, tight against the tube socket – circled yellow in photo, below). These are extremely

difficult to get to and, given they only have a few volts across them and leakage is not an issue, unless there is cause for concern,

ie. a fault traced to these, eg. a short or instability, they are best left alone as there is a high chance of disturbing/damaging something else getting to them. I have changed these out on other Eddystone sets, but is very time-consuming, ie. it's a 'needs must' type of job in my book.

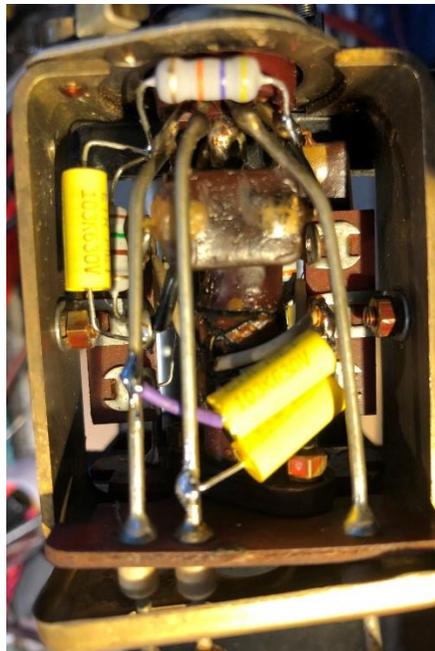
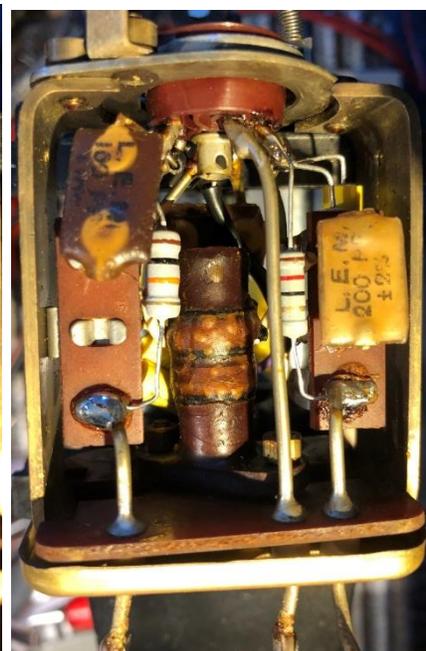
With the Product Detector back in place and function tested, I moved on to the 2nd converter unit. This is sandwiched between the 1st IF transformer (1.62MHz) and the 2nd IF transformer (85KHz). Removal is a similar process to removing the Product Detector – unsoldering several wires and noting where they go/taking a photo, etc., removing a couple of screws and it pulls out. Once removed and the screening can taken off it was obvious that nobody had been in there since the set was manufactured. It contained three 'ratshit' caps: two functioning as heater bypass and one as the screen bypass cap (with around 55vDC on it). The 10Kohm screen dropper resistor looked ok though, so it was not leaking excessively (it measured 400Kohms when removed). I replaced all the paper caps and resistors (photos, right) before reassembling the

unit and fitting back into the chassis. It function tested ok once installed and wired-up. I noticed that one of the resistors that someone had replaced previously (the 27Kohm screen dropper connecting to the 2nd converter unit in the IF/AF compartment) was also an incorrect value, so I replaced that also.

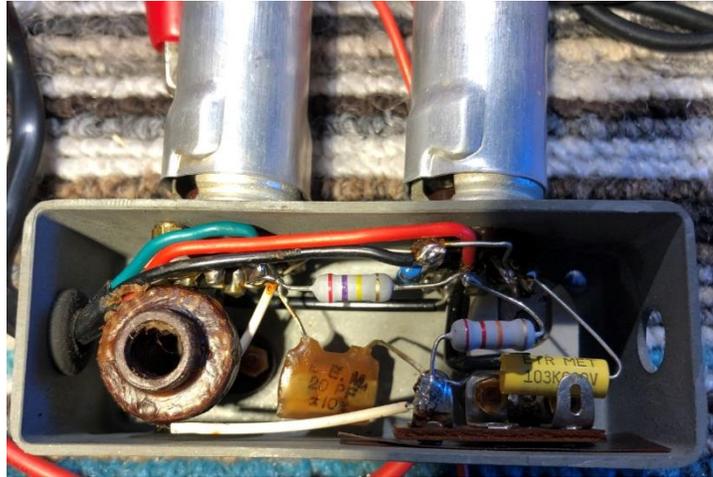
Next-up was the crystal calibrator: this is very similar to the one I refurbished recently for the S.940 (ex. S.730/4) – I replaced the single paper cap and the three resistors in this unit (photo, right).

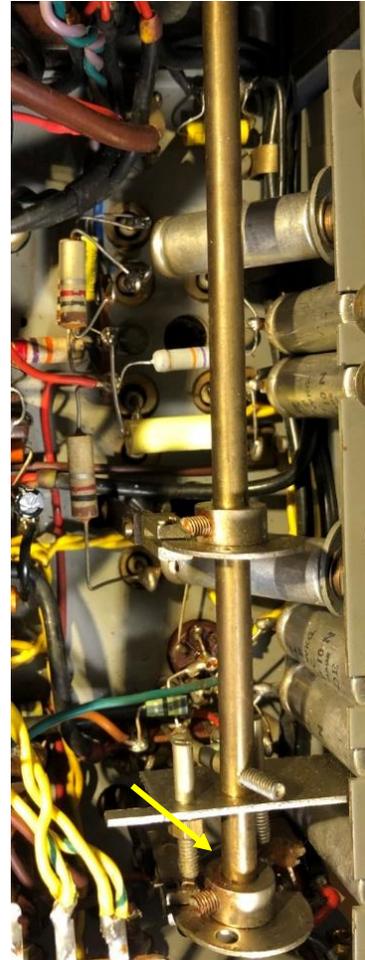
The manual provides the alignment method for both IF frequencies and the RF section – this is straightforward, especially as there is no crystal filter to set-up. The main complicating factor is the two IFs and the need for a signal generator that goes down to 85KHz. None of my analogue RF signal generators do, so I used my Heathkit audio signal generator which goes from 1Hz through 100KHz. However, this is not modulated, so I could not use an output meter for this part of the alignment procedure. Instead, I used a 'scope attached to the AM detector diode (a VTVM on the AGC line cannot be used for adjusting the final IF transformer cores as the AGC diode is fed from the anode of the 85KHz IF tube, ie. before the final IF transformer). An output meter was used for the 1.62MHz IF alignment as my signal generators can provide AM modulation at this frequency. All went smoothly and I was surprised at how far out of alignment both the 85KHz and 1.62MHz IFs were given the performance of the set prior to making these adjustments. The lower cores in the IF transformers (T1, T2 and T3) and the second local oscillator core (T4) are a little difficult to access – especially that for T3, which necessitated use of a long thin trim tool fashioned from a plastic knitting needle as my usual trim tools would not quite pass through the components and IF bandwidth control shaft above the core access hole (arrow on photo, above right).

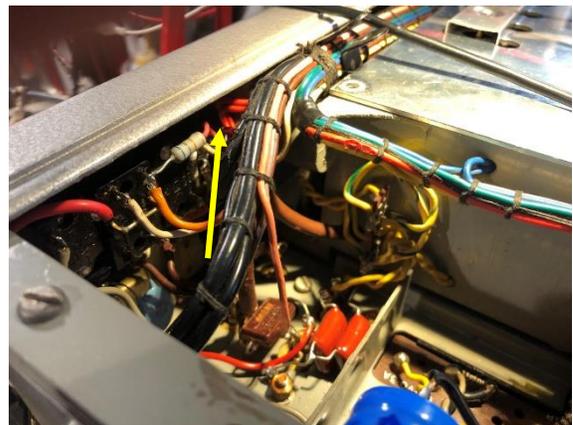
Following re-alignment, the set was left on 'soak test' for a couple of days. I started to notice some intermittent 'static' type noise – most prevalent on the 20M band, but discernable on the other bands also. This was traced to three noisy resistors: the anode load resistors of the RF and 2nd converter stages, and, in particular, the HT bleed resistor to the RF gain pot. The latter is very difficult to change (and hard to spot!) – its located behind the front panel, tucked away behind the crystal calibrator switch and a wiring loom - follow arrow in photo, right (no, its not the resistor you can see – its behind those red wires). I changed these resistors out, plus some others that connected to the same circuit nodes for 'good measure'. That solved the noise problem, and the set was now working well and reliably.

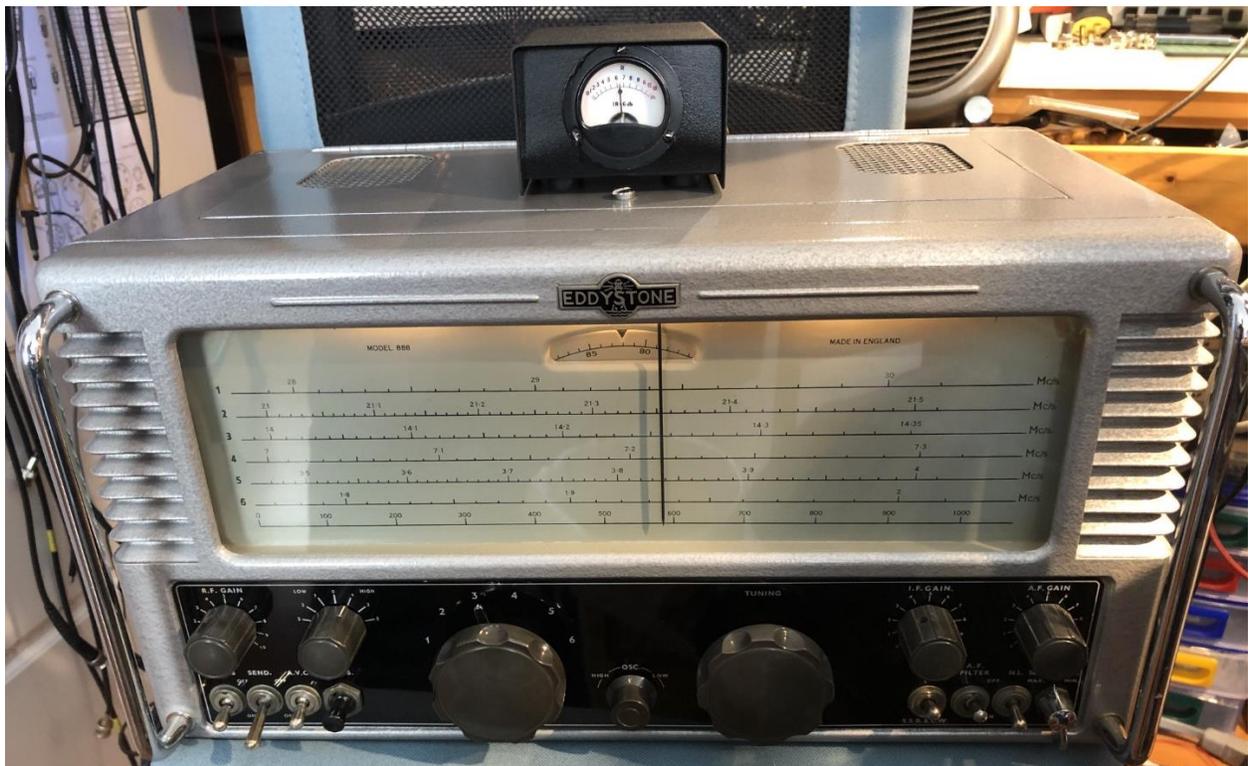
The S.888A came with a homebrew S-Meter. This comprised a small plastic box containing the zero adjustment potentiometer and fixed resistors, a small 'R-Meter'¹ on a (2 wire) flying lead connecting into the box wiring, and another (4 wire) flying lead terminating in an Octal plug. The circuit is that of an Eddystone S-Meter (Type 669)².

I tried this out on the S.888A and it worked well. It seemed a shame for it not to be housed in a box as it was not really usable the way it had been constructed. So I found a suitable small metal project box in my seemingly bottomless junk-box and installed the meter and plastic box assembly into it. Maybe not quite as good-looking as a real Type 669 S-Meter, but perfectly acceptable – photos below.
