My Eddystone 'Jewel in the Crown' (S.830/4) 'Re-re-re-visited' – Gerry O'Hara

This month's featured model

Eddystone 830

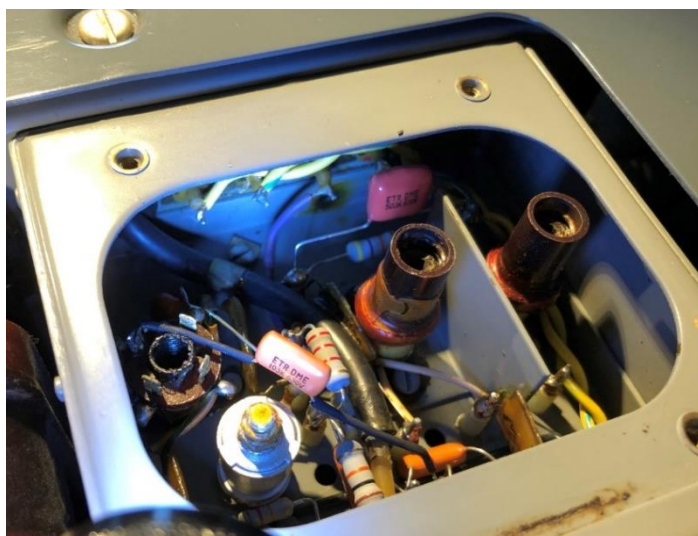
All Dubilier and Hunts paper caps had been replaced in 2011, together with all electrolytics (some in 2006), with the exception of the Plessey can electrolytics in the power supply (dated August 1968) which tested fine and so were left in place. All other caps are either silver mica or ceramic (tubular or disc), which have a very respectable reliability record. As noted in the above-referenced articles, I had replaced several resistors in 2006 and more in 2011, however, given it was 9 years since I had last checked the set over, I decided to measure each and every one, including some NOS 2W carbon compo ones I had installed in 2006. This is not a quick task in an S.830/4 with its 101 resistors, many of which are hiding in places that are very difficult to access (or even find!), eg. in the 1st Local Oscillator and RF/Antenna compartments, and 'buried' under layers of other components as in the cramped 'forest' of parts in the detector/AF section of the IF/AF compartment.

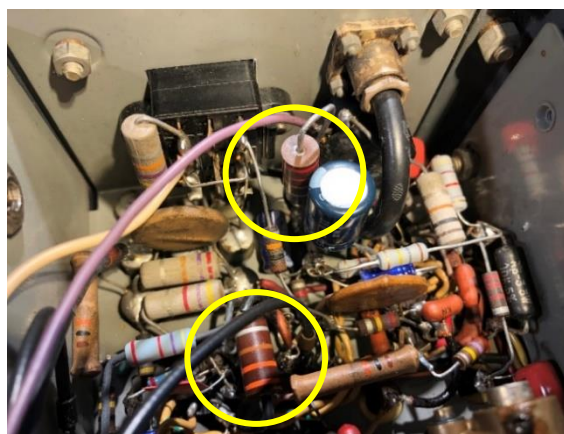
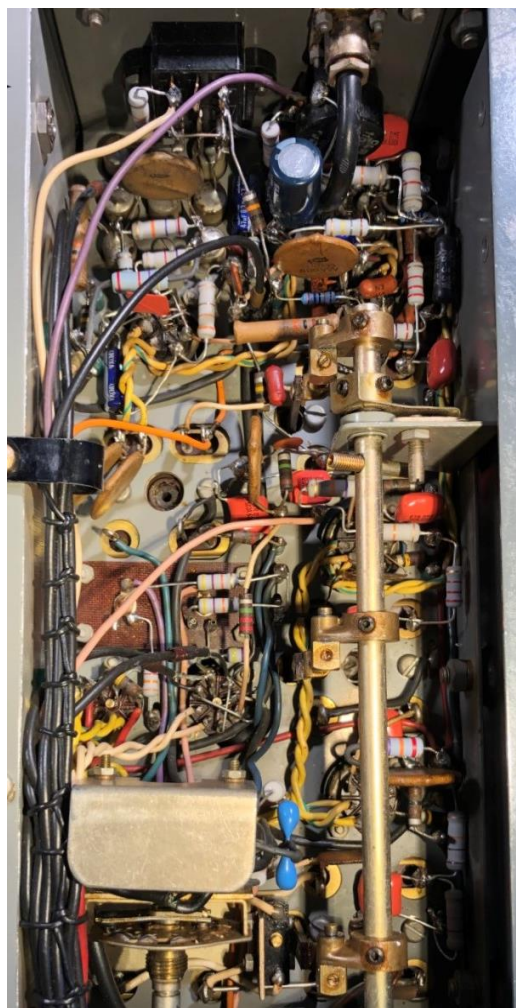
Most of the replaced resistors were in the IF/AF compartment (photo, left, after replacements installed), however, a few resistors in the RF/Antenna and Mixer stages were also changed out, necessitating extraction of the bandswitch shaft – a straightforward operation (loosen one set screw) that provides better access to the valve

bases in all three compartments. The photos, left, show the Mixer compartment access with the shaft in place (top) and with it withdrawn (below). However, even with the shaft extracted and the coupler removed, the components around the 1st Local Oscillator valve base are still not easy to access due to the layered construction. I had replaced all the paper caps in there in 2011 (it took some time as I recall), but I should have changed-out all the resistors while I was at it, though they tested well-within tolerance at that time. Thankfully, all resistors in the 1st Local Oscillator section still tested within tolerance, except R67, the screen dropper resistor for V12A, a 6.8Kohm part. It measured 7.9Kohms, so 16% off its nominal value (6% outside its marked tolerance), R66 (10.8% off nominal) and R75 (12.1% off nominal), these being the grid leaks for V12a and V12b respectively. I consider these fairly minor deviations to be ok for screen dropper and grid leak applications (and I don't use the crystal oscillator, V12b, anyway), so they were left in place given the level of effort to access these, combined with likely disturbance of the alignment on the higher frequency bands. I did, however, removed the crystal calibrator unit and replaced the resistors in that.

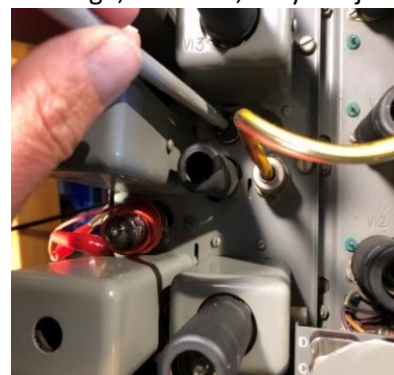
A check on dial accuracy was carried out, and given this was (amazingly) accurate, I did not undertake a full RF re-alignment – I just tweaked (peaked) the Mixer and RF stage/Antenna trimmers very slightly (most were peaked correctly anyway). I did confirm the IF centre (crystal) frequency and then adjusted the upper and lower sideband carrier insertion frequency pre-sets. I did not use the method as detailed in the manual – instead, I inserted a signal at the 2nd IF frequency by removing the screening can from the 1st 100KHz IF amplifier valve, and wrapping a wire connected to the signal generator output around the valve. I used a Heathkit (audio) signal generator that can be stepped in 1KHz increments. With the signal generator set at the crystal frequency, and with the S.830/4 in CW mode, I checked that the centre mark on the BFO pitch control was zero beat (it was). I then switched the signal generator 1KHz higher, and with the S.830/4 set to USB mode, adjusted the USB trimmer pot for zero beat (photo, above right). Next, I switched the signal generator to 1KHz

below the crystal frequency and, with the S.830/4 in LSB mode, adjusted the LSB trimmer pot for zero beat. This gave nominal 1KHz offsets on the correct sides of the 2nd IF centre frequency on USB and LSB modes. However, the offset should be 1.5KHz - this was achieved by connecting a frequency counter to the audio output and, with the signal generator again set at the 2nd IF centre frequency, adjusting the trimmer pots a little to obtain a 1.5KHz signal. I also adjusted the S-Meter zero as the bridge resistors had all been replaced in that circuit.

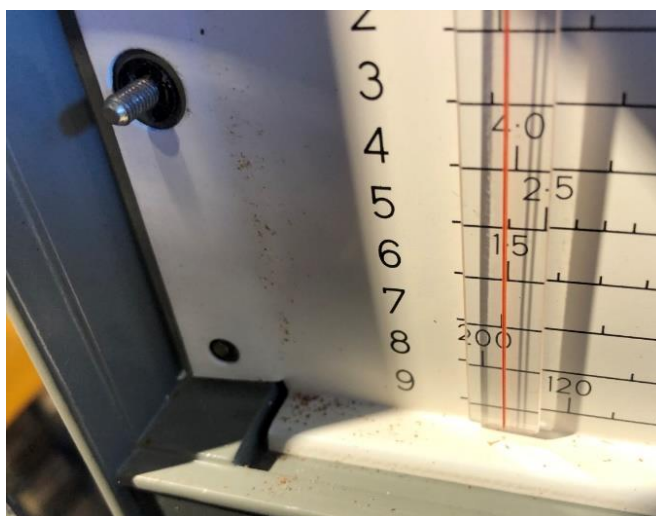
Some debris had accumulated behind the dial glass during the past 9 years – mainly stuck in the lower corners of the dial (photo, right - with cheek plates and dial glass removed for access). I removed the dial glass as described in the manual and gently brushed this away, and cleaned the dial glass before re-assembly. I also touched-up the white markings on several of the knobs.

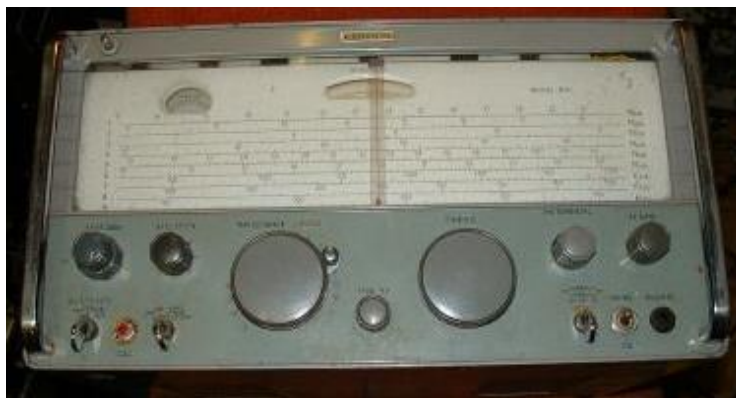
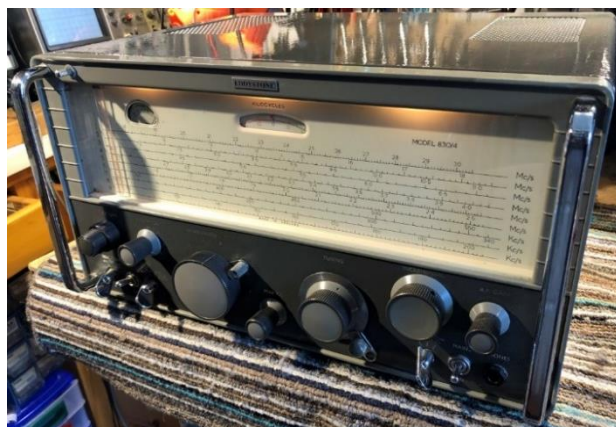
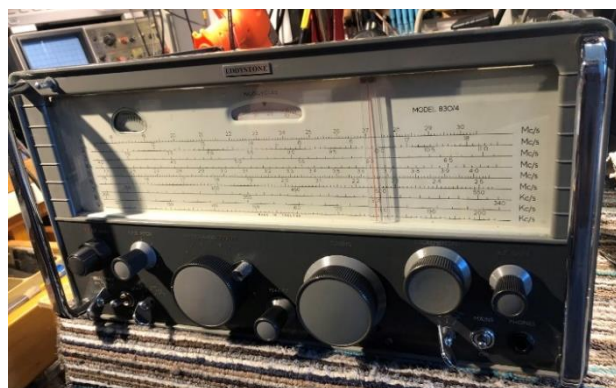
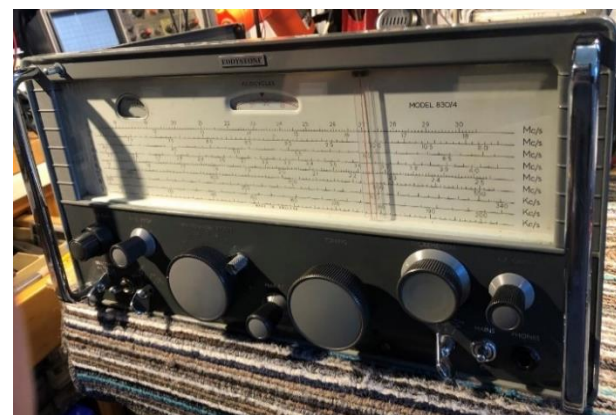
variant with the metal locking disk on the Tuning knob (and associated clamp and locking screw offset beneath). Yes, I know this is 'original'... but is it? - a photo of a 'development' model of the S.830 (photo, right) shows matching large bandswitch and (main) Tuning control knobs – much better!

two NOS large bandswitch/ tuning knobs. I must have bought these for my S.940 many years ago as the skirts on the knobs on my S.940 were chipped slightly. For whatever reason, I had not fit them then, but did so now (and look good!). Then, following an email exchange with another Canadian Eddystone enthusiast, Dave Whiting (see his article on 'The Eddystone 830/4 in Canadian Government Service' in [Lighthouse Issue 79](#), June 2003, p28, and 'Letter from South Porcupine' in [Lighthouse Issue 80](#), August 2003, p4), it was suggested that I try one of the larger knobs (off the S.940) on the S.830/4 in place of the small knob. Well, I did and I like it! – so for now it stays. I tried it with and without the skirt on the knob (centre and lower photos, left: compare with the original locking disc Tuning knob fitted in the top photo). Although the latter better-matched the un-skirted bandchange knob, to me at least, it did not look right, as the rear of the knob was too far from the fingerplate and the spacing cannot be adjusted closer due to the front of the bearing (unless a rebate was machined into the knob). Also, the bandchange knob cannot be fitted with a skirt because of the crystal selector switch lever.

This 'mod' left two threaded holes in the fingerplate to the lower right of the Tuning knob vacated by the screws of the locking mechanism clamp. To blank these off, I fitted a couple of 4BA screws into these holes, with their heads painted grey. Serendipitously, however, at about the same time there was a posting on the EUG website from

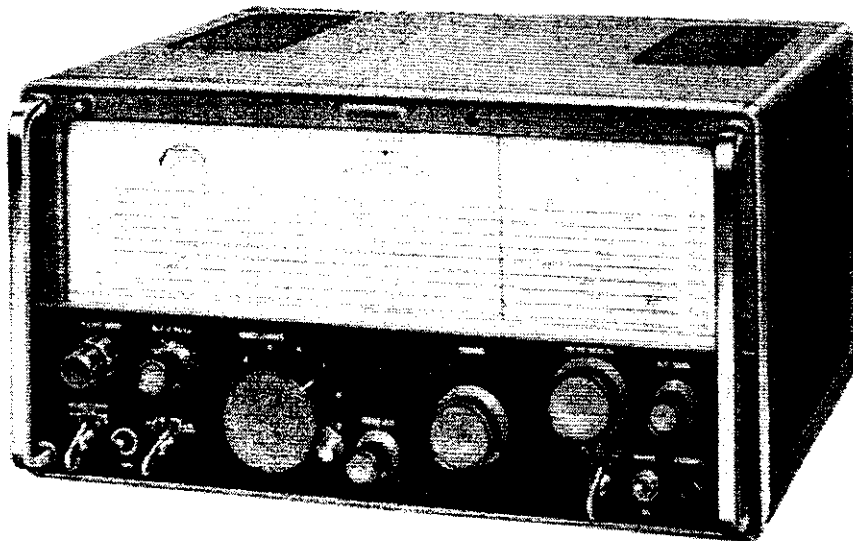
Eddystone Model 830/7 (Retail price £275-£442)

The Eddystone "830/7" is a high-grade general purpose HF/MF communications receiver covering from 300 kc/s to 30 Mc/s in nine ranges. It is of compact dimensions and both rack-mounting and table versions are available. Operation is from any standard AC mains supply and provision is also made for using external power supplies.

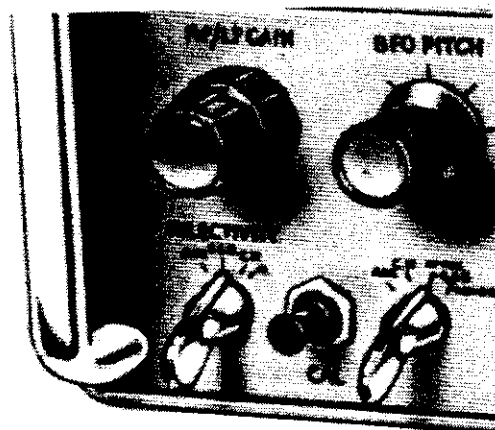
The black Bakelite CAL button.
