My S680/2 Revisited in 2020 – Gerry O’Hara VE7GUH

Background

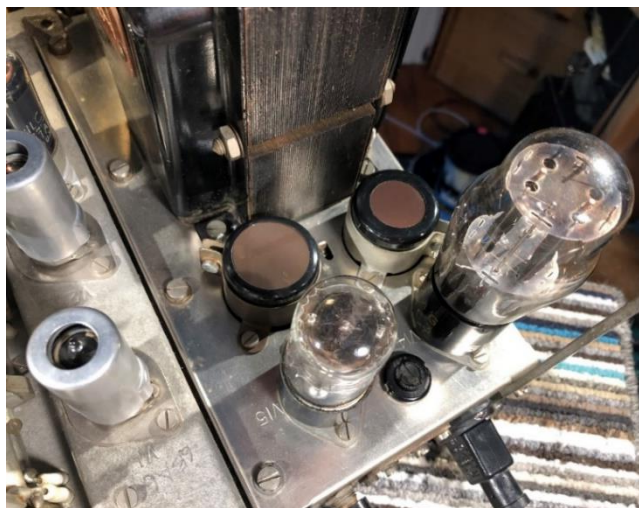
I then replaced the 5Z4 with the NOS 'mil. spec.' 5Z4G (photo, right) and found that the HT voltages rose slightly, but still within the 10% tolerance of nominal. Then, just as I was thinking the set was running fine with the upgraded power supply, I smelled that distinctive aroma of burning electronics...

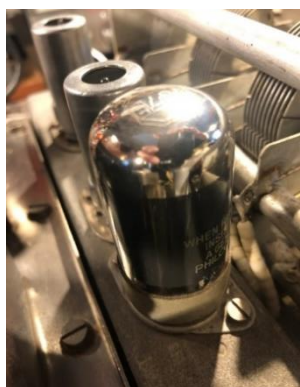
I switched the set off immediately, and upended the chassis again. On switching it on, I saw a wisp of smoke float out of the rheostat that is used to dim the dial lights. After some poking about I found the problem - I had nipped one of the leads going from the rheostat to the dial lights beneath one of the

bolts that hold down the can capacitor clamps – it cannot have been making good contact, but turning the chassis the right way up must have been just enough to instigate a short. A sleeve of yellow heat-shrink soon fixed that problem and, thankfully, the rheostat still worked just fine (good old 'Colvern' – I think their motto must have been 'We may be scratchy and rough, but we're also solid and tough!' ...).

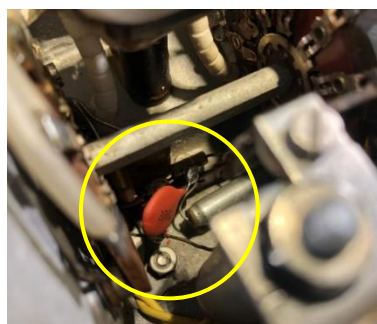
controlled valve grids, so I was not concerned at the AGC bypass caps being overly-leaky. All the 0.1uF 'Metalboss' caps tested were an order of magnitude less leaky than the 'Metalmite' ones, and so even the plate and screen supply bypass caps were not causing issues such as lowering voltages or overloading resistors, and, of course, those used as cathode or heater bypass caps were also fine at these very low leakage levels. All the caps tested were close to the marked capacitance values, so, for now at least, I decided to leave these capacitor types installed in the set. I have some thin-bodied 0.1uF 630Vw plastic film caps that will enable the 'Metalboss' caps to be stuffed in the future if the leakage worsens significantly – not an insignificant task though, especially given the possibility of PCBs being present... While I was in 'capacitor mode', I installed a couple of Y-Class 0.01uF mains filter caps on the IEC power socket, and installed C11(b), a 0.01uF cathode bypass cap in parallel with the 0.1uF 'Metalboss' one in the 1st RF stage. These are both marked 'C11' on the schematic and parts list, and the 0.01uF part was missing in my set – it was likely a later revision introduced during the production run of these sets and is shown on the schematic as being located right at the valve socket, likely to improve bypass efficiency at higher frequencies (a similar cap was added to the 2nd RF stage cathode in the S.680X⁴). I used a disc ceramic cap as these are relatively low-inductance, especially if the leads are kept short, and are thus very suitable

for RF bypass applications. Also, their compact size allows relatively easy installation in the rather cramped space available adjacent to the 1st RF amplifier valve base (circled in photo, left).

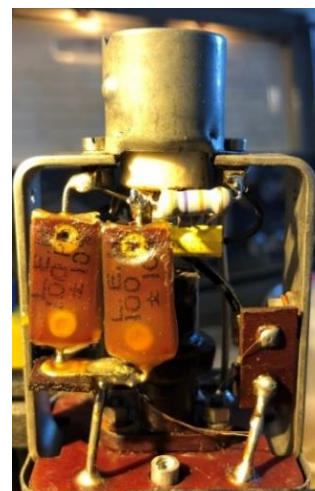
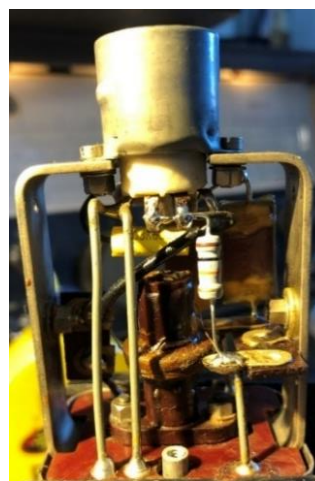
one end was disconnected when checking capacitors, or where in-circuit testing gave ambiguous results. I eventually ended up replacing 17 resistors. The worst drifting had occurred in three of the cathode resistors (1st RF, 2nd RF and 1st IF amplifier stages), where these were 150 – 400% higher than their marked values. The others replaced were either marginally outside their marked tolerance or were in the BFO can: the two resistors in the BFO can tested ok, but were replaced anyway as I took the unit off to replace the paper bypass cap inside (photos, right). This is a prudent thing to do as removal/replacement of the can takes a while⁵. On checking the receiver after the cathode bypass resistors had been replaced there was noticeably more gain.

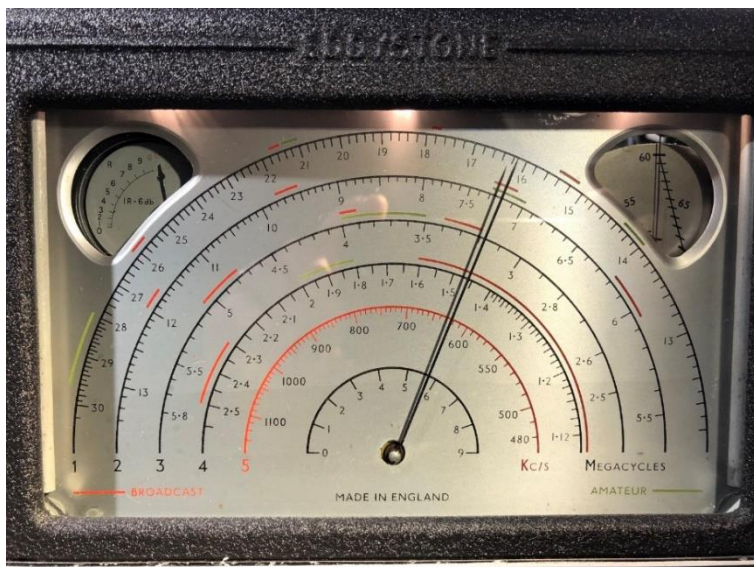
(see pages 10 – 16, [here](#)) and found that the alignment was still pretty good, though the widest IF bandwidth setting showed a slightly asymmetrical top to the flattened response curve. A very slight tweak of the slugs in the primary core of T1 and secondary cores of T2 and T3 corrected that.

I also noticed that the amplitude of the response curve in the widest bandwidth setting was around half of that on the other three settings. Checking the schematic, I noted that the gain of the 2nd IF amplifier stage is controlled by varying the cathode resistor between each bandwidth setting. In the widest setting, an 8.2Kohm resistor is switched into circuit. This had drifted a little high in value (8.9kohm), but was within tolerance. I experimented a little with different resistor values and found that a 2.7Kohm resistor equalized the amplitude of the response curve with the other bandwidth settings. On comparing with the S.680X schematic, I noted that only the second-widest bandwidth setting in that circuit contains a resistor (560 Ohms), the others are simply shorted out. Given this, I thought I may as well leave the 2.7Kohm resistor in circuit – an easily reversed tweak if anyone ever wanted to revert to the original value. The upper four photos, right, show the IF responses, from 'Minimum' at the top, to 'Maximum', the bottom photo showing the response on 'Minimum' with the crystal filter switched in.

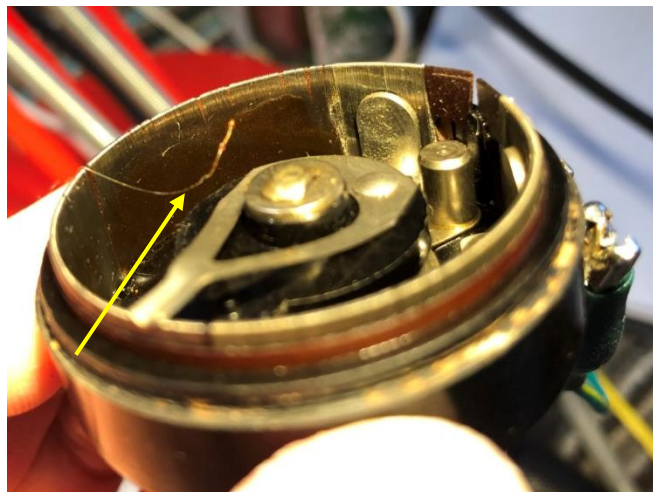
I was using the receiver following the alignment work when I noticed something wrong with the RF gain pot (used as a rheostat). As in other Eddystone valve receivers, this is a 'bespoke' wire-wound 10Kohm anti-log law part. This particular example was a little rough, in that you can feel each time the wiper passes over a change in the Nichrome wire it is wound with: to obtain the correct law, the winding is actually a combination of several windings of different resistance value Nichrome wire, these 'segments' overlapping, to provide continuity. I have felt this effect in some other RF gain controls on Eddystone sets, though not as pronounced, but now I noticed when this RF gain pot was backed-off

around two-thirds of its travel, the signal cut out. I decided to remove the control, open it up and inspect it. The problem was obvious – a piece of Nichrome wire from one of the winding segments had detached and was not making connection with the adjacent segment (arrow in photo, left). Nichrome wire does not take solder well, so I decided to effect a repair using glue and electrically-conducting paint (the type used to repair rear window defoggers in cars). I trimmed the loose wire, cleaned it and the adjacent winding segment with IPA, then held the end of the wire down against the cleaned

section with a dab of epoxy glue. When the epoxy had set, I applied four coats of the conductive paint over where the wire was held against the adjacent segment. When dry, I applied a coat of clear varnish over the conductive paint to provide additional physical stability/protection, plus a little silicone grease to the wire track for lubrication (photo, right). The control was tested (and worked ok), before re-assembling and re-installing in the receiver. It was now working as it should again – phew! (these pots are 'unobtainium', and a linear-law pot does not work well, cramping all the 'action' into a quarter of the rotation).

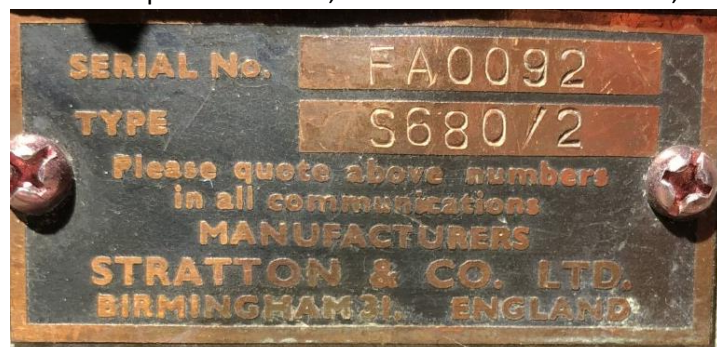
Eddystone stalwarts introduced in the 1950's (such as the S.680X, its military derivative, the S.730 series, and the S.888/S.888A amateur band models), and the early-1960's (such as the S.830 series, S.940 and EA12). This particular S.680/2, S/N FA0092, dates from June, 1949 (photo, left), and was therefore from an early, possibly the first, production run of
