## Eddystone S.820 Revisited – Gerry O’Hara VE7GUH

### Background

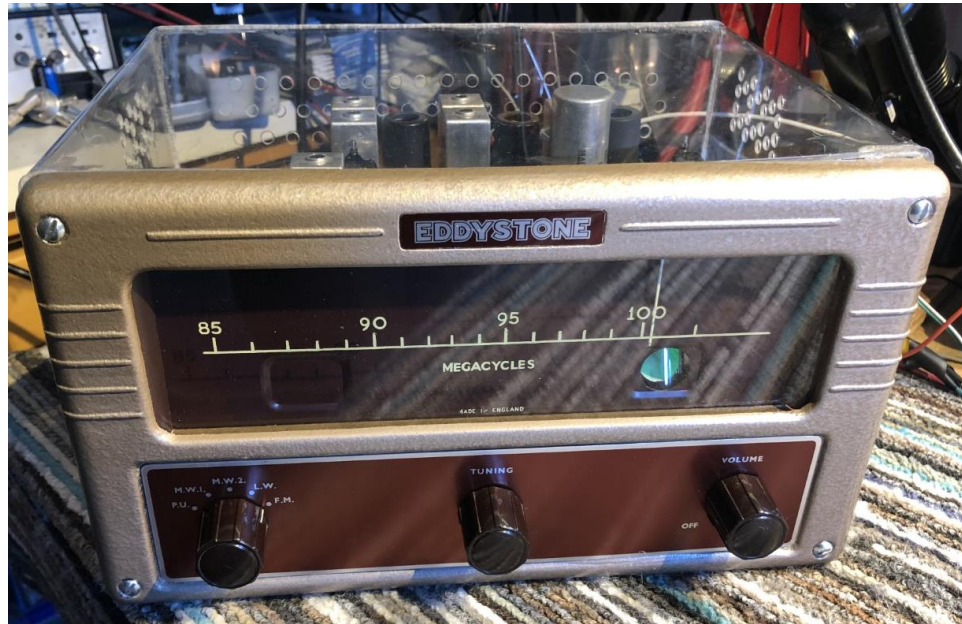
Having worked my way through most of my remaining collection of Eddystone sets earlier this year during the Covid-19 ‘lockdown’, I thought it was probably time to give my Eddystone S.820 AM/FM tuner the ‘once-over’ as well. I last worked on this little guy in 2007 – mainly cosmetic work,

constructing a case from acrylic (photo, above), and realignment, but I also replaced some resistors and installed fuses. I had not powered it up for several years, mainly because it is a 240vAC unit and therefore a little inconvenient to set up here in Canada (120vAC power), so I tend to use one of my refurbished QUAD tuners, which are set for 120vAC operation, when I feel like listening to FM stations through my ‘HiFi’. I did recall that the last time I had it running – probably five years or so ago - it did not seem as good as when I had restored it. So here it is on the bench again. An article on my earlier restoration work can be viewed [here](#) (I cannot believe it was 13 years ago!).

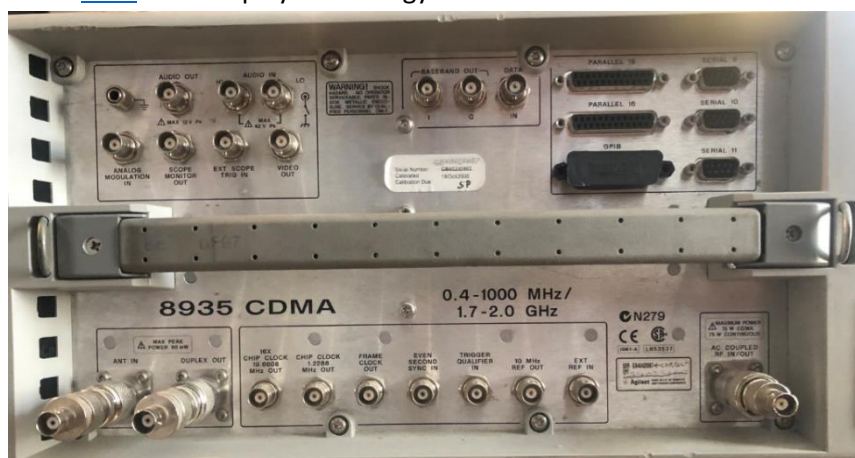
Agilent unit are located on a panel on the side (photo, above), making it awkward to use on the bench. To overcome this I built a couple of 'breakout boxes' to facilitate making connections at the front of the unit (visible to the right of the Agilent and the Drake MSR-2 receiver in the photo, right).

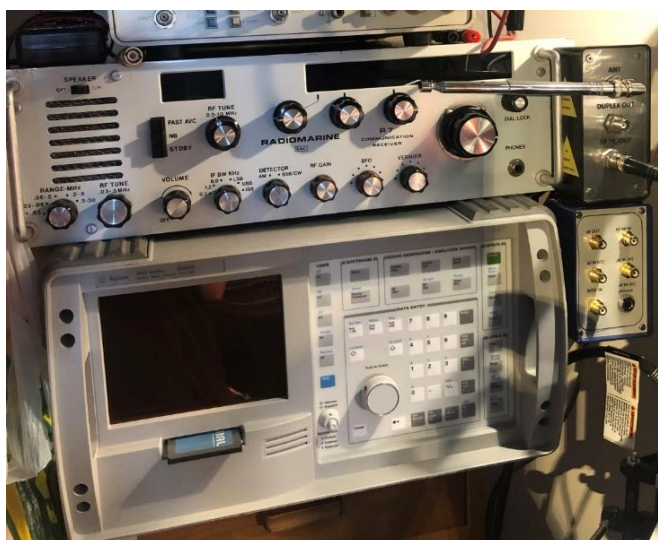
It turns out that the spectrum analyser menu allows the user to 'jump' to the RF generator menu while still using the spectrum analyser, and change the mode from 'fixed' to 'track'. It also includes sub-menus for the markers and other functions. Another 'quirk' of the Agilent is the input/output facilities: signals can be

input via the 'Ant' and the 'RF In/Out' ports, and the RF generator can be routed to either the 'RF In/Out' or 'Duplex Out' ports. These options are all software-selectable in the appropriate menus. This is to accommodate the many different receiver/transmitter testing options available – some quite specialized to cell phone applications. For example, the 'RF In/Out' port can handle up to 100W transmitter output as well as being used for all but the most sensitive input signals. The unit can even be used as an AM/FM/SSB receiver when an antenna is connected to the (more sensitive) 'Ant' port, however, the maximum reverse power into this and the Duplex port is only 60mW, though warnings/protection are provided. Altogether this is an impressive<sup>2</sup> piece of kit, but somewhat confusing when trying to learn how to use it from the manuals. One good feature I discovered is that it can save a particular test setup of the instrument so the positions of the various screen settings can be quickly recalled. A large number of these can be saved by the user, recalled by a menu system, and then re-loaded quickly. This, plus user-defined shortcut keys, help to quickly navigate the often convoluted menus. I really must keep using it to keep up my proficiency (I find donning a pair of noise cancelling headphones helps...).

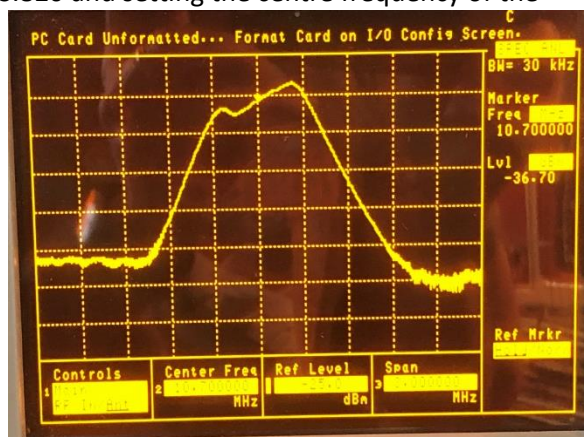
The resultant response curve – as set some 13 years ago by me, following the procedure in the tuner's [manual](#) (a simple peaking for maximum output method) - was not that good (upper photo, right), showing some marked asymmetry. This could be the result of age-related/component drift, or, of course, me doing a crappy job 13 years ago. I decided to see if I could improve the response curve using a visual technique with the Agilent 8935 connected. Indeed I could – see lower photo, right.

This proved an interesting experiment and now I felt I had at last mastered at least some of the Agilent's controls(!). The tuner definitely sounded better after this - around 20 mins work tweaking all six 10.7MHz IF transformer slugs a little and repeating until an almost flat-top and reasonably steep-skirted response was obtained symmetrically around the centre frequency of 10.7MHz. I did not tweak the discriminator transformer slugs.

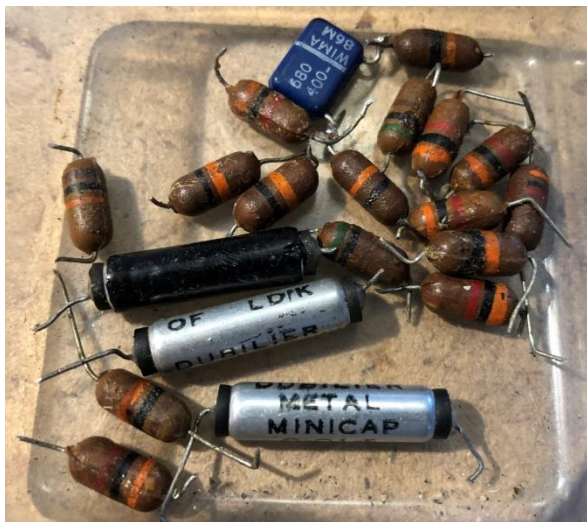
'Wima' branded capacitor that someone had fitted as a bypass in the VHF amplifier (not the best choice) – the photo left shows the removed capacitors. Changing-out several of the rat-crap capacitors is quite a chore as they are tucked in behind/ underneath several other components, often in tight spaces, making selecting/placing replacements critical regarding physical size and lead dress. I used mainly plastic film capacitors as replacements, though decided to use disc ceramics for bypass in the VHF RF amplifier stage where these were a better physical fit and likely have better bypass characteristics at VHF. I also added an X-Class 0.047uF safety capacitor across the dual pole power

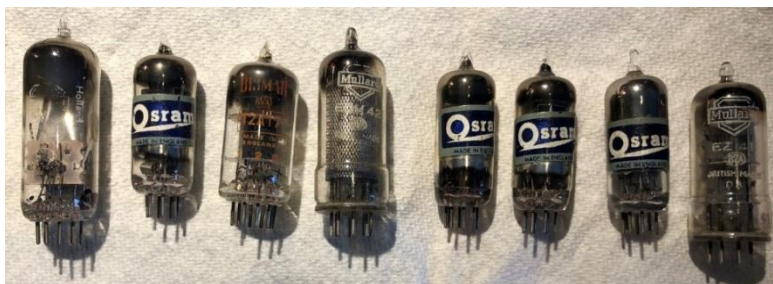
I then tested all the valves using a Precision 10-12 tester. All tested very good for emission and shorts, except the hexode section of the ECH42, which tested at only 56% emission, and the EM80, where the display brightness is a bit lacking. I will buy a NOS ECH42 and see if it makes any difference to performance and an EM80 to make the front panel sparkle again. Interestingly all the 6AM6 and the 6AL5 valves are 'Osram' brand (photo, above), and the remainder are

'Mullard', except the 12AT7, which is 'Brimar'. I suspect that some (or all) of these, being of UK-manufacture, may be original fitment.

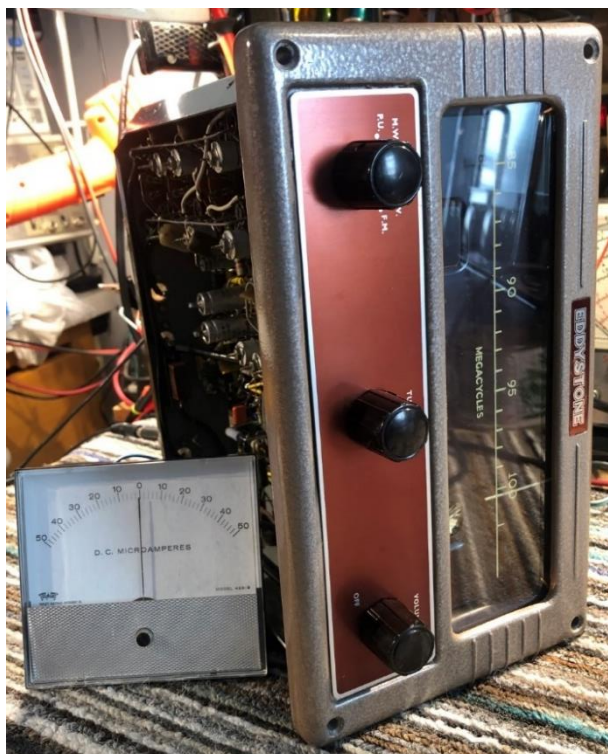
Set-up of the FM circuitry this way requires a 50-0-50uA meter - I have a nice large one of these that I don't think has been used since I last re-aligned this tuner 13 years ago. It is first used to peak the 10.7MHz IF section while feeding in a 10.7MHz signal, and then to set up the discriminator (photo, right).

The AM IF alignment is done simply by injecting 465KHz into the mixer and peaking all the 465KHz transformer slugs. I had to remove several of the powdered iron slugs from the 10.7MHz IF transformers and the discriminator transformer, clean small fragments of broken slug material out and then lube the slugs with ROCOL 'Kilopoise' high viscosity grease prior to re-inserting them. Before I did this, peaking the transformer responses was somewhat erratic, especially on the discriminator stage - after this 'clean-up' and lube was completed they all adjusted perfectly.

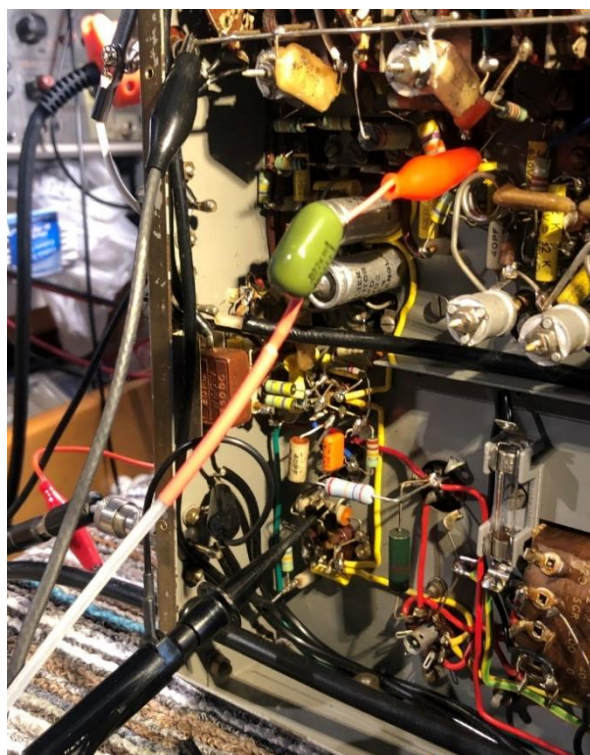
Above: 10.7MHz IF response with marker pip at 10.979MHz (~280KHz high of centre), showing a signal level of -25.48dB, ie. 8.9dB down at +280KHz.  
Left: connections for the spectrum analyser - the tracking generator (Duplex port on the Agilent 8935) connected to the mixer valve grid via a 0.022uF capacitor, and the secondary of the discriminator transformer connected to the RF In/Out port of the Agilent 8935 via a x10 'scope probe

Before I started any refurbishment work, I decided to check out the tuner's 10.7MHz IF response curve using the Agilent 8935. To do this, I connected the 'Duplex Out' port to the grid of the VHF mixer valve in the S.820 via a 0.022uF capacitor, and the 'Ant' port to the discriminator transformer secondary via a x10 'scope probe, disconnecting the antenna from the S.820 and setting the centre frequency of the spectrum analyzer/tracking generator to 10.7MHz.

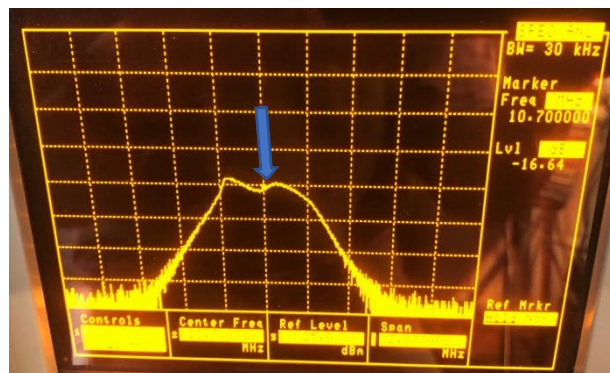
Above: 10.7MHz IF response with marker pip at 10.7MHz (centre of passband), showing a signal level of -16.64dB

On completion, I connected the Agilent as I had before (except I used the less-sensitive 'RF In/Out' port), and the spectrum analyser showed that the 10.7MHz IF response curve was not 'perfect', but was very similar to the best I had obtained using the Agilent before starting the work on the chassis (lower photo on page 4), and the tuner sounded so good that I was loath to try to tweak it! See the captioned photos, right, which show the response obtained, showing a nice, symmetrical response.
