## Refurbishing a 'Jewel in the (Canadian) Crown': An Eddystone S830/4 – Gerry O'Hara

#### The S830/4 Variant

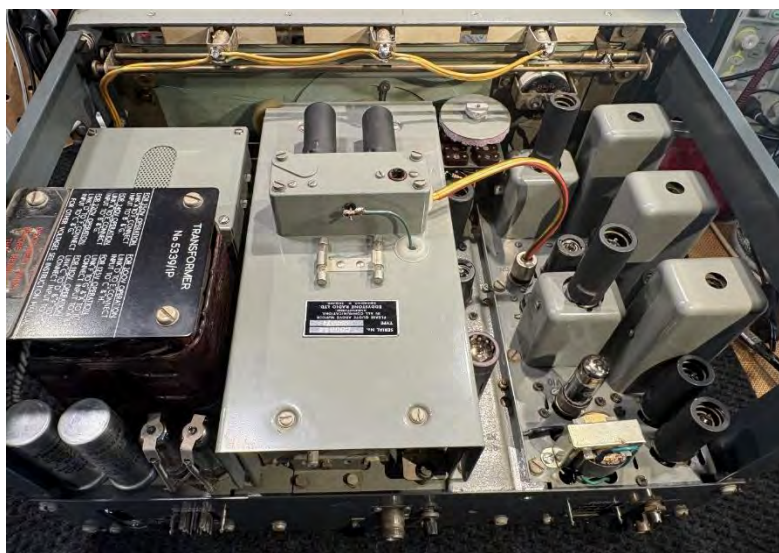
The S830 sets have a very robust construction, mainly of heavy-gauge painted steel – photo, right. The Appendix includes above and below chassis layout diagrams.

The chassis comprises the following major components: pressed-steel side panels, front panel (cast aluminum), 2nd IF/AF (pressed steel) sub-chassis, power supply (pressed steel) sub-chassis, coilbox (cast aluminum with steel cover plate), 2nd mixer/2nd local oscillator sub-chassis (painted brass plate), calibrator (painted cast aluminum), tuning gang cover (pressed steel), rear apron (steel), and a one-piece

welded steel cabinet with inset perforated steel sections to provide ventilation. The front panel is attached to the front of the coilbox with four tapered OBA screws. The painted/silk-screened aluminum fingerplate, drilled for the various control shafts to pass through, is attached to the front panel with double-sided sticky tape and several of the control pot securing nuts, and must be removed to access the tapered bolts if the front panel needs to be removed.

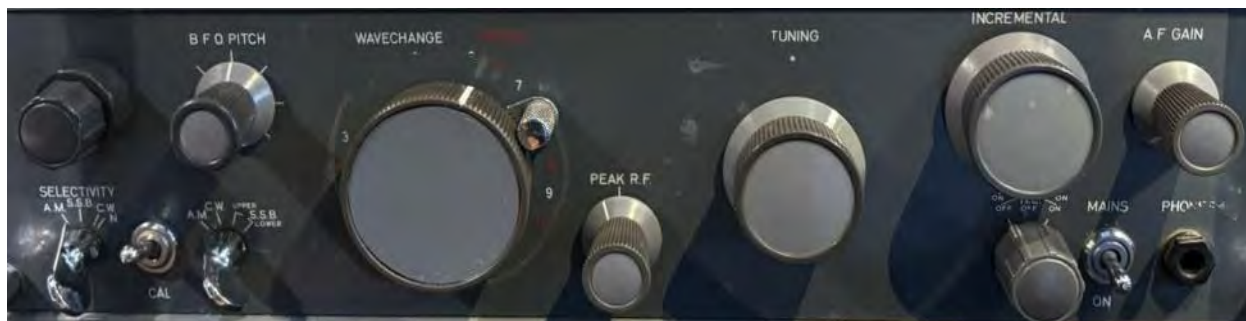
The front panel controls (photo, top of page 6) comprise: RF gain, IF gain (these are concentric on the same shaft), BFO Pitch, 'Wavechange', Crystal (1st local oscillator VFO/crystal) select lever, Cal. (crystal calibrator momentary toggle switch), Peak RF (this trims the antenna, RF amplifier, and 1st mixer stage tuned circuits on all bands), (main) Tuning, Incremental (tuning), AF gain, Selectivity (AM/SSB/CW/N), Mode (AM/CW/USB/LSB), AGC/Noise Limiter, Mains toggle switch (power), and a high-impedance  $\frac{1}{4}$ " jack 'phones socket that defeats the speaker when a jack plug is inserted. A small knurled metal knob at

the top left of the front panel allows for minor mechanical correction of the pointer position on the main tuning dial. The signal strength meter is visible through a cut-out on the upper left of the main tuning dial, and the signal strength meter zero adjust preset is located on the rear apron of the set.

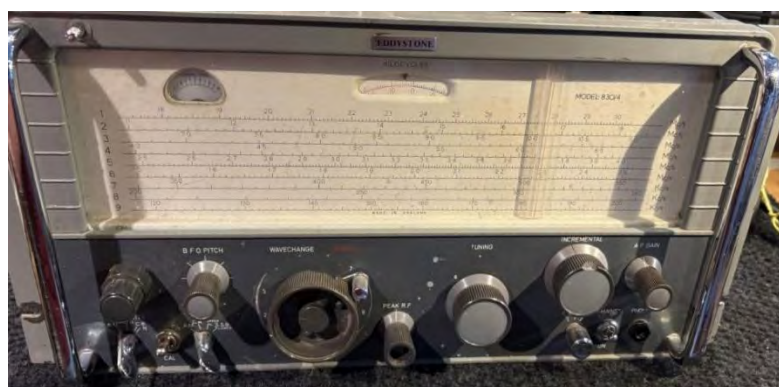
This example looks to have had a hard life since it left the Eddystone factory (in July 1963 according to its Serial No. 'GO0844'<sup>5</sup> – photo, below). It was not in the best cosmetic shape, with a rusty cabinet, missing/ broken/ 'mongrel' knobs (photo, right), and a full compliment of deceased arachnid residents,

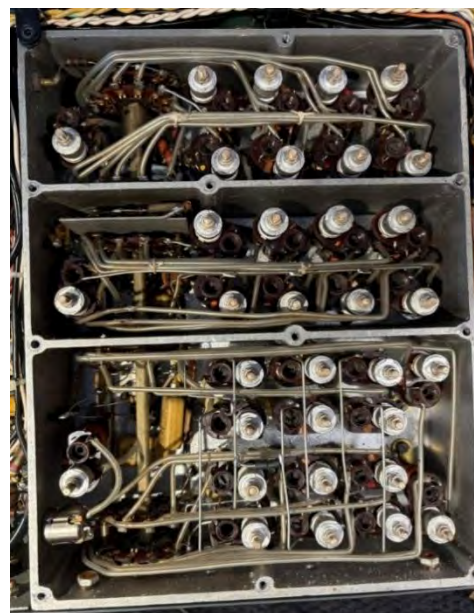
With the set now on my bench and its case removed, I took the coilbox cover plate off to inspect the RF amplifier, 1st mixer and 1st local oscillator compartments (photo, right). These looked untouched, with many 'tired-looking' components present (like the rest of the chassis!). The usual 'suspects' were there - including the nasty little 'Dubilier'-brand grey plastic-encapsulated paper capacitors in the RF, 1st mixer and 1st local oscillator compartments – in my experience, these are almost always either very leaky, open circuit or way off

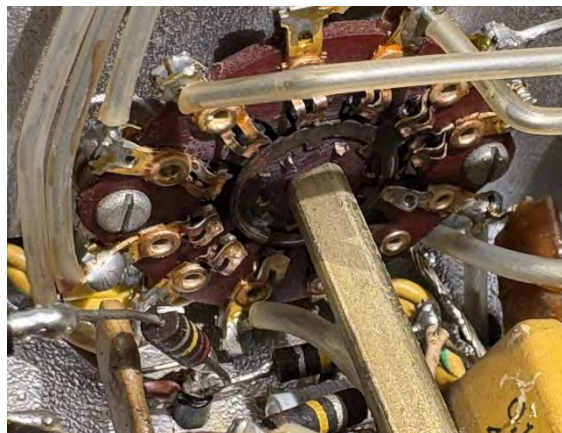
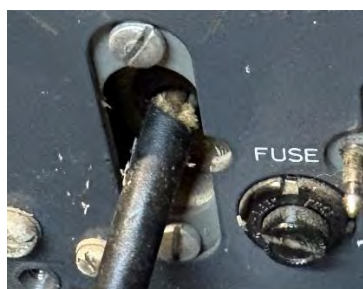
I noted that the band change wafer switch contacts were very tarnished (as usual) – photo, right, but at least the coilbox looked complete and should refurbish ok.

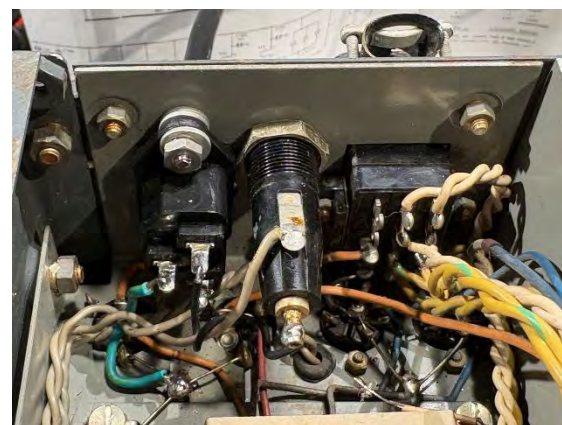
After wiring-in the IEC socket and changing the line fuse to a 2A fast-blow part (a 5A slow-blow fuse was installed), I made a few resistance measurements between critical circuit nodes and snipped one of the leads of a damaged electrolytic (bypass capacitor in the audio section, so not a critical part). Satisfied that nothing 'untoward' was present after doing this and a further close visual inspection, I decided to try powering-up the chassis slowly (over around 10 mins in approx. 25vAC increments) using a Variac to allow the B+ filter electrolytics to re-form - they usually do so in Eddystone sets in my experience, however, after 60+ years should probably be replaced anyway.

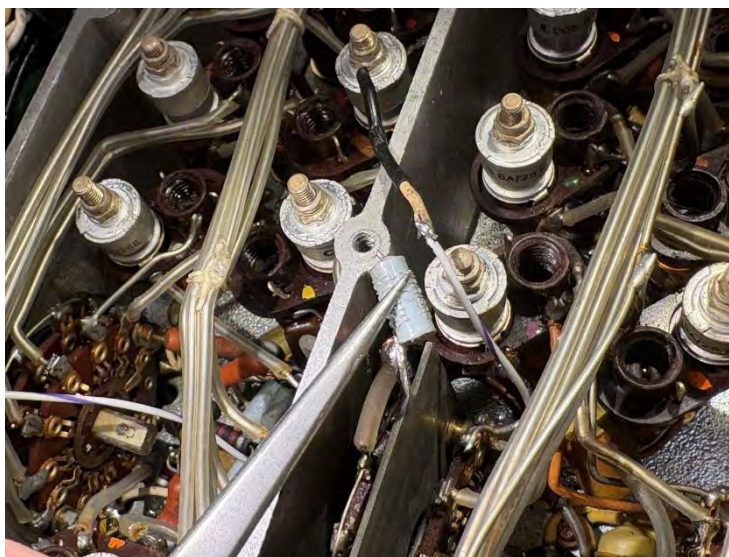
(pin 2, cathode), with the other end of the Teflon-insulated wire connected to the 1st local oscillator tube socket (pin 6). The photo, left shows the refurbished 1<sup>st</sup> mixer stage compartment with the replacement coupling capacitor (yellow bodied part) circled.

stiff wire connecting it to the nearby band change switch wafer unsoldered. This allows a little extra room to insert dental tools and forceps down the side of the coil former to manipulate the capacitor from where it is jammed, and then extracted - hopefully pulling the Teflon-insulated wire along with it (photo, right). Once the Teflon-insulated wire is through the (hidden) hole, a new 0.01uF capacitor can be soldered to it and insulated with some heat-shrink tubing, and the other capacitor lead soldered onto the 1st mixer tube socket

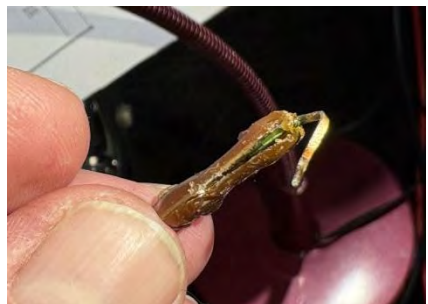
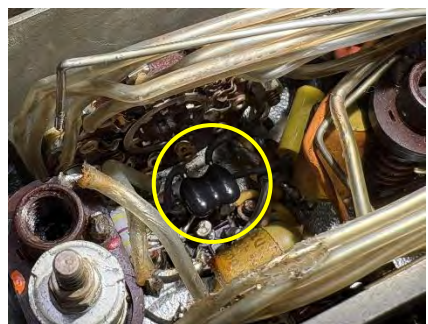
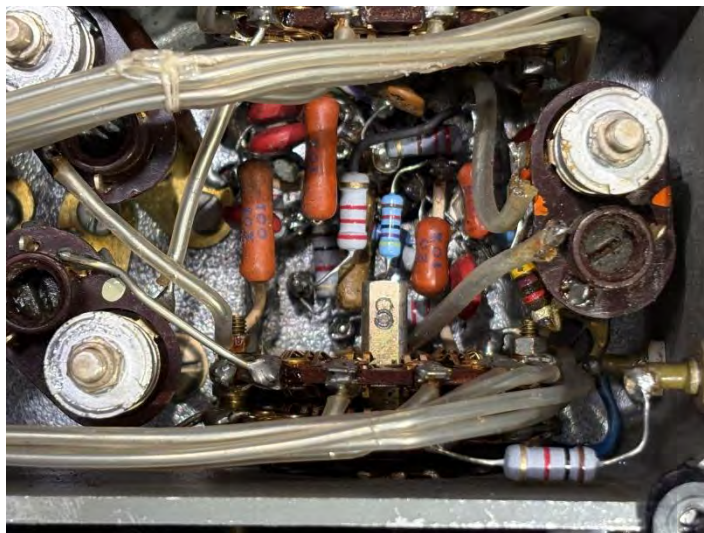
With 'fresh eyes' (the next day), I spent some time carefully checking and re-checking the location of every new component installed in the RF amplifier, 1<sup>st</sup> mixer, 1<sup>st</sup> local oscillator and the 2<sup>nd</sup> local oscillator/2<sup>nd</sup> mixer compartments visually

and with resistance measurements, looking for any issues. I did not find any errors, but noted that the band change switch shaft had been catching on a wax-coated 100pF silver mica coupling capacitor in the 1<sup>st</sup> mixer stage (probably since the set was new!). On closer inspection, I noted that the wax coating was splitting along the edge of the capacitor (photo, above left), where the switch shaft was contacting it, thus compromising its ability to keep moisture out of the part. Given this, I decided to remove the capacitor and replace it with a new 100pF epoxy encapsulated silver mica capacitor (circled in the photo, below left). I then re-checked lead and component dress in each of the compartments and made sure that no other components would contact the switch shaft.

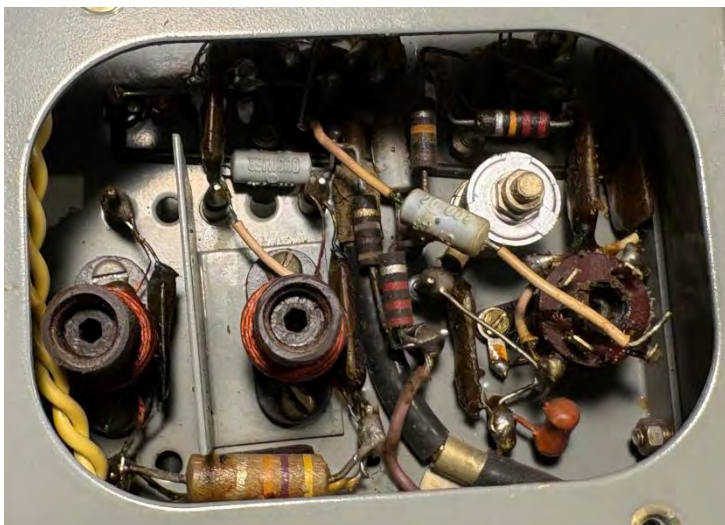
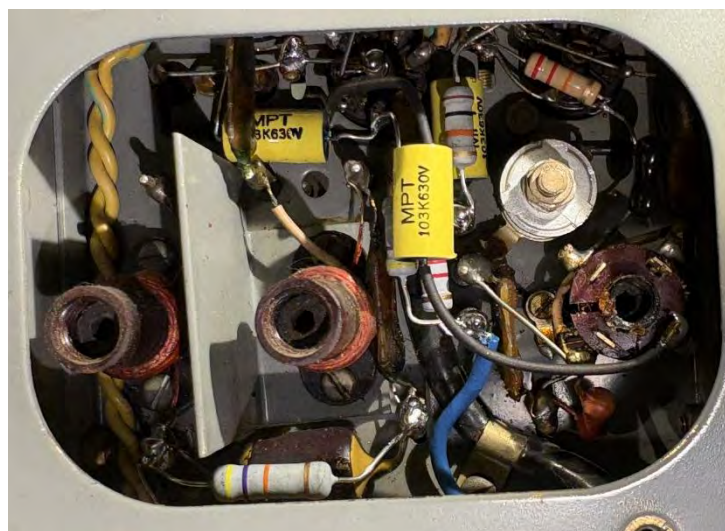
sections of the chassis. I replaced all the resistors and tubular paper (Dubilier) bypass capacitors, a wax-coated silver mica capacitor that I accidentally melted the wax on with a soldering iron (oops!) - the capacitor tested ok, but I changed it out anyway, plus I replaced a wire that was fraying at one end. The photos, right, show the 2nd local oscillator, 2nd mixer and tunable 2nd IF compartment before (above), and after (below) refurbishing.

I tested several of the parts after removal: as usual, the Dubilier tubular paper capacitors were 'all over the map' regarding capacitance and leakage, so definitely needed replacing. Most of the resistors were only marginally outside tolerance, though two measured 50% above their nominal values.

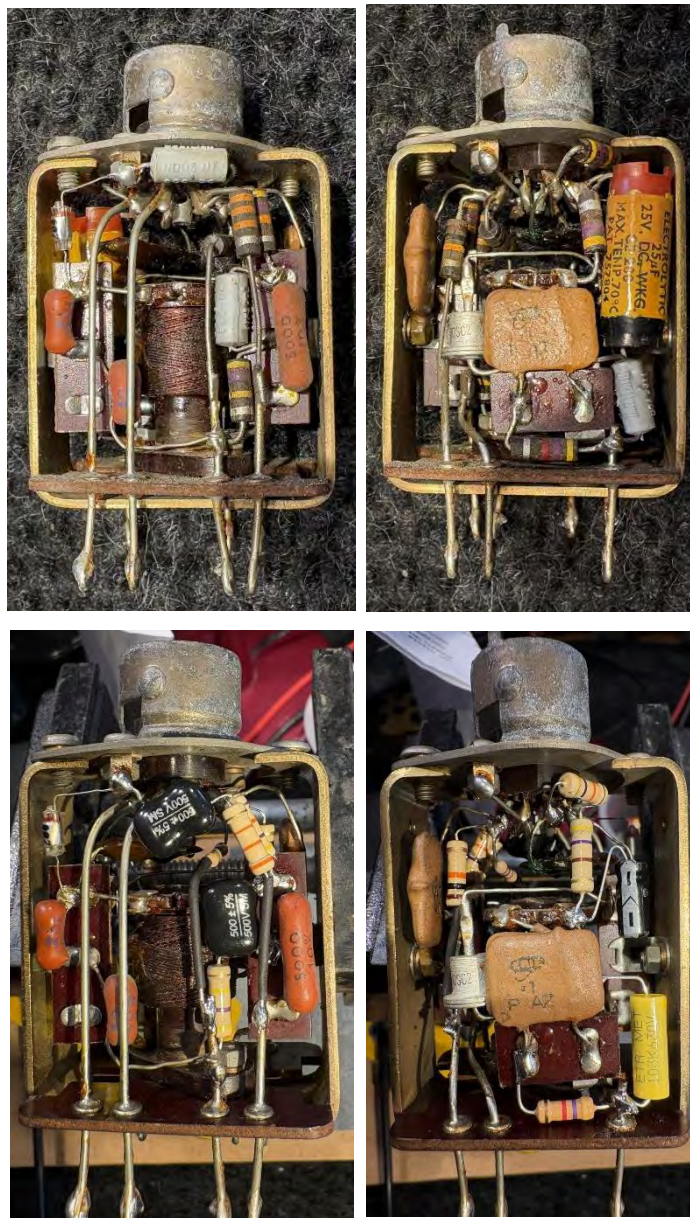
Most of the BFO/product detector circuitry is contained in a screening can with the tube mounted on top of this can<sup>12</sup>, the unit being located above the 2nd IF/audio section of the main chassis in this model. To service this unit, the connections to it must be unsoldered and the unit removed from the main chassis. The screening can is then removed from the internal metal frame, allowing the components and wiring inside to be inspected/changed-out as needed. True to form, the Dubilier tubular paper capacitors in this unit were 'all over the map' on value and leakage, the 25uF electrolytic was effectively an open circuit, and some resistors measured over 50% above their nominal values. Amazingly, the unit was still working reasonably well - it always surprises me how tolerant tube circuitry can be to failing/failed components(!).

I decided to replace all the paper capacitors, the electrolytic, and all resistors in this unit, as it is 'PITA' to remove and re-install the unit if another part needs replacing at a future date. The tubular ceramic and the single polystyrene dielectric capacitors in the unit were left in place as these are generally very reliable, as was the varicap diode. After double-checking the components and wiring after replacement, the unit was reassembled and installed back onto the chassis and tested - it was working well on CW, LSB and USB settings. The photos above show the internals of this unit before (above) and after (below) refurbishing.

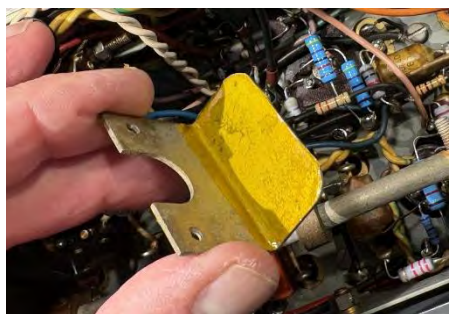
Following completion of the majority of component replacement, I undertook some further cleaning of the band change and mode switches with Deoxit D5, cleaned some wiring and the underside and inside walls of the chassis with IPA, reinstalled the metal screening plate on the mode switch (I added some Kapton tape to its underside, photo, left, as a precaution against shorts as it is in close proximity to some of the mode switch contact lugs), replaced a resistor mounted on the 1st local oscillator VFO/crystal switch (located above the chassis), cleaned the switch contacts with Deoxit D5, and tidied-up some of the wiring, again re-testing the chassis after this work was completed. I then investigated the switch issue I had noted earlier - a 2.2Mohm resistor on the band change switch (wafer 'S1g', closest to the front of the chassis) was shorted out in all switch positions instead of only Band 7-9), however, this was now working correctly<sup>15</sup>.

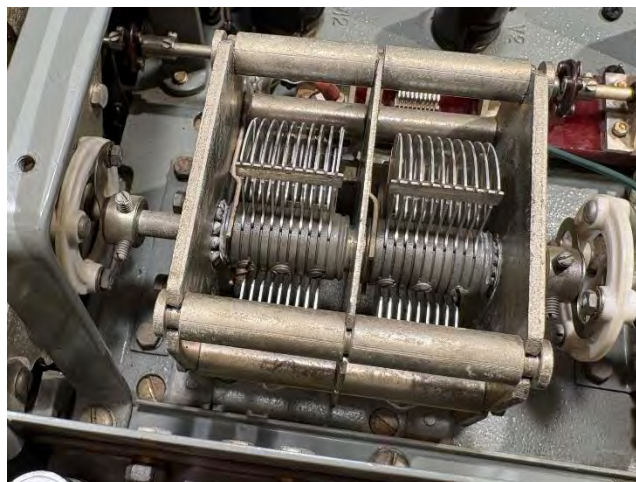
grease from the ball races and re-lubricating with fresh lithium grease (photo, right), cleaning the ground contact surfaces with Deoxit D5, adding a spot of light machine oil to the rear ball bearing, and cleaning between the stator and rotor vanes on all gang sections. I had noted the 'Peak RF' control was not working well, with the signal cutting out over part of its rotation - this is a common issue with this control, and is caused by incorrect setting of the rear ball bearing thrust (adjusted by a screw) and/or misaligned stator/rotor vanes on one or more of the gang sections. Close visual observation identified the

issue to be some of the vanes in the antenna section of the gang were shorting. I first optimized the setting of the rear bearing thrust, and then used an Exacto knife blade to very carefully re-set the errant vanes on the antenna section of this tuning gang (photo, left). Doing this fixed the problem.

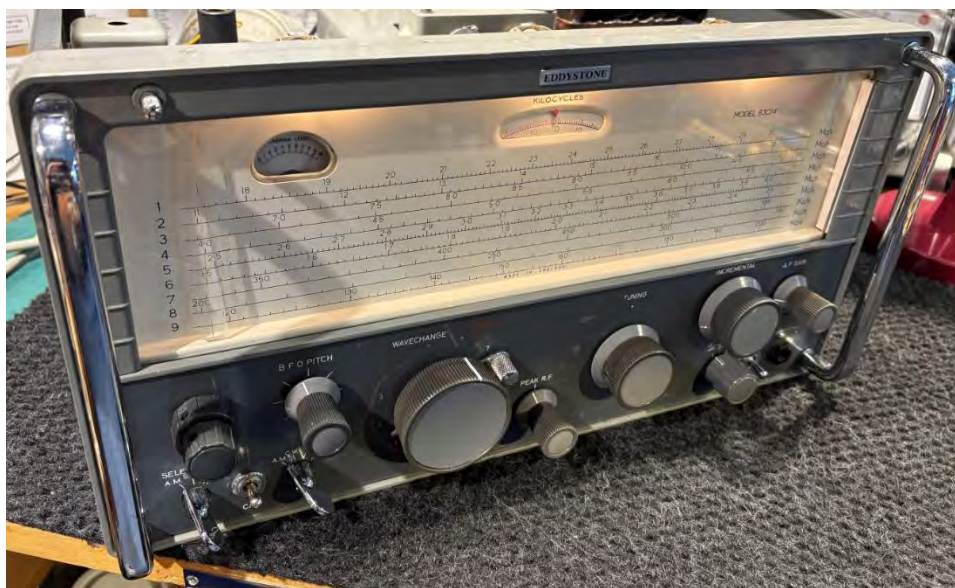
The set looked quite a bit more 'presentable' after the above effort (photo, right), however, hopefully NOS knobs of the correct type and a reproduction fingerplate can be obtained at some point to make it look really sharp, especially after the case has been resprayed or powder-coated.

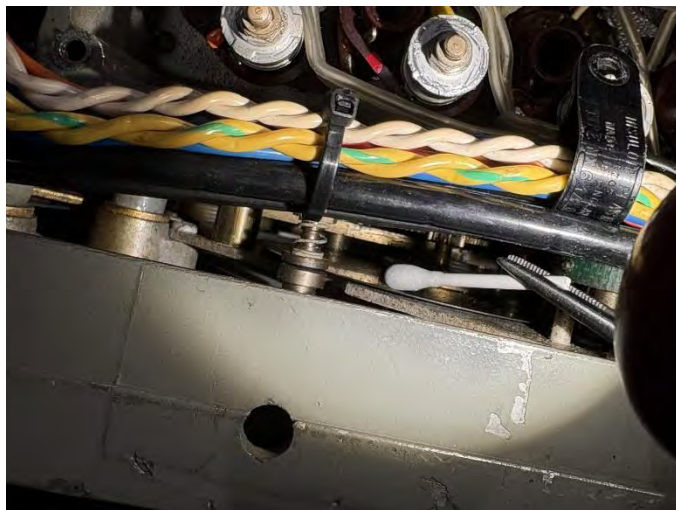
pinch wheel (clutch) were covered in dirty grease. I cleaned these with Q-Tips soaked in naphtha (photo, left), as well as the axles, pinions and gears, before applying a small drop of light machine oil to the bearings with a precision oiler, and did the same for the Incremental Tuning mechanism. I then adjusted the end play on the main tuning knob shaft.

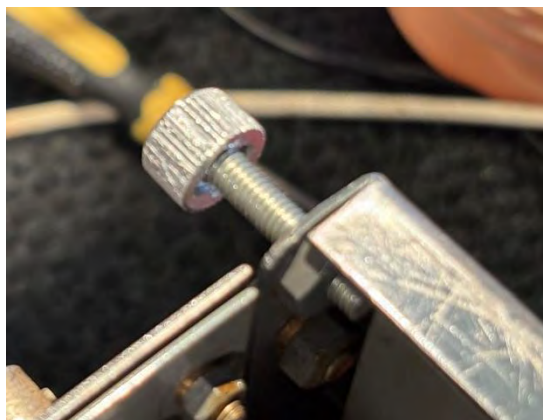
chassis for the alignment work. As I was sorting through the screws removed from the chassis to re-fit the coilbox cover, I noted that the case had been secured to the chassis with three regular machine screws instead of the 2BA knurled 'thumbscrews' that Eddystone would have fitted - the fourth screw was missing as the remnants of the original thumbscrew was jammed into one of the captive 2BA nuts fixed to the rear of the chassis side panels. I removed the remnants of the original thumbscrew, and, for convenience of removal of the case when needed in future, I decided to make some new thumbscrews using some incorrect size thumbscrews from my junk box (that were too small and had incorrect threads) and some 2BA bolts. To do this, I hacksawed off the heads of the small thumbscrews, part-drilled a hole into these and screwed in the 2BA bolts after applying some 2-part epoxy to the threads and into the holes, tightening the bolts into the holes (self-threading as the thumbscrew heads were aluminum). The photo, right, shows one of the fabricated thumbscrews.

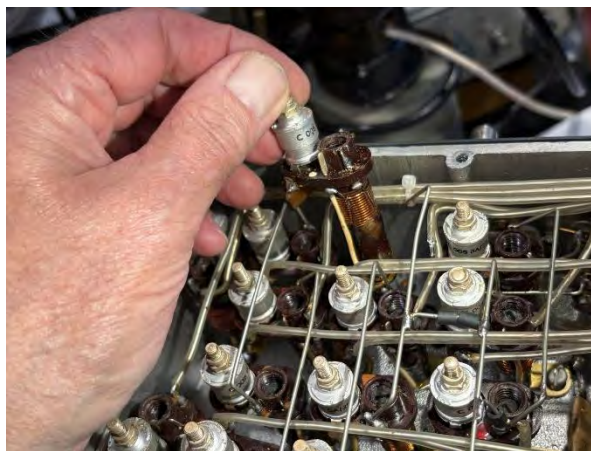
With the Band 3 antenna transformer assembly removed, I checked the continuity from the antenna to the chassis with the transformer disconnected and it measured very low resistance, indicating the band change switch contacts were ok. I also measured the resistance from the antenna socket to ground with the transformer disconnected, and this was exactly 1Mohm, which is the value of the static discharge resistor wired between the antenna socket and ground, so that was also ok.

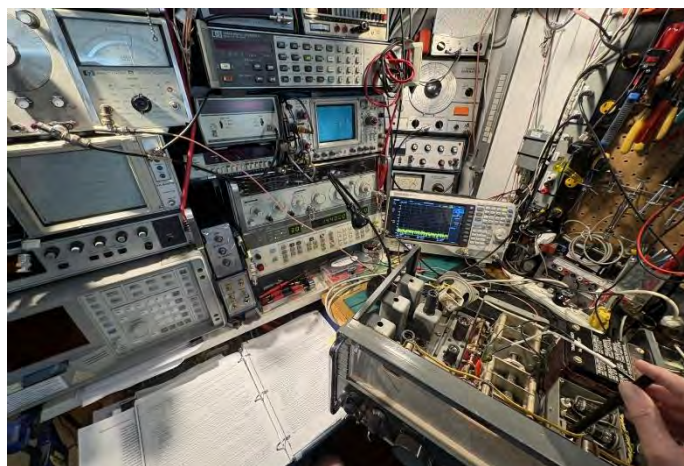
Next, I removed the top cover again, this time to allow access to the two trimmers (C74/C77) for the tunable 1st IF transformer – photo, right. The two corresponding slugs (L34/L35) are accessed through holes on the side cover<sup>22</sup>. I managed to adjust the slugs/trimmers ok (not stuck slugs as in the S830/2 I worked on previously thank goodness!), and only around six iterations were needed to obtain good tracking and level output across the 200KHz incremental tuning span (1250KHz to 1450kHz).

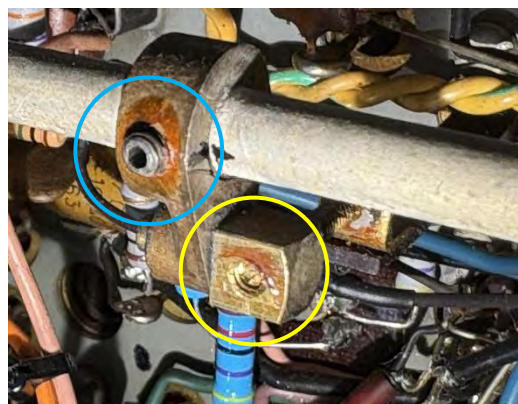
Inspecting the three actuating rod adjustment screws (present on T1, T3 and T4), it appeared that the screw on the rod for T3 (circled yellow in photo, right) had been screwed inwards much more than on T1 or T4, and the

varnish used to seal the locking nut on this screw had been disturbed. I therefore considered that this was likely to be the reason for the over-coupling observed on the response curves. I loosened the locking nut and then tried to turn the (brass) screw, but it was jammed tight, and I risked gnarling the screw head. As the eccentric collars can be rotated a little on the control shaft by undoing their set screws (circled blue on the photo at the bottom of page 27), I decided to try this instead, but after I had completed the initial RF alignment.

As noted above, I tried rotating the eccentric collars slightly with respect to the selectivity control shaft, however, although this helped, I still could not obtain satisfactory response curves. I concluded that the screw adjuster on the T3 IF transformer primary needed to be re-set to a similar position to the screw adjusters on T1 and T4. The screw adjuster on T3 had been tampered with by someone, as the varnish used to seal the screw and its locking nut in position (at the factory) had been disturbed, and the screw head was screwed as far into the threaded bushing as it would go (increasing the coupling in that IF transformer).

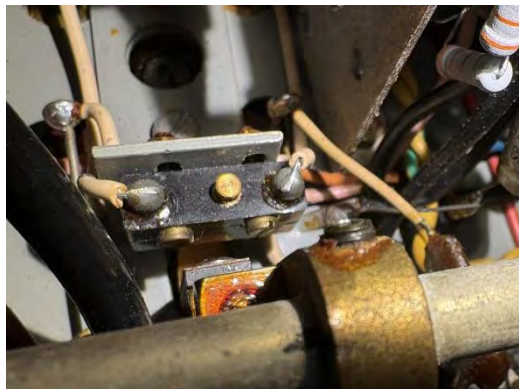
I found that the setting of the eccentric collar adjustment on T1 was critical, as the rod linking the eccentric collar to the transformer primary also operates the microswitch that opens its contacts in the 'N' (crystal in circuit) selectivity position, and if set too far towards the less-coupled end of its travel, the crystal is placed in circuit too soon, ie. at the 'CW' selectivity setting. The location of the microswitch relative to the actuating rod can be altered to adjust this setting, however, the screws/nuts to loosen the microswitch face the side of the chassis/coilbox and are therefore not accessible unless significant disassembly is undertaken (or incorrect tools are used, with possible resultant damage) – photo, right.

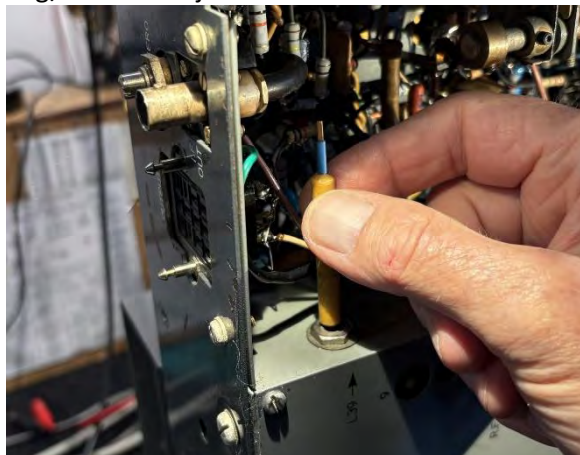
Next, I adjusted the 100KHz IF trap when the receiver was tuned to 125KHz on Band 9 (photo, left), and tweaked the crystal calibrator to exactly 100KHz against the (GPS-disciplined) HP8656B – photo, below).

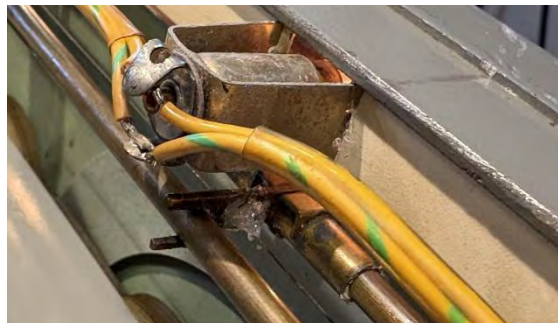
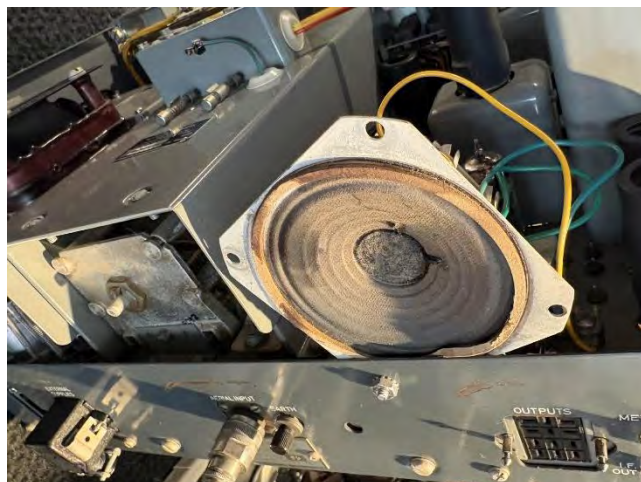
The set's owner had asked me to remove the internal speaker (added, rather crudely using one bolt, by a former owner – photo, left). I did this and noted that the output transformer was a replacement (the original would have been shrouded). Some wiring changes that had been done to accommodate the internal speaker were also reversed so that the external speaker would be cut off when the 'phones jack was inserted on the front panel (as it should). I also disconnected the muting circuit shorting link that had been wired behind the output Jones socket, and added a link into the mating Jones plug to do this

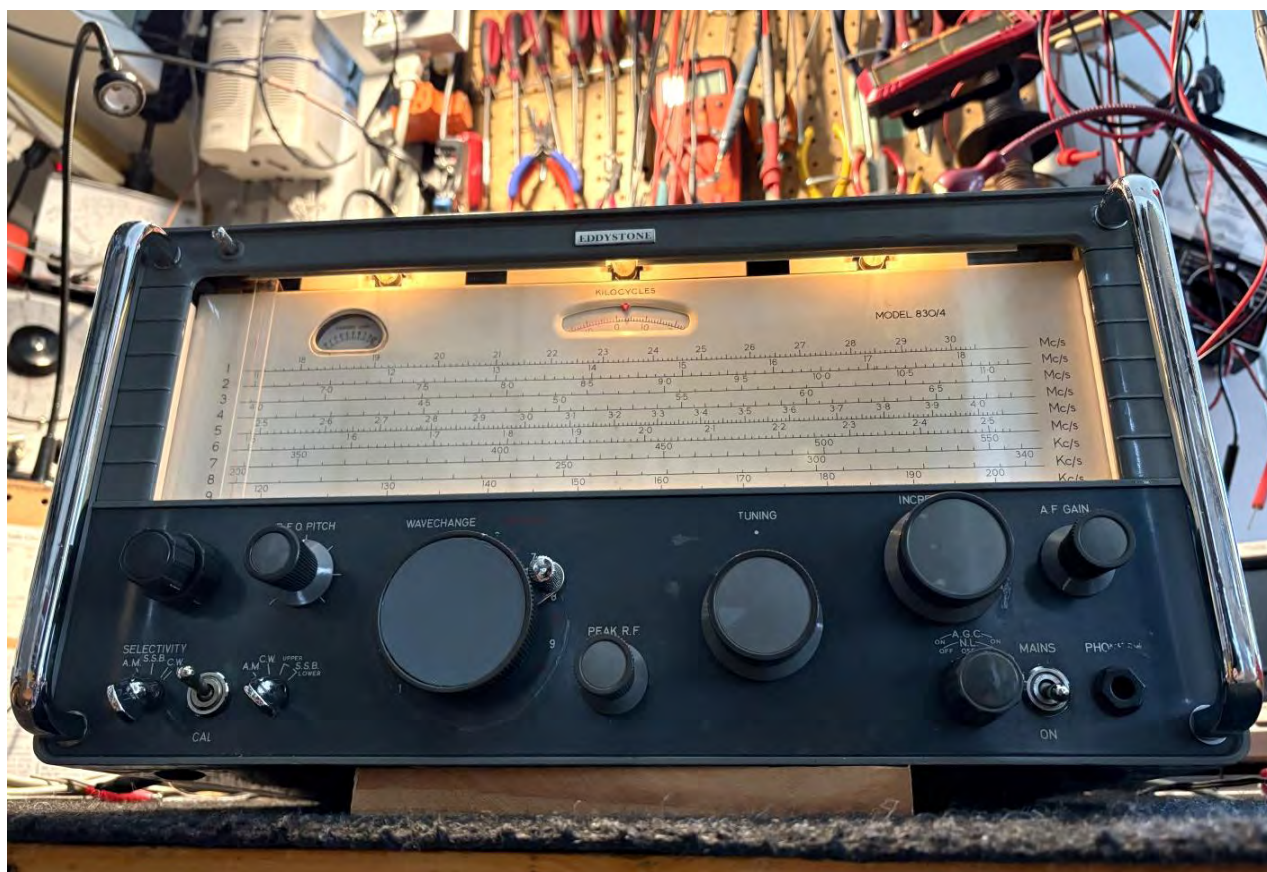
Above: front panel of the S830/4 prior to commencing refurbishment work – note the damaged knobs and the non-Eddystone knob on the AGC/Noise limiter control

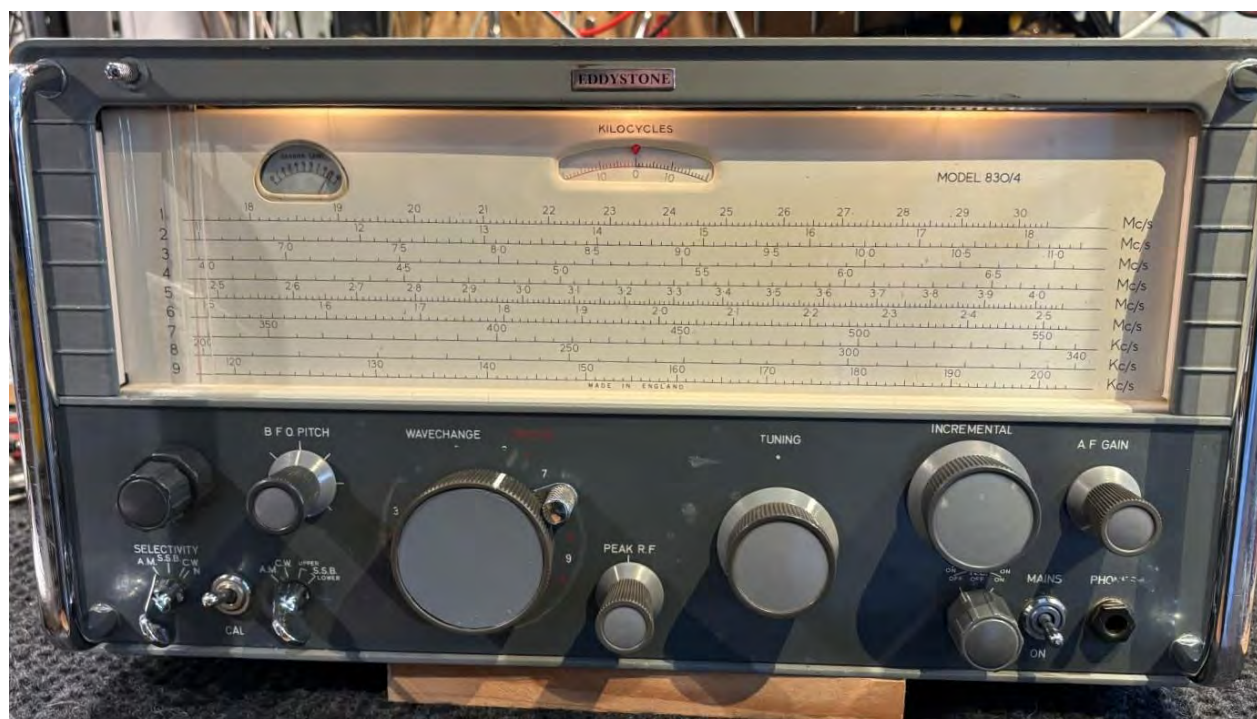
Below: front panel of the S830/4 after undertaking the refurbishment work – the damaged knobs have been repaired and the AGC/Noise Limiter knob has been replaced with an Eddystone knob (from an EC10 receiver)

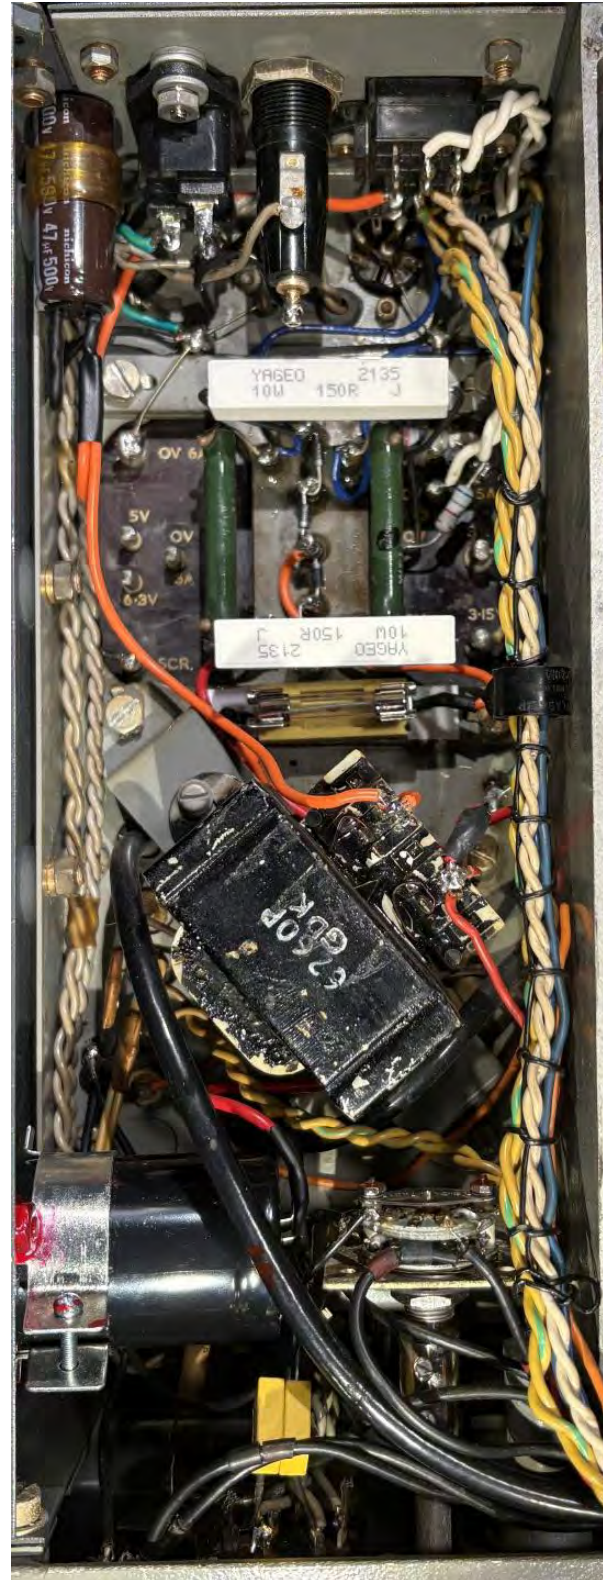
Above left: the power supply compartment before refurbishment. Above right: the power supply compartment after refurbishment

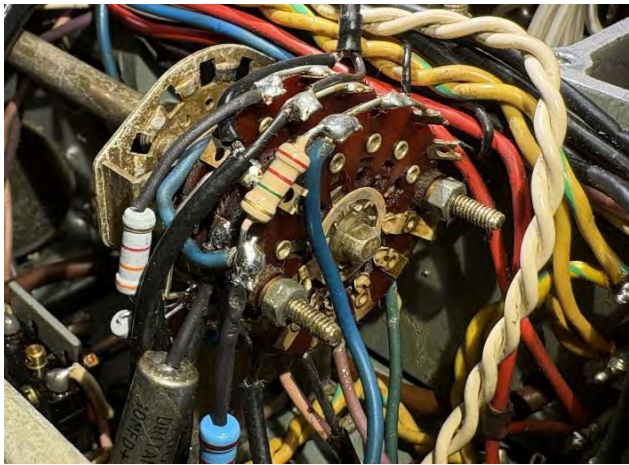
Above left/right: close-up of the components on the 'mode' (AM/CW/USB/LSB) switch – only the metal clad tantalum capacitor is original (tested very good). Left: the AGC/NL had been replaced by someone in the past (this is working ok). Below left: the 100KHz 2<sup>nd</sup> IF filter crystal. Bottom left: measuring the leakage current on a Dubilier 0.01uF capacitor at 160uA(!). Below top: fishpaper installed in the 'External Supplies' Jones plug. Below bottom: measuring the capacitance value of a Dubilier 0.01uF capacitor at 138pF(!)

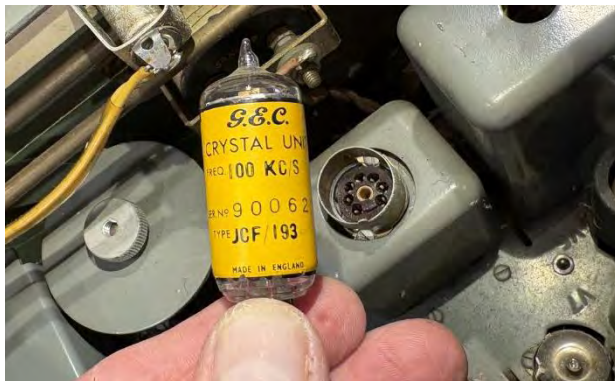
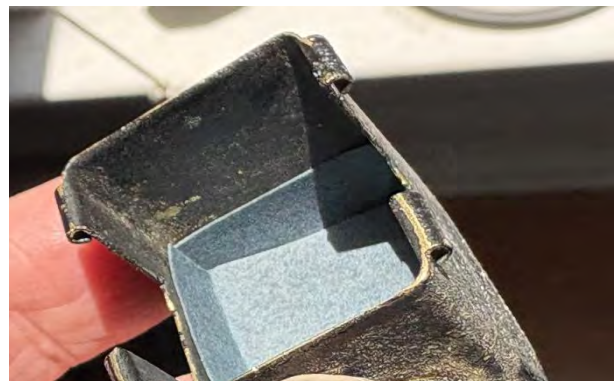
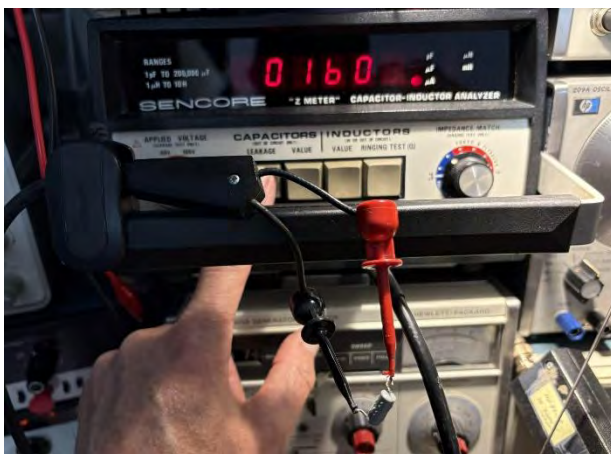
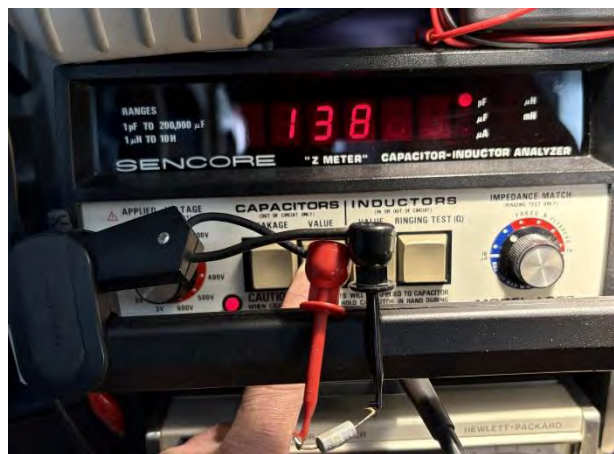
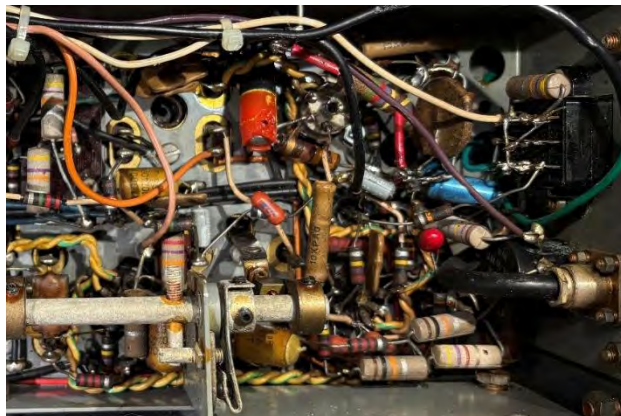
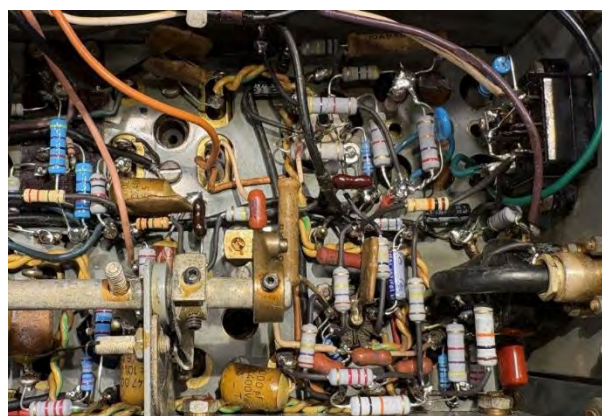
Above: the BFO/AM detector/noise limiter/1<sup>st</sup> audio and audio output section of the chassis (left – before refurbishment, right – after refurbishment). Below: close-ups of the same

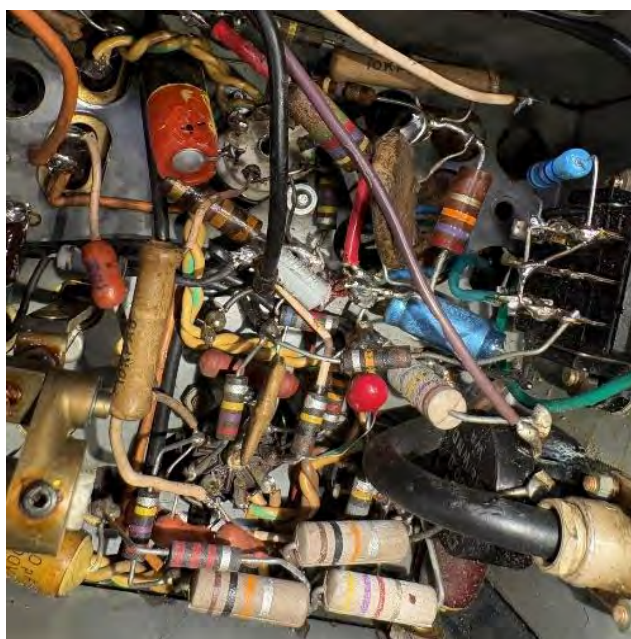
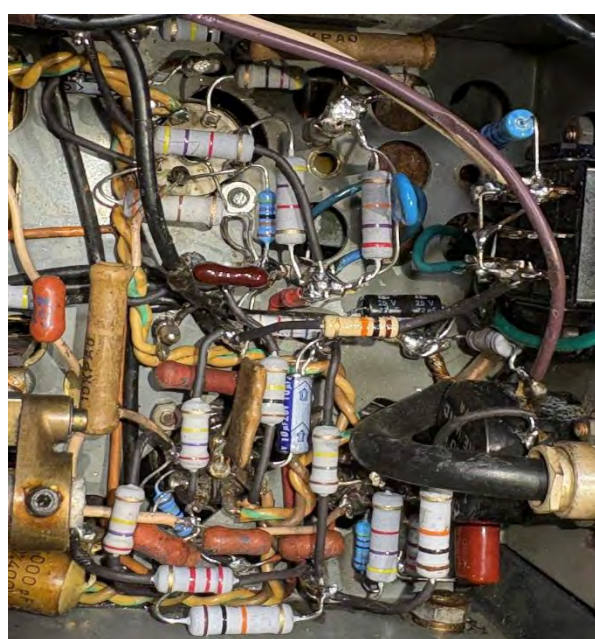
Left: oblique photo of the refurbished BFO/AM detector/noise limiter/1<sup>st</sup> audio and audio output section of the chassis, showing the layered construction technique used

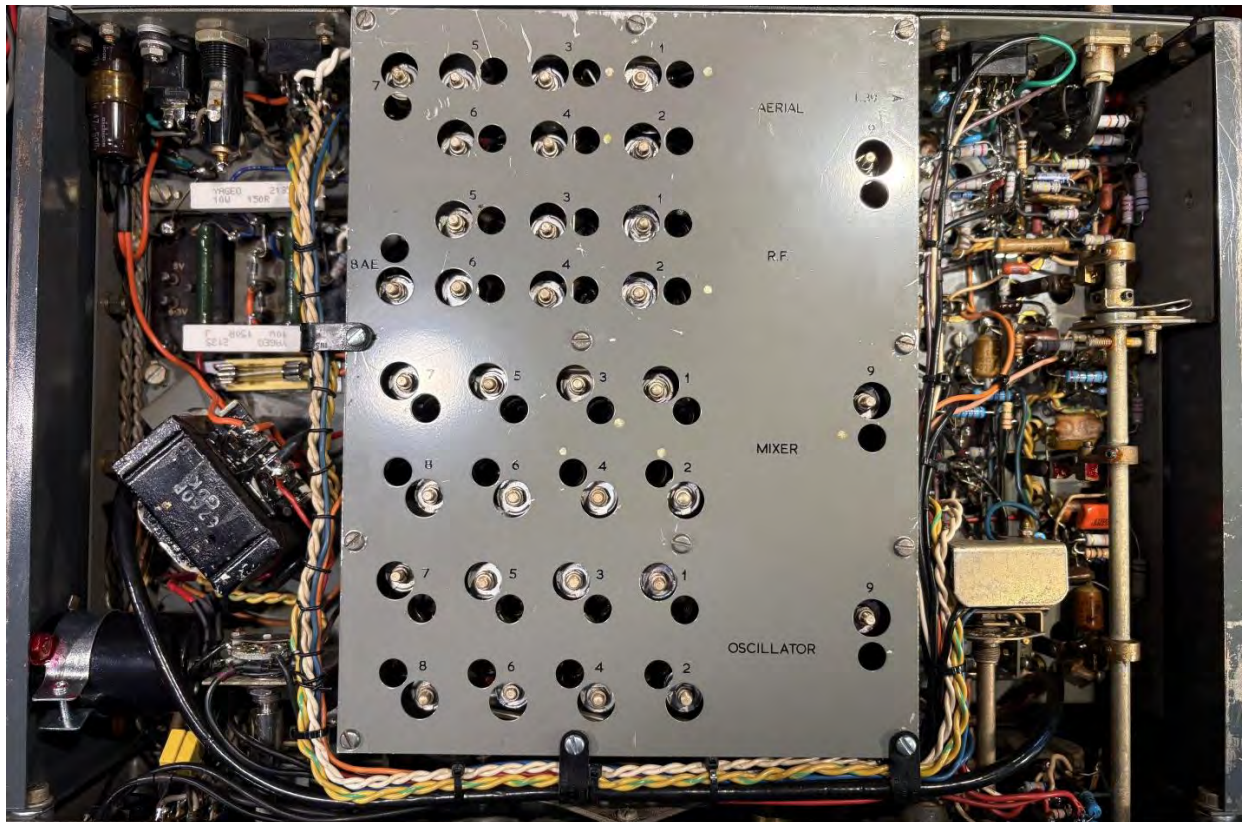
Above: underside of the chassis after refurbishment (with coilbox cover installed).  
 Below: the refurbished set on soak test – performing well!

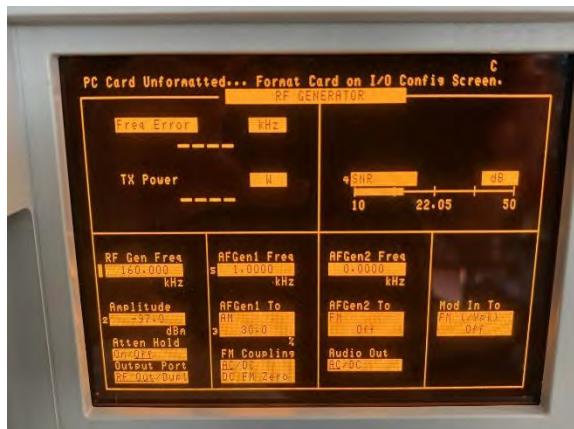
Above left: SNR on Band 9 (160KHz) = >22dB

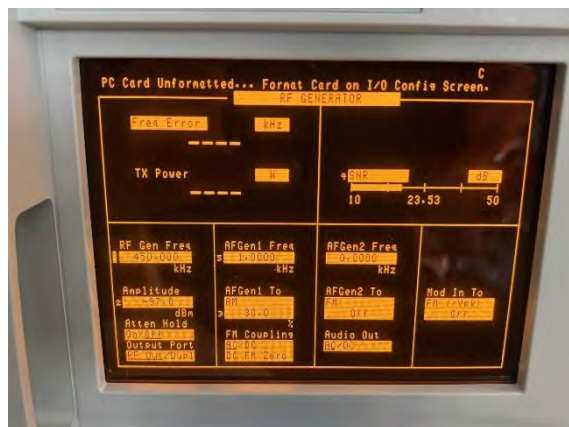
Above left: SNR on Band 7 (450KHz) = >23dB

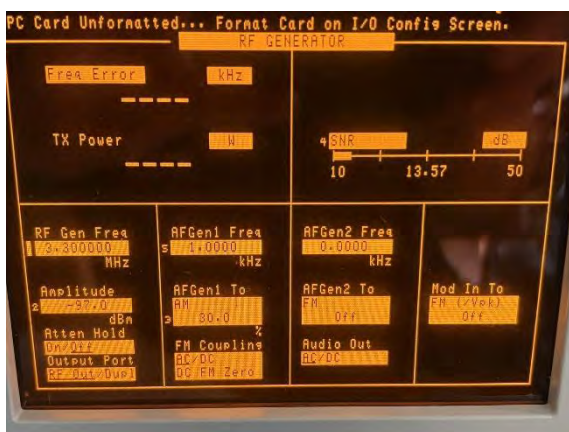
Above left: SNR on Band 5 (3.3MHz) = >13dB

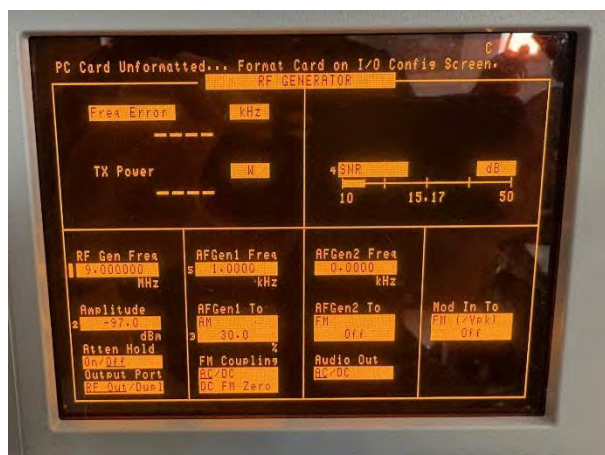
Above left: SNR on Band 3 (9.0MHz) = &gt;15dB

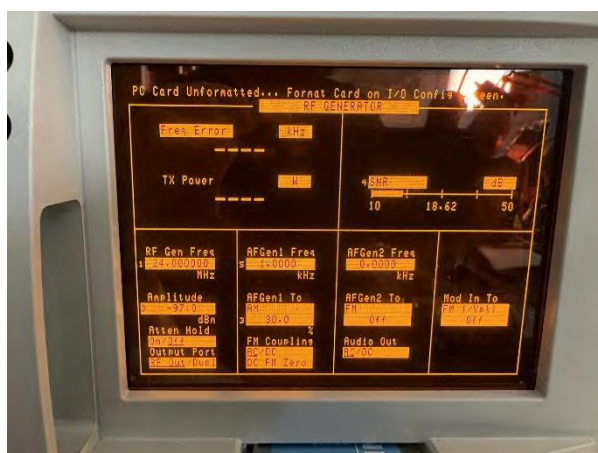
Above: SNR on Band 1 (24.0MHz) = &gt;18dB

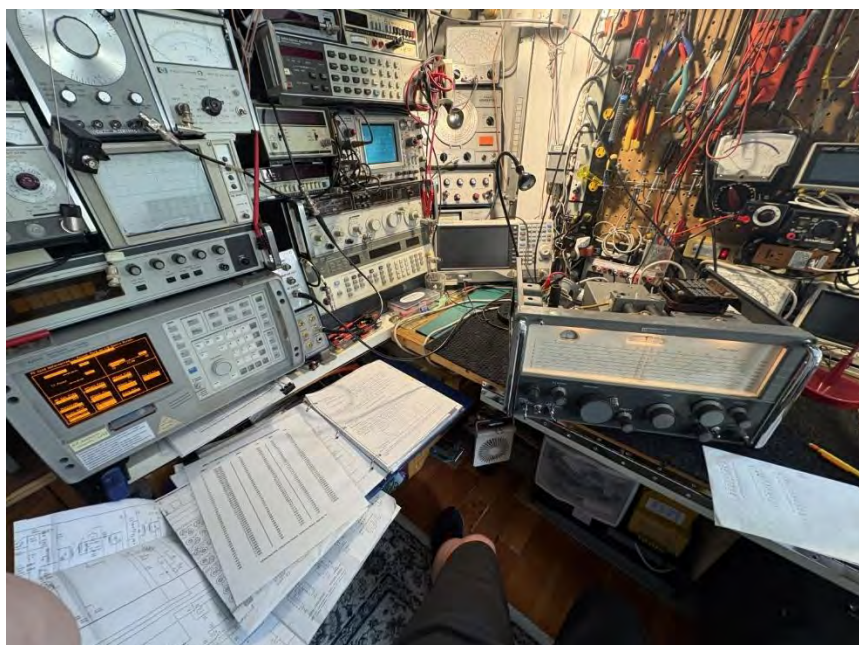
Right: Test set-up for making SNR measurements with the Agilent 8935 E6380A CDMA Test Set (located at the bottom left of the instrument stack)
