My Eddystone S.750 Revisited – Gerry O’Hara VE7GUH

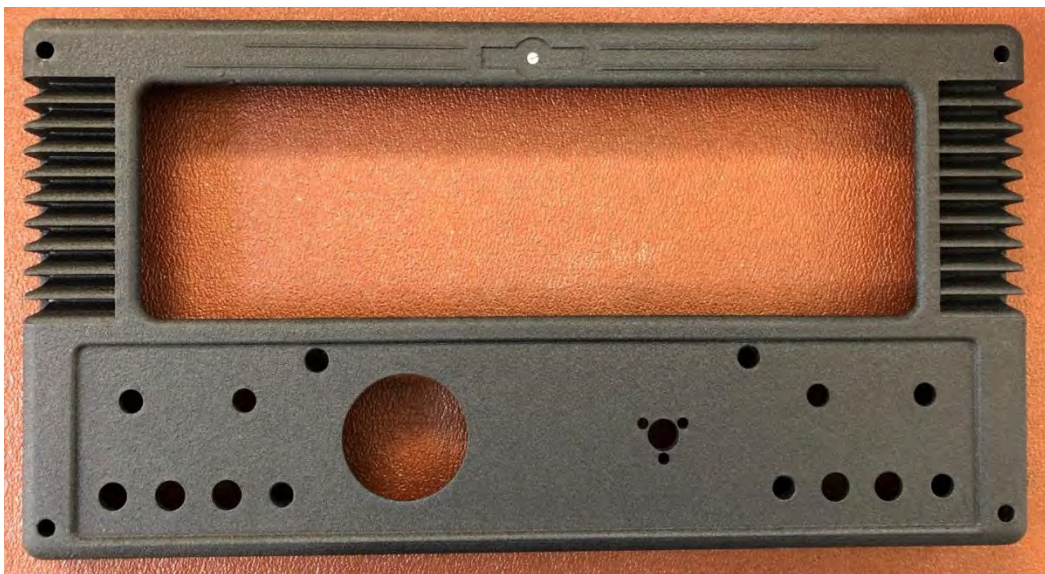
I had painted the original (silver hammer finish) front panel in 2006 using black wrinkle finish spray paint (can) as the original finish was in poor shape. Shortly after doing that, and putting the set back together, I was given an S.750 front panel by a friend at the SPARC Museum in Coquitlam, BC (from a parts set). I had this one sand-blasted and re-finished in black wrinkle powder coat (photo, below left), planning on changing it out for the re-painted one as the powder-coated one looked really great. Changing the front panel out on an Eddystone set of this style only takes about an hour or so (if you

know what your doing), but as I was a busy guy and the one that I had re-painted looked ok, albeit not as good as the powder coated one (and not as durable), I decided to pack it away and one day I would ‘get around to it’. Of course, I never did...

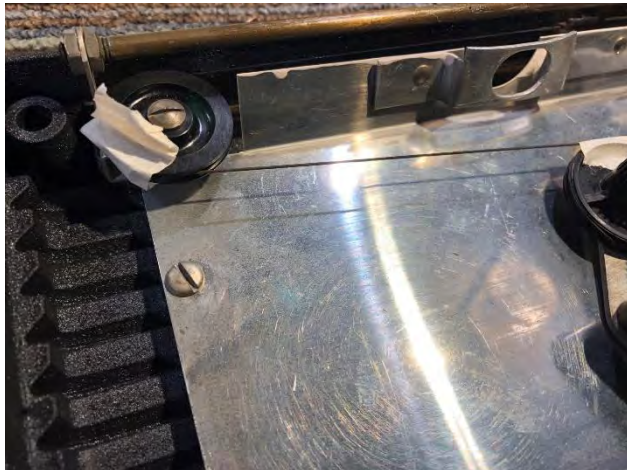
First though, I needed to transfer the drive mechanism/gearbox and dial to the replacement front panel. This is a fairly straightforward process – the main thing to be aware of is to use some small pieces of masking tape to temporarily hold the dial cord onto the four pulleys (photo, left) - two spool pulleys and two idler pulleys – if this is not done, it means a lot of cursing and wasted time while you try to do this from scratch when re-assembling.
