A Story about an Eddystone 888A

Introduction

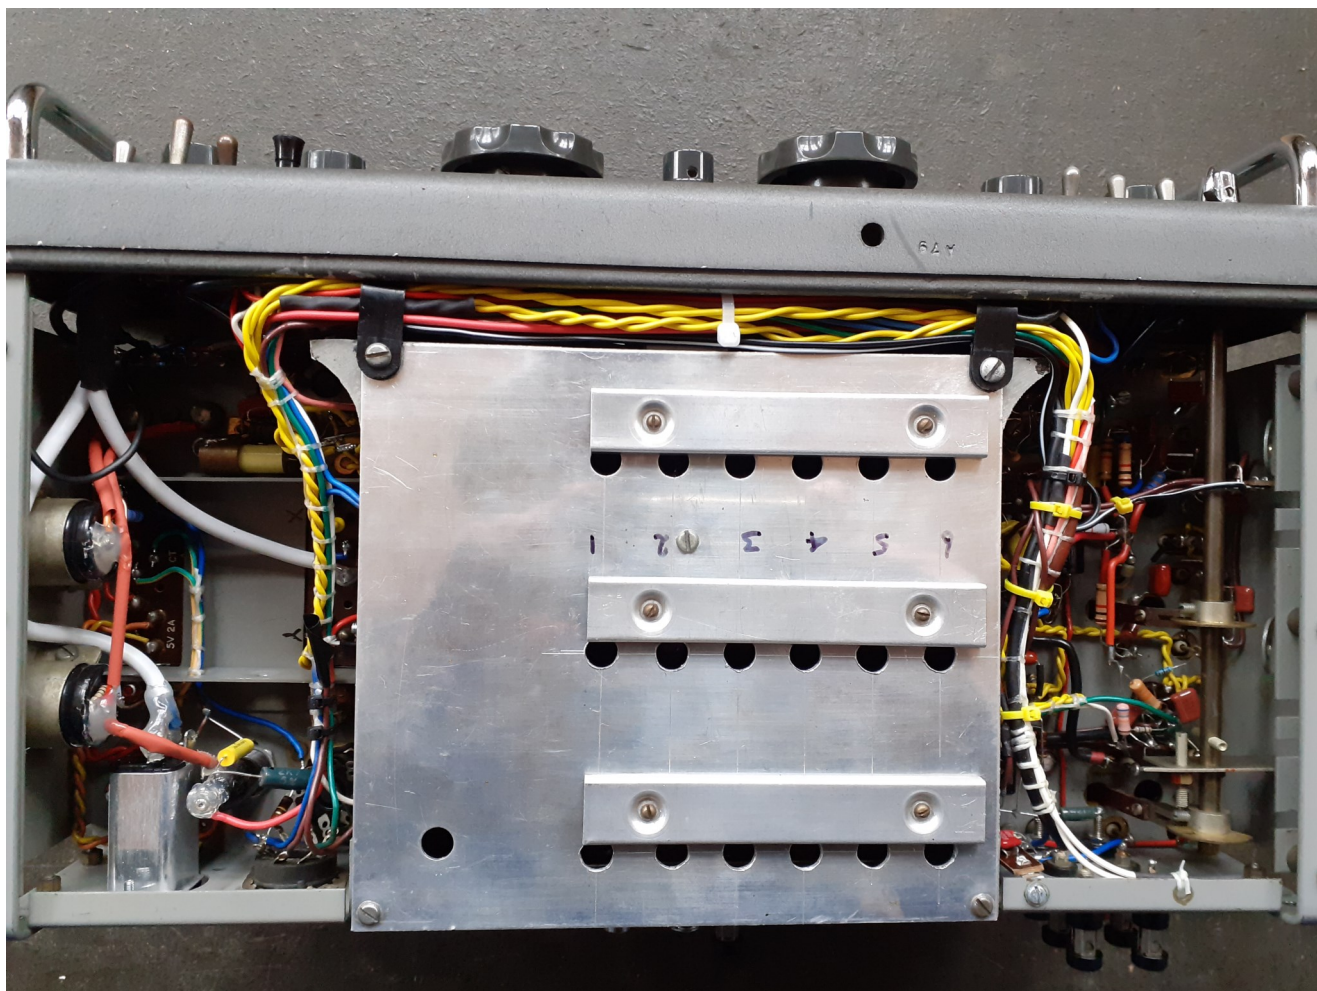
By the end of the second week, I was feeling quite cheerful; good progress had been made and my 888A was all back together and looking good.

The mains input wiring had been sorted and made safe; the power supply had been refurbished and was working, ready to power the receiver; the hard-to-access components behind the front panel had been changed; I had changed all the other components that had looked to be damaged or just suspect; and, all the mechanical components had been cleaned and lubricated. I had tested the repaired heater wiring and confirmed that it worked correctly and all the valves had heaters which worked.
