Refurbishing an Eddystone Model S830/2 Communications Receiver – Gerry O'Hara

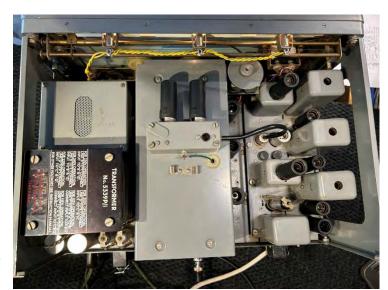
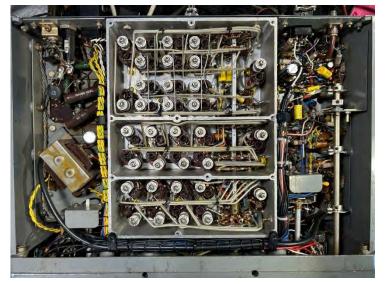
The S830 sets have a very robust construction, mainly of heavy-gauge painted steel. Photos of the S830/2 prior to refurbishing, are shown right (top of chassis), and below (under chassis with the coil box cover removed). The Appendix includes above and below chassis layout diagrams.

The owner (or a previous owner) of the S830/2 has replaced quite a number of components (underchassis photo on page 5), comprising some paper capacitors, electrolytics and a few resistors, but missed replacing several critical paper capacitors in the coilbox (the well-hidden, almost impossible to get to grey Dubilier or 'rat poop'-shaped ones), and the resistors around the cascode RF stage — especially the two 100Kohm bias resistors on the 2nd triode grid, which, if drifted significantly apart and/or high in value can make the set very 'deaf'.

It looked like the dial lamp holders had shorted at some time, as the wiring to them had partially-melted insulation (photo, right). Although the dial lamps were currently working, this damaged wiring needed to be replaced for long-term reliability. I also noticed that a resistor had come adrift off the rear of the calibration push-switch, although this was not the cause of the calibrator switch not functioning (I tested the switch and it was open circuit - a common issue with these sets). The wiring in that area of the chassis, ie. around the calibrator switch and RF/IF gain controls, had been hacked quite a bit.

Given the owners expectations, I decided to replace (almost) all resistors and any remaining paper and electrolytic capacitors in the chassis, and make an overall much tidier job of things (component and lead

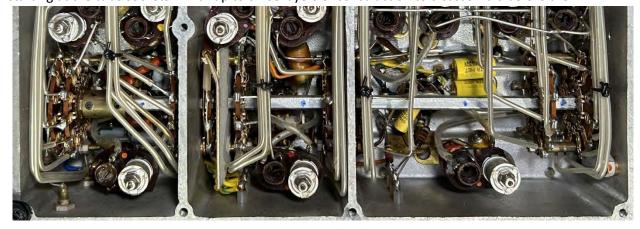
The RF amplifier, 1st mixer and 1st local oscillator stages of the S830/2 (photo below, before rework), are by far the most difficult areas to work in due to the way Eddystone constructed these stages, ie. in layers starting at the tube sockets – with up to three layers of construction to disassemble before the

components right next to the tube sockets can be reached. Also, the space available to work in is very limited. especially in the $\mathbf{1}^{\text{st}}$ mixer and $\mathbf{1}^{\text{st}}$ local oscillator compartments, and there are several wires connecting the tuned circuits to the band change switch wafers running across these compartments, which are better not disturbed if possible.

To gain reasonable access, the band change switch shaft and coupler to the switch detent mechanism need to be removed, and then it's a case of 'slowly, slowly, catchy monkey'. In order to meet the owners expectations, and to mitigate having to access these areas of the chassis again for some time (hopefully!), I decided to replace all paper capacitors and resistors, leaving only the (generally very reliable) Philips 'mustard' (polyester dielectric), silver mica, and tubular ceramic/disc ceramic capacitors in place.

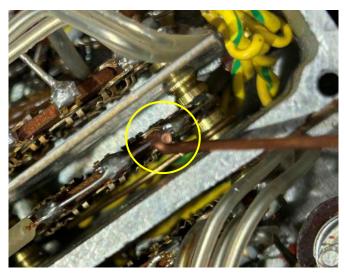
With the above completed and re-re-checked, I re-installed the band change switch shaft, having to make a tool out of a length of stout wire to pull some of the detent springs into place (tip of this tool circled in photo, right). I then carried out some resistance/continuity checks of the RF sections - all checked out ok, apart from the plate supply connection to the 1st mixer tube – this was open circuit. I traced the fault to the connection from the short piece of coax that runs from the plate of that tube (6AK5, pin 5) to a section of the band change switch ('S1f'). The contacts on this switch wafer change the source of the plate

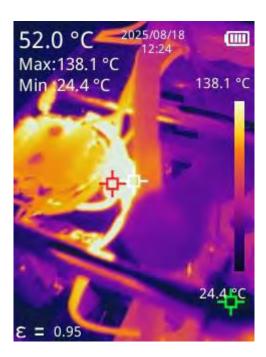
The chassis was placed on soak test for a few hours to make sure everything was stable and working ok in the RF sections – all seemed ok, though some thermal images taken identified that the two 47Kohm 1W resistors from the 240vDC B+ supply to the RF and IF gain controls were running very hot (138C) – image, right. I calculated that these were dissipating 1.2W. Why Eddystone underspec'd these parts is a bit of a mystery - anyway, I replaced them with 2W parts for reliability. I also cleaned the band change switch contacts before leaving the chassis on soak test for several more hours. The only issue noted, apart from the inability to fully defeat the audio with the AF gain control, as noted above, was some intermittent instability (parasitic?) when both RF and IF gains were fully advanced. I decided to leave troubleshooting this until I had completed component replacement in the IF/AF stages and checked alignment.

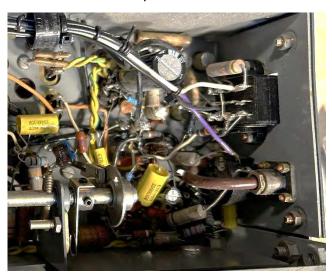
detector diode and grid of the triode in the 6AT6 tube? I then started to suspect that there may be an issue in the audio stages. So, next, I completely re-built this area of the chassis - several components had already been replaced (photo, left), and the workmanship and component dress was really bad, with shorts occurring with the slightest movement of some parts or wires, and several components were completely obscuring the underside of the 6AT6 tube socket. I took my time and tried to replicate the original factory (very 'regimental' and neat) component dress, replacing all resistors and paper/electrolytic capacitors. I also

had to remove/strip and re-attach a couple of the miniature screened leads as the braid was frayed, and was almost shorting to the inner wires. While doing this rework, I found that someone had made an error in the wiring during previous component replacement, such that the cathode of the 6AT6 was not bypassed correctly. I have found in all S830 sets I have worked on that providing good cathode bypass is essential to minimize the audio breakthrough in the 6AT6. The original circuit has two cathode resistors to this tube in series (3.3Kohm and 6.8Kohm) providing the delayed AGC action, the 3.3Kohm resistor bypassed with a 10uF electrolytic and the 6.8Kohm resistor bypassed with a 25uF electrolytic. This results in these cathode bypass capacitors being in series, giving in an effective bypass capacitance of only around 7uF. I have found that increasing the value of these capacitors significantly reduces the audio breakthrough in the 6AT6. I had to use values up to 220uF in place of the 25uF part on one set, and add a 100uF directly between the cathode and ground on another to fully 'quiet' the set with the AF gain control turned fully CCW. The optimal values seem to vary with each set, so I started out here by doubling the original values, ie. with a 22uF and a 47uF capacitor in place of the 10uF and 25uF parts. These parts are easily changed-out if this is needed, especially if radial lead parts are used. Another odd mistake made by someone, this time in the audio output stage, was that a 33uF 450vw electrolytic had

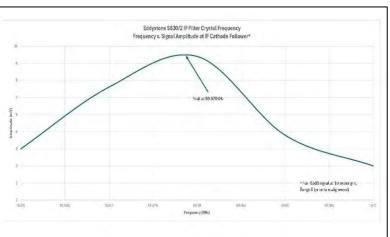
So, instead, I used my HP8656B (digital, GPS-controlled) signal generator to determine the crystal frequency (photo, above). However, this unit has a frequency step of 10Hz, so to accurately determine the resonant frequency of the crystal, I plotted the output level of the 100KHz IF cathode follower stage against frequency. A plot of the results is shown right, which indicated that the series resonant

frequency of the crystal to be 99.978KHz (coincidentally, this is the same resonant frequency as the 100KHz crystal in one of the 830/4 I owned and measured back in 2011).

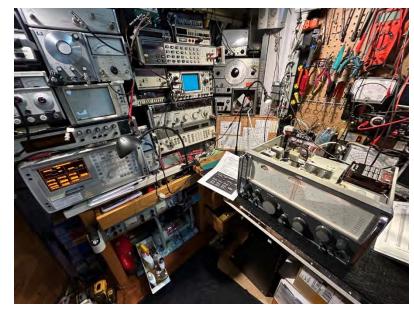
The published spec. for this receiver is for a SNR of >15db with a 3uV signal on all bands – this set was now easily meeting that, and exceeding it by a very large margin across most of its range (up to 8dB better than spec. on Band 8), with a 1uV signal achieving an AM SNR of >12dB.

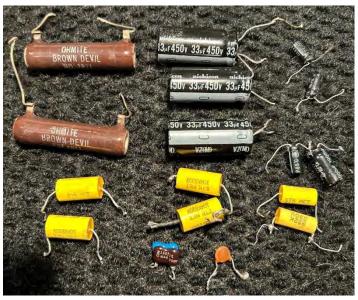
Top of page: testing the 100KHz crystal using a NanoVNA (not very successfully due to limited resolution of the NanoVNA!). Above left: the GEC 100kHz crystal used for the IF filter in the S830/2 (left) and a spare (Marconi) 100KHz crystal used for comparison. Above right: parts removed from the S830/2 (most of them). Left: some previously-replaced parts that were removed can be re-used in other projects. These were removed as they were either the incorrect value, incorrect type, or their leads were too short to dress correctly in the chassis

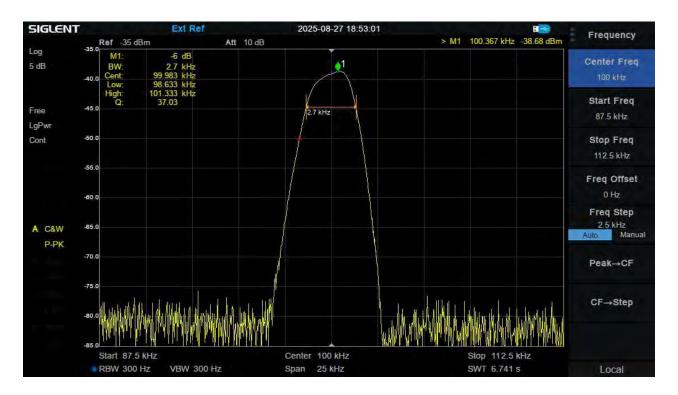
Above: 100KHz IF response on 'AM' setting of the Selectivity control (5.37KHz @ -6dB). This was subsequently tweaked to provide a 6KHz bandwidth and a flatter top to the response curve. Below: 100KHz IF response on 'SSB' setting of the Selectivity control (2.7KHz @ -6dB)

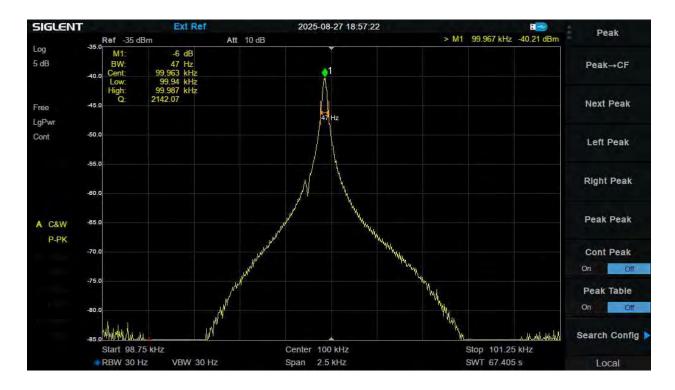
Above: 100KHz IF response on 'CW' setting of the Selectivity control (1.23KHz @ -6dB). This was subsequently tweaked to provide a 1.3KHz bandwidth. Below: 100KHz IF response on 'N' (crystal) setting of the Selectivity control (47Hz @ -6dB). This was subsequently tweaked to provide a slightly wider (73Hz) bandwidth.

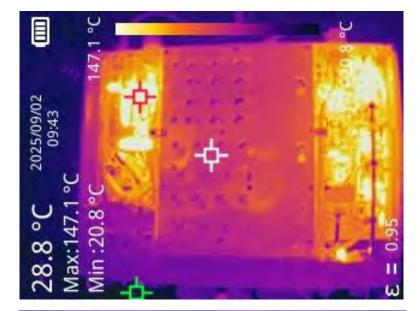
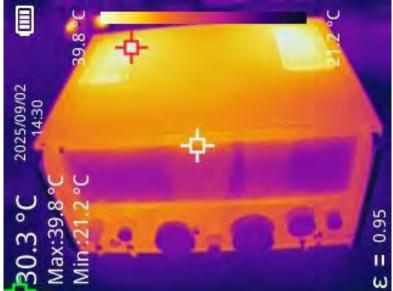
Above left: thermal image of the underside of the (inverted) refurbished chassis after 2 hours operation. The hot spot is one of the dropper resistors to one of the OA2 150v stabilizer tubes (around 147C). Below left: thermal image of the refurbished S830/1 in its cabinet after 2 hours operation. The hot spot is the perforated ventilation plate above the audio output tube (around 40C). Below left: thermocouple measurement of the inside case temperature above the 2nd IF/AF sub-chassis after 2 hours operation in the cabinet (around 40C, 105F). Below right: thermocouple measurement of the inside case temperature between the power transformer and the 2nd mixer/2nd local oscillator subchassis after 2 hours operation in the cabinet (around 34C, 93F).
