## Unusual Instability Issue on a Refurbished Eddystone S830/2 – Gerry O'Hara

### Instability Noted

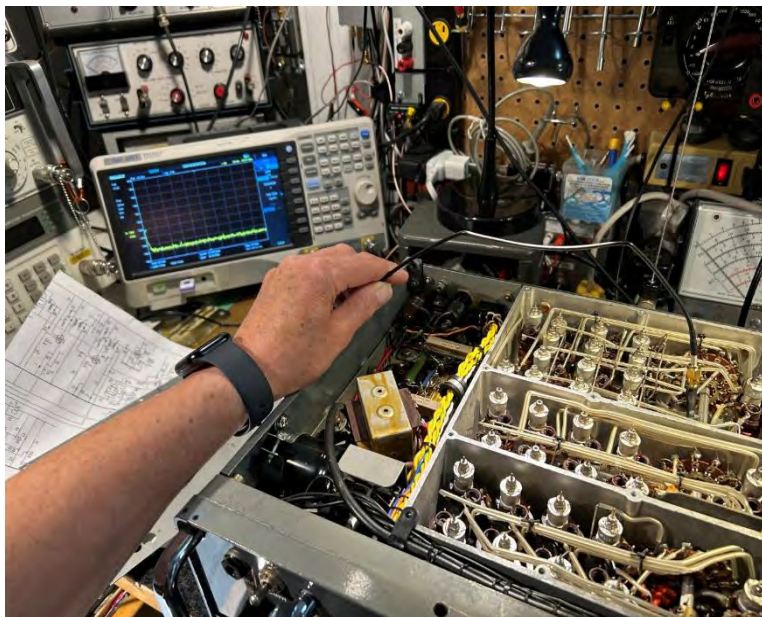
Following this, I 'sniffed around' in the three coilbox compartments using an e-field probe and the Siglent spectrum analyzer to see if any other unusual RF signals were present that could indicate instability at various setting of the 'Peak RF' control (photo, right) – nothing untoward was observed.

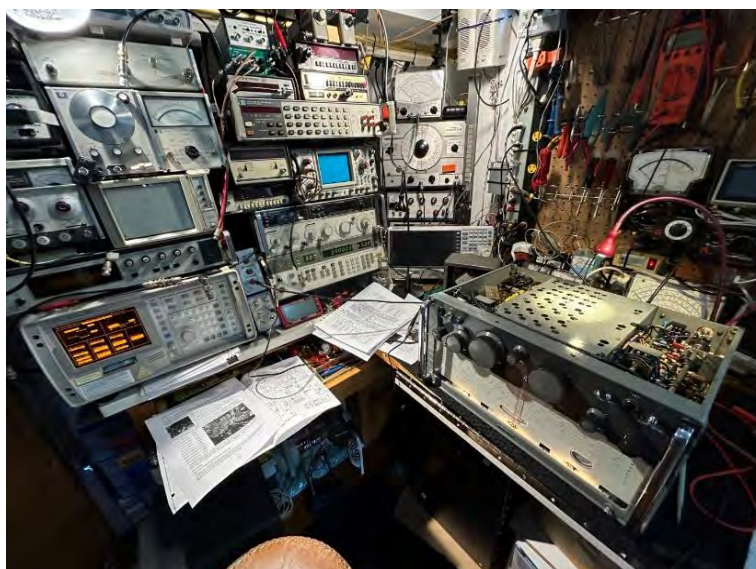
Following the realignment, I re-checked the SNR of the receiver at the same frequencies on each of the bands as I had previously, and obtained almost identical results on the dual-conversion bands, and significantly better results on the single conversion bands. This is likely due to the ECC189 having a higher gain/lower noise than the E88CC in this application, giving the improved results on the single conversion bands, the additional noise added by the 2nd mixer stage tending to mask this in the dual conversion results. That said, all the results easily exceed the S830/2 spec. of 15dB for a 3uV signal on AM with a 3KHz (SSB) selectivity setting. So, using the correct dual-triode in the RF stage is definitely recommended, especially if interested in frequencies below 1.5MHz. Results as follows, together with a comparison to the previous results, obtained with the E88CC tube installed (all with a 3uV signal from an Agilent 8935 test set as noted in the refurbishment article referenced earlier – photo, right):
