Unusual Instability Issue on a Refurbished Eddystone S830/2 – Gerry O’Hara

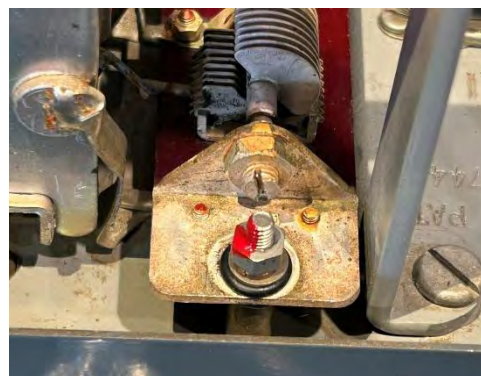
attached to the screw on the top of the chassis. The rubber grommet that the screw passes through on the end bracket of the assembly was perished (hardened) – photo, above left, so I replaced that as well (photo, right). None of this effort made the slightest difference to the motorboating (of course!), but at least the 'Peak RF' assembly is working well and secured properly on a resilient mount.

It would be very difficult to replace this nut and lock-washer due to the very poor access without removal of at least the Band 1 antenna coil assembly, and likely disconnecting several wires running to other antenna coil assemblies. So instead, I inserted the screw from within the coilbox, with the lock-washer and nut then being easily

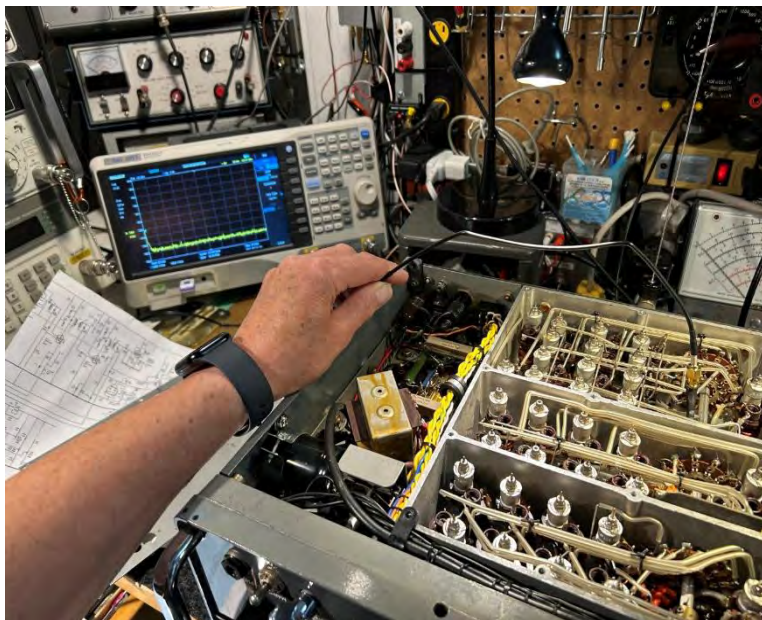
Following this, I 'sniffed around' in the three coilbox compartments using an e-field probe and the Siglent spectrum analyzer to see if any other unusual RF signals were present that could indicate instability at various setting of the 'Peak RF' control (photo, right) – nothing untoward was observed.

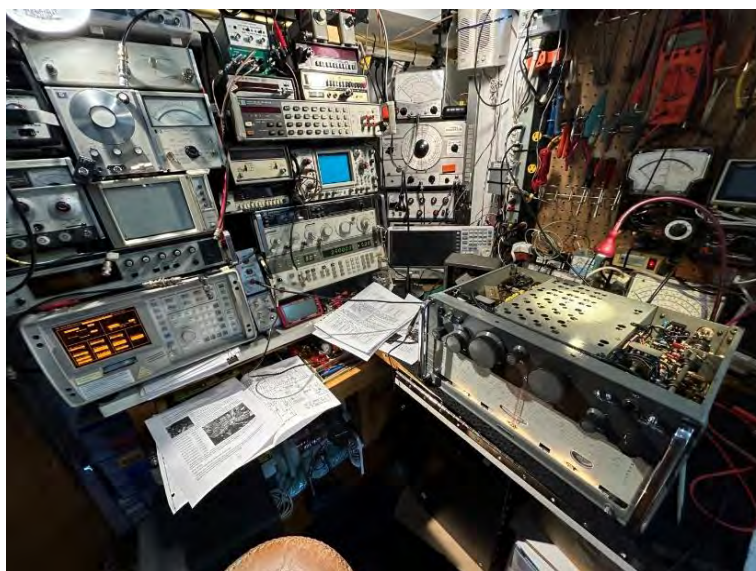
Following the realignment, I re-checked the SNR of the receiver at the same frequencies on each of the bands as I had previously, and obtained almost identical results on the dual-conversion bands, and significantly better results on the single conversion bands. This is likely due to the ECC189 having a higher gain/lower noise than the E88CC in this application, giving the improved results on the single conversion bands, the additional noise added by the 2nd mixer stage tending to mask this in the dual conversion results. That said, all the results easily exceed the S830/2 spec. of 15dB for a 3uV signal on AM with a 3KHz (SSB) selectivity setting. So, using the correct dual-triode in the RF stage is definitely recommended, especially if interested in frequencies below 1.5MHz. Results as follows, together with a comparison to the previous results, obtained with the E88CC tube installed (all with a 3uV signal from an Agilent 8935 test set as noted in the refurbishment article referenced earlier – photo, right):

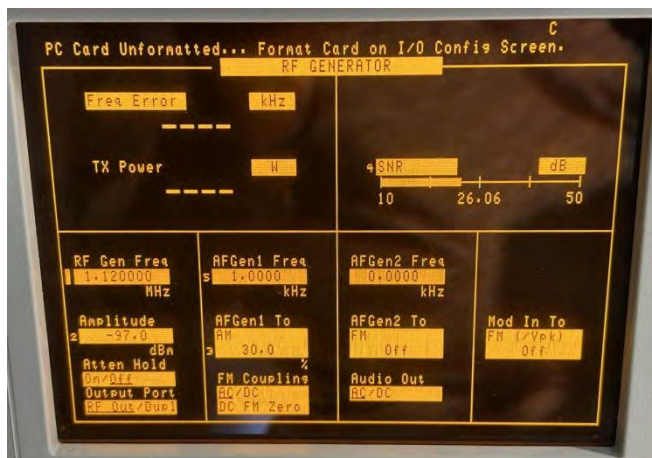
E88CC	ECC189
Band 1 (30MHz):	>16dB	>17dB
Band 1 (23.5MHz):	>20dB	>20dB
Band 2 (14.5MHz):	>21dB	>20dB
Band 3 (8.8MHz):	>21dB	>21dB
Band 4 (5.3MHz):	>21dB	>21dB
Band 5 (3.2MHz):	>19dB	>20dB
Band 6: (1.95MHz):	>21dB	>21dB
Band 7 (1.12MHz):	>22dB	>26dB (screenshot of Agilent SNR measurement on this band above)
Band 8 (650KHz):	>23dB	>26dB
Band 9 (450KHz):	>22dB	>26dB
