Serendipity - Restoration of an Eddystone S.358X for the SPARC Museum Collection, by Gerry O'Hara, VE7GUH/G8GUH

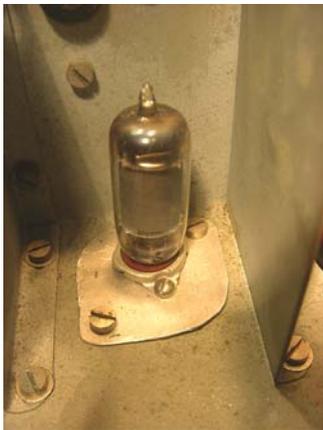
- A Q-multiplier fitted to the converter stage – built on a small aluminium sub-chassis (ok, ‘chassis’ is probably too grandiose a term, a better one would be ‘bracket’ – photo, right) mounted beneath the front panel meter. The circuit was built around a dual-triode (an ECC82 (12AU7)) ;

front panel with a couple of screws and by its toggle switch. One control for it passed through the panel where the meter switch used to be. The heater and HT supplies were fed via a three-way plug and socket mounted on the main chassis (very 'professional') and the signal leads through holes drilled in the chassis (still with drilling burs on them).

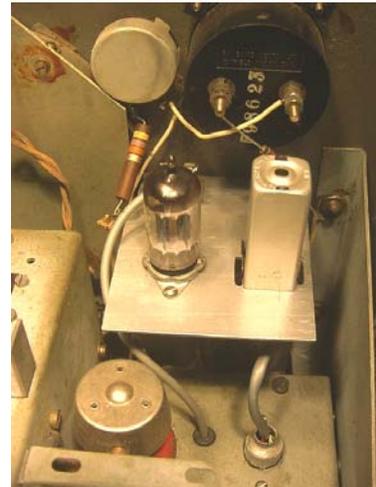
- Octal RF stage valve (EF39) changed to a miniature type (6BA6) and associated passive components changed (photo, left);
- Un-tuned RF stage fitted (missing a valve - 6BA6?) – located in the space on the chassis behind the original RF stage (photo, below);

Having got rid of the extra bits, the next job was to reverse the modifications. The RF stage was the first – I removed all the components, including the B7G valveholder and (very-homebrew) adapter plate, installed an International Octal valveholder and then rebuilt the stage using all-new parts (630v

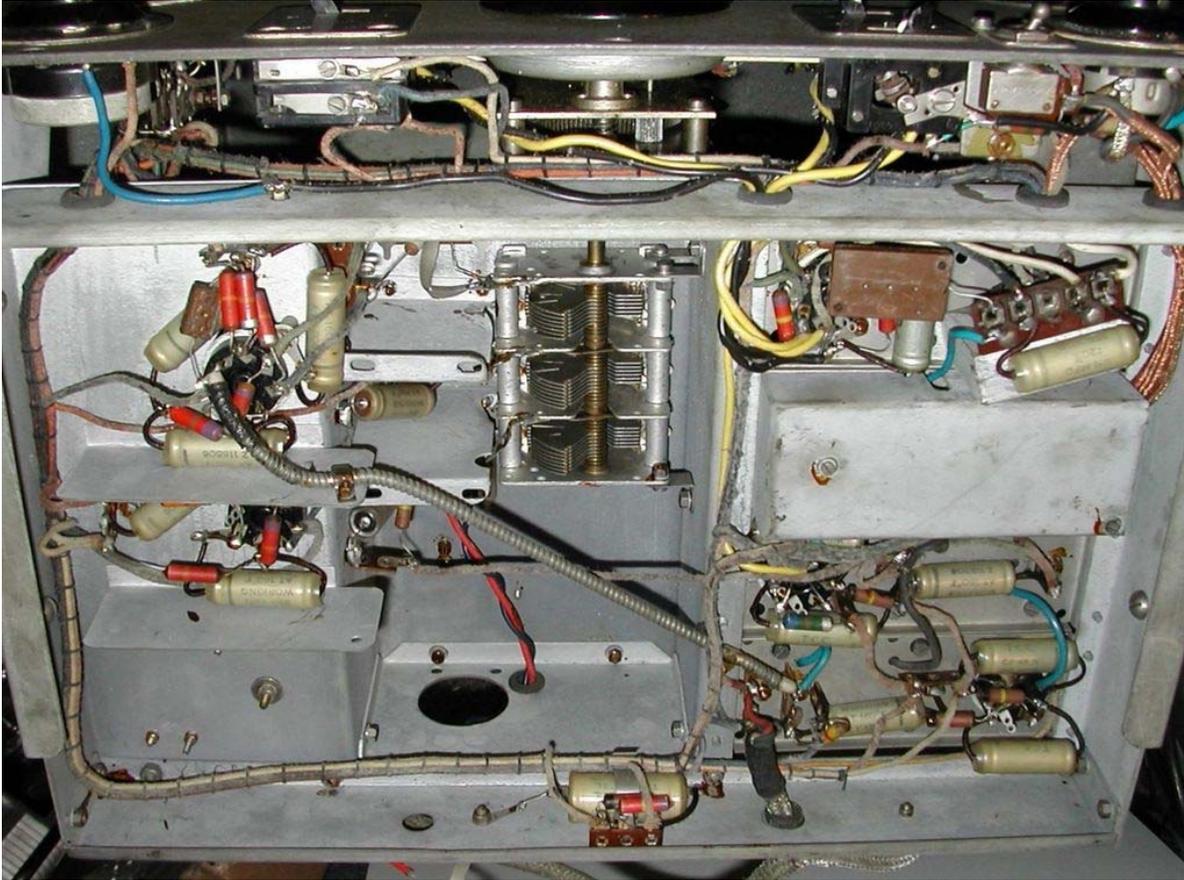
Above: under-chassis view of one of Alan Ainslie's S.358X sets in (almost) ex-factory condition. Not the screen covering the detector stage on the right (missing on the SPARC museum's set) and all those large 0.1µF by-pass capacitors

In order to retain a semblance of how the set looked originally, I asked Alan Ainslie⁴ if he could take some detailed photos of an S.358X in reasonably original condition (photo, above), which he most kindly did (thanks Alan!). These photos were very useful during the restoration, however, I must admit to using some 'artistic license' in dressing components, particularly where smaller replacement parts allowed shorter grounds etc.

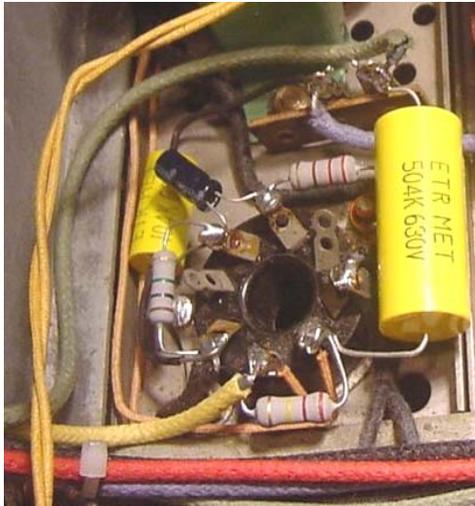
rated metalized poly film capacitors and metal-film 1 Watt resistors) – photo, right.

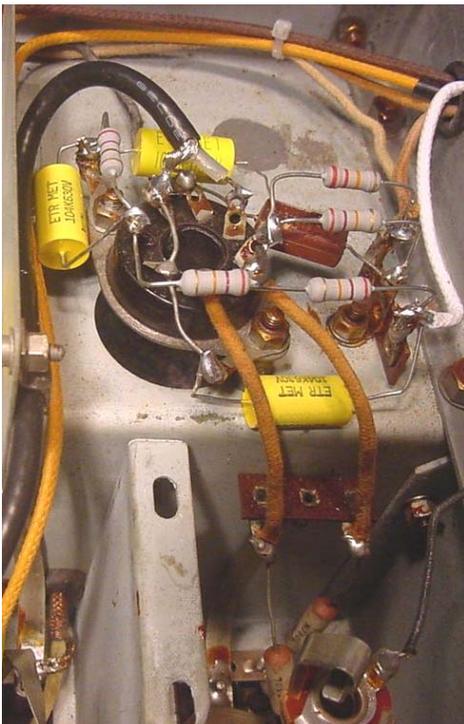
I then decided to start the main electronic component replacement work, together with re-wiring where needed. Having already completed the RF stage work, I started on the mixer/local oscillator stage (photo, left), working my way back through the set towards the audio output stage (which I had also already completed). I took my time, carefully dressing the components and wiring to be at least as neat as the original would have been when 'Bath Tub fresh'. Once the main under-chassis component replacement work had been

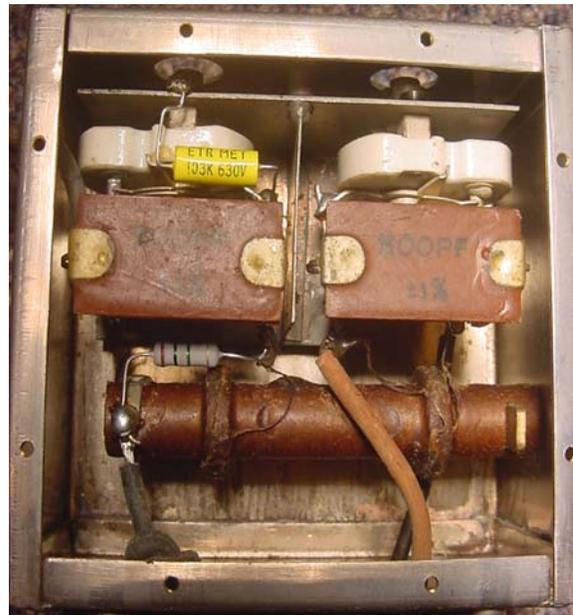
The BFO is housed in a separate compartment (box), mounted on the front panel. This was opened-up and resistors/paper capacitors replaced, along with the heater and HT flying leads. The variable capacitor was cleaned with De-Oxit, adjusted to mid-travel and the shaft marked such that I knew what setting the capacitor was at once re-assembled.

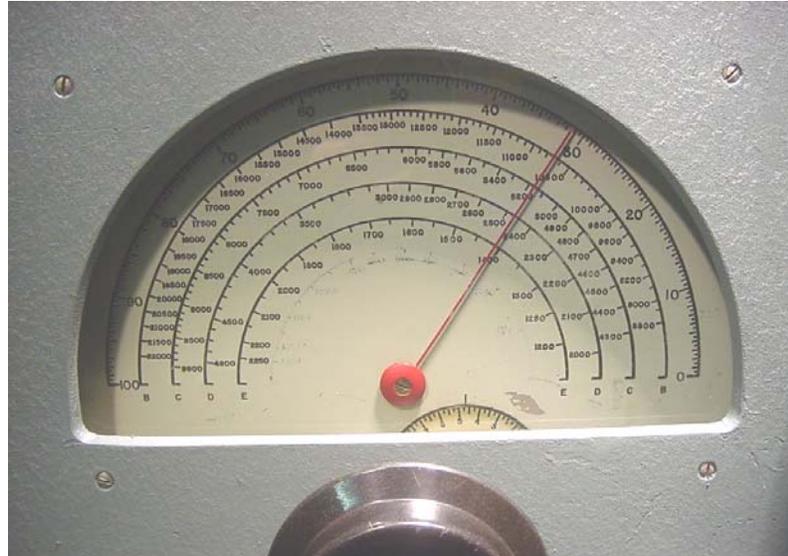
The (rather thick) dial glass was cleaned using lens-cleaner fluid and the scale cleaned using warm soapy water and a cotton wool pad. Unfortunately the scale has had two additional ranges scratched into it: most of the Broadcast Band (Range 'F'), on the inside of the five factory-engraved ranges ('B' through 'E' plus logging scale), and Range 'A' (21 MHz to 32MHz) to the outside of

the logging scale engraving. I decided to leave these 'as-found', along with a scuff mark present near the bottom of the scale plate that had removed the paint. In my opinion, the only really satisfactory remedy for this degree of damage to such a highly-visible part of the set would be to remove all the original paint from the scale/engraving and repaint the entire scale white, along with re-filling the engraved markings with black enamel paint. I decided that the visual appearance as-found was more acceptable than risking making a mess of such an extensive cosmetic job – at least for the time being.

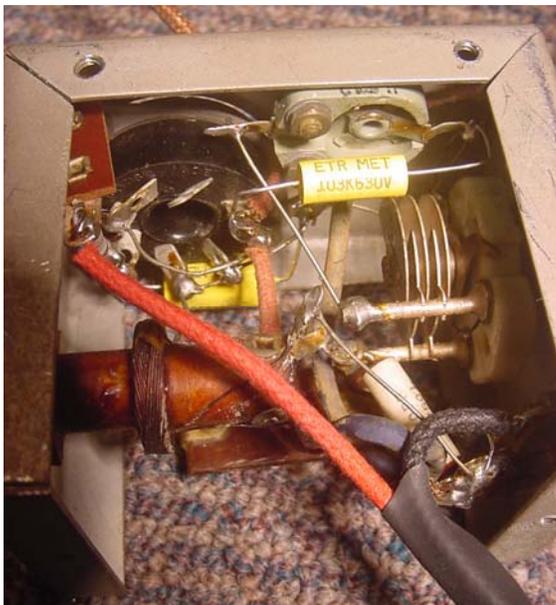
Above: BFO unit with new resistors and capacitors fitted. Note new flying leads

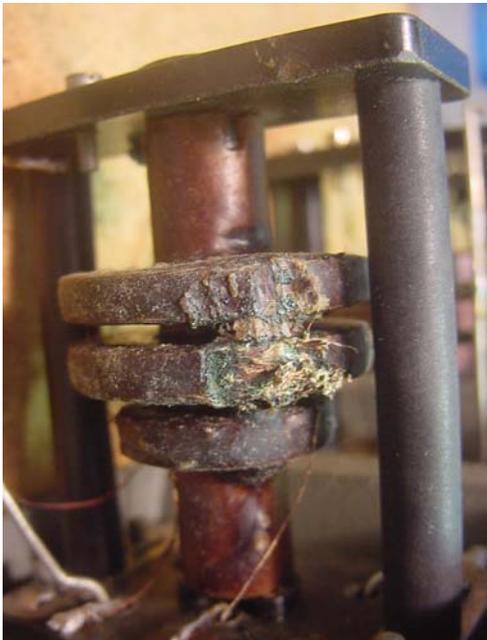
where I found the aerial tuned circuit trimmer missing (a ceramic type) – it had simply been removed and no attempt made to bridge-over the tuned circuit with a capacitor had

been made – I concluded that someone had 'robbed' the part to replace a trimmer in one of the more-frequently used coilpacks, and that they had not been interested in using Range 'I'. Then I opened-up the Range 'J' coilpack, only to find that all of the tuned circuit trimmers (except the padder) had been removed. Nothing was found that was an exact match for these ceramic trimmers in my junk box, but I tried some

air-spaced ones as a stop-gap – these just squeezed in between the coil formers and the upper housing of the coilpack when re-assembled. In addition, I noted that one of the prongs was broken off the 5-pin aerial plug (one of the aerial connections). To fix this I removed an adjacent earth prong (not really essential) and relocated it in the correct position, gluing it in place with epoxy. I then noticed that the aerial coil had been damaged (photo, left) by someone attempting to drill the old prong out at some point (aaargh! was there no end to that maniac's ineptitude?) – of concern was that there were several of the extremely fine Litz wires sticking through the damaged section of coil – virtually impossible to repair – so I decided to just

leave it and see what happened when I tried to tune the circuit (the aerial coil could be bypassed if needed, making the RF amplifier grid circuit aperiodic – probably not a big deal at these low frequencies);

where I found some suitable ceramic 7 – 45pF trimmers in the ‘spares warehouse’. These were an exact fit, so the (now very) temporary air-spaced ones were removed and the ceramic ones fitted to the Range ‘I’ and ‘J’ coilpacks (photo right);

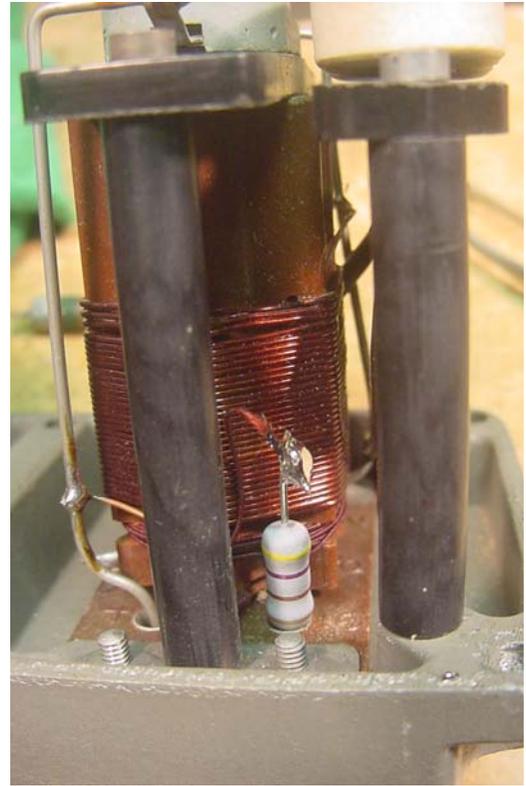
Above left: Five-pole plug on coilpack – proudly displaying ‘Eddystone Made in England’. Above right: New resistor fitted into local oscillator section of a higher-frequency coilpack. Left: broken coil former in same coilpack. Below left: chassis under repair – note LCD monitor behind – very useful tool in front of you in the workshop for pulling up schematics, manuals and photos of the set. Below: Rubberized insulation in the screened cables was in poor condition – replaced with new cloth-covered wire pushed into the original braided copper screen.

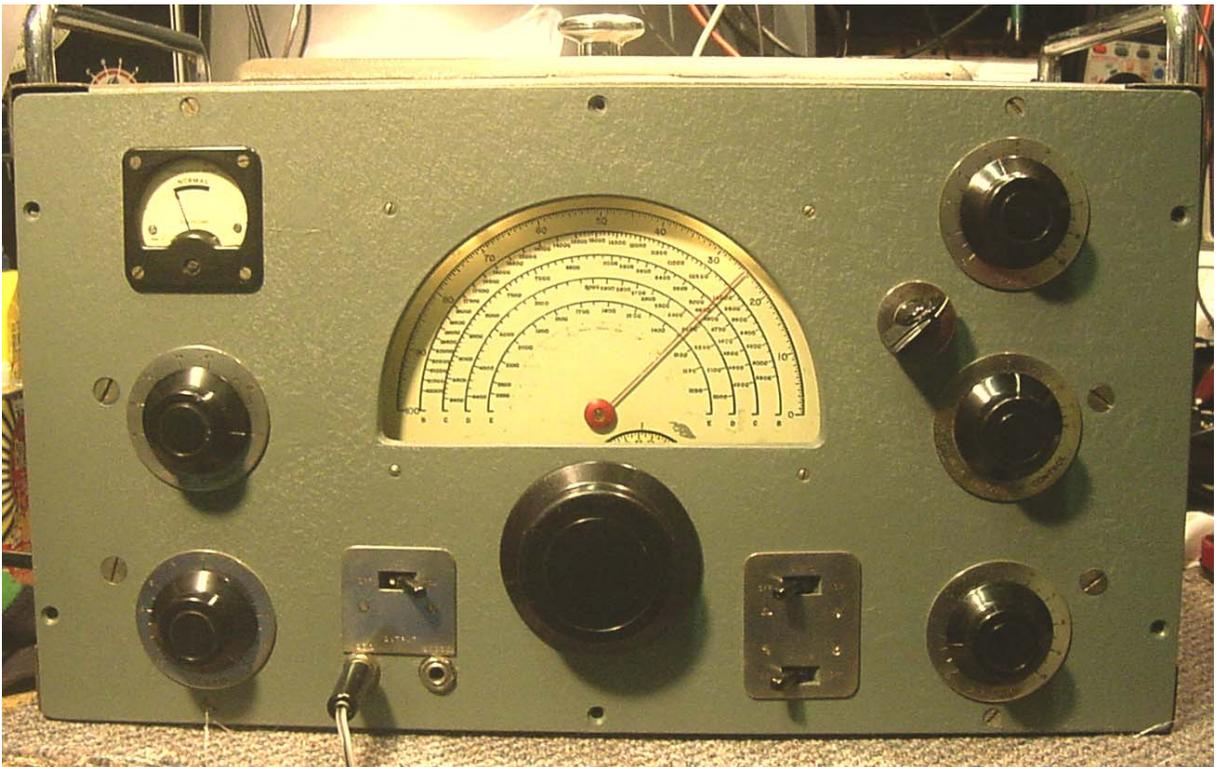
Above: View through the opened lid of the restored receiver. Below: Boxed-up, working well and ready for the rigors of a new life being gawked-at on display in the SPARC museum

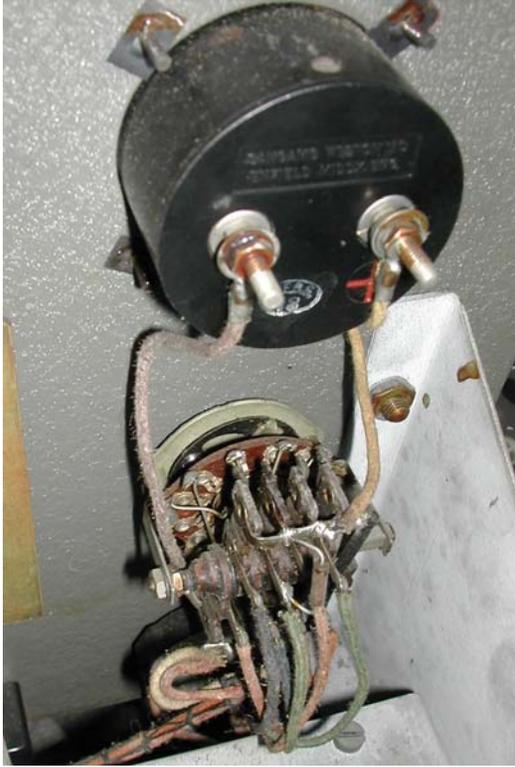
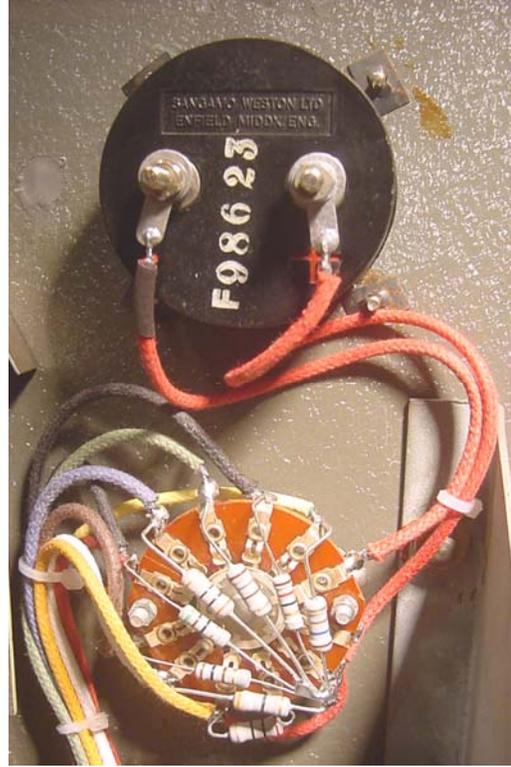
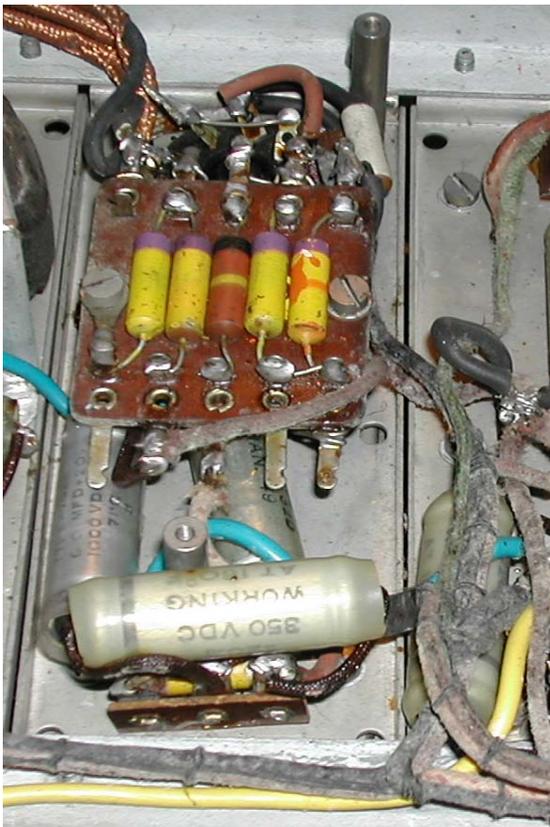
Above left: original meter shunts and switch (per Alan Ainslie's set), Above right, replacement meter shunt circuits in the SPARC museum set built using standard components. Below left: original detector/AGC/1st audio stage module (beneath the shield per Alan Ainslie's set), Below right: replacement components in the SPARC museum set

The next job was to restore the original anode metering wiring, switching arrangement and shunt circuits. The switch was missing, so I needed a single-pole, 8-way Yaxley type as its replacement. Not finding anything suitable in my junk box, I checked-out the parts store at SPARC. I did not find exactly what I needed, but managed to cobble-together a suitable switch using the indent mechanism from one switch and a 12-way wafer from another, installing a stop (a 6BA screw and solder tag) through the indent mechanism at the 8 way point. Now, what about those shunt resistors – the originals had been bespoke wire-wound types and not easy to replicate. A trip down to one of the local electronics stores on Main Street in Vancouver solved this – I managed to obtain stock value 5% resistors that were very close to the original values (some non-preferred values that they, luckily, had in stock) – all sold in packs of 10, so I was able to hand-select resistors even closer to the original fitment values. The finished arrangement is shown on the photo, right. Note that I used cloth-covered wire in various colours (obtainable from Radio Daze or Antique Electronic Supplies) for the new wiring harness, as well as for other re-wiring in the set, including replacement of the nasty plastic-covered assortment and some original fitment rubber-covered wiring. I used standard plastic cable ties to hold things together neatly temporarily (this also allows for changes to be made easily), but plan to eventually lace the wiring to get a more original look.

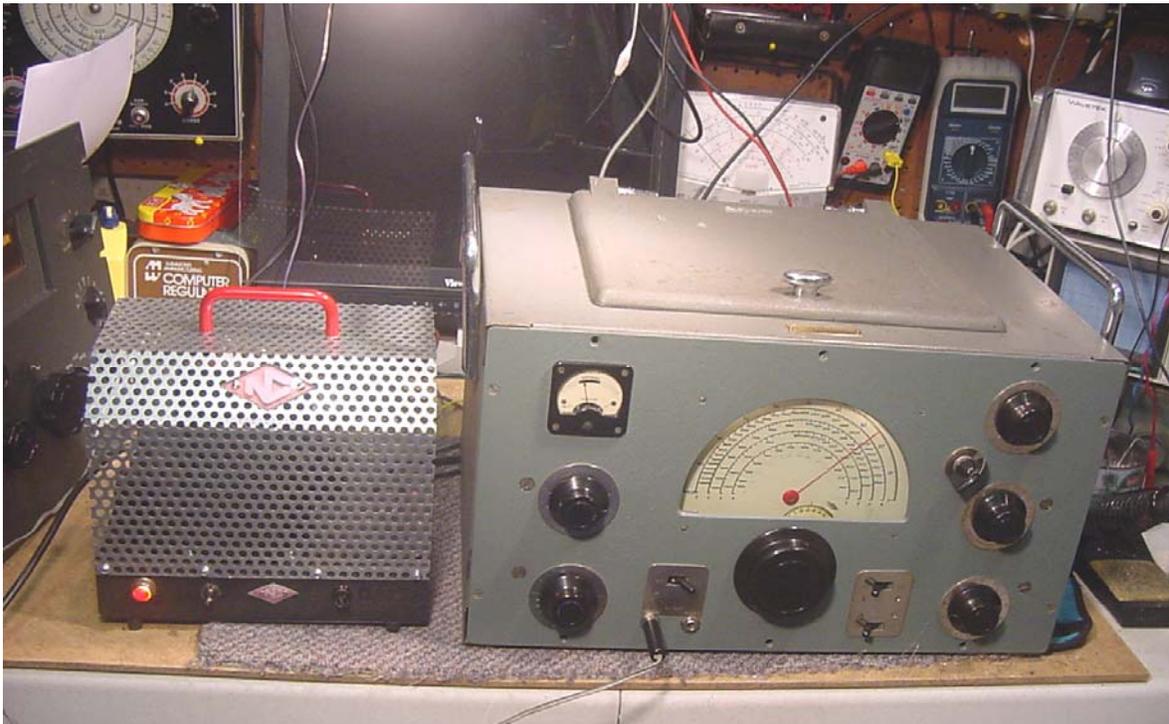
Below: my homebrew HRO power supply doing a stalwart job of running the S.358X.

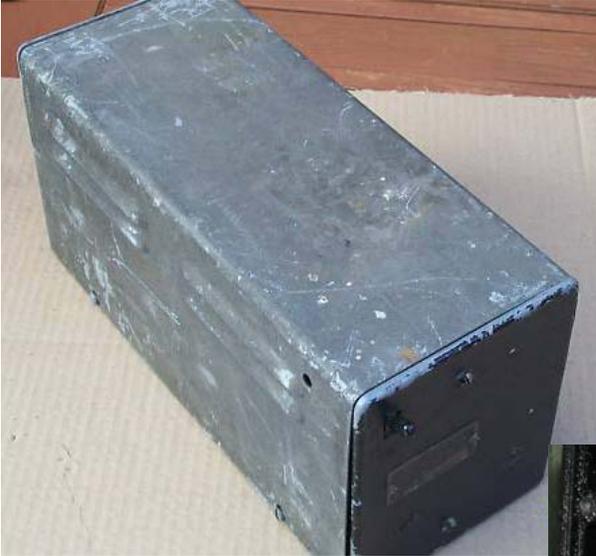
Two different power supply models were available for the S.358 series: the S.390 was the standard issue. Cosmetically, this is a no-frills utilitarian design (see photo, left from a

recent Ebay auction, where it is described as an S.451, although looks identical to the S.390B model in the manual, there described as a 'replacement unit' with the same electrical characteristics as the S.390. The S.451 is not mentioned in the manual or the QRG) – externally a steel box with louvers for ventilation, a power switch and indicator lamp. The circuit was equally no-frills, though the HT was well-filtered by two chokes and three capacitors.

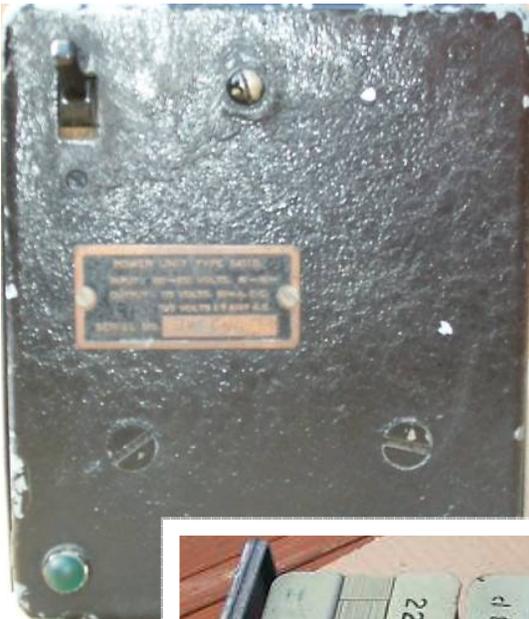
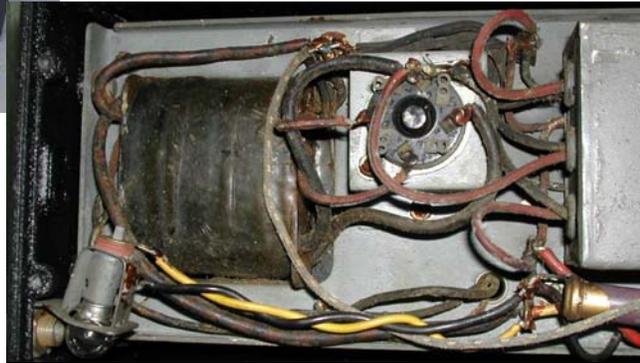
Above left: Power supply external appearance. Left: power switch and indicator lamp (bottom left), Above right, under chassis view (Alan Ainslie's set) – triple smoothing capacitor unit to the right, Below: above chassis view – power transformer to the right, rectifier (5Z4G) centre and smoothing chokes to the left.
